ACCIDENT

Aircraft Type and Registration:	Hawker Hurricane 1, G-HRLI	
No & Type of Engines:	1 Rolls-Royce Merlin III piston engine	
Year of Manufacture:	1940 (Serial no: 41H-136172)	
Date & Time (UTC):	1 June 2020 at 1203 hrs	
Location:	Duxford Airfield, Cambridge	
Type of Flight:	Private	
Persons on Board:	Crew - 1	Passengers - None
Injuries:	Crew - None	Passengers - N/A
Nature of Damage:	Landing gear and lower fuselage damaged	
Commander's Licence:	Private Pilot's Licence	
Commander's Age:	60 years	
Commander's Flying Experience:	850 hours (of which 8.3 were on type) Last 90 days - 1.4 hours Last 28 days - 0.2 hours	
Information Source:	Aircraft Accident Report Form submitted by the pilot and further enquiries by the AAIB

Synopsis

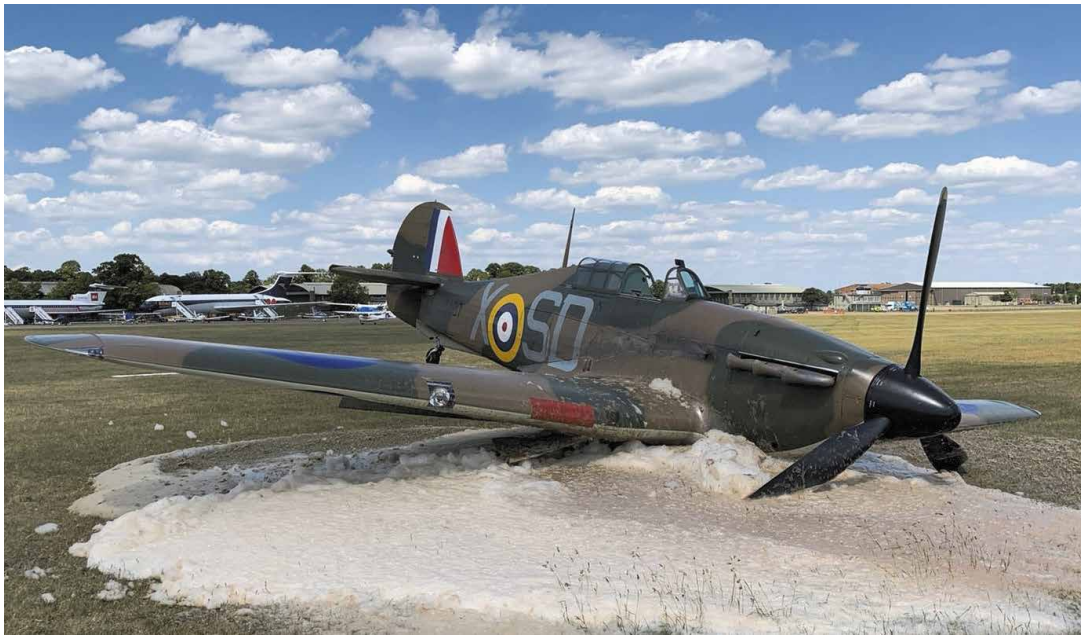
Figure 1

G-HRLI after the accident and application of fire-suppressing agent

An examination of the aircraft after removal from the accident site did not reveal any evidence of pre-existing mechanical defects that might have contributed to the loss of control or landing gear collapse.

When the aircraft bounced while turning to the right the tail lifted and it is likely most of the aircraft's weight was supported on the left mainwheel. The aircraft's momentum being largely in the landing direction, and its cg behind the mainwheels, the swing to the right became more pronounced and the aircraft began to slide in the landing direction. This exceeded the side loads for which the landing gear was designed, and it collapsed.

The pilot intends to conduct refresher training in a relevant dual control aircraft such as the Harvard before flying the Hurricane after a significant absence. The operator will amend its Operational Control Manual to require that pilots new to the type with less than 5 hours experience on equivalent types will be limited to a maximum 5 kt crosswind component from the right.

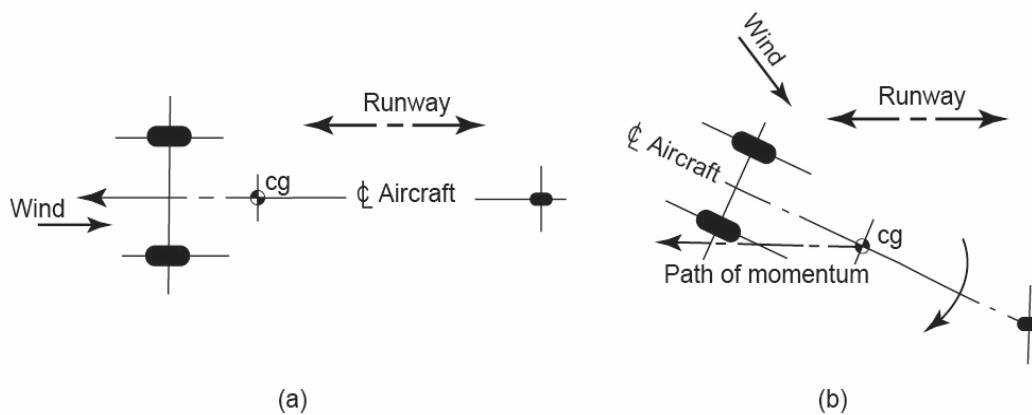
Figure 2

On the ground, in the absence of an opposing force, an aircraft’s vertical tail surfaces usually tend to turn it into wind or to ‘weathercock’.² This tendency is pronounced on tailwheel aircraft like the Hurricane whose main wheels are ahead of the aircraft cg, and may become uncontrollable if the cg moves beyond the edge of effective mainwheel contact (Figure 2).³

Diagram (a) shows the wind aligned with the landing direction. Diagram (b) shows a crosswind from the right. The aircraft has turned towards the wind and the path of momentum from the aircraft cg is at the outside edge of effective mainwheel contact. The castoring tailwheel is aligned with its path over the ground and provides little stabilising reaction. Without corrective control inputs the rate of turn to the right will increase. The further aft the cg, the more pronounced this effect will be.⁴

⁴ The aft position of the cg is exaggerated in diagram (b) to illustrate this.
