**ACCIDENT**

<b>Aircraft Type and Registration:</b>	1) Bristell NG5 Speed Wing, G-COLF 2) DH82A Tiger Moth, G-BAFG
<b>No &amp; Type of Engines:</b>	1) 1 Rotax 912ULS piston engine 2) 1 De Havilland Gipsy Major 1F piston engine
<b>Year of Manufacture:</b>	1) 2015 (Serial no: 14045-2762) 2) 1942 (Serial no: 85995)
<b>Date &amp; Time (UTC):</b>	12 July 2020 at 1350 hrs
<b>Location:</b>	Private Strip, Birdsedge, Yorkshire
<b>Type of Flight:</b>	1) Private 2) Private
<b>Persons on Board:</b>	1) Crew - 1                      Passengers - 1 2) Crew - 1                      Passengers - 1
<b>Injuries:</b>	1) Crew - None                  Passengers - None 2) Crew - None                  Passengers - None
<b>Nature of Damage:</b>	1) Wing and tailplane 2) Wing
<b>Commander's Licence:</b>	1) Light Aircraft Pilot's Licence 2) Air Transport Pilot's Licence
<b>Commander's Age:</b>	1) 81 Years 2) 37 Years
<b>Commander's Flying Experience:</b>	1) 1,117 hours (of which 455 were on type) Last 90 days - 16 hours Last 28 days - 8 hours  2) 10,000 hours (of which 3 were on type) Last 90 days - 1 hour Last 28 days - 0 hours

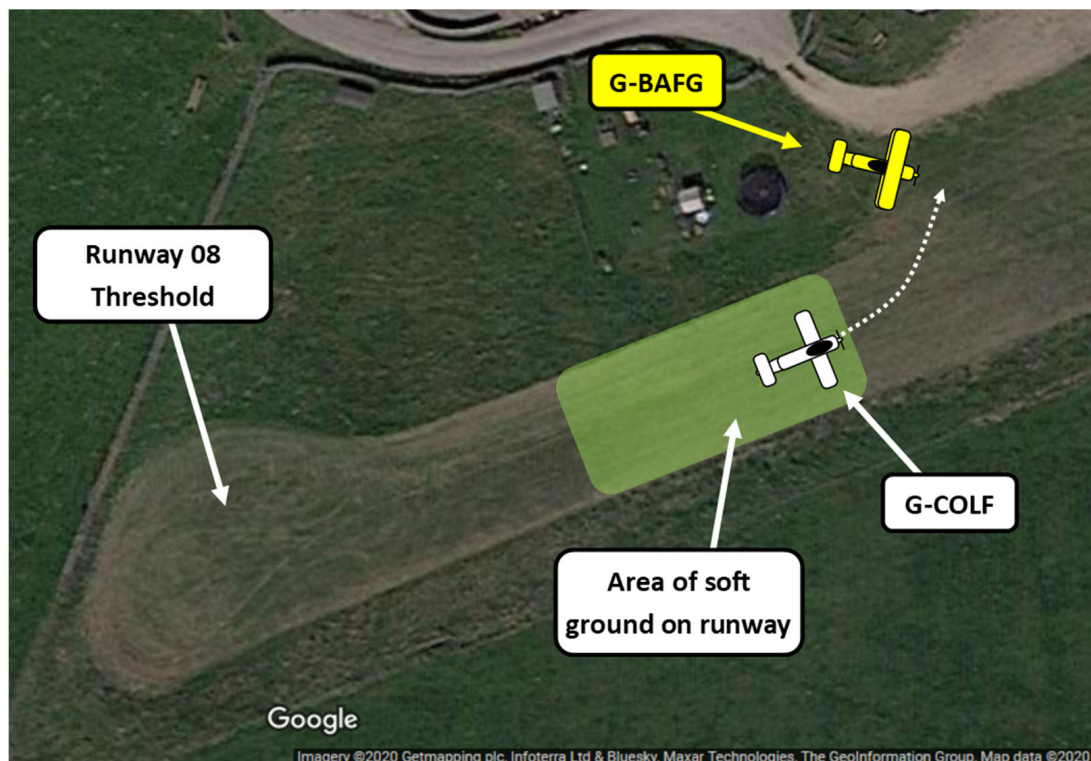
**Figure 1**

While backtracking, the pilot of G-COLF noticed an area of undulating soft ground across Runway 08 (Figure 1). After turning around at the threshold, he taxied forwards to position beyond the area before starting his takeoff. While crossing the soft ground the aircraft became bogged down and the pilot applied increasingly more power to overcome the resistance. G-COLF's power setting increased to such a level that bystanders thought it was starting its takeoff run. They then saw the nosewheel castor left before the aircraft veered off the runway and collided with G-BAFG on the adjacent grass parking area. The pilot of G-COLF believed his aircraft may have become stuck in a rut on the runway,

leading to the left wheel spat digging into the ground and causing the aircraft to pivot under power. The proximity of G-BAFG to the runway edge meant that the accident pilot had little time to react before the collision.

Approximate parked position of G-BAFG and G-COLF's ground track
