ACCIDENT

Aircraft Type and Registration:	Jodel DR1051-M1, G-BHTC	
No & Type of Engines:	1 Continental Motors Corp O-200-A piston engine	
Year of Manufacture:	1964 (Serial no: 581)	
Date & Time (UTC):	4 August 2020 at 1430 hrs	
Location:	Saltford (Avon Lane) Airfield, Somerset	
Type of Flight:	Private	
Persons on Board:	Crew - 1	Passengers - 1
Injuries:	Crew - None	Passengers - None
Nature of Damage:	Right wing severed off at crank position. Left wing spar broken	
Commander's Licence:	Private Pilot's Licence	
Commander's Age:	57 years	
Commander's Flying Experience:	1604 hours (of which 1057 were on type) Last 90 days - 9 hours Last 28 days - 8 hours	
Information Source:	Aircraft Accident Report Form submitted by the pilot and further enquiries made by the AAIB

Synopsis

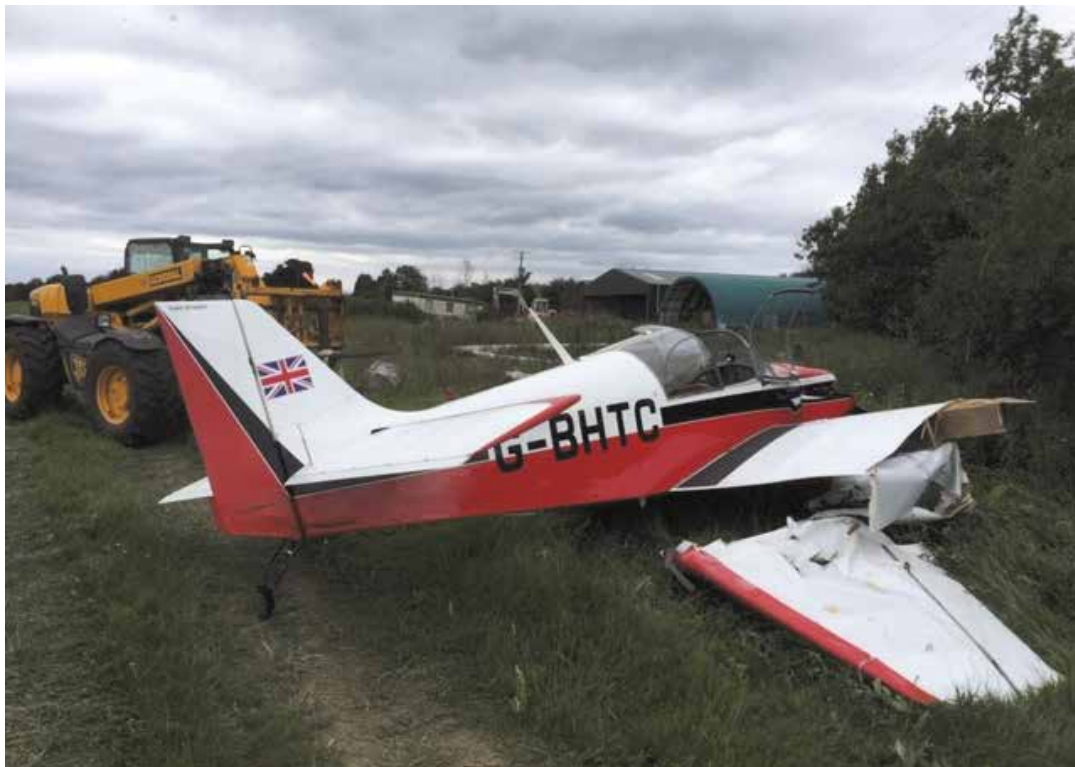
Figure 1

However, at about two metres agl, the aircraft rolled 30° to the right and, despite rapid application of stick and rudder, the aircraft contacted the ground and bounced upwards about one metre, and the right main wheel rolled over the left edge of a rubble bank at the side of the runway. Directional control had then been lost and the right wing hit a large bush. The impact broke the outer cranked portion of the right wing off (Figure 1), the aircraft swung to the right and came to a stop. Neither of the crew were injured, the aircraft was made safe and they were able to vacate the aircraft normally. Inspection of the aircraft found that the left main spar, fuselage and propeller had also been damaged.

Damage to the right wing

- The runway is relatively narrow with a difficult approach which requires a high level of concentration.
- The turbulence in the circuit was tolerable, but curlover from the flat portion of the runway caused increased lift from the left wing and hence the right roll.
- The roll took the aircraft off the centre line where it encountered the edge of the bank on the right side of the runway.
- The loss of directional control and the proximity of the hedge meant the landing could not be “rescued”.
