SERIOUS INCIDENT

Aircraft Type and Registration:	Reims Cessna F150M, G-CSBM	
No & Type of Engines:	1 Continental Motors Corp O-200-A	
Year of Manufacture:	1977 (Serial no: 1359)	
Date & Time (UTC):	10 July 2020 at 1438 hrs	
Location:	Winchfield, Hampshire	
Type of Flight:	Private	
Persons on Board:	Crew - 1	Passengers - 1
Injuries:	Crew - None	Passengers - None
Nature of Damage:	None	
Commander's Licence:	Private Pilot's Licence	
Commander's Age:	24 years	
Commander's Flying Experience:	215 hours (of which 103 were on type) Last 90 days - 23 hours Last 28 days - 17 hours	
Information Source:	Aircraft Accident Report Form submitted by the pilot and further enquiries by the AAIB

Synopsis

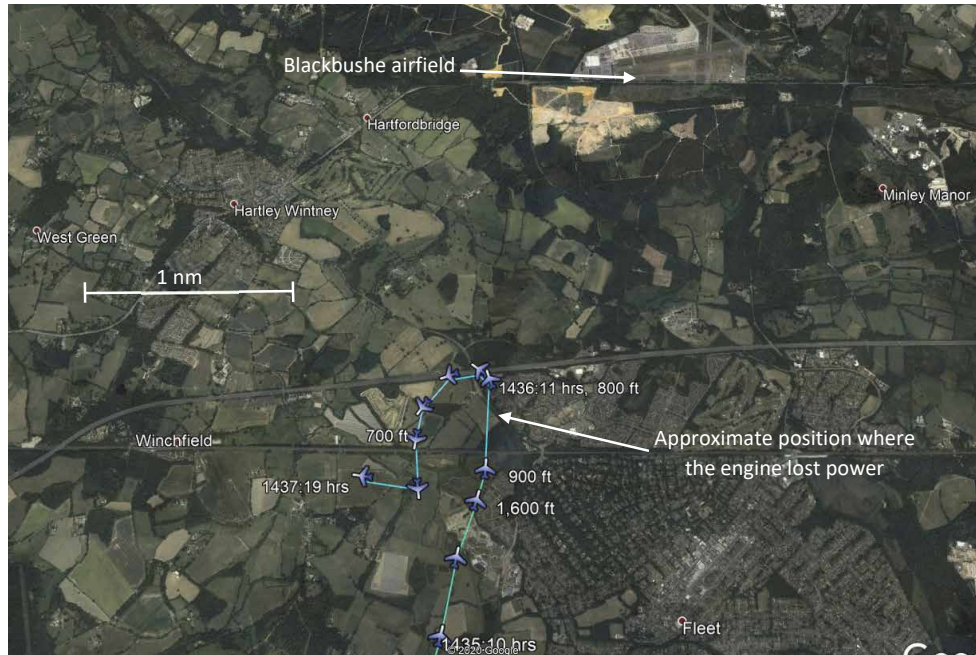
Figure 1

Aircraft track approaching Blackbushe Airport

The return flight was uneventful until the aircraft was approximately 2 nm from Blackbushe. The pilot had just descended to circuit height when the engine started to cough and lose power. He did not know what was wrong with the engine but, being aware that landing options close to the airport were limited if the engine failed completely, he decided the safest option was to make a precautionary landing in a field. He selected a large grass field on his left side and made an 180° turn to position the aircraft on a base leg for the field (Figure 1). The engine continued to run but was still losing power. He landed in the field using full flap and stopped the aircraft (Figure 2). There was no damage to the aircraft and both occupants were uninjured.

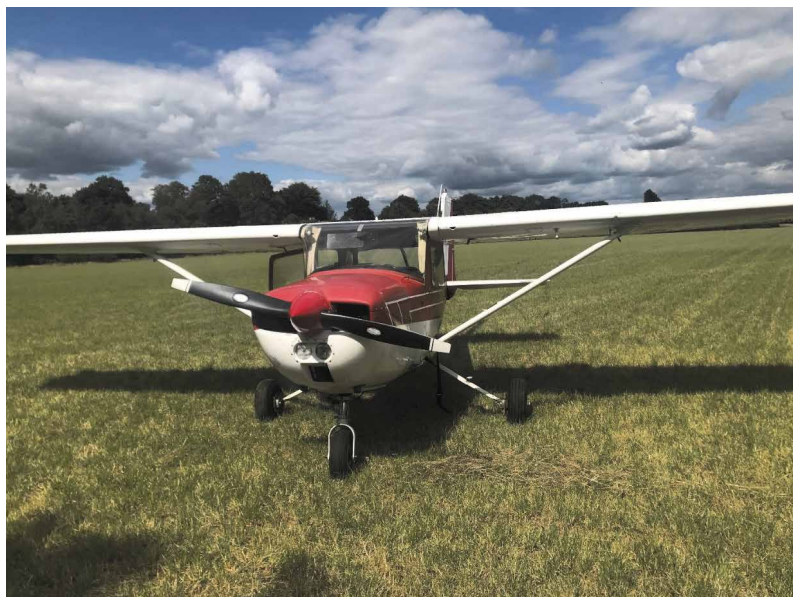
Figure 2

After landing no fuel could be seen visually in either fuel tank. It was subsequently discovered that the dipstick the pilot had used was calibrated for a Cessna 172 so showed a greater quantity of fuel than was actually present.

G-CSBM after the precautionary landing

The flying club have reminded pilots of the importance of only using the dipstick calibrated for the aircraft they are flying.

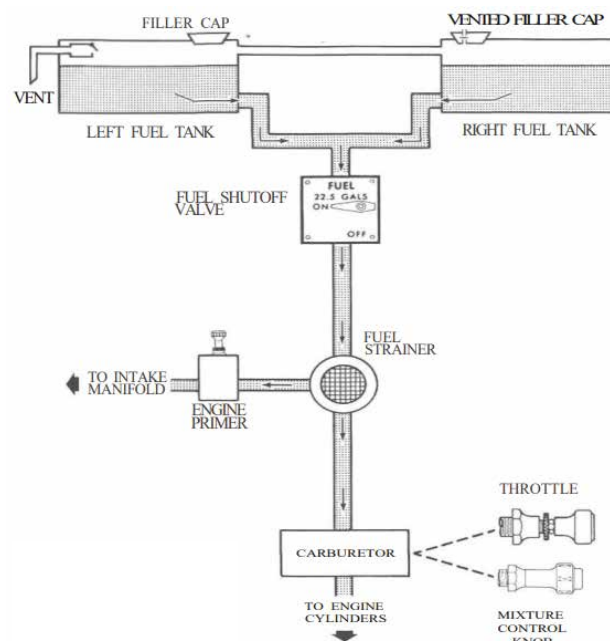
The Cessna 150 has two interconnected fuel tanks, one in each wing. Fuel is gravity fed to the engine (Figure 3). The tanks can hold 26 US gal of fuel but 3.5 US gal is unusable, giving a total usable capacity of 22.5 US gal.

Although the fuel tanks are interconnected, it was reported that it is not uncommon for the fuel to be imbalanced after flight. This can be caused by several banked turns in the same direction prior to landing causing the fuel to migrate to one side.

Figure 3
Cessna 150 fuel system
