ACCIDENT

| Aircraft Type and Registration: | Robinson R44 Raven II, G-WTWT | |
| Date & Time (UTC): | 26 July 2020 at 0904 hrs | |
| Location: | Herne Bay, Canterbury, Kent | |

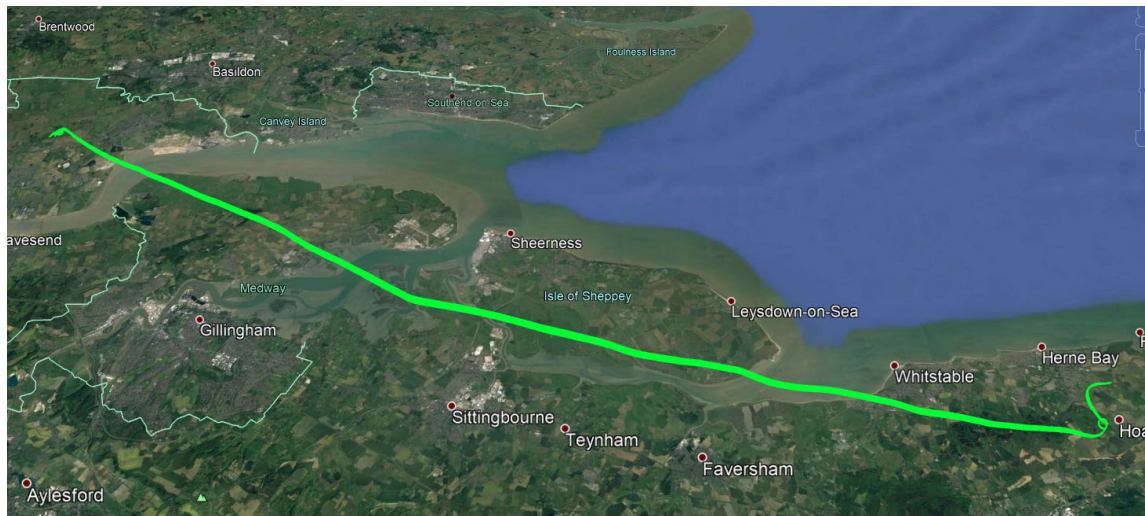
Figure 1

The first flight from Orsett near Thurrock, where the helicopter is kept, to his friend's house near Herne Bay was uneventful (Figure 1). The landing site was located close to Maypole airfield. The pilot had contacted the owner of the airfield the day before and had been advised to make blind calls on the airfield frequency and to remain west of the centreline for noise abatement. The pilot overflowed the landing site from the south-west and flew an orbit of the field. The wind was from the south-west so he made a crosswind approach to

GPS track of first flight and accident flight
© 2020 Google, Image © SIO, NOAA, U.S. Navy, NGA, GEBCO)

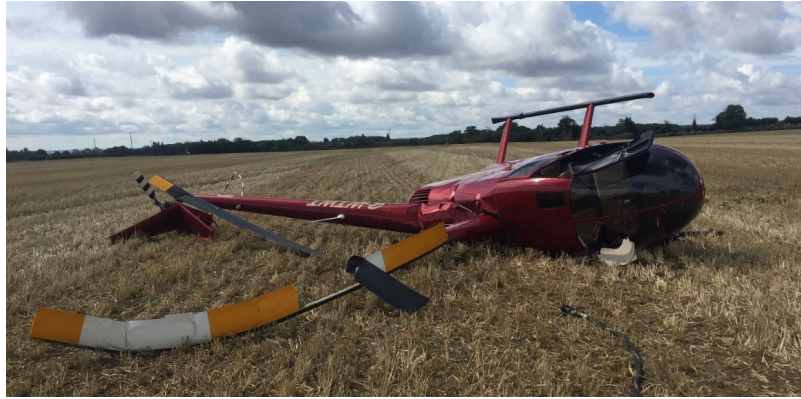
Figure 2

The helicopter stuck the ground with the right skid first. The skid dug in and the helicopter rolled onto its right side (Figure 2). The pilot and front seat passenger were able to climb out of the left front door and helped the two rear seat passengers exit. Emergency services arrived shortly afterwards.

G-WTWT after the accident

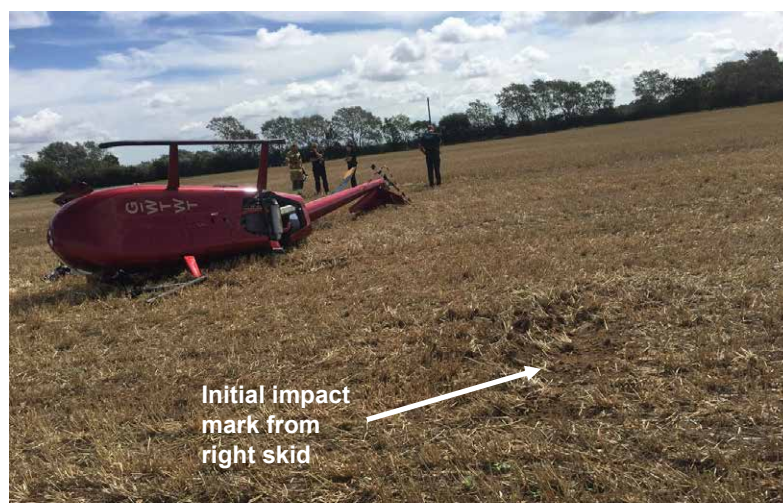
Figure 3 shows the initial impact mark where the right skid dug into the soil causing the helicopter to roll over.

Accident site showing the initial impact mark from the right skid

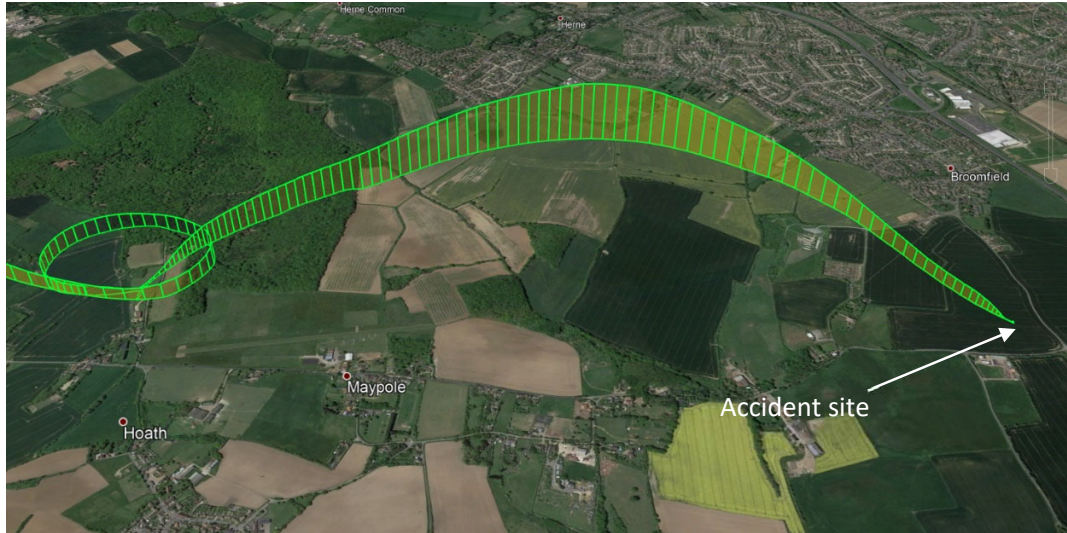
Figure 4

The pilot was using a flight planning and navigation app on a tablet computer which recorded the accident flight. Figures 4 and 5 show the helicopter's track downloaded from the tablet. The orbit around the first landing site can be seen in the figures to the west of Mayfield. The helicopter reached a GPS altitude of 746 ft above the landing field elevation.

Accident flight showing altitude profile
(© 2020 Google, Image © SIO, NOAA, U.S. Navy, NGA, GEBCO)

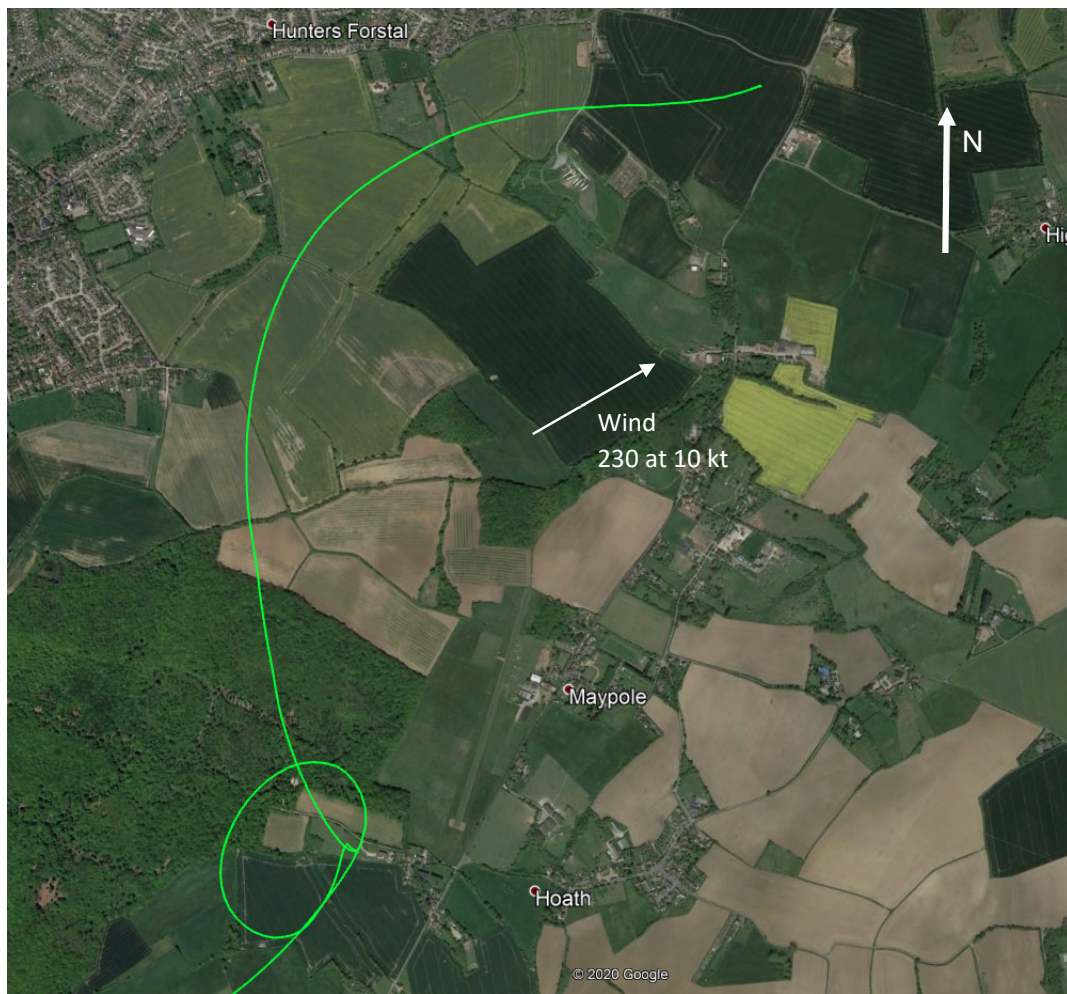
Figure 5

Accident flight ground track orientated north up
(© 2020 Google, Image © SIO, NOAA, U.S. Navy, NGA, GEBCO)

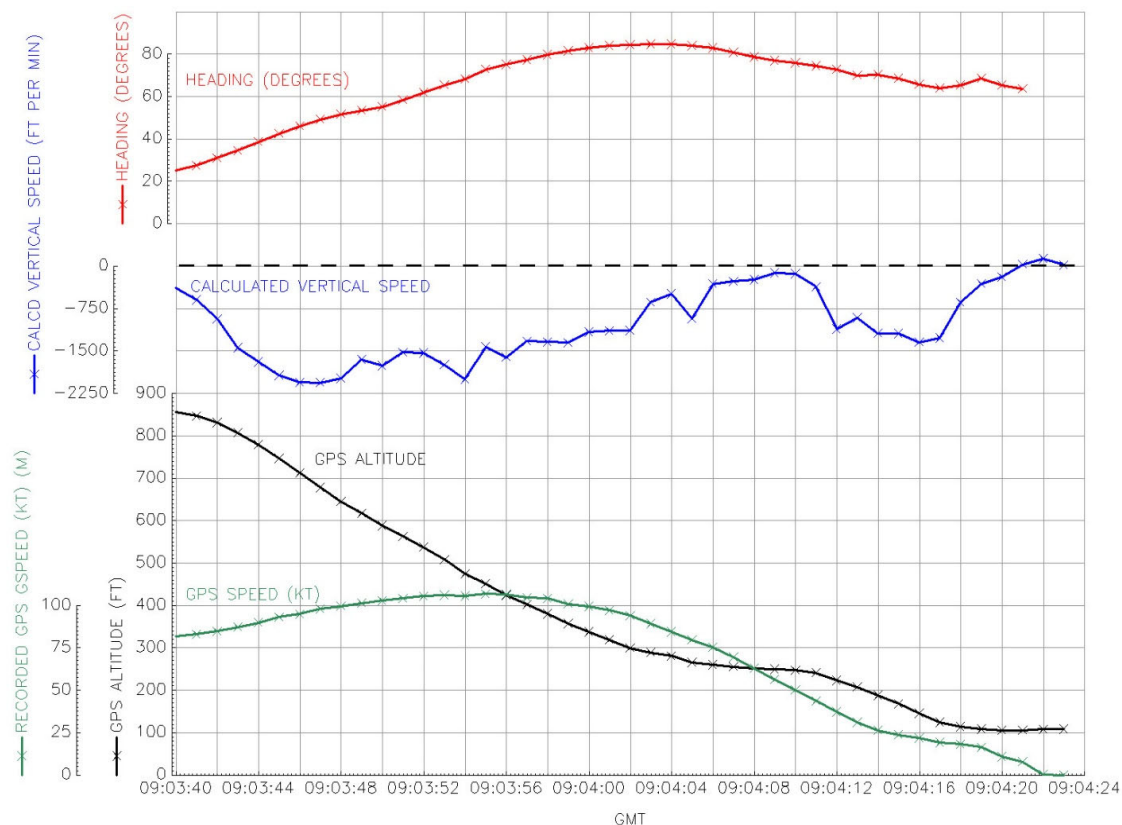
Figure 6 shows the data extracted. The helicopter's heading as it approached the ground was approximately 070°. The groundspeed reached a maximum of 107 kt then reduced steadily during the descent. Table 1 shows the helicopter's rate of descent, groundspeed and estimated airspeed as it descended below 100 ft. The airspeed has been estimated assuming a 10 kt tailwind.

GPS data from last part of accident flight

As the helicopter descended below 100 ft the rate of descent was greater than 1,000 ft/min and the airspeed dropped below 15 kt. It is likely that the helicopter started to enter a vortex ring state. This would explain why the helicopter did not respond to increasing collective and did not turn left with cyclic input. The pilot did not recognise the helicopter was entering vortex ring so did not apply corrective action.
