ACCIDENT

Aircraft Type and Registration:	Easy Raider 503(1), G-SRII
No & Type of Engines:	1 Rotax 503-DCDI-2V piston engine
Year of Manufacture:	2001 (Serial no: BMAA/HB/163)
Date & Time (UTC):	12 July 2020 at 1320 hrs
Location:	Near Dunnington, York
Type of Flight:	Private
Persons on Board:	Crew - 1 Passengers - None
Injuries:	Crew - 1 (None) Passengers - N/A
Nature of Damage:	Engine seized, damage to propeller, landing gear, tail and fuselage
Commander's Licence:	National Private Pilot's Licence
Commander's Age:	53 years
Commander's Flying Experience:	212 hours (of which 116 were on type) Last 90 days - 4 hours Last 28 days - 4 hours
Information Source:	Aircraft Accident Report Form submitted by the pilot and additional enquiries by the AAIB

Synopsis

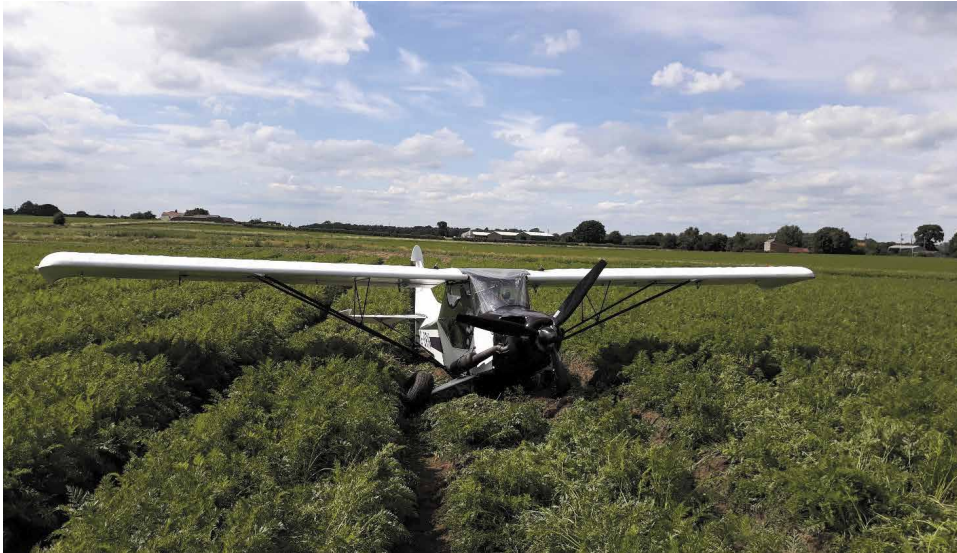
pilot completed a successful forced landing in a crop field and was uninjured, exiting the aircraft without assistance, but the aircraft sustained substantial damage due to the furrowed surface of the field (Figure 1). After landing, he examined the unused fuel in the jerry can and discovered that there was no evidence of the dye he would have expected to see if two-stroke oil had been present in the fuel.

Figure 1
G-SR11 after landing

The engine seized in flight due to a lack of sufficient lubrication. When preparing for the flight the pilot inadvertently omitted to add two-stroke oil to the aircraft's fuel. The manner in which the fuel was added to the aircraft prevented him from detecting the absence of the two-stroke oil. The pilot completed a successful forced landing because his training and practice enabled him to identify a suitable landing site within the gliding capability of the aircraft.

The pilot stated that in future he would add the two-stroke oil as he poured the fuel into the aircraft fuel tanks. If he did need to prepare a jerry can in advance, he would take the oil to the fuel cans, rather than measure it out in the hangar.
