ACCIDENT

Aircraft Type and Registration:	Tecnam P92-EM Echo, G-WHEN	
No & Type of Engines:	1 Jabiru 2200A piston aero engine	
Year of Manufacture:	2004 (Serial no: PFA 318-13679)	
Date & Time (UTC):	23 June 2020 at 13:00 hrs	
Location:	Lleweni Parc Denbigh Airfield, Denbigh	
Type of Flight:	Private	
Persons on Board:	Crew - 1	Passengers - None
Injuries:	Crew - None	Passengers - N/A
Nature of Damage:	Propeller broken, left wing dented and displaced	
Commander's Licence:	National Private Pilot's Licence	
Commander's Age:	73 years	
Commander's Flying Experience:	780 hours (of which 700 were on type) Last 90 days - 2 hours Last 28 days - 2 hours	
Information Source:	Aircraft Accident Report Form submitted by the pilot and enquiries made by the AAIB

Synopsis

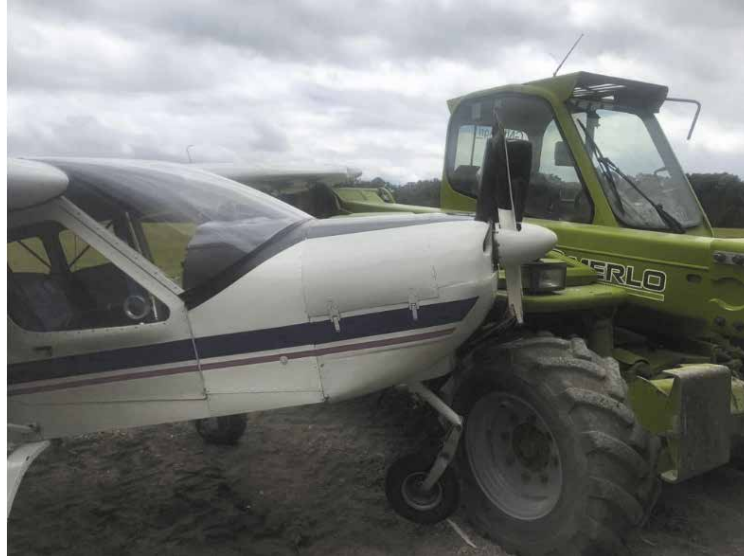
Figure 1

Whilst taxiing back to the hangar, the left wing struck a stationary telehandler parked alongside the taxiway. The aircraft pivoted to the left and came to a stop wedged against the telehandler (Figure 1). The impact dented the left wing leading edge near the wing tip, displaced the wing and distorted the flap. The propeller was severely damaged, and the lower engine cowl was dented. The pilot and a construction worker, who was standing close to the telehandler at the time, were uninjured.

Aircraft and telehandler following the collision

The pilot described how he allowed the right main wheel to run into the ditch to make room to pass the telehandler. In his opinion, it was the wheel running in the ditch that caused the aircraft to swing around to the left and into the telehandler.

Individuals who responded to the collision commented that there was a dent on the left leading edge consistent with the outer section of the left wing contacting the telehandler, causing the aircraft to swing to the left and hit the main body of the vehicle.

The series of events during the flight would have been very stressful for the pilot. It is possible that his relief, at landing safely, resulted in a lapse in concentration as he taxied to the hangar, such that there was insufficient wingtip clearance between the aircraft and telehandler.
