ACCIDENT

Aircraft Type and Registration:	Cessna 172S, G-CBXJ
No & Type of Engines:	1 Lycoming IO-360-L2A Piston engine
Year of Manufacture:	1999 (Serial no: 172S8125)
Date & Time (UTC):	25 November 2019 at 1140 hrs
Location:	Near Puffin Island, Anglesey
Type of Flight:	Private
Persons on Board:	Crew - 1 Passengers - None
Injuries:	Crew - 1 (Fatal) Passengers - N/A
Nature of Damage:	Aircraft destroyed
Commander's Licence:	Private Pilot's Licence
Commander's Age:	79 years
Commander's Flying Experience:	More than 2,200 hours (hours on type not known) ¹ Last 90 days – 4 hours Last 28 days – 1 hour
Information Source:	AAIB Field Investigation

Synopsis

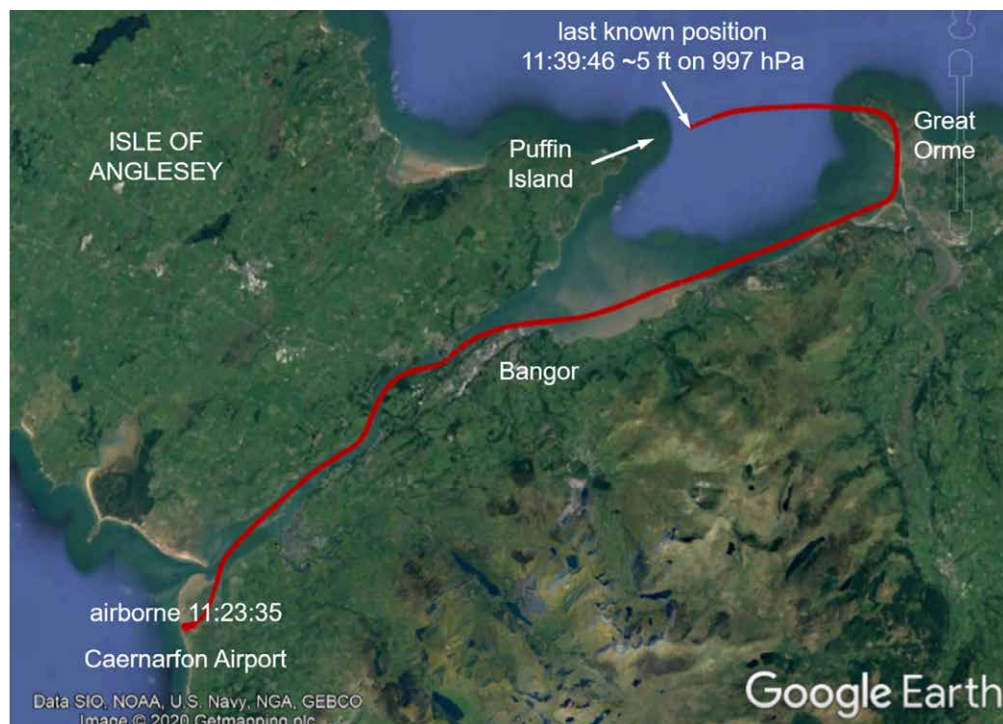
The aircraft flew up the Menai Straits at about 1,400 ft amsl² and passed abeam Bangor at about 1130 hrs (Figure 1). The aircraft continued to follow the mainland coastline and climbed to 1,500 ft amsl as it turned left towards Great Orme, before turning left again towards Puffin Island.

Figure 1
ADS-B³ track of G-CBXJ

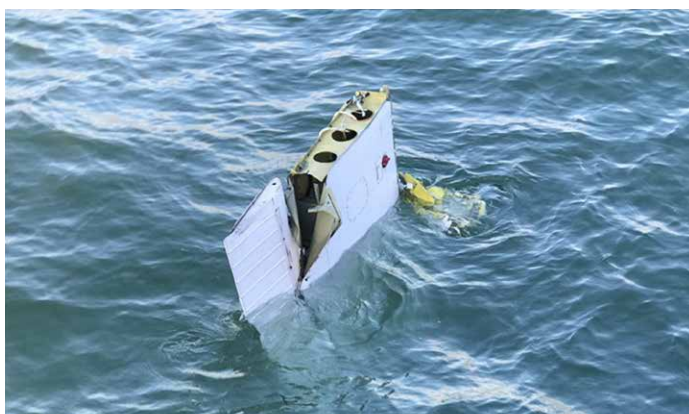
Figure 2

During the search for the aircraft, a lifeboat crew found the aircraft's right wing (Figure 2), part of the nose landing gear, a first aid kit and some personal effects floating in the sea approximately 3 miles north-west of Puffin Island. The wing was floating with its root up and photographs show that the leading edge had crumpled. An attempt by the lifeboat crew to recover the wing was abandoned when the wing came into contact with the lifeboat, puncturing the side. It was not found again and is thought to have later sunk. The other items were recovered back to shore.

Inboard end of the right wing found floating in the sea

Whilst the right wing was found detached from the aircraft, the similar damage to both wing leading edges indicate that the aircraft was intact at the time it struck the water. The nature of the crumpling and buckling is consistent with the aircraft striking the water at high speed, with sufficient force to cause the right wing to detach. The separation of the nose landing gear from the airframe indicates that it was subject to significant force and it is considered the aircraft was pitched nose down with the wings approximately level when it hit the water.

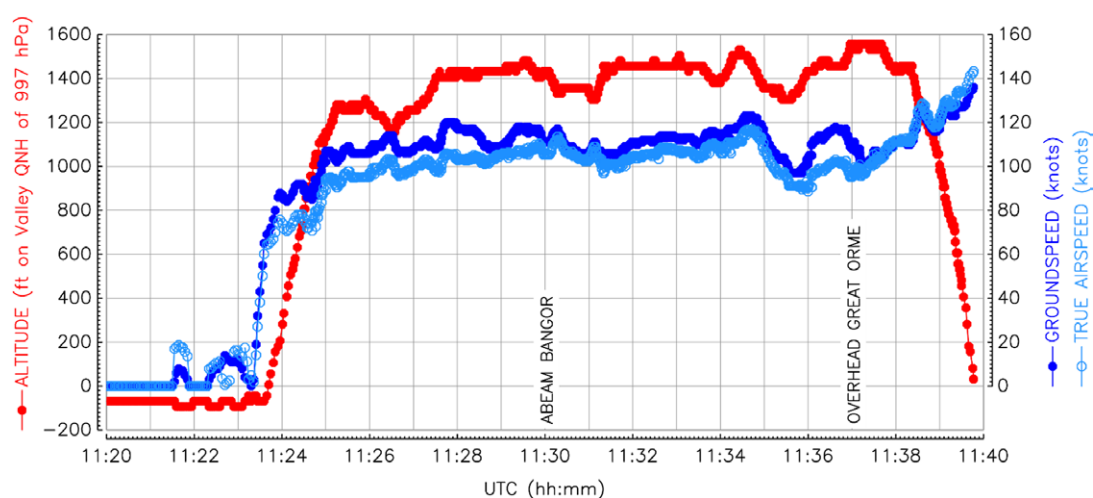
Figure 3 shows the aircraft's altitude (adjusted to the Holyhead QNH of 997 hPa) and groundspeed from the ADS-B Out broadcasts. Also plotted is the calculated true airspeed assuming a 15 kt southerly wind, which shows the aircraft flying at about 100 KTAS as it transited the Menai Straits and followed the coastline to the east.

Figure 3
ADS-B data of accident flight

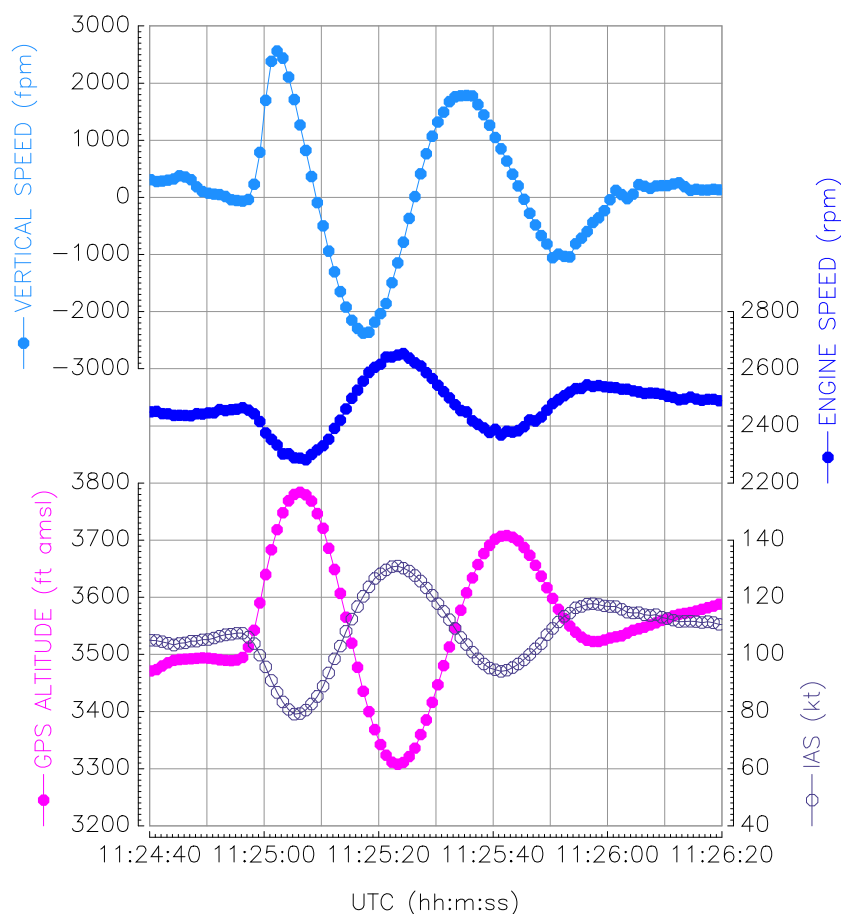
Figure 5 plots the recorded data from the test aircraft for the phugoid. It shows that the vertical speed peaked at $\pm 2,500$ ft/min during the first oscillation with a corresponding change in altitude of ± 300 ft. The airspeed varied ± 25 KIAS and engine speed by about $\pm 1,500$ rpm.

Test aircraft phugoid characteristics
