Report on the investigation of
the collision between two
fire and rescue service boats
resulting in one fatality

River Cleddau, Milford Haven, Wales

17 September 2019

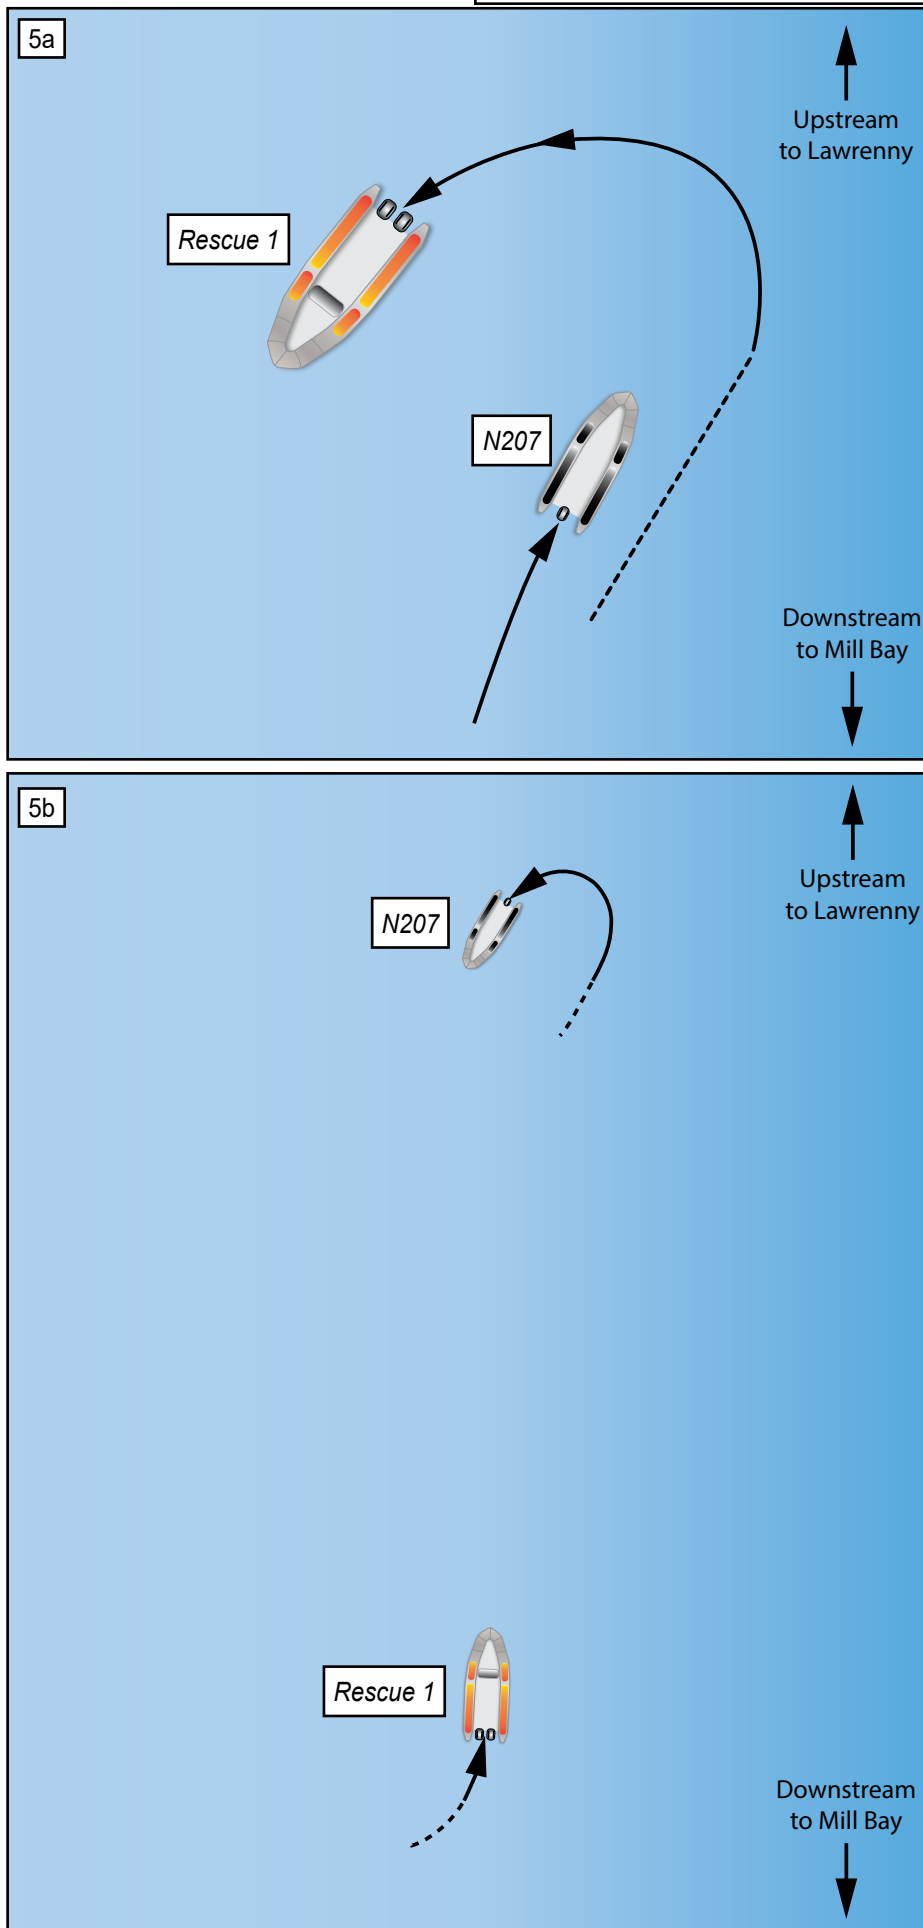
Figure 5: Tracks of boats before collision

Once ahead and clear of *N207*, *Rescue 1*'s helmsman commenced a large full-circle turn of the boat to port (**Figure 5a**). As the boat neared the end of its final turn to port travelling at about 15kts, the helmsman saw *N207* ahead of him in the distance, slightly to port, and noted that it now appeared to be headed downstream towards Mill Bay (**Figure 5b**). He decided to pass between *N207* and the shoreline. As *Rescue 1* came out of its turn, the helmsman's attention was briefly taken away from *N207* and was split between operating the steering in front of him, checking the engine gauges, and controlling the throttles.

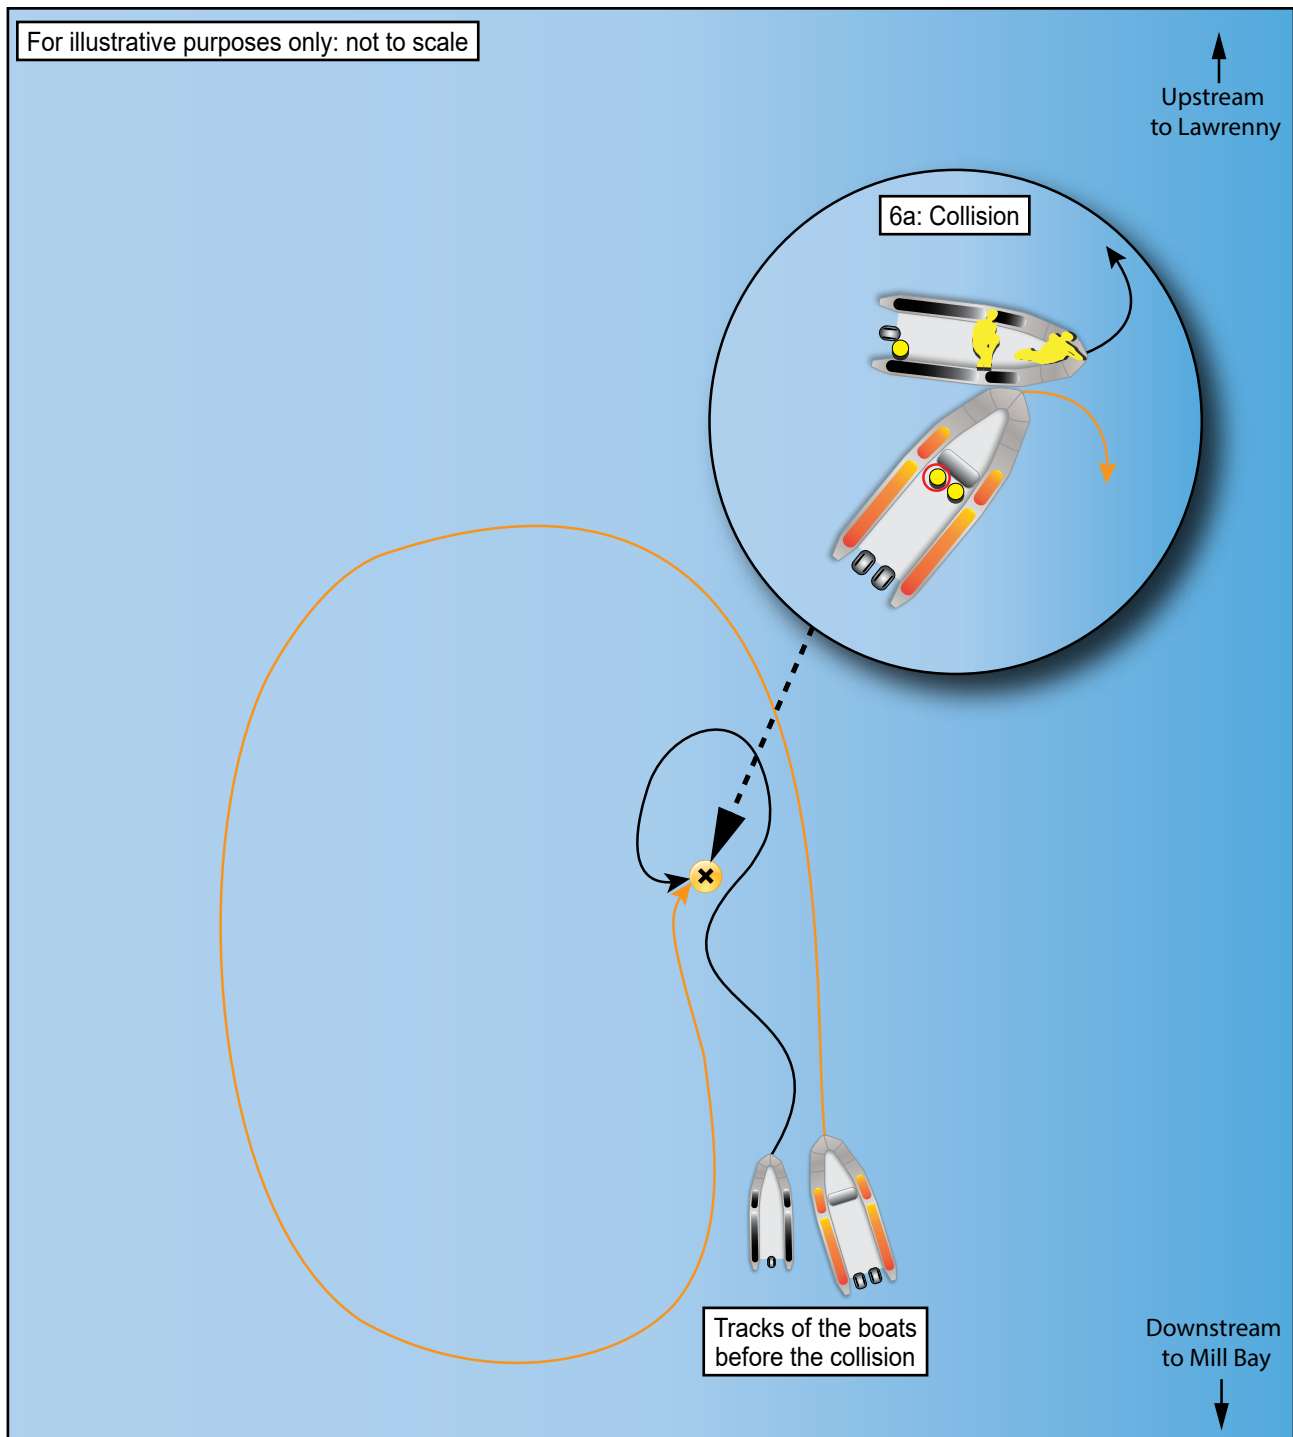
Figure 6: Manoeuvring leading to the collision

After turning *N207* to port and now headed downriver, the helmsman saw *Rescue 1* closing rapidly in front of him. In an attempt to avoid crossing ahead of it, he pulled the outboard motor tiller sharply towards him to turn the boat further to port. The trainer saw that *Rescue 1* was fast approaching, and realised that they were on a collision course. He shouted a warning to the helmsman and pointed at *Rescue 1*. When *Rescue 1*'s helmsman looked ahead, he saw *N207* close in front of him and attempted to avoid a collision by increasing speed and turning full helm to starboard (**Figure 6**). At about 1125, despite the attempts of both helmsmen, the two boats collided.

Rescue 1's bow struck *N207* in the middle of the boat at an angle of about 45° and rode over its buoyancy tube toward its bow (**Figure 6a**). *Rescue 1*'s helmsman pulled his kill-cord, which stopped the boat's engines. The force of the impact threw *N207*'s helmsman forward, which pulled out his kill-cord and stopped the boat's engine. The firefighter in the bow of *N207* was knocked or thrown into the water. He was struck on the head during the collision and as the boats separated was seen floating motionless on the water.

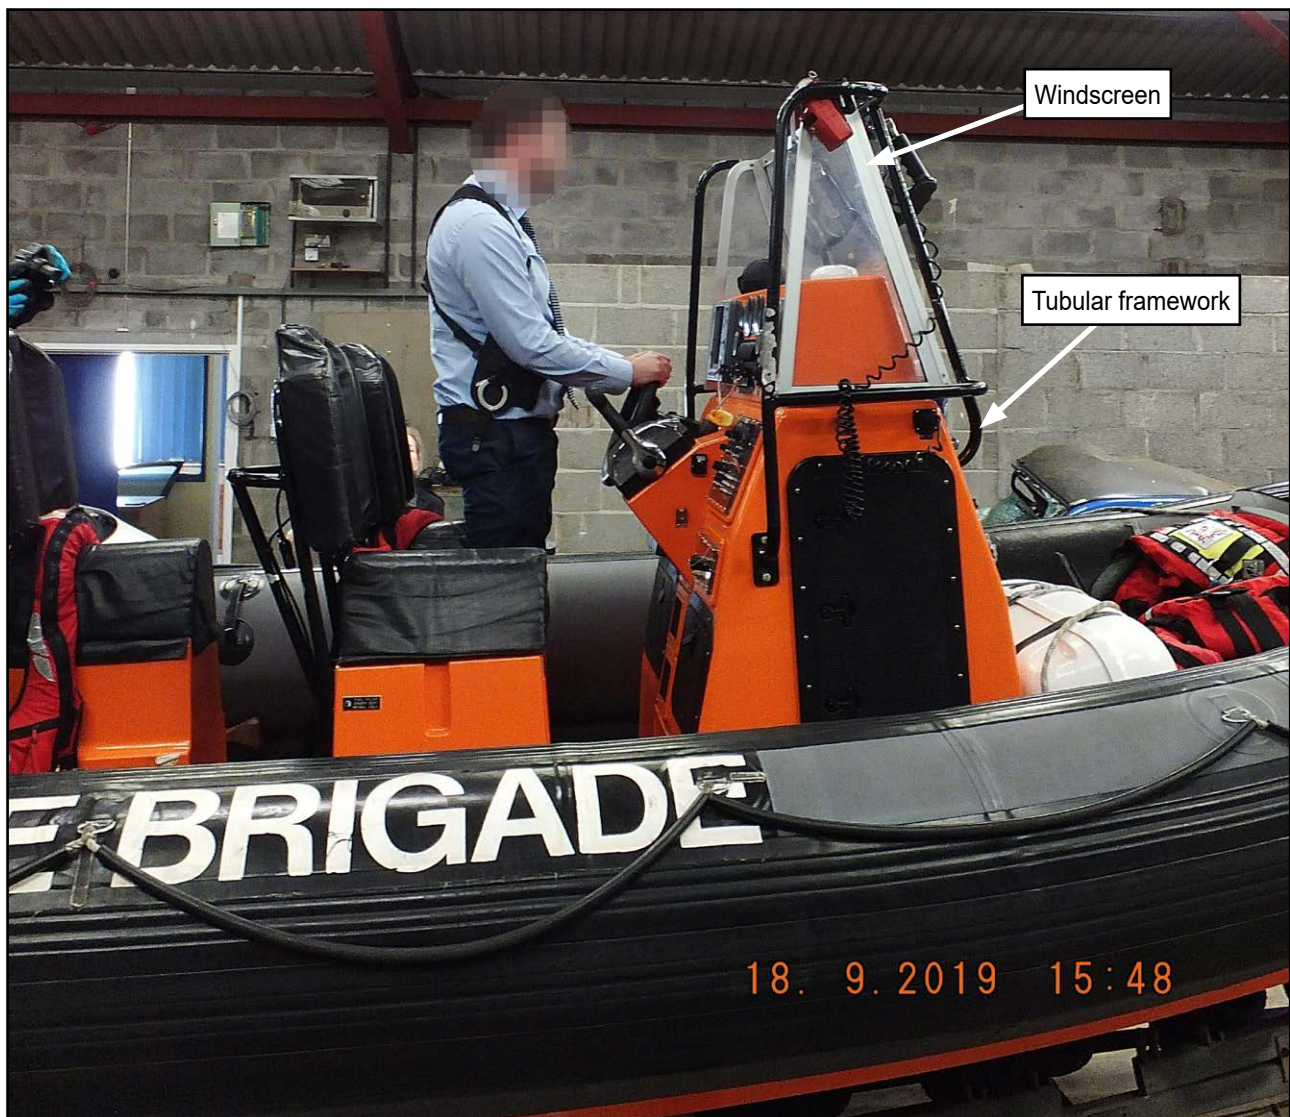
Figure 8: Windscreen of *Rescue 1*

Rescue 1 was a Delta 6.4m RIB that came into service with MWWFRS in 2001 to replace a boat that had come to the end of its service life. It was fitted with twin 90hp two-stroke engines, which were not fitted with propeller guards, and was stored on a trailer at the fire station. The engine throttles and gauges were to the right of the steering wheel in the middle of the console in front of the crew (**Figure 7**). A large windscreen was mounted on top of the console, which was surrounded by a tubular framework (**Figure 8**). When standing astride the boat's jockey seat, the helmsman's view was not obstructed by the windscreen and framework. However, when standing, the helmsman partially obstructed the seated crewman's field of view to port.
