Urgent Safety Advice 02/2020: Maintenance arrangements for wagons that primarily carry dangerous goods

Published 5 November 2020

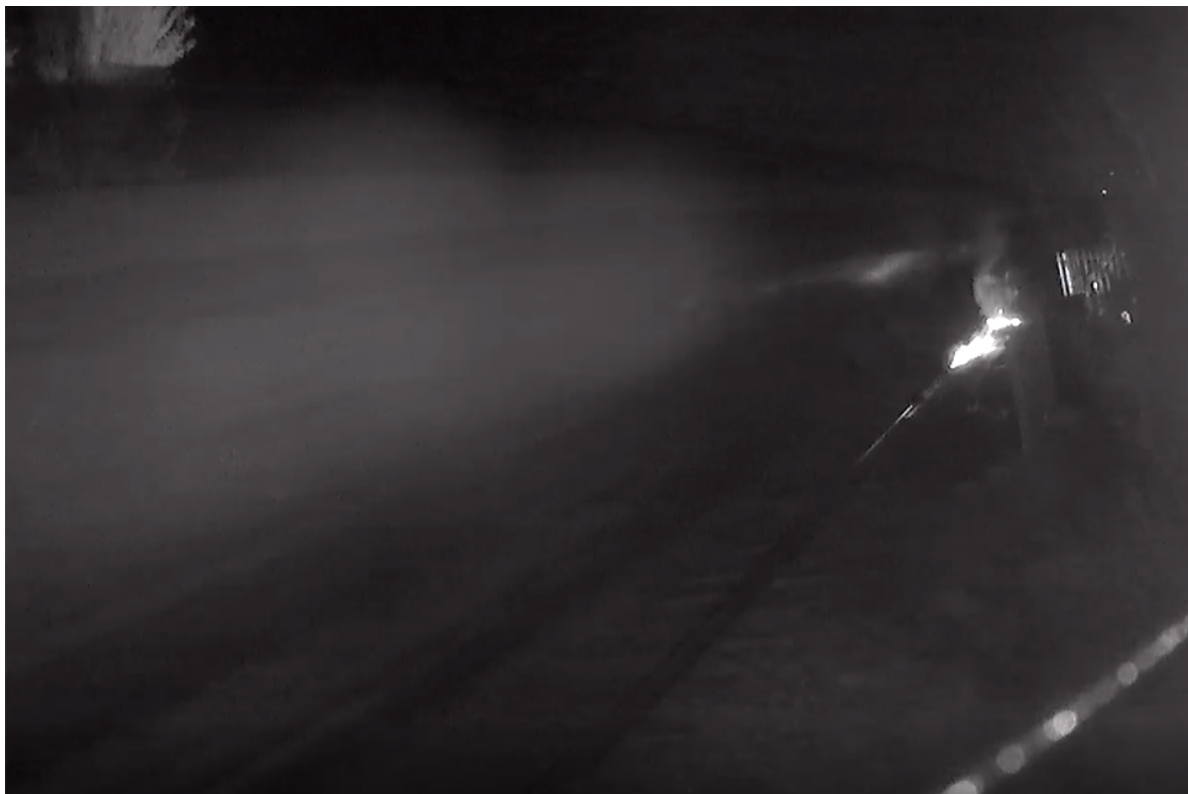
RAIB's preliminary examination found that, although all the wheels of the train were probably rotating freely when the train left Robeston, at some point during the journey the brakes on all wheels of the third wagon of the train had become applied, and remained so until the derailment. Although their brakes were dragging, three of the four axles of this wagon continued to turn. At some point in the journey the leading axle ceased to rotate altogether, as evidenced by a CCTV camera located at Pen-y-Bedd level crossing (12 miles (19 km) from Morlais Junction), and marks on the railhead.

CCTV image showing the third wagon passing Pen-y-Bedd level crossing

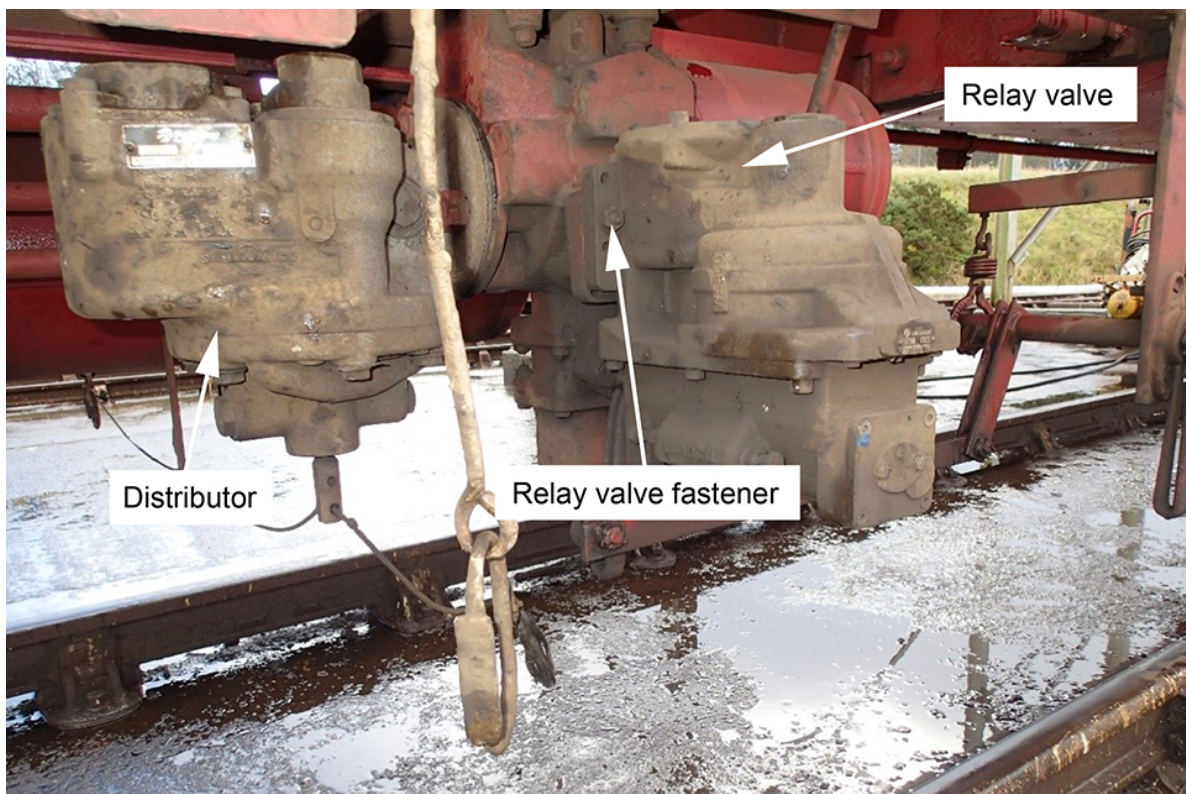
Examination of the brake group on the third wagon (TEA wagon GERS89005) found that the relay valve was loose on the pipe bracket. A sealing ring from one of the ports in the mating face had migrated to a position where it lodged between two other ports, distorted the sealing rings of those ports, and probably created a route for air to pass directly from the auxiliary reservoir to the wagon brake cylinder. This would have had the effect of applying the brakes on the wagon, producing the result described above.

Brake group on TEA wagon

The ECM for the wagon was unable to identify with any degree of certainty where and when the fastenings of the relay valve had last been disturbed. However, this may have taken place during routine repairs in the sidings at Robeston terminal or during scheduled maintenance elsewhere. There was no record of any check on the tightness of the fastenings ever having been made, and no process requiring such checks or provision of any measures, such as witness markings, which would have indicated that fastenings were becoming loose.

Entities in Charge of Maintenance (ECMs) should review their system of inspection and maintenance for wagons that primarily carry dangerous goods, to ensure that they have appropriate arrangements in place to manage the safety risk associated with malfunction of the braking system. This should include an assessment of the adequacy of:

- facilities, tools and equipment at all maintenance locations
- systems for assuring the competence of those involved
- management systems and instructions for assuring the quality of work undertaken
- methods for initial and ongoing assurance of the security of fastenings
- processes for the identification and tracking of safety critical components.
