Rail Accident Investigation Branch

Rail Accident Report

**Signal passed at danger at Loughborough
South Junction, Leicestershire
26 March 2020**

Report 10/2020
November 2020

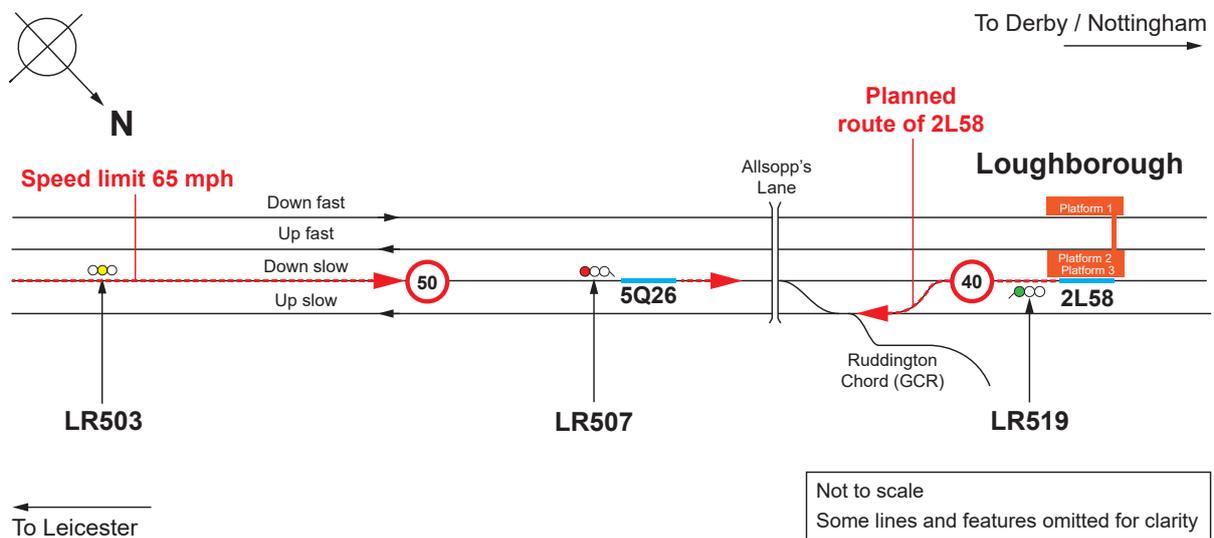
- 6 The railway at this location comprises four tracks: the up and down fast lines, and the up and down slow lines (figure 2). On the down slow line approaching Loughborough station, the maximum permitted speed is initially 65 mph (105 km/h), reducing to 50 mph (80 km/h) around 300 metres on the approach to signal LR507, then reduces again to 40 mph (64 km/h) just before Loughborough station. There is a gently falling gradient (1 in 508) until Loughborough station, where the track levels out.
- 7 Automatic warning system (AWS; see paragraph 36) equipment is fitted 186 metres on the approach to the sign indicating the start of the 50 mph speed restriction; this is to draw drivers' attention to a warning sign, co-located with the 50 mph board, for the 40 mph limit ahead.

Figure 2: Track layout on the approach to Loughborough, showing significant features referenced in the text

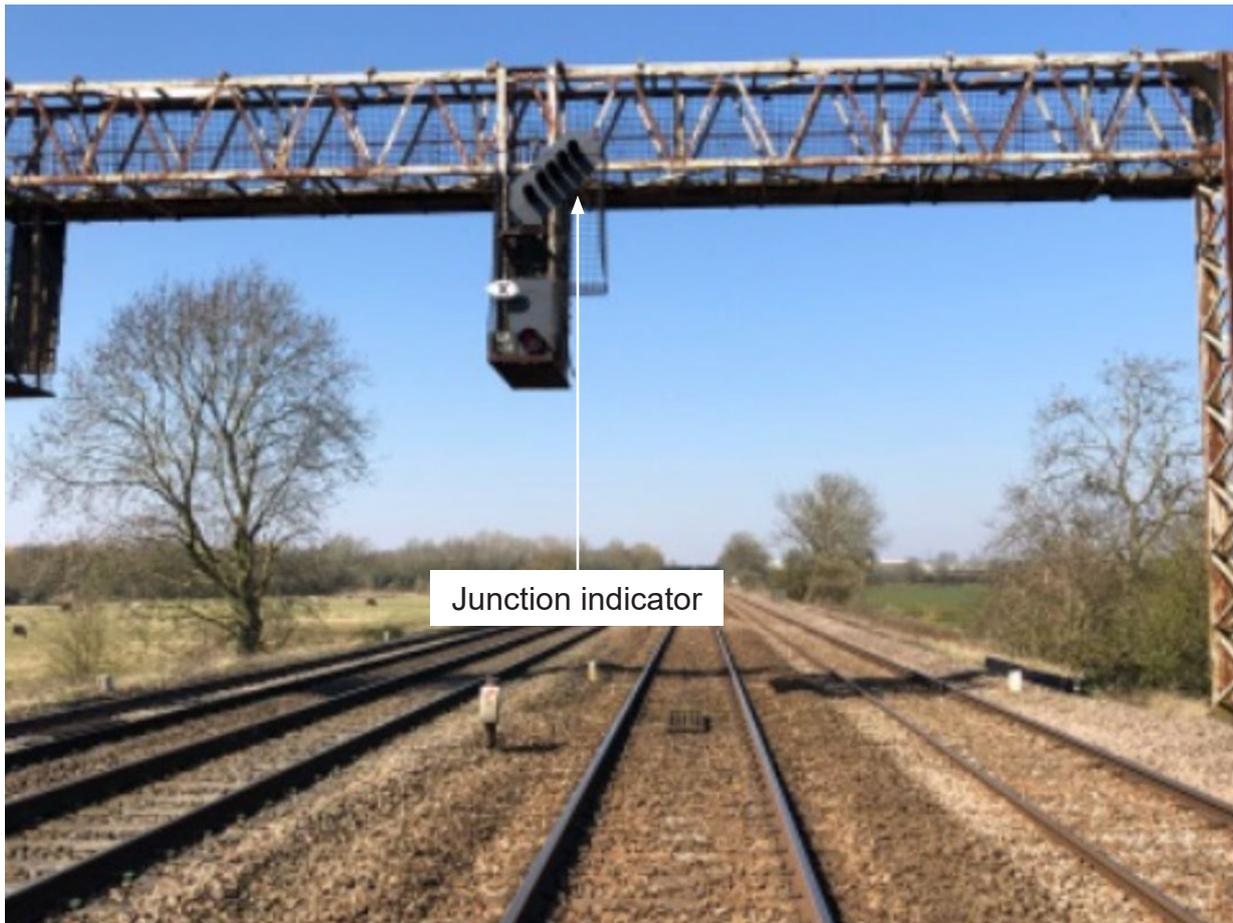
- 16 Signal LR507 is a three-aspect LED type signal with a position four junction indicator, mounted on a gantry above the down slow line (figure 3). The same gantry also carries signal LR505 for the down fast line.

- 19 There has been no previous recorded incidence of signal LR507 being passed at danger. A post-incident assessment found no issues with signal sighting that may have contributed to the incident; the assessment determined that the available reading distance for LR507 (that is, how far away the signal could actually be seen from) was 800 metres, while the minimum reading distance (that required in signal sighting standards for safe operation of the railway) was 183 metres.

Figure 3: Signal LR507 with position 4 junction indicator (picture courtesy of Network Rail)

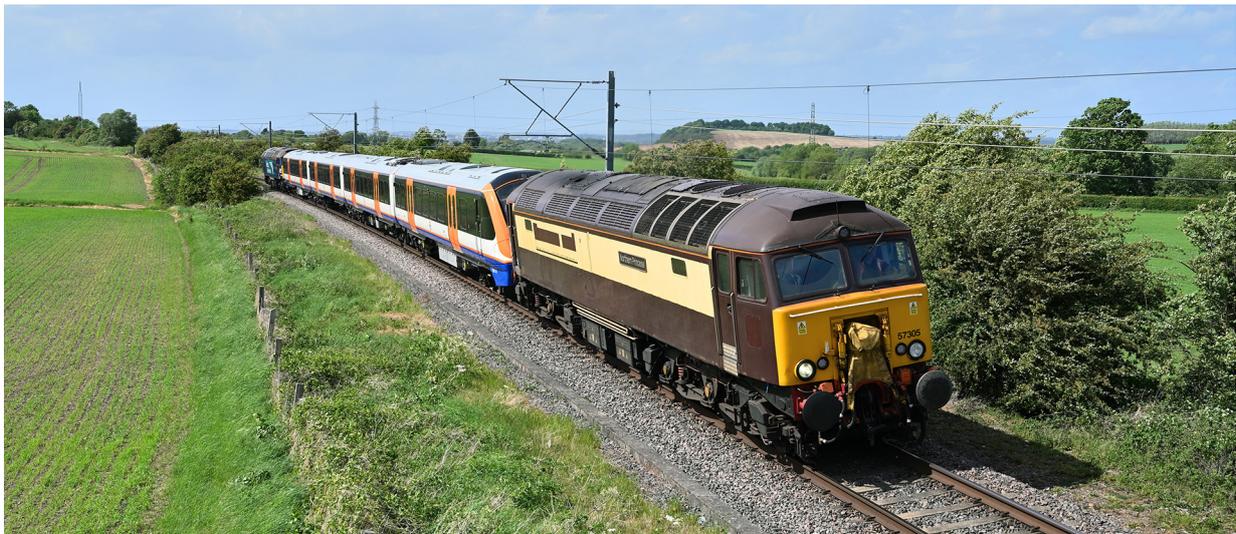
- 11 Train 5Q26 was the 09:57 hrs Old Dalby to Worksop Down Yard movement. It was formed of a four-coach, class 710, dual-voltage, passenger electric multiple unit (unit number 710272) and two class 57 locomotives, one at the front of the train (locomotive number 57305) and one at the rear (57310).

Figure 6: The train during RAIB's reconstruction at RIDC Melton on 22 May 2020 (image courtesy of Jason Cross)

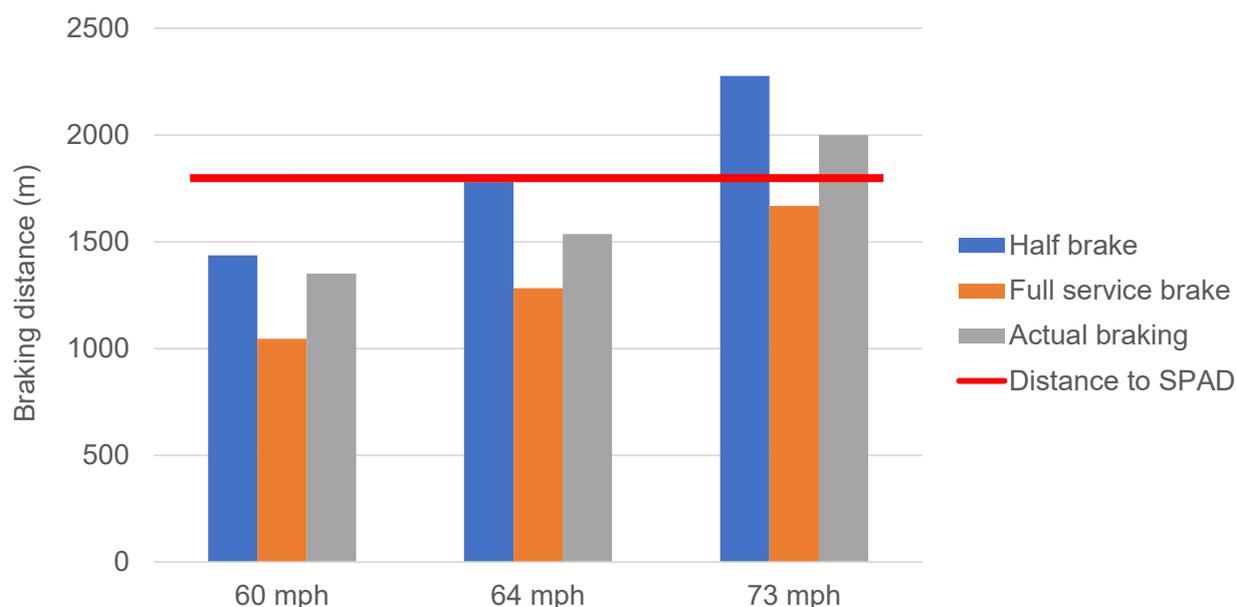
- 15 Train 2L58 was the 09:37 hrs East Midlands Railway passenger service from Lincoln to Leicester.

Rail equipment/systems involved

Figure 7: Graph of the brake test results, showing the distance to stop from different speeds and levels of braking, as well as the distance to the red signal from driver's declared initial braking point
