# Rail Accident Report

**Signal passed at danger at Loughborough  
South Junction, Leicestershire  
26 March 2020**

Report 10/2020  
November 2020

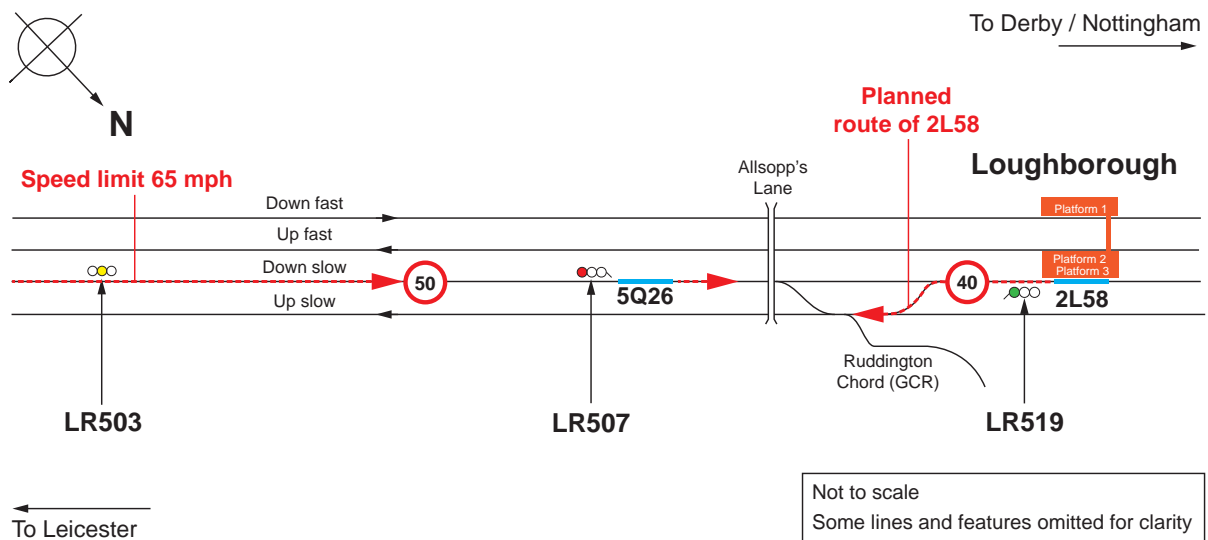
- 6 The railway at this location comprises four tracks: the up and down fast lines, and the up and down slow lines (figure 2). On the down slow line approaching Loughborough station, the maximum permitted speed is initially 65 mph (105 km/h), reducing to 50 mph (80 km/h) around 300 metres on the approach to signal LR507, then reduces again to 40 mph (64 km/h) just before Loughborough station. There is a gently falling gradient (1 in 508) until Loughborough station, where the track levels out.
- 7 Automatic warning system (AWS; see paragraph 36) equipment is fitted 186 metres on the approach to the sign indicating the start of the 50 mph speed restriction; this is to draw drivers' attention to a warning sign, co-located with the 50 mph board, for the 40 mph limit ahead.

Figure 2: Track layout on the approach to Loughborough, showing significant features referenced in the text

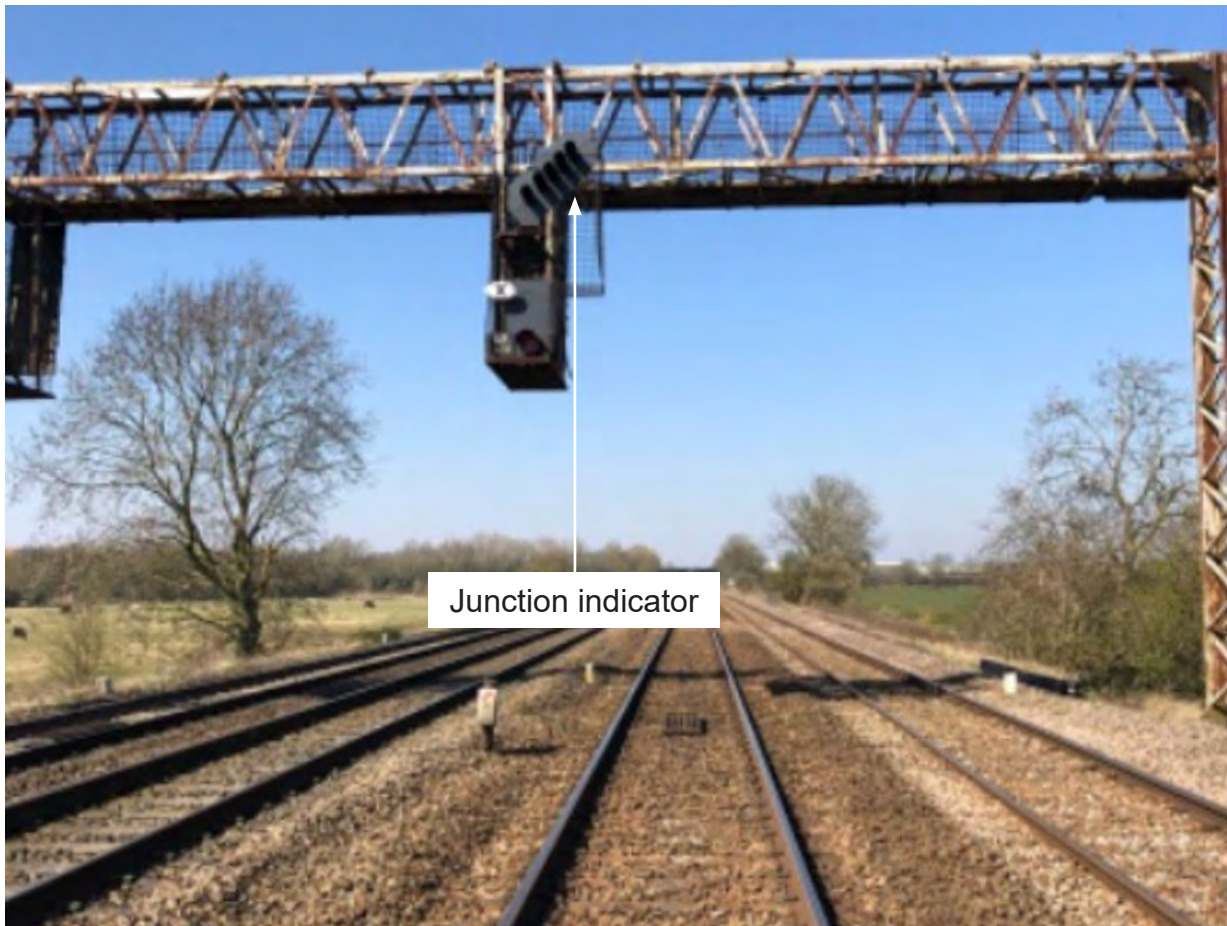
- 16 Signal LR507 is a three-aspect LED type signal with a position four junction indicator, mounted on a gantry above the down slow line (figure 3). The same gantry also carries signal LR505 for the down fast line.

- 19 There has been no previous recorded incidence of signal LR507 being passed at danger. A post-incident assessment found no issues with signal sighting that may have contributed to the incident; the assessment determined that the available reading distance for LR507 (that is, how far away the signal could actually be seen from) was 800 metres, while the minimum reading distance (that required in signal sighting standards for safe operation of the railway) was 183 metres.

Figure 3: Signal LR507 with position 4 junction indicator (picture courtesy of Network Rail)

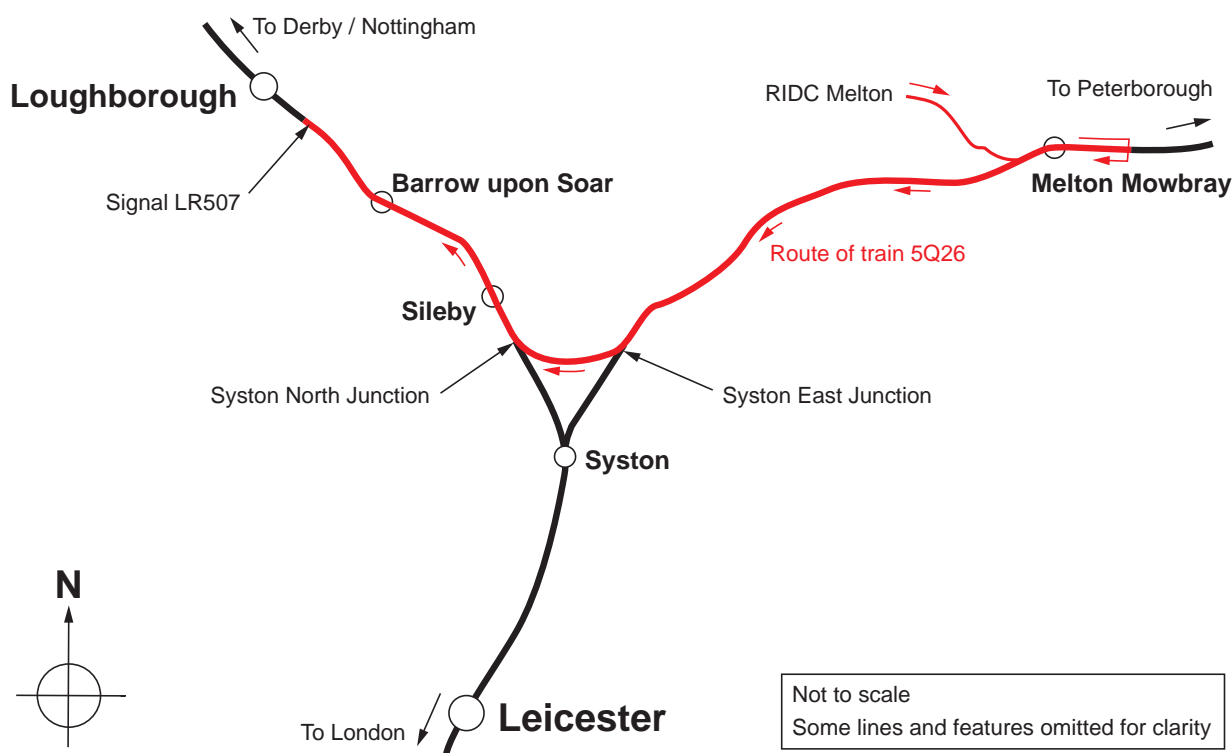
- 26 Train 5Q26 departed RIDC Melton at 09:23 hrs, 34 minutes before its scheduled departure time, and moved to a goods loop outside Melton Mowbray station, where it reversed direction. The train was held in the loop for 45 minutes to allow other services to pass through, and departed from Melton Mowbray at 10:38 hrs, two minutes before its scheduled departure time. It travelled under clear signals towards Syston East Junction where it braked for the 10 mph (16 km/h) speed restriction there. At Syston, the train joined the Midland main line around 7 miles (11 km) south of Loughborough and accelerated northwards (figure 4).

Figure 4: The route of the train

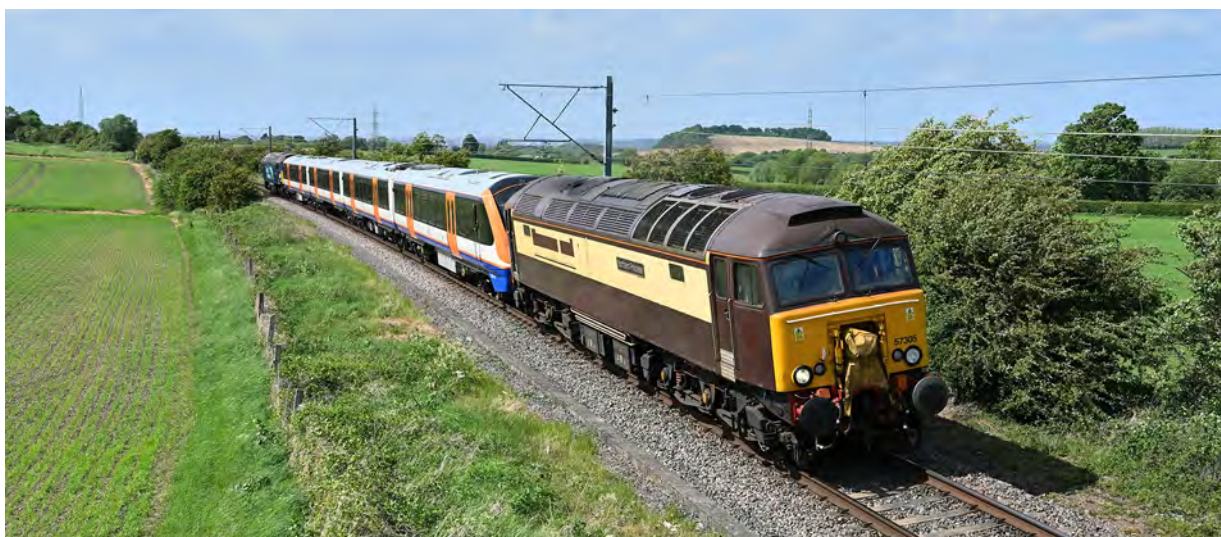
- 11 Train 5Q26 was the 09:57 hrs Old Dalby to Worksop Down Yard movement. It was formed of a four-coach, class 710, dual-voltage, passenger electric multiple unit (unit number 710272) and two class 57 locomotives, one at the front of the train (locomotive number 57305) and one at the rear (57310).

Figure 6: The train during RAIB's reconstruction at RIDC Melton on 22 May 2020 (image courtesy of Jason Cross)

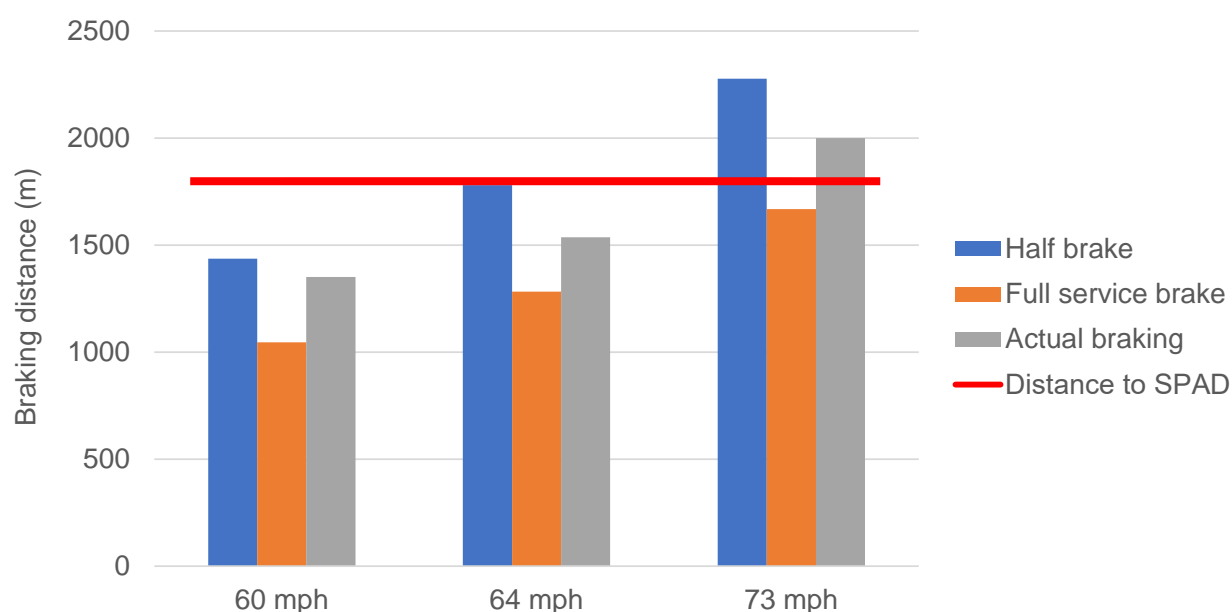
- 15 Train 2L58 was the 09:37 hrs East Midlands Railway passenger service from Lincoln to Leicester.

#### Rail equipment/systems involved

Figure 7: Graph of the brake test results, showing the distance to stop from different speeds and levels of braking, as well as the distance to the red signal from driver's declared initial braking point
