SERIOUS INCIDENT

Aircraft Type and Registration:	Bombardier BD-700-1A10 Global 6000, 9H-VJM	
No & Type of Engines:	2 Rolls-Royce BR710A2-20 turbofan engines	
Year of Manufacture:	2013 (Serial no: 9630)	
Date & Time (UTC):	11 December 2019 at 0550 hrs	
Location:	Liverpool Airport	
Type of Flight:	Commercial Air Transport (Passenger)	
Persons on Board:	Crew - 3	Passengers - 1
Injuries:	Crew - None	Passengers - None
Nature of Damage:	None	
Commander's Licence:	Airline Transport Pilot's Licence	
Commander's Age:	53 years	
Commander's Flying Experience:	11,506 hours (of which 3,864 were on type) Last 90 days - 104 hours Last 28 days - 48 hours	
Information Source:	AAIB Field investigation

Synopsis

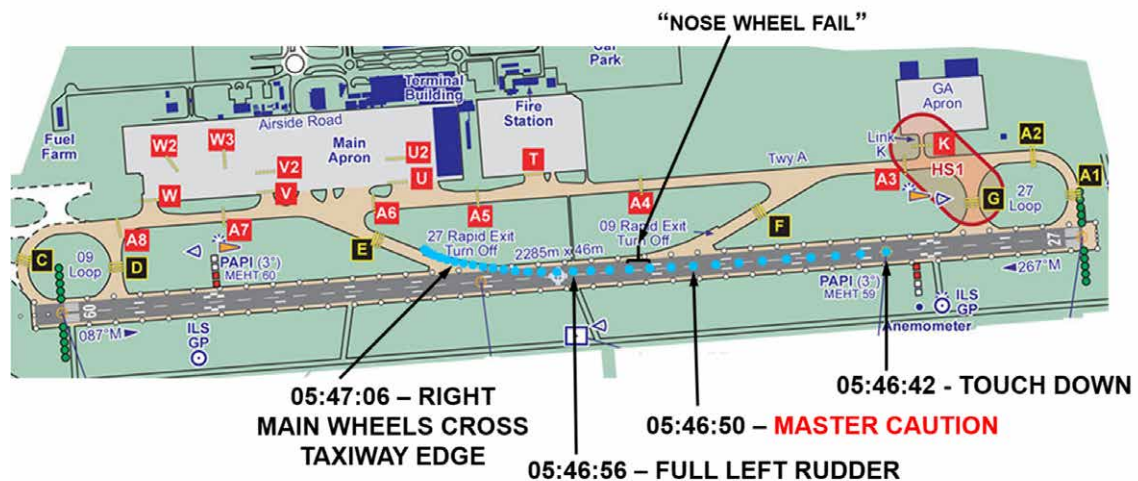
Figure 1

Liverpool Airport with the aircraft's ground track shown as blue dots (at one second intervals)

As the speed reduced, the aircraft turned more rapidly to the right and the commander was unable to keep the aircraft on the paved surface. The commander did not recall the speed at which the aircraft left the paved surface, but the co-pilot believed it was approximately 50 kt and he recalled seeing the NOSE STEER FAIL caution on the EICAS before the aircraft left the runway.

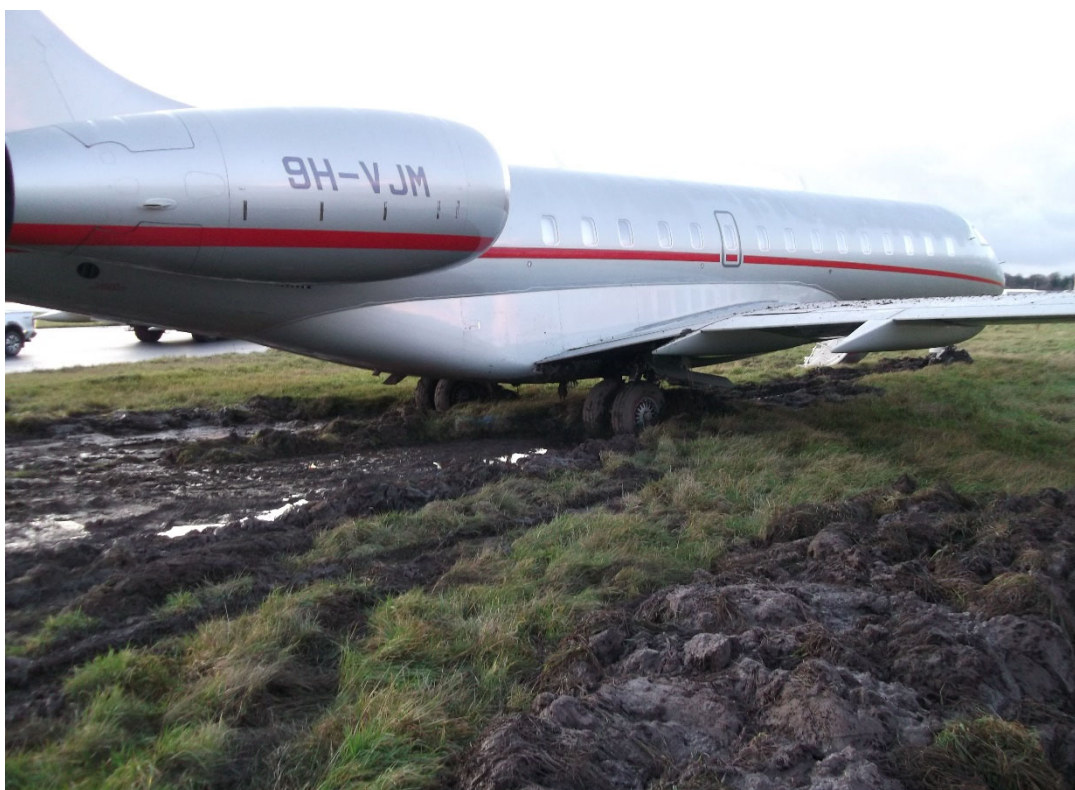
Figure 2

The aircraft had left the runway just before the start of runway rapid exit turnout (Exit E) to the right. It travelled approximately 30 m on the grassed area and its landing gear wheels sank into the topsoil and brought the aircraft to a stop. Mud and soil encased the lower parts of the landing gear (Figure 2). The flaps and slats were up, and mud and soil had been thrown upwards to become entrapped within the flap track mechanisms and fairings. Mud was also present on the wing leading edges and wheel bays and there were mud spatters on the engine intake rings.

9H-VJM on the soft ground

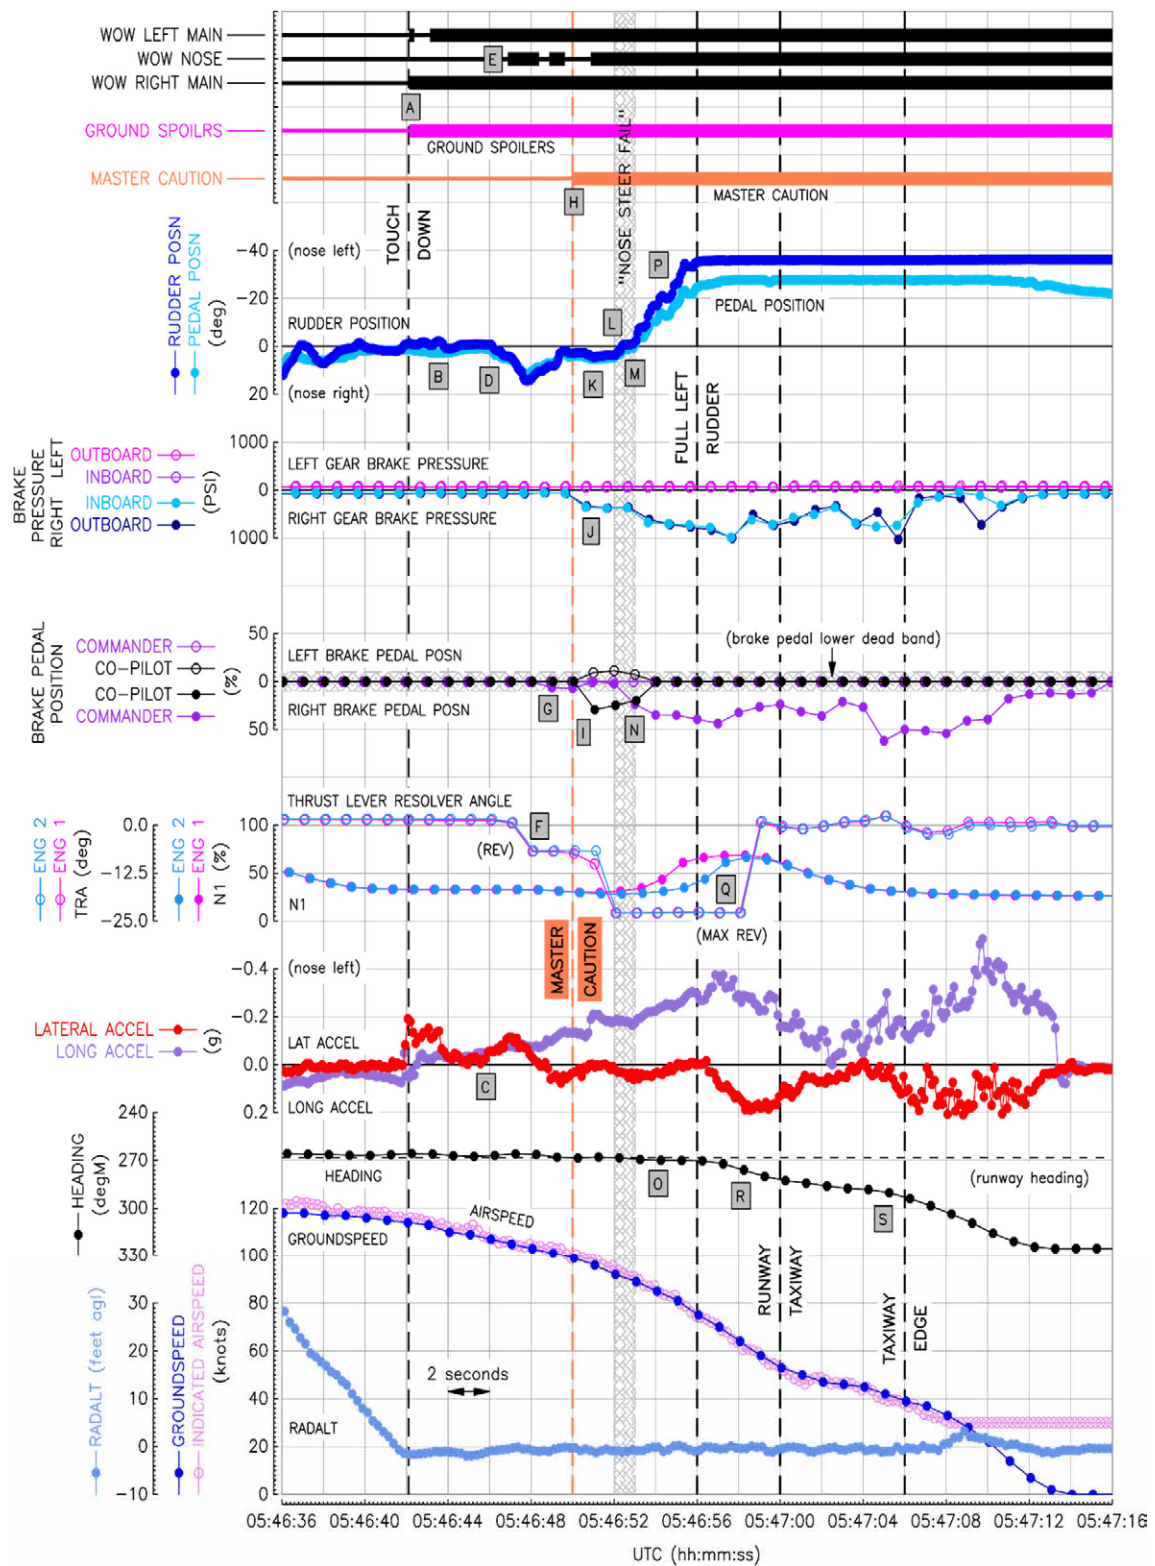
Figure 3
Recorded data for the landing

The key points from Figure 3 are:

- 0546:42 – the aircraft touched down on mainwheels [A] slightly right wing down and nose left. The airspeed was about 115 KIAS and the ground spoilers deployed.

- Small right rudder pedal inputs² made [B] to straighten up the aircraft (still on just the main gear).
- The aircraft started to turn left [C] – one of the crew immediately applied right rudder pedal to counter this movement [D].

- The nosewheel touched down nearly five seconds after initial ground contact of the main wheels [E].
- The thrust levers [F] were pulled back from IDLE to REV[ERSE].

- A small input on the commander's right brake pedal is recorded [G] but within the brake pedal's dead band³ so brake pressure was not applied. The input lasted about two seconds.

- The nosewheel 'bounced' twice over a period of four seconds during which a MASTER CAUTION occurred (with corresponding illumination of the MASTER CAUTION button, and a single chime heard on the CVR recording) [H].

- The co-pilot applied a small input to the brake pedals – left travel is in the dead band and just under one quarter travel on the right [I] so only right gear brakes were applied [J]. A corresponding input on the right rudder pedal is also recorded [K].

- Two seconds after the MASTER CAUTION is issued, the commander verbally announced a "NOSE STEER FAIL" (heard on the CVR recording) [L] just as the thrust levers were pulled back to MAX REV[ERSE]. A left rudder pedal input was made [M] (co-pilot still applying right brake) with a corresponding right brake pedal input by the commander [N].

- The aircraft started to veer to the right [O] and increasing amounts of left rudder (and right brake by the commander) were applied. Maximum rudder deflection was reached after four seconds [P] and no further braking by the

- A two-second delay is recorded between the engines each reaching the N_1 corresponding to maximum reverse thrust, with the left engine leading [Q].
- At about 70 kt groundspeed (when full left rudder was reached), the aircraft started to veer more rapidly to the right [R] onto the taxiway before veering further to the right [S] over the edge of the taxiway, which the right main gear crossed at about 40 kt, 10 seconds after full left rudder was applied.
- 0547:14 – the aircraft came to a stop 24 seconds after the MASTER CAUTION was issued; the MASTER CAUTION had remained illuminated throughout.
