ACCIDENT

Aircraft Type and Registration:	Cirrus SR22, N374SR	
No & Type of Engines:	1 Continental IO550 piston engine	
Year of Manufacture:	2007 (Serial no: 2734)	
Date & Time (UTC):	26 May 2020 at 1400 hrs	
Location:	Fairoaks Airport, Surrey	
Type of Flight:	Private	
Persons on Board:	Crew - 1	Passengers - None
Injuries:	Crew - None	Passengers - N/A
Nature of Damage:	Damage to both wings, propeller, fuselage and landing gear	
Commander's Licence:	Private Pilot's Licence	
Commander's Age:	65 years	
Commander's Flying Experience:	451 hours (of which 144 were on type) Last 90 days - 5 hours Last 28 days - 4 hours	
Information Source:	Aircraft Accident Report Form submitted by the pilot

Synopsis

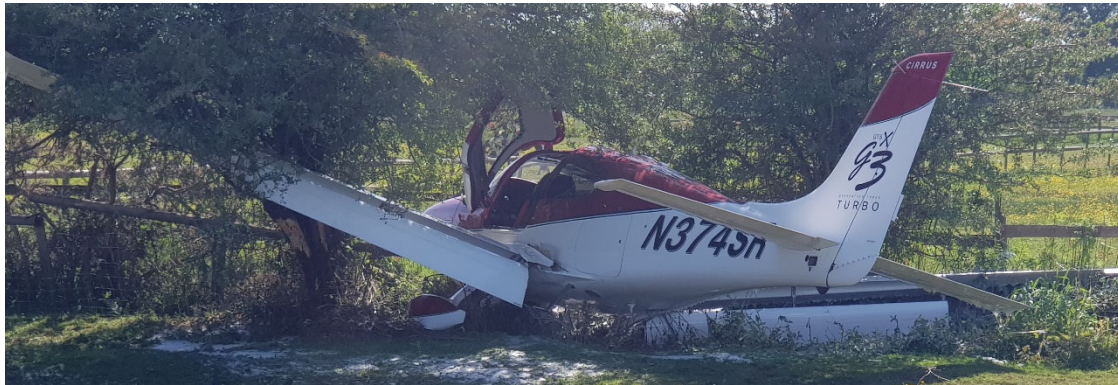
Figure 1

Despite the application of full braking, the aircraft overran the runway, went through the airfield boundary fence and crossed a public footpath before colliding with trees (Figure 1). N374SR sustained significant damage to wings and fuselage, but the pilot was able to vacate unaided and uninjured.

N374SR after colliding with trees in the runway overshoot
(photograph ©Surrey Police)

The runway overrun occurred because the aircraft landed too far down the runway for it to be stopped in the landing distance remaining. It is possible that a higher than normal engine idle speed contributed to the aircraft floating rather than achieving a positive touchdown. Additionally, the north-westerly wind gave little or no headwind component to reduce the aircraft's groundspeed relative to its approach speed. A decision to go around would likely have been successful if made before the trees in the overshoot became a limiting consideration.

Runway overruns resulting from deep landings are a known hazard in aviation. Pilots can mitigate this risk with an awareness of their aircraft's landing performance capabilities and the runway's physical characteristics and by factoring the expected environmental conditions into their threat and error management considerations. It is good airmanship to decide on a 'touchdown or go-around' decision point before committing to an approach. Where obstacles could compromise a go-around flightpath, they should also be factored into the decision point selection process.
