Rail Accident Investigation Branch

Rail Accident Report

Collision and derailment at Neville Hill 13 November 2019

Report 13/2020
November 2020

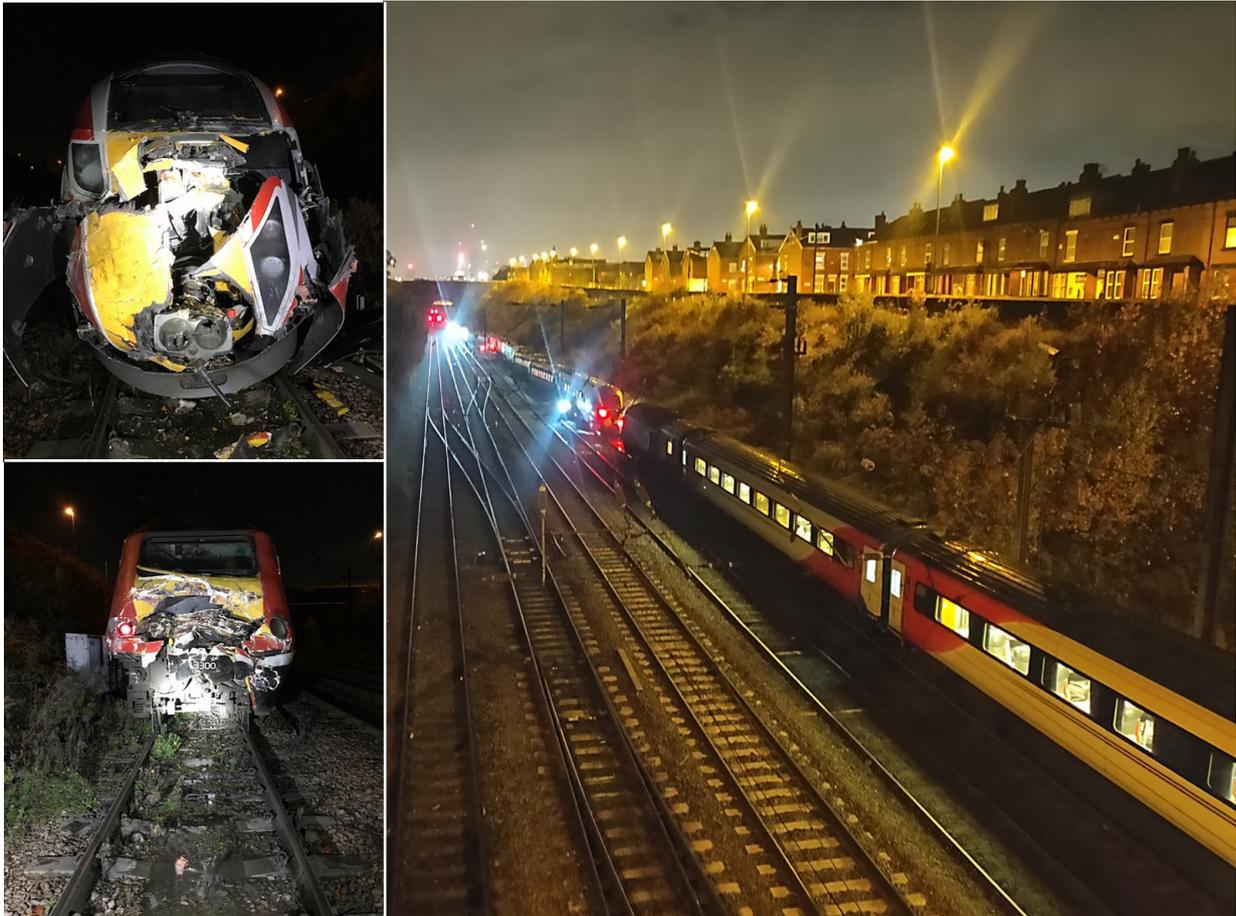
Figure 2: The class 800 train (top) and HST set (bottom) involved in the accident and the crash scene to the right (images courtesy of Network Rail)

- 5 The colliding train was a 9-coach class 800 set, part of the Intercity Express Programme, operated by London North Eastern Railway (LNER). Its leading end suffered significant damage during the collision (figure 2). The second train was a High Speed Train (HST) set comprising 9 coaches and a class 43 locomotive at each end. It was also operated by LNER. The trailing class 43 locomotive also suffered significant damage (figure 2).

- 6 As a result of the collision, the trailing bogie of the second and third vehicles and the trailing wheelset of the fourth vehicle on the class 800 train, derailed to the right in the direction of travel.

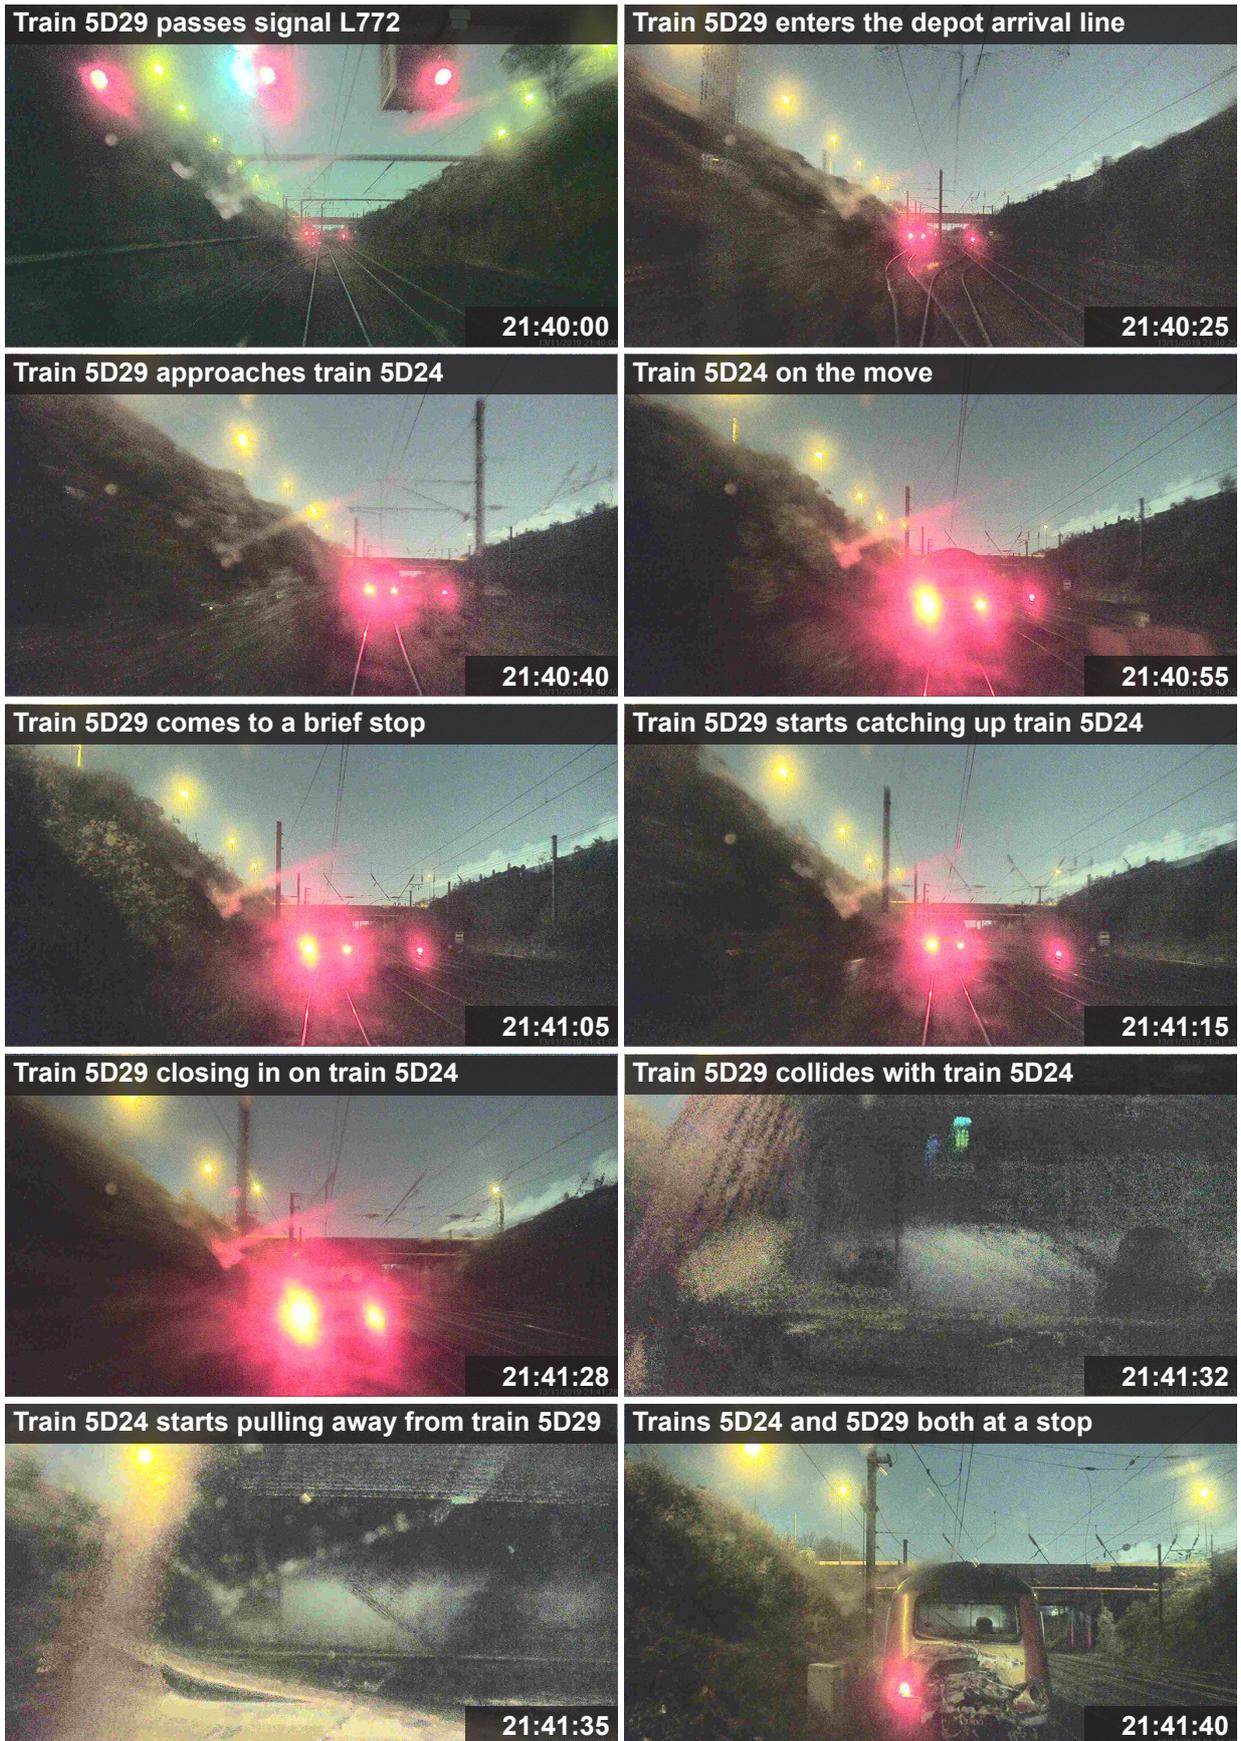
Figure 5: FFCCTV footage from unit 800109

51 Normal railway operation is based on the principle that only one train can be in a signal section⁵ at any time. The intent of this is to prevent the risk of collision between trains. However, there are certain circumstances where it is normal railway practice to authorise a train to enter a section already occupied by another train. This is called permissive working and it is covered by specific rules and requirements in the Rule Book. Permissive working is most commonly in place at stations to allow two or more trains to use the same platform, but is also often found on freight-only lines and the approach to yards and depots. Rules require that the driver should proceed at caution, ready to stop short of any obstruction.

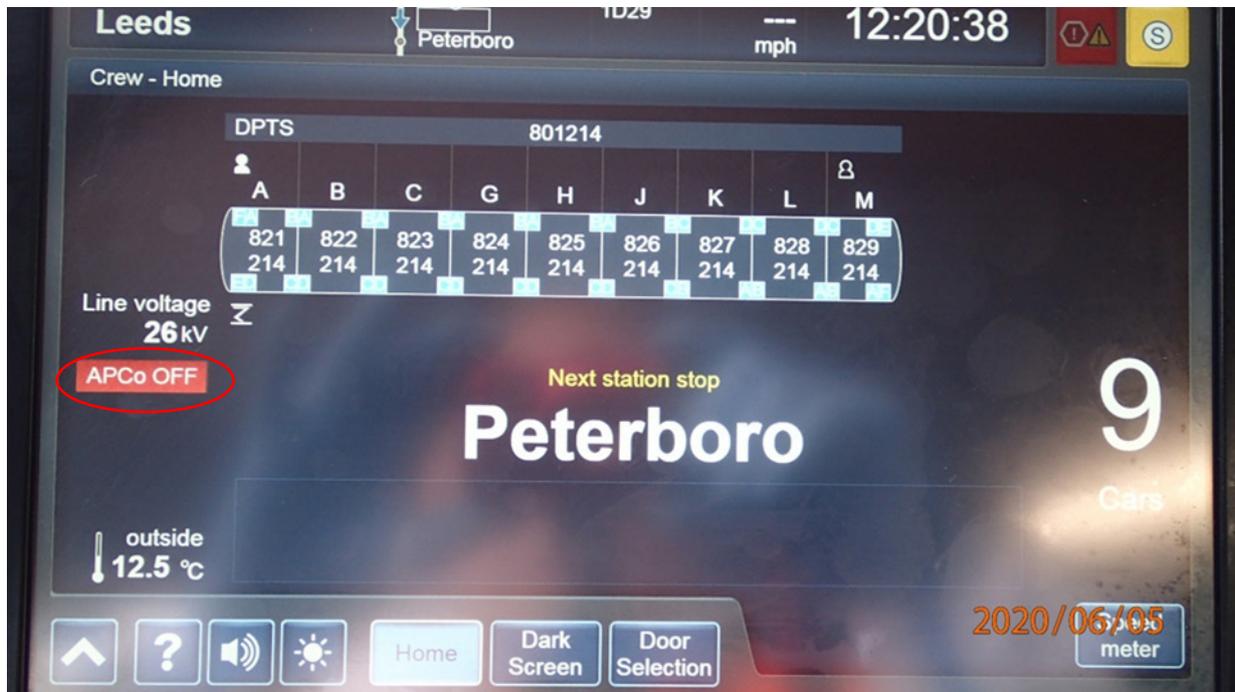
Figure 8: APCO isolation on TMS home screen

- 75 However, at the start of November 2019, the TMS software was updated to provide an indication of an APCO isolation on the home screen (figure 8). As part of the update, a driver also received a warning that APCO was isolated when starting a train using the master switch.

- 76 The driver was unaware of this new feature because he had not been briefed by LNER on the introduction of the software update. LNER and Hitachi have an engineering change process for managing and briefing such changes, which normally results in briefing updates being provided to drivers. However, in this instance, it appears that the importance of this information was lost in the vast array of changes introduced in this particular software update. It is possible that, if a more thorough description of the change had been included in Hitachi's engineering change pack, its relevance would have been more easily identified.

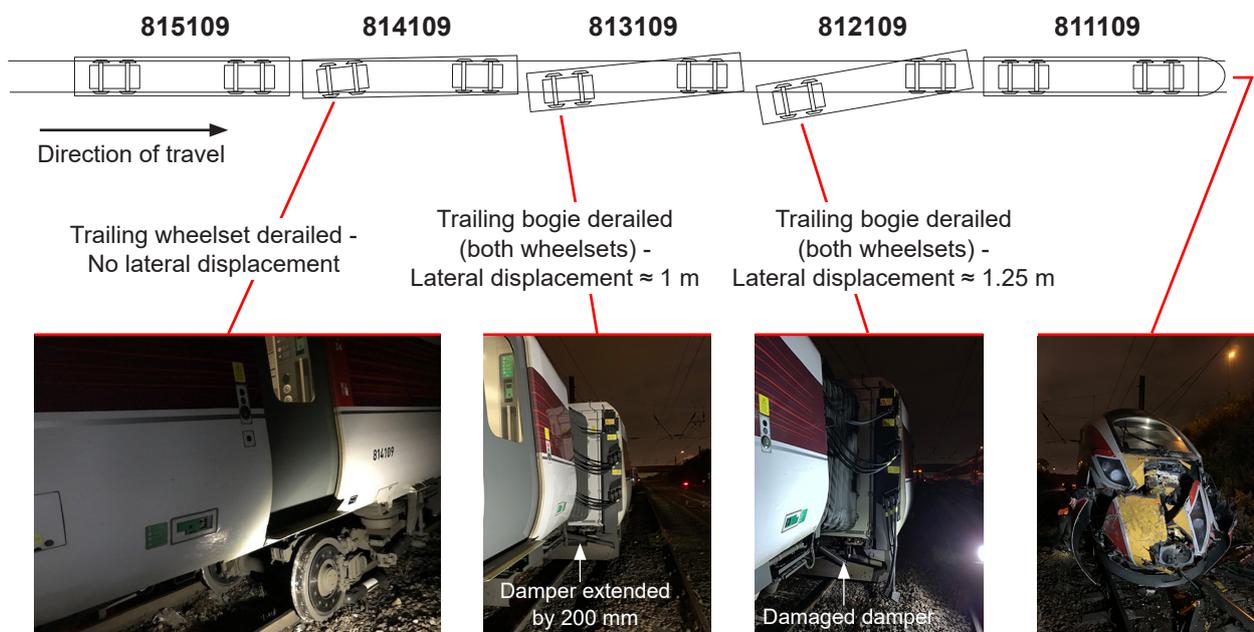
Figure 9: Schematic showing extent of derailment during collision (not to scale)

89 The trailing bogie of the second and third vehicles and the trailing wheelset of the fourth vehicle on the IET, derailed to the right in the direction of travel as a result of the collision. Figure 9 shows the lateral movement of the vehicles during the collision as witnessed by the marks left by the couplers on the vehicle structures. The extent of the derailment (up to 1.25 metre of lateral displacement on the second vehicle) would have been sufficient to significantly infringe the swept path of a vehicle travelling on an adjacent line, assuming a typical gap between adjacent running lines (known as the 'six-foot'), as shown in figure 10.

- 90 Post-accident testing of the IET revealed that there was no vehicle defect which would explain the derailment, such as wheel load imbalance, suspension lock-up, or body twist. RAIB also measured and analysed the track geometry following the accident and found no track feature which would explain the derailment, such as twist, gauge, or lateral track alignment faults.

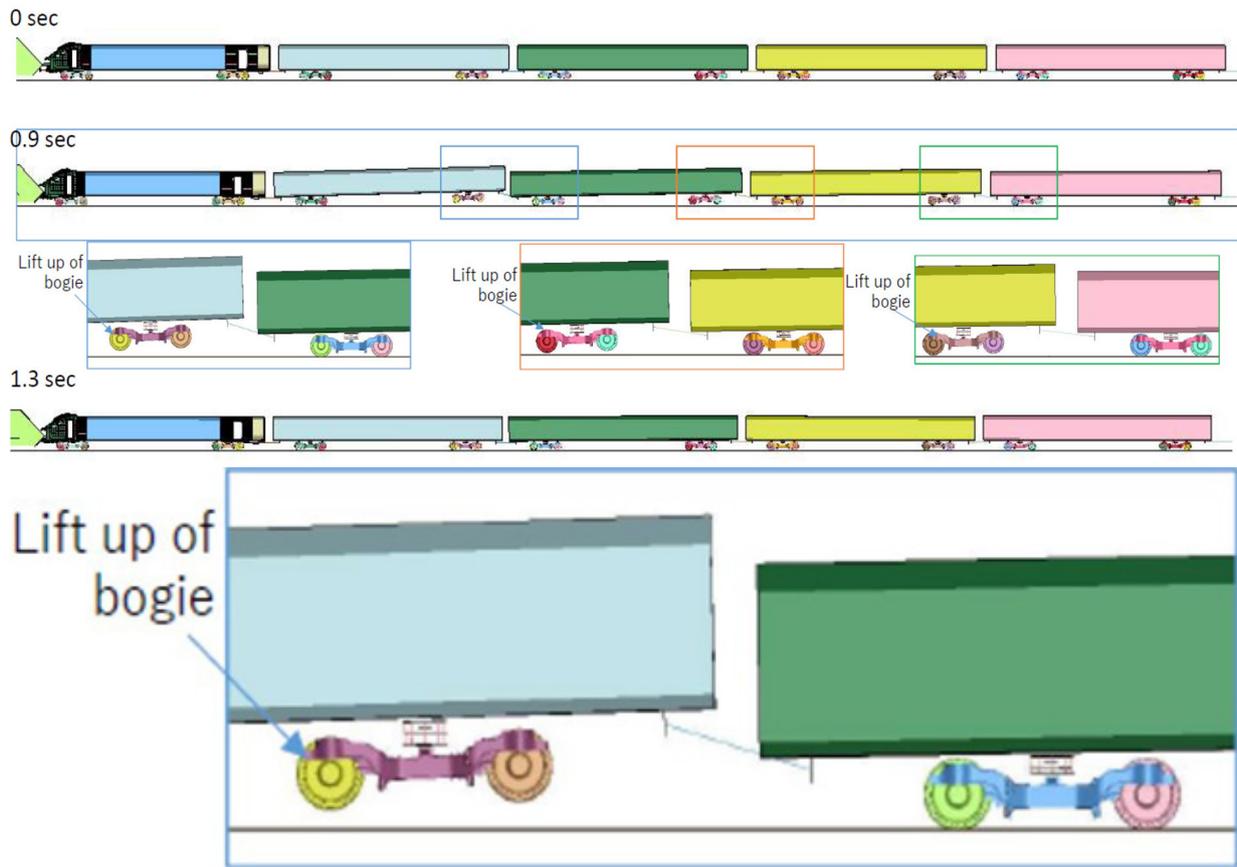
Figure 13: Output from collision and derailment simulation – sequence of events (courtesy of Hitachi)

- 98 Figure 13 shows the results from the 3D simulation at the relative collision speed of 10 mph (16 km/h). The amount of deformation on the class 43 power car and at the leading end of the IET was checked to ensure that it was representative of what had been experienced during the accident. As shown on figure 13, the trailing bogies of vehicles 2, 3 and 4 on the IET were predicted in the simulation to lift up above the railhead during the collision.
- 99 Figure 14 shows the predicted lateral displacement on the first five vehicles. The trailing bogies of vehicles 2, 3 and 4 were predicted in the simulation to derail to the right during the collision. Vehicle 5 was predicted to remain guided by the rails.

100 The Hitachi 3D model predicted that the leading couplers of the HST and IET would deflect each other sideways during the collision. This generated yaw movement on the leading vehicle which was then transferred to the other vehicles. Overall, the Hitachi 3D model predicted vertical and lateral displacements on all vehicles which were consistent in magnitude and direction with the observations on site.

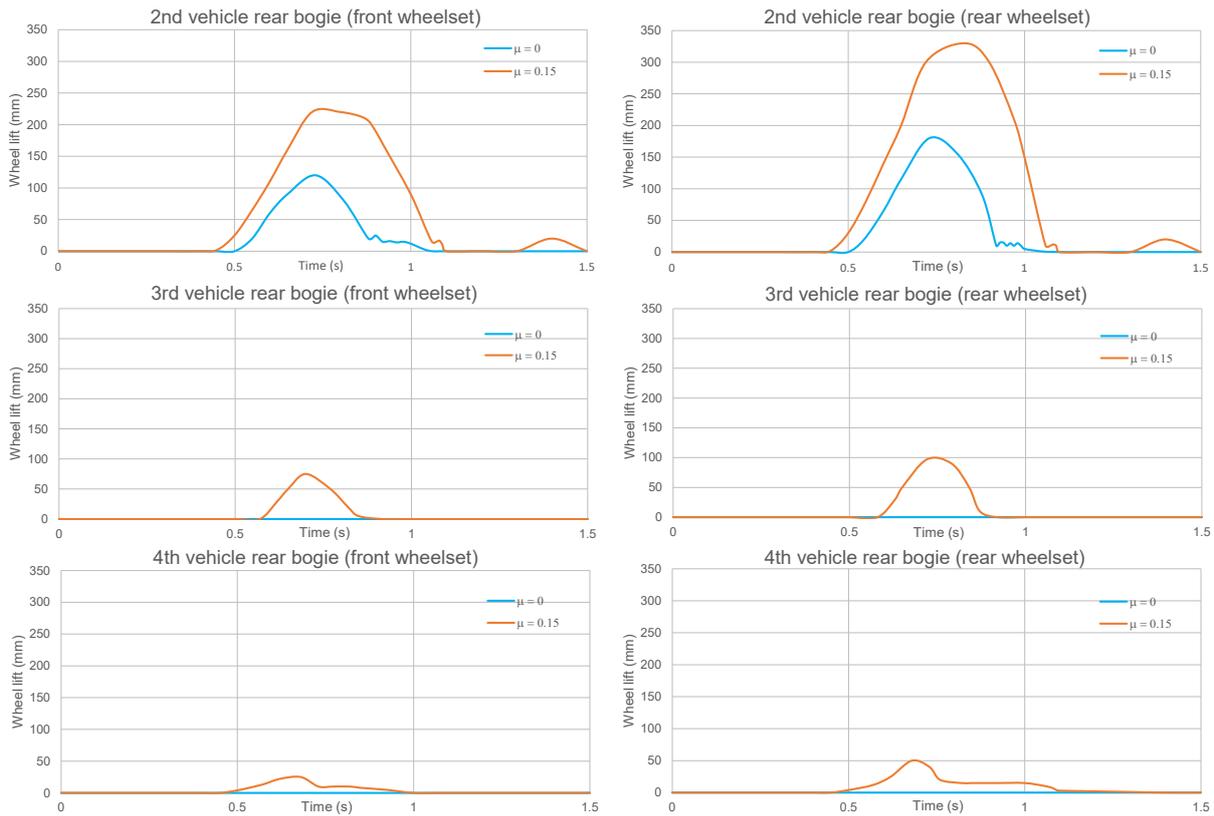
Figure 15: Output from collision and derailment simulation – wheelset vertical lift (courtesy of Hitachi)

105 Braking increased the likelihood of derailment following the collision.

- 106 Figure 15 shows the predicted amount of wheel lift for the leading and trailing wheelset of the trailing bogie of vehicles 2, 3 and 4 for different coefficients of friction at the wheel-rail interface. These results show that the amount of wheel lift predicted in the 3D model was dependent on the amount of friction at the wheel-rail interface in the model (representing the amount of braking). In the case of zero friction (representing an unbraked train), only the trailing bogie of vehicle 2 was predicted to lift vertically. As modelled friction was increased, so did the amount of wheel lift on vehicles 2, 3 and 4. This is due to the additional vehicle body pitching introduced by braking.
- 107 The effect of braking on the degree of lateral displacement was not investigated.

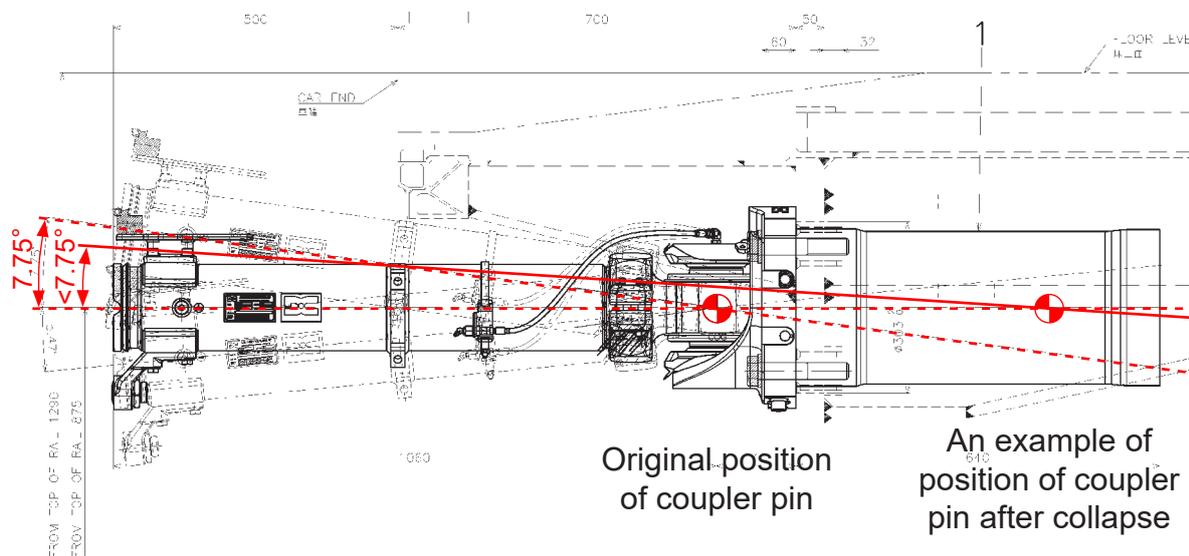
Figure 16: Effect of coupler collapse on pitch freedom

110 At 22.5 mph (36 km/h), the inter-vehicle couplers were predicted to collapse significantly, which reduced the angle that the couplers can freely pitch and yaw (figure 16). The original 1D models had been set with a constant $\pm 8^\circ$ pitch limit (and $\pm 24^\circ$ yaw limit) which was only accurate for the cases where the couplers did not collapse. The model with the 22.5 mph (36 km/h) collision speed was rerun initially with a constant pitch limit of $\pm 6^\circ$ (and $\pm 6^\circ$ yaw limit) and then with a constant pitch limit of $\pm 5^\circ$ (and $\pm 5^\circ$ yaw limit) representing increasing levels of coupler collapse.

- 111 Prior to the coupler starting to collapse, as the speed of collision increased the degree of lateral displacement of a derailment increased.
- 112 However, as the coupler started to collapse, and the pitch limit decreased, the predicted amount of wheel lift decreased. Similarly, as the yaw limit decreased, the predicted amount of lateral displacement also decreased. RAIB concluded that it was therefore probable that the risk of derailment decreased as the speed of collision increased (because the inter-vehicle couplers collapse and limit the pitch and yaw movement of the couplers). Overall, the risk of derailment appeared to be greatest at low speeds: very low speeds do not generate enough energy to lead to a derailment and high speeds create enough energy to collapse the inter-vehicle couplers which appear to reduce the risk of derailment.

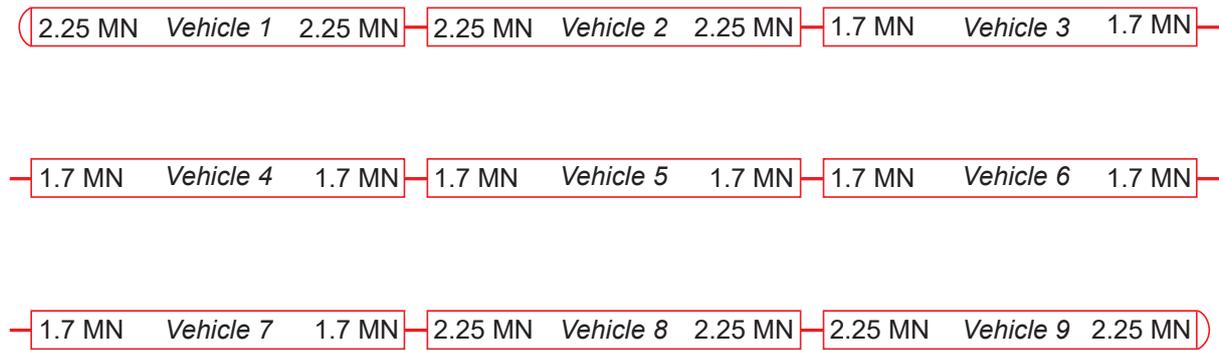
Figure 17: Distribution of coupler collapsing strength along the IET rake

113 The high collapsing strength of the inter-vehicle couplers increased both the likelihood of derailment following the collision, and the extent of lateral displacement.

114 The couplers fitted to an IET are all designed to collapse in the event of a collision. However, the load at which they will collapse is not the same throughout the train. Figure 17 shows the distribution of coupler collapsing strength along the train.

115 The IET coupler collapsing strengths of 2.25 MN and 1.7 MN are high compared to those of other trains on the UK network. The requirement in EN 12663¹³ is to design the carbody of trains to withstand a compressive 1.5 MN load at the coupler attachment. The coupler collapsing strength tends to be designed to be the same or less than 1.5 MN to ensure that the coupler will collapse before the carbody starts deforming permanently.
