Aircraft Type and Registration:	Boeing 737-8K5, G-TAWG	
No & Type of Engines:	2 CFM CFM56-7B27E turbofan engines	
Year of Manufacture:	2012 (Serial no: 37266)	
Date & Time (UTC):	24 December 2019 at 0048 hrs	
Location:	Manchester Airport	
Type of Flight:	Commercial Air Transport (Passenger)	
Persons on Board:	Crew - 6	Passengers - 181
Injuries:	Crew - None	Passengers - None
Nature of Damage:	Bearing failure, separation of No 4 (right outer) mainwheel and severe damage to the associated brake unit	
Commander's Licence:	Airline Transport Pilot's Licence	
Commander's Age:	41 years	
Commander's Flying Experience:	6,709 hours (of which 246 were on type) Last 90 days - 68 hours Last 28 days - 27 hours	
Information Source:	AAIB Field Investigation

Shortly after a normal touchdown, the right outer (No 4) mainwheel separated from its axle and was seen, by the pilots, to pass down the right side of the aircraft. The aircraft vacated the runway and was safely brought to a halt on the taxiway. The wheel separated as a result of a failure of the inboard wheel bearing which led to the failure of the outer bearing. The exact cause of the initial failure to the inboard bearing could not be determ

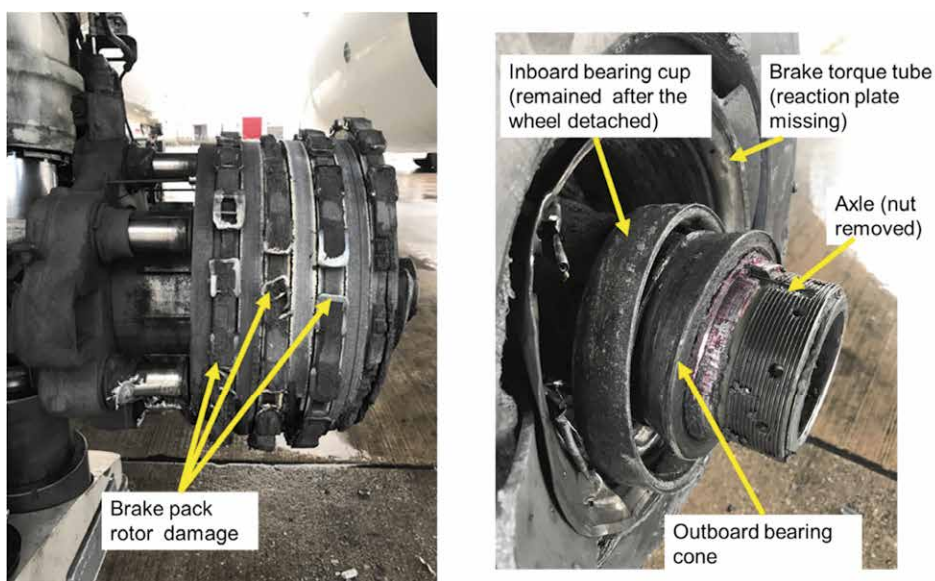
Figures 5 and 6
Brake pack and bearing damage

Prior to moving the aircraft, an inspection was carried out by the operator's engineers who found significant damage on the brake pack and to the wheel bearing cones, which were still attached to the axle. The tracks were heavily scored, exhibited heat damage and the remains of some of the rollers were smeared onto the bearing tracks. The inboard bearing cup had detached from the hub and was loosely hanging on the axle (Figures 5 and 6). The nut and washer were still in place on the axle and were relatively undamaged. The brake pack reaction plate was found on the runway.

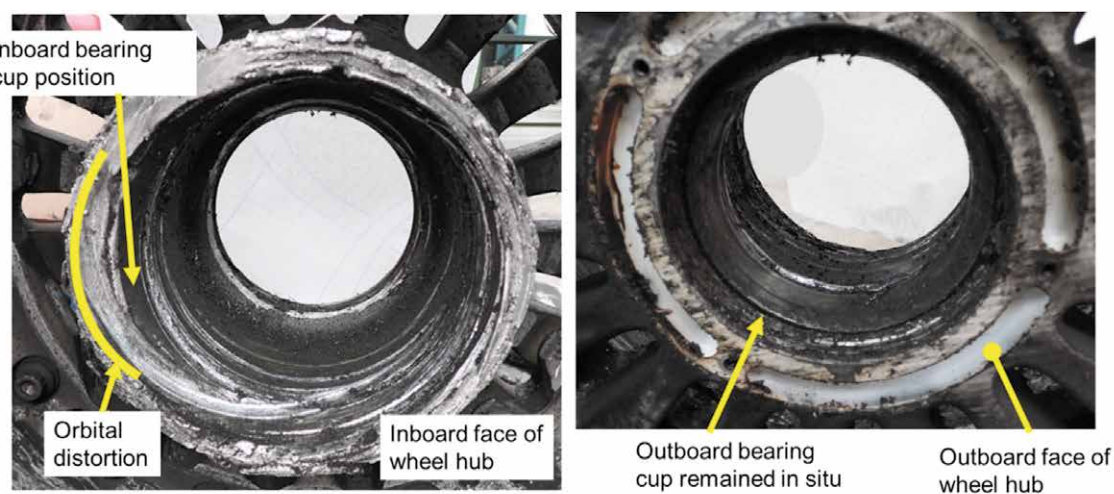
Figures 7 and 8

All but one of the brake rotor drive keys had detached and the inner face of the hub was heavily scored over its entire surface. The outboard bearing cup was in place, but the inboard bearing cup had detached. The hub, where the inboard cup had been fitted, was badly distorted and had taken on an offset elliptical shape (Figures 7 and 8).

Hub damage around the inboard and outboard bearing cup area

The elliptical damage to the hub, and the area where the inboard bearing cup is located, is consistent with the inboard bearing becoming loose allowing the wheel to wobble about its axle.

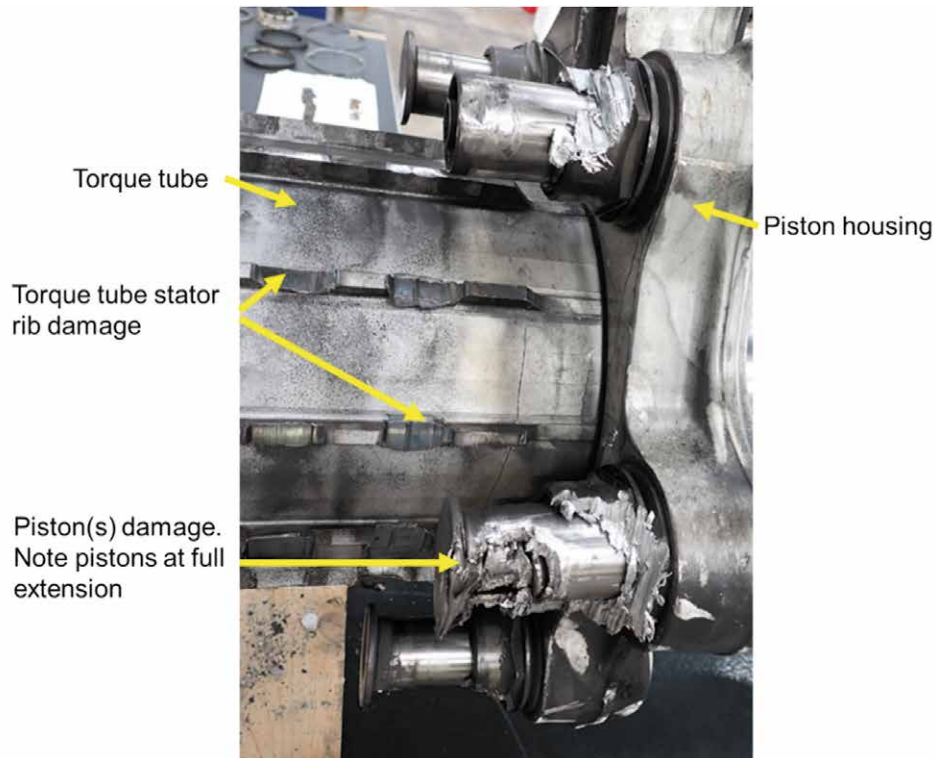
The brake pack rotors and stators were all present, although they had been pushed outwards by the brake pistons which had travelled to their full extension. There was no evidence of hydraulic fluid leakage. The outer reaction plate had detached along with a large portion of the brake torque tube. Some of the lower-most pistons had deep gouges in their outer surfaces. Most of the rotors and stators were distorted and had various cracks and fissures across their surfaces. Figure 9 shows the damage to the brake pack torque tube and pistons.

Damage to the torque tube and pistons

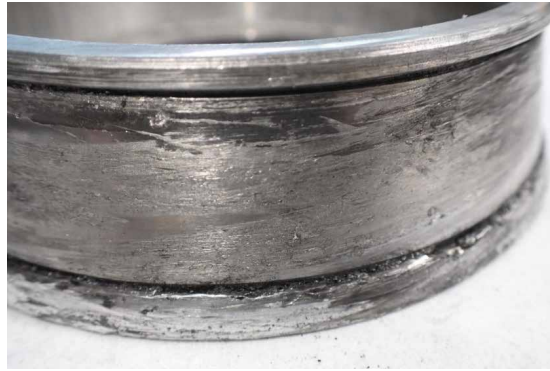
Only 20% of the outboard and 50% of the inboard bearings were recognisable. The outboard bearing cone, which was still fitted to the axle, was scored and showed evidence of metallic smearing on its bearing track. None of the rollers or the cage were in place. The remains of the rollers were found on the runway and showed signs of skidding welding and overheating. The outboard bearing cup remained within the wheel hub and exhibited similar damage to the bearing cone.

Figure 10
Outboard bearing cone

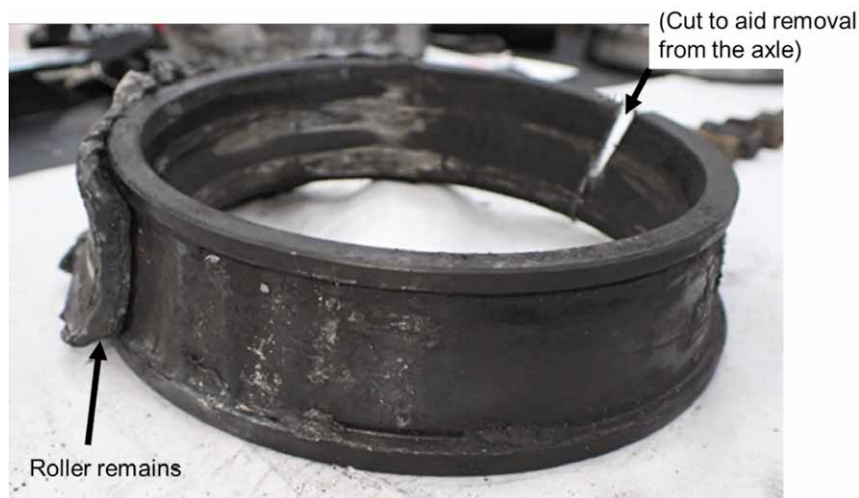
The damage to the inboard bearing was far worse than on the outboard bearing components. The inboard cone was severely overheated, its bearing track was worn and misshapen and the remains of several rollers were smeared and welded to its surface. The inboard bearing cup exhibited very similar damage to the cup on its bearing track. Figures 10 and 11 show the condition of the outboard and inboard bearing cones.

Figure 11
Inboard bearing cone

The inboard bearing was more severely damaged than the outboard bearing indicating that the inboard bearing failed first, causing secondary damage to the outboard bearing. The severity of the damage to the inboard bearing indicates that it may have been running for a period of time in a distressed condition during which large amounts of heat were generated.

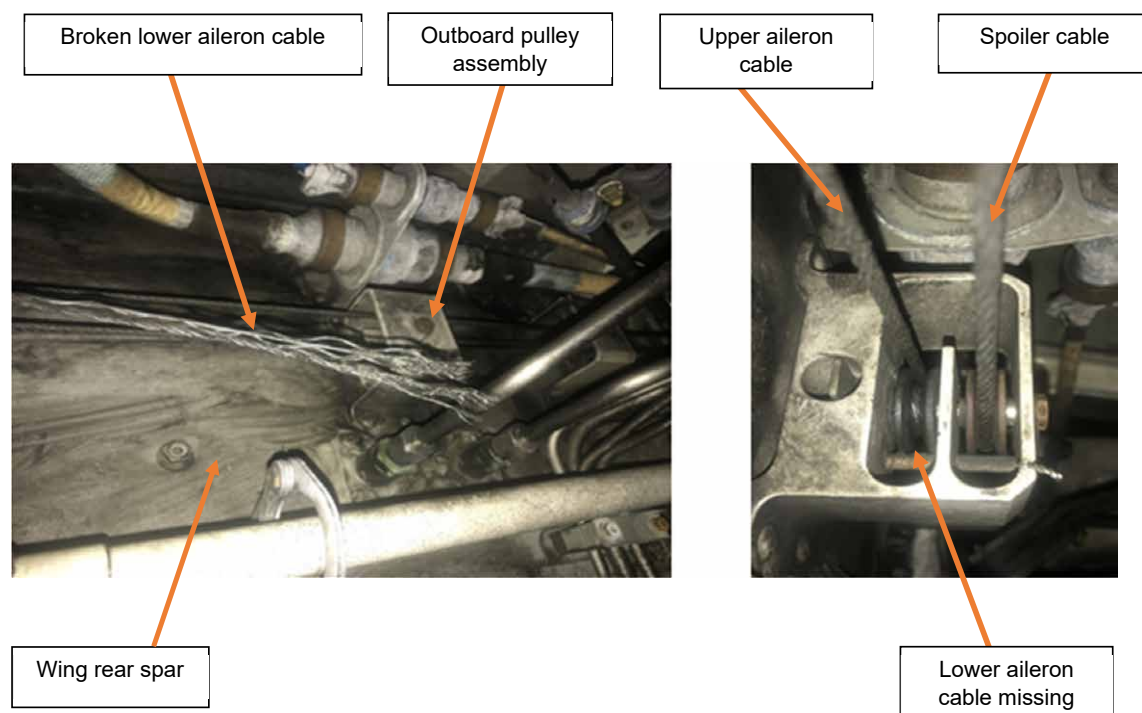
Figure 1

Post-flight examination revealed that the lower left aileron cable broke just outboard of the engine where it passed over a pulley to accommodate a change in the wing dihedral (Figure 1). There was no other damage to the aircraft.

Broken aileron cable and associated pulley

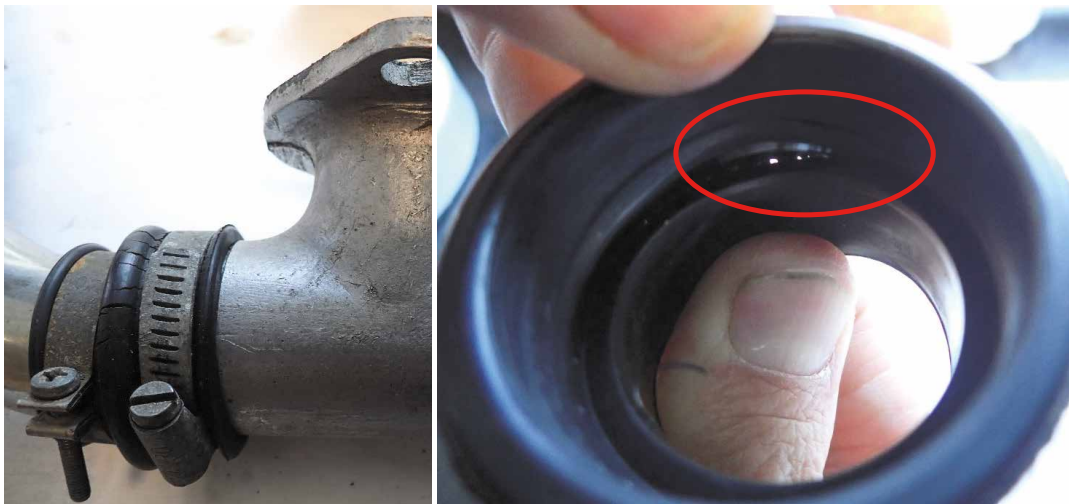
level and size of the particles was consistent with normal operation without an air filter. It was noted that the external surface of a flexible joint in the inlet manifold to the left cylinder head was cracked. Upon closer examination it was found that the crack went all the way through and was approximately 10 mm in length (Figure 7). This crack would have resulted in air entering the system 'leaning' the fuel air mixture. When the interfaces between the inlet manifolds and the engine cylinder heads were disassembled it was found that, in addition to the metal gasket, there was large amounts of silicone instant gasket material. It was not possible to determine whether the metal gasket alone would have provided a suitable seal. No leak paths could be identified.

Figure 7
Inlet manifold flexible joint

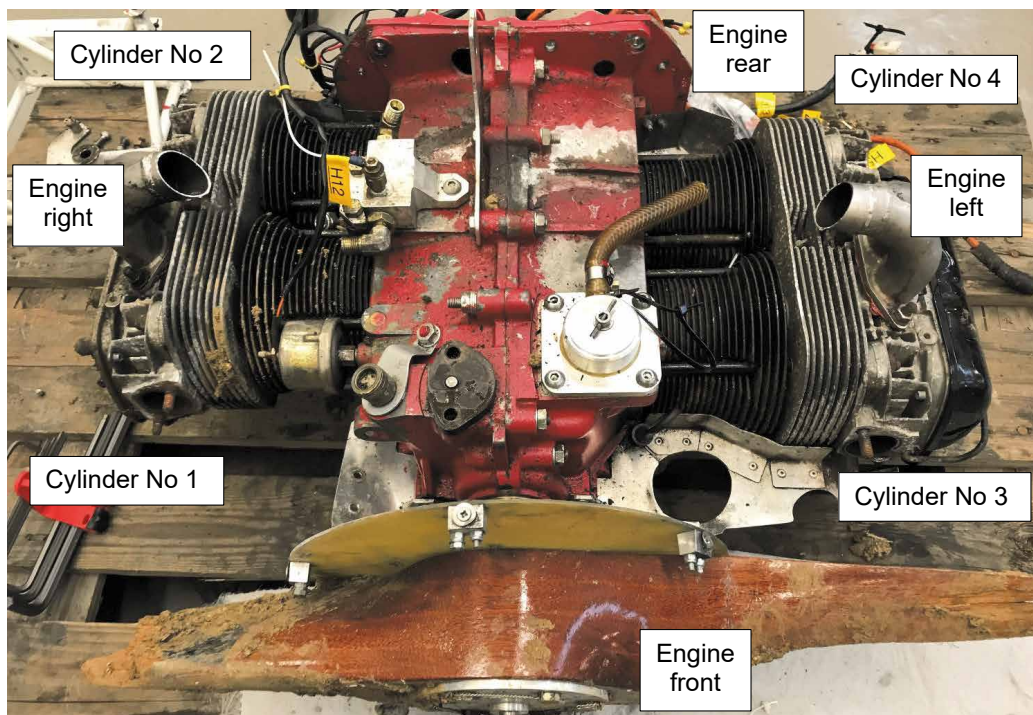
Figure 8

An external inspection of the engine (Figure 8) revealed that the right side had struck the ground, the right rocker cover was missing and the two push rod guide tubes for cylinder 1 were crushed. The rocker cover was found on the accident site and, although covered with soil, was not visibly damaged. The left rocker cover and rocker assembly were removed, and it was noted that the thread on one of the rocker attachment studs differed from the other three suggesting it had been replaced. Furthermore, the nut had been cross threaded onto the stud damaging the thread profile, but it is not considered that this impaired the function of the rocker assembly. All the rocker valve clearance adjusters showed signs of wear. The engine logbooks showed that the valve clearances were checked and adjusted by the owner approximately every 50 hours. The spark plugs were examined, and they all showed signs of use with some build-up of black and light brown coloured deposits.

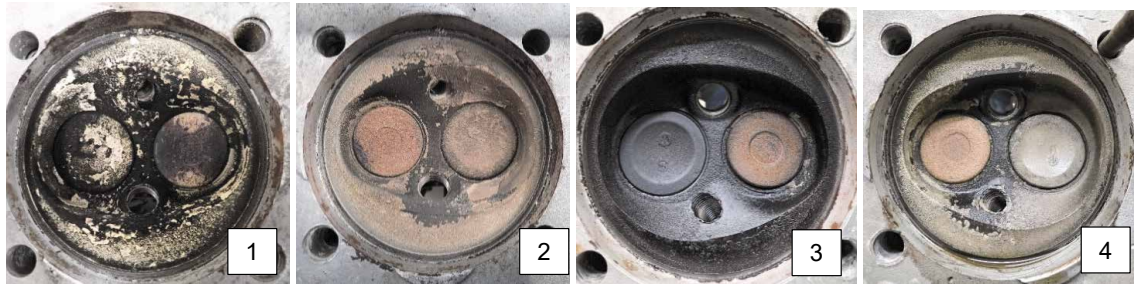
Both cylinder heads were removed and examined along with the crowns of the pistons (Figures 9 & 10). All the cylinders had evidence of the build-up of combustion deposits. The largest build-up was seen in cylinder 1 with black and white deposits on both the piston crown and the head. Cylinders 2 & 4 showed some build-up of a hard, light brown deposits, whereas cylinder 3 was predominantly a soft black deposit.

Figure 9
Cylinder heads

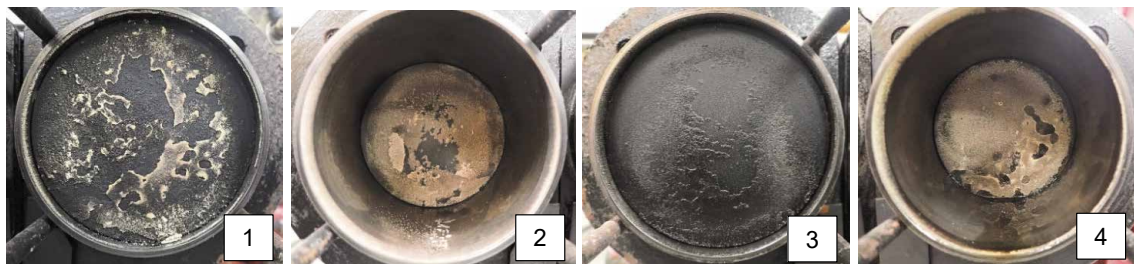
Figure 10
Piston crowns

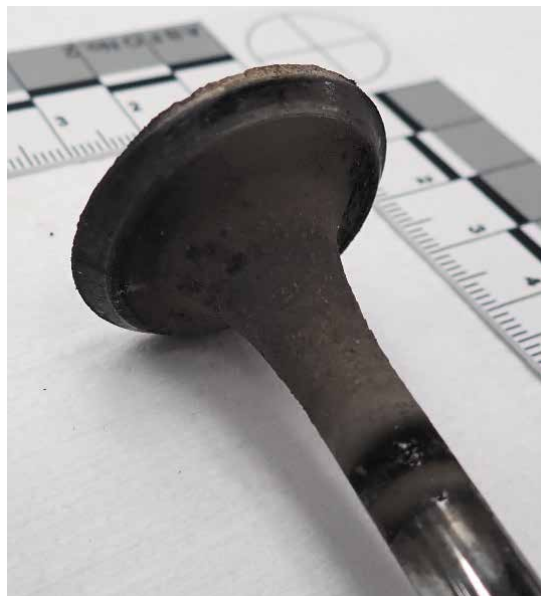
The valves were removed to facilitate an examination of the valves and their seats. The exhaust valves from cylinders 1, 2 and 3 all showed signs of localised overheating and evidence of uneven seating in the valve seat (Figure 11). All the inlet valves showed signs of carbon build-up on the back face which is thought to be typical for an engine of this age.

Figure 11
Exhaust valve from cylinder 1

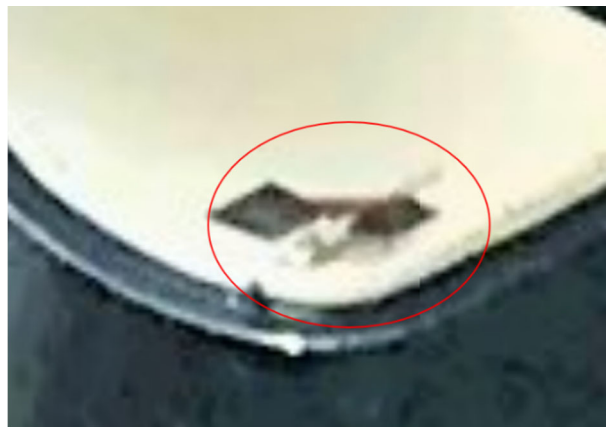
Figure 4

Closer examination and magnification of Figure 1 shows that the internal handle was in a partly open position before the flight (Figure 4). The image is grainy due to the magnification and the contrast and colour have been adjusted to show the handle more clearly. The image has been rotated 180° to align more with the image in Figure 5, which shows the similar position of the internal operating handle after landing, for comparison.

Extract of Figure 1 showing internal operating handle partially open before flight

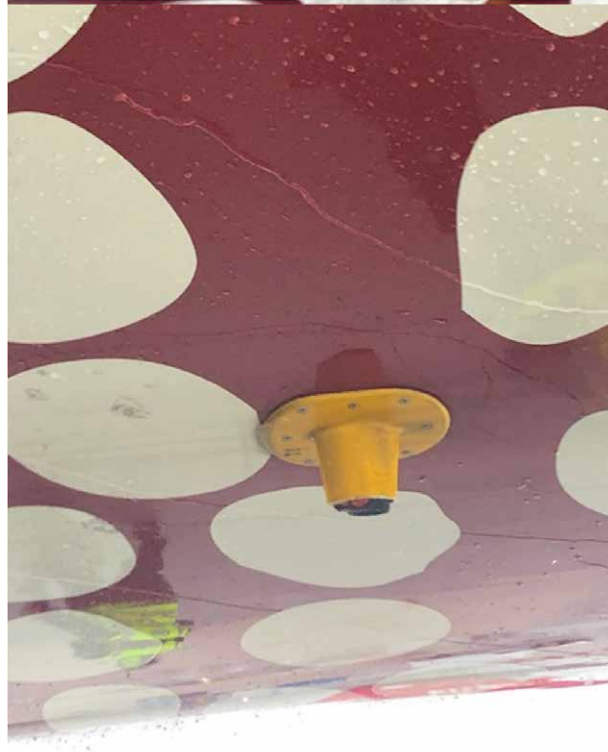
Figure 2

After landing, it was identified that the tip of the tail strike detection sensor (Figure 2) had been abraded due to contact with the runway. No further damage was found.

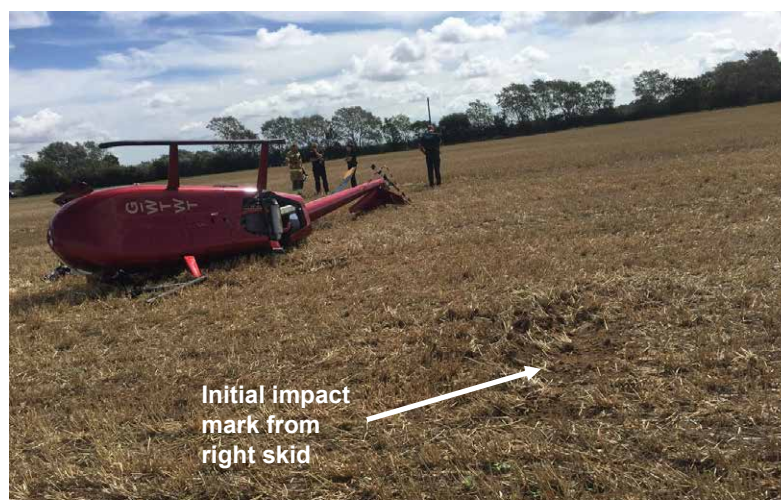
Figure 3 shows the initial impact mark where the right skid dug into the soil causing the helicopter to roll over.

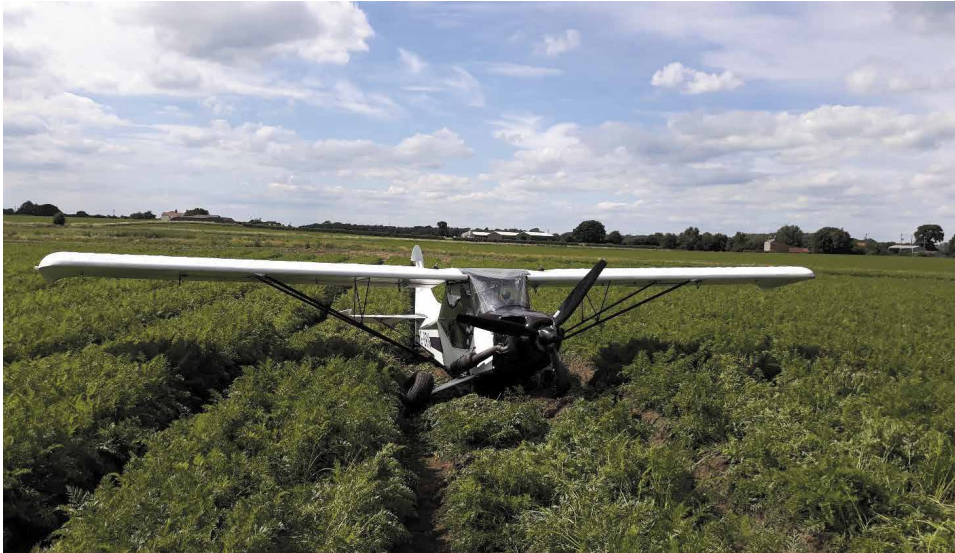
pilot completed a successful forced landing in a crop field and was uninjured, exiting the aircraft without assistance, but the aircraft sustained substantial damage due to the furrowed surface of the field (Figure 1). After landing, he examined the unused fuel in the jerry can and discovered that there was no evidence of the dye he would have expected to see if two-stroke oil had been present in the fuel.

Figure 1
G-SR11 after landing
