HMS Daedalus, Lee-on-Solent Land Quality Assessment

Phase Two: Radiological Investigation
Project No 05502

Draft Report

8 April 2003

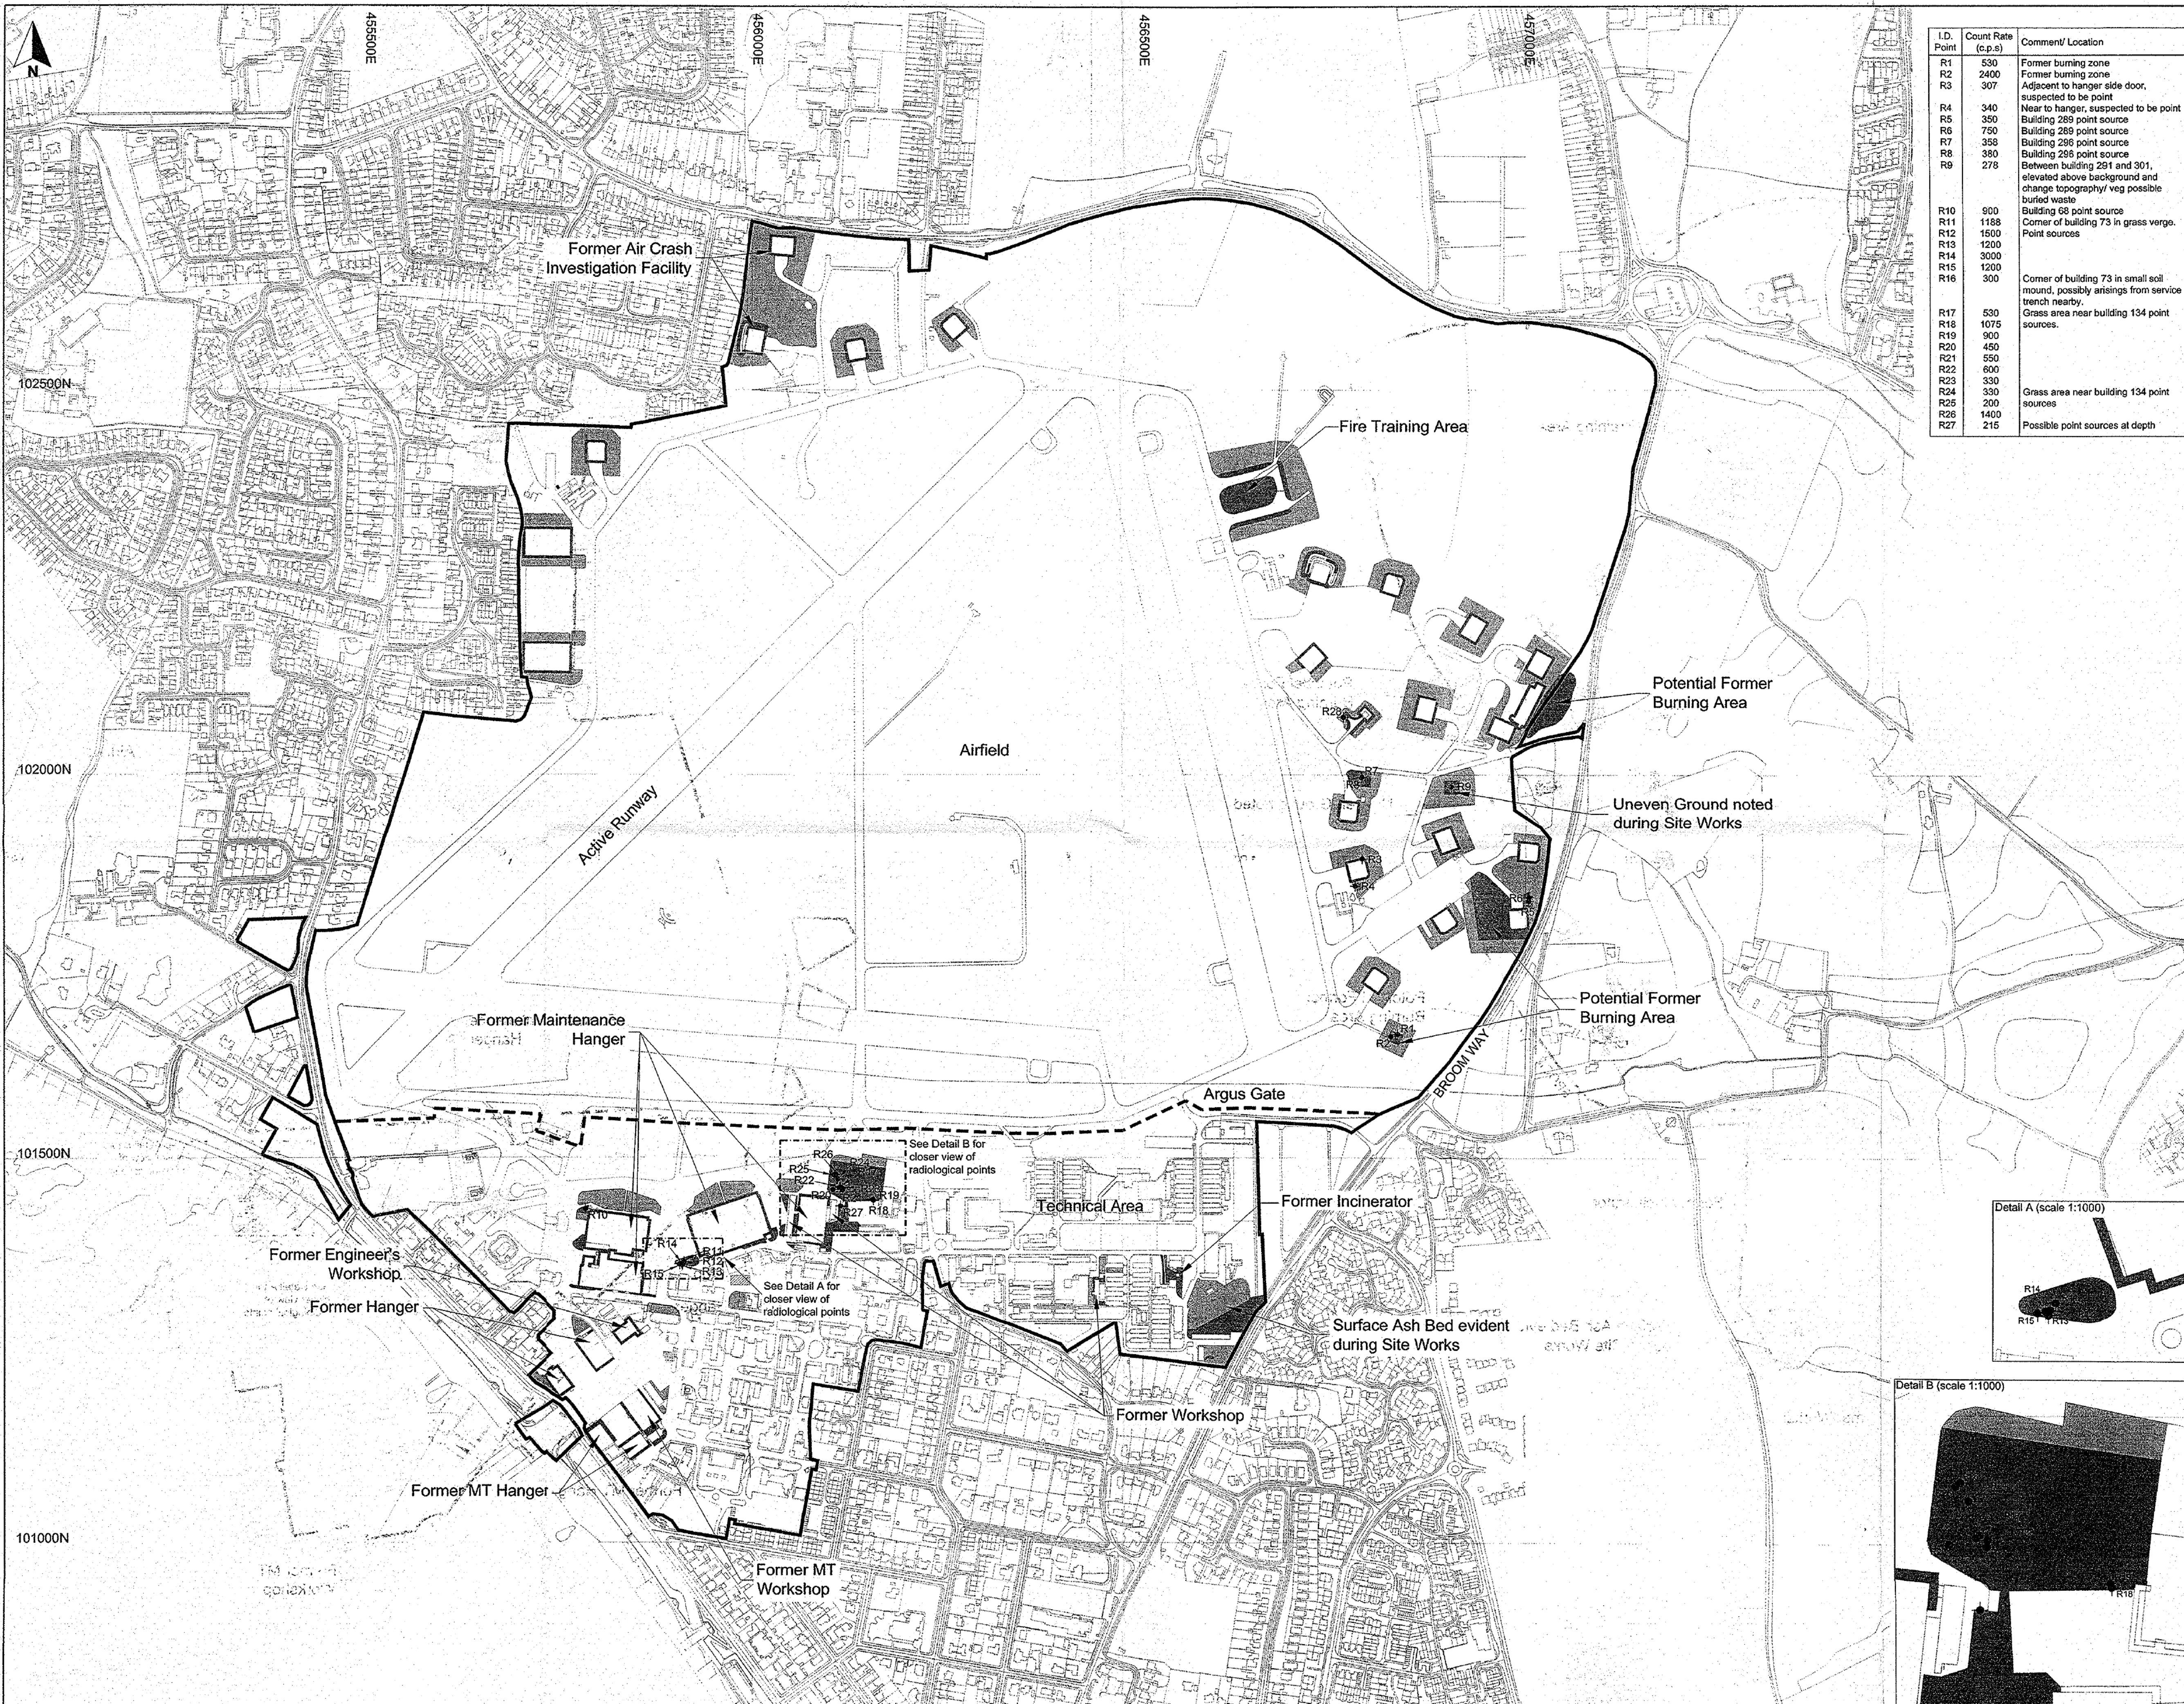
Two radiological point sources (R1 and R2) were identified within a former burning ground, located to the south of Bldg 286. The radiological point sources were noted at 1410 cps and 2280 cps, corresponding to 2.82 Bq/g and 4.56 Bq/g respectively.

I.D. Point	Count Rate (c.p.s)	Comment/ Location
R1	530	Former burning zone
R2	2400	Former burning zone
R3	307	Adjacent to hanger side door, suspected to be point
R4	340	Near to hanger, suspected to be point
R5	350	Building 289 point source
R6	750	Building 289 point source
R7	358	Building 289 point source
R8	380	Building 289 point source
R9	278	Between building 291 and 301, elevated above background and change topography/veg possible buried waste
R10	900	Building 68 point source
R11	1188	Corner of building 73 in grass verge.
R12	1500	Point sources
R13	1200	
R14	3000	
R15	1200	
R16	300	Corner of building 73 in small soil mound, possibly arising from service trench nearby.
R17	530	Grass area near building 134 point sources.
R18	1075	
R19	900	
R20	450	
R21	550	
R22	600	
R23	330	
R24	330	Grass area near building 134 point sources
R25	200	
R26	1400	
R27	215	Possible point sources at depth
