RADIATION WALKOVER SURVEY AT DAEDALUS

19 APRIL 2017 COMMERCIAL IN CONFIDENCE

Report Title:	Radiation walkover survey at Daedalus		
Customer Contact:	Reg 13(1) Campbell Reith		
	Raven House,		
Customer	29 Linkfield Lane,		
Address:	Redhill, Surrey		
RH1 1SS			
Telephone:	: 01737 784 500		
Date:	09/05/17		
Reference:	AHP/CMB/REP/17/01		
Please Contact:	Reg 13(1)		
Telephone: Reg 13(1)			
Mobile:	Reg 13(1)		
Email: Reg 13(1)@aurorahp.co.uk

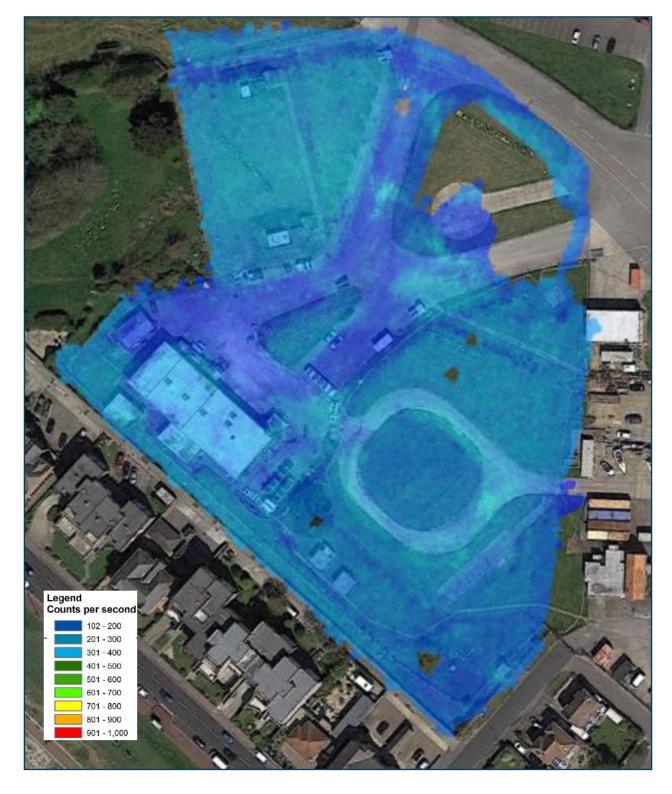
Figure 3. RadSurvey results showing levels in counts per second.

The survey collected 34,586 data points ranging between 92 and 434 counts per second (cps). The average reading on the site was 241 cps with a standard deviation of 50 cps. There were no areas of the site with statistically significant elevated count rates. The results of the RadSurvey can be seen as a surface picture in Figure 3.

The site generally showed readings commensurate with those expected from natural background, taking into account variations dues to different surface materials.

There are several areas in Figure 3 that are missing GPS data points (marked with no colouring). These are locations where either tree cover or site works prevented acquisition of a GPS signal or where a surface structure prevented access for monitoring. Where tree coverage prevents a GPS

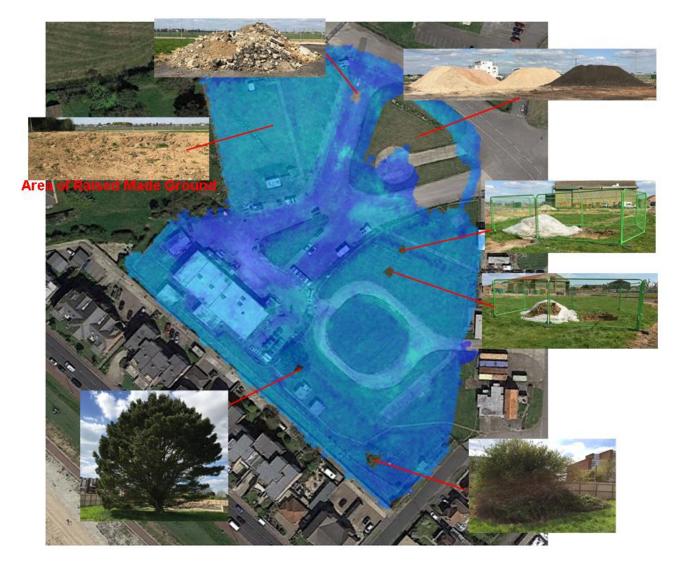
Figure 4. RadSurvey map showing locations that could not be surveyed

signal being recorded the data is reviewed by the operator to confirm that no elevated reading are present in the data. The areas of missed coverage can be seen in Figure 4 below.

In addition, there was a section to the West side of the site that was composed of 'made ground' with up to approximately 50 cm additional depth of material (see Figure 4). Therefore, the surface measurements in this area are not representative of the material that is below the original ground.

Whilst the majority of the site area was subject to a RadSurvey, some areas could not be surveyed due to the presence of piles of excavated material as indicated in Figure 4. If these areas are cleared, then these locations could be surveyed to provide comprehensive coverage and information on their radiological status.
