Report on the investigation of  
the enclosed space accident  
on board the fishing vessel  
***Sunbeam (FR487)***  
in Fraserburgh, Scotland  
on 14 August 2018  
resulting in one fatality

*Sunbeam (FR 487)*

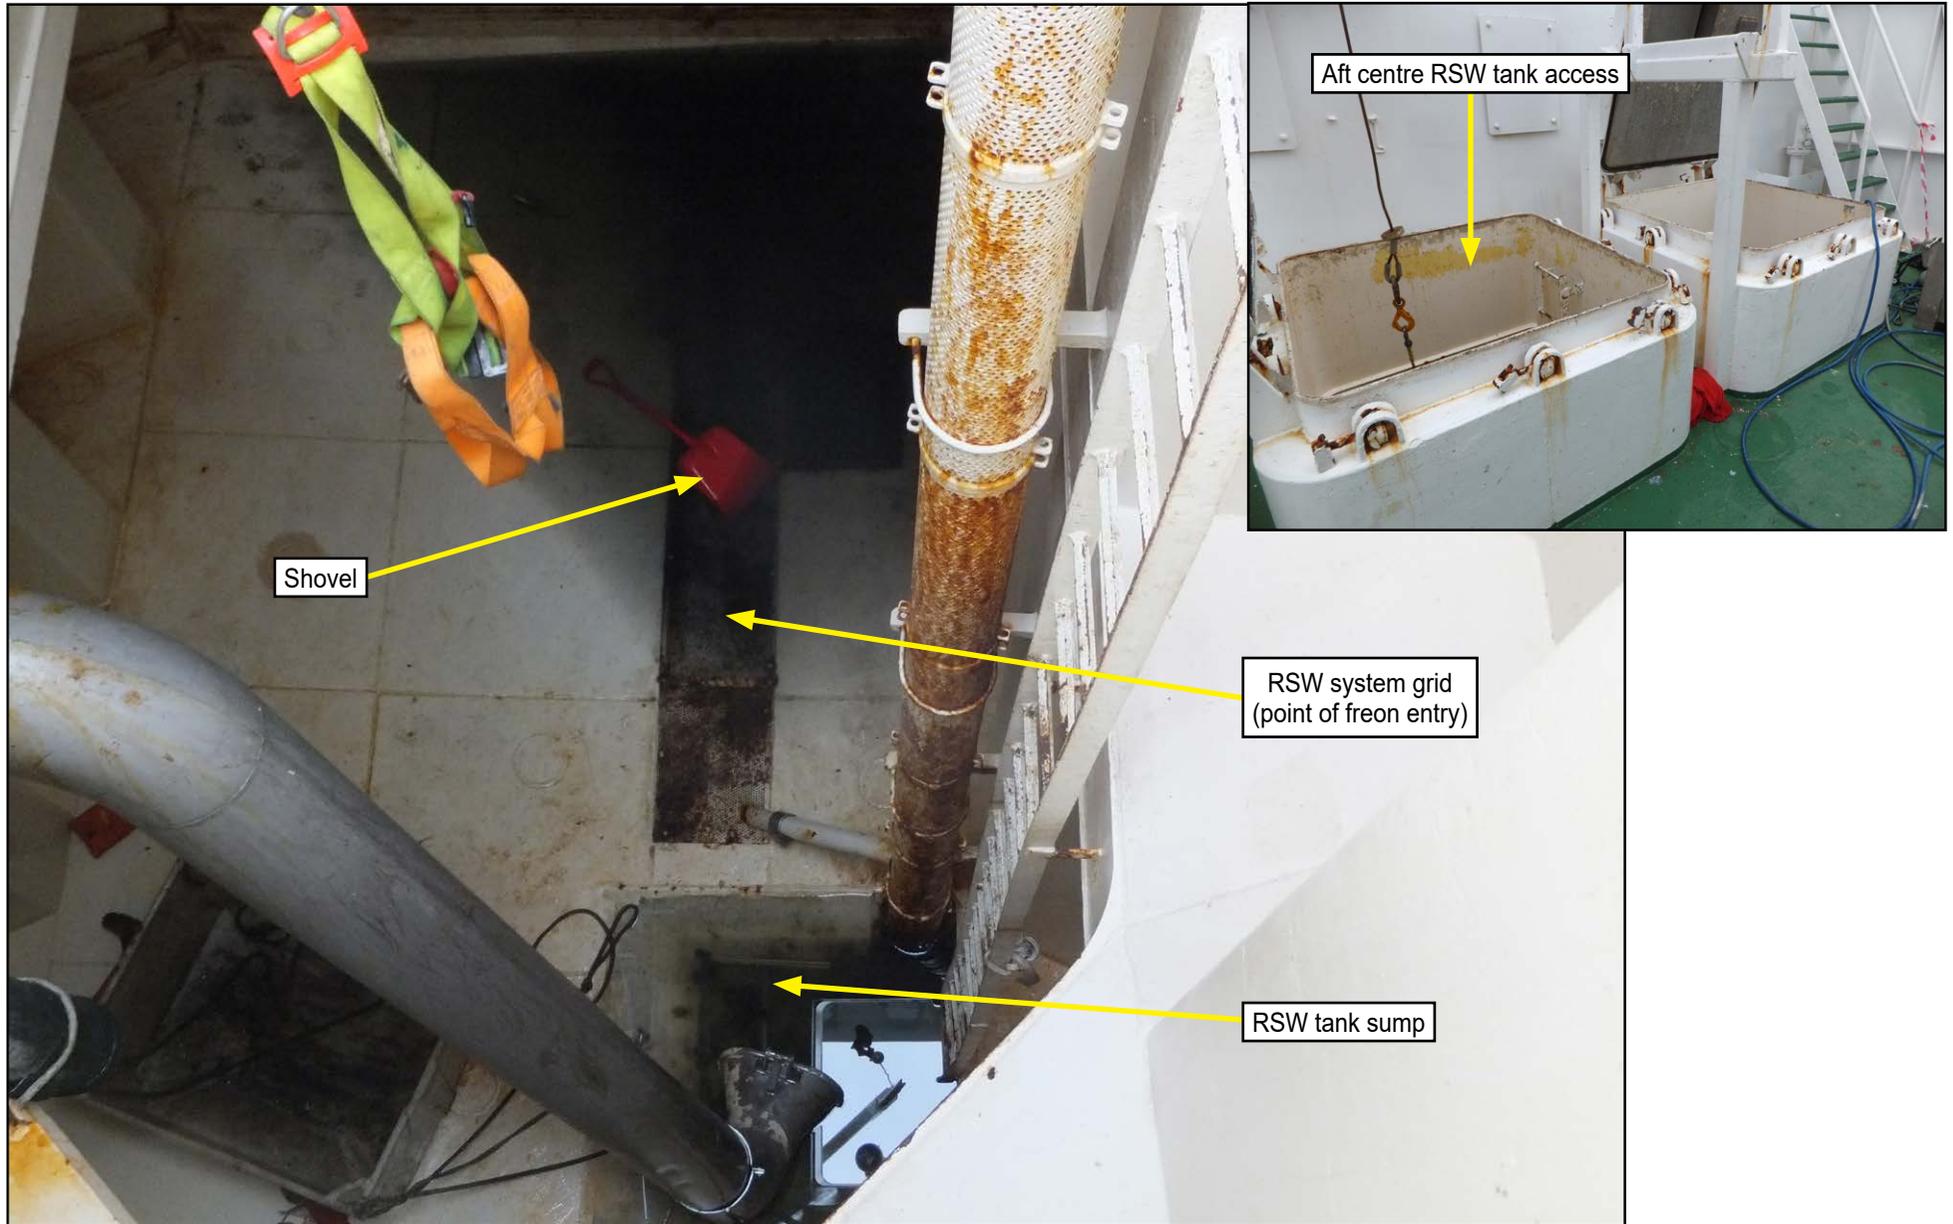
Returning to the upper deck, the 2/E looked into the aft centre RSW tank (**Figure 2**) and saw Mr Ironside lying face down at the bottom of the tank, near a pool of water. The 2/E raised the alarm by shouting loudly, and other members of the crew ran to assist. The 2/E then descended the ladder into the tank and found that Mr Ironside was unconscious and not breathing. One of the deck crew also descended the ladder and assisted the 2/E with cardio pulmonary resuscitation.

**Figure 2:** Sunbeam's aft centre RSW tank after the accident showing the shovel and residual water with hatch access inset.

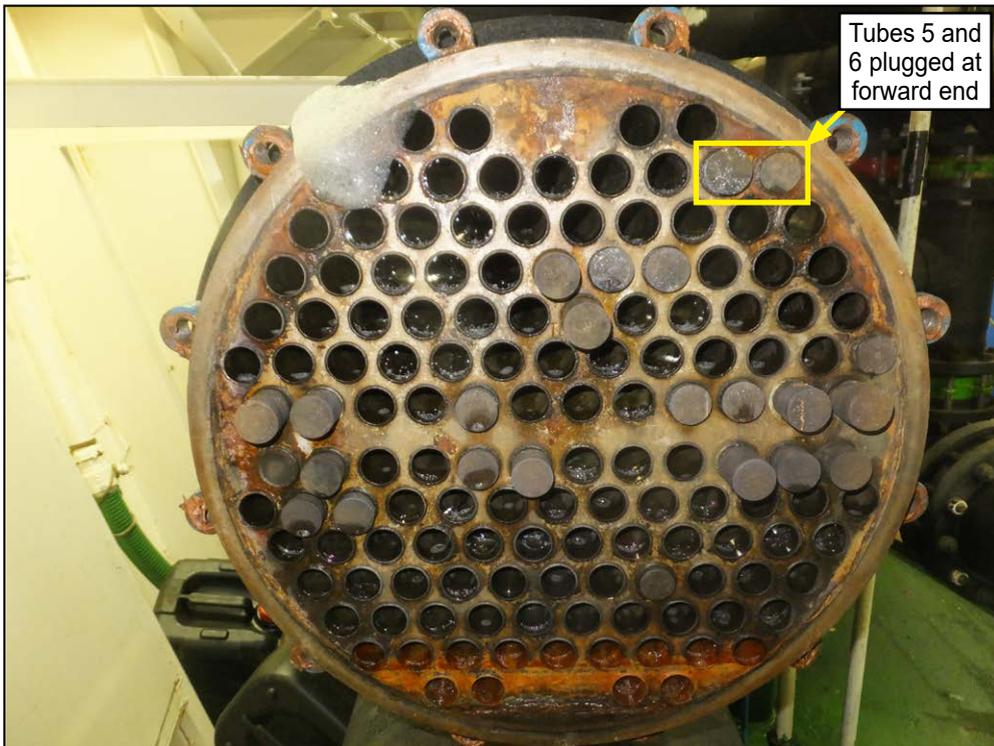
27 plugged tubes, 23 had a plug in each end and 4 of the tubes<sup>9</sup> had a plug fitted at only one end (**Figures 5a and 5b**). Pressure testing identified leaks on four of the tubes<sup>10</sup> in the starboard evaporator; one of which, tube 5, had been plugged at only one end.

**Figure 5a:** Sunbeam's starboard upper heat exchanger, forward end showing tubes 5 and 6 sealed with brass plugs

- *The method for sealing the leaking tubes by fitting brass plugs at both ends of a leaking tube was suitable... However, it is clear that a mistake was made in plugging Tube 5, when only its forward end was sealed. This was compounded by not having a post repair check process in place for the heat exchanger after the plugs were fitted. A post repair pressure test or pulling a vacuum and holding it for a period of time, prior to recharging the system with R22, would have clearly shown there were still leaks.*

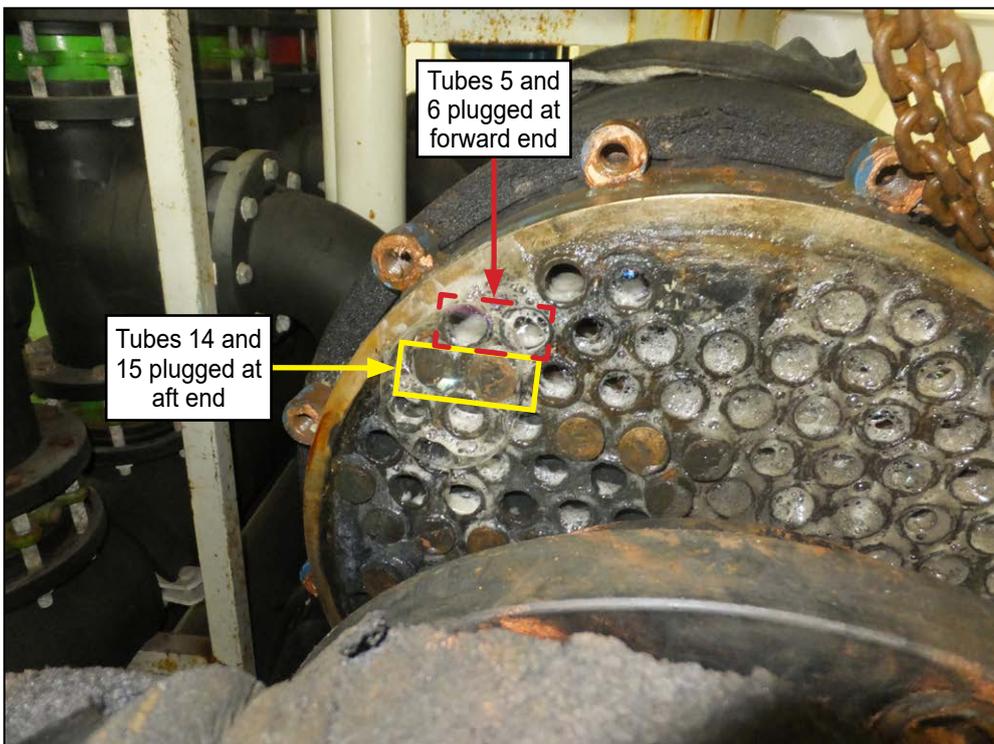
**Figure 5b:** Sunbeam's starboard upper heat exchanger, aft end showing tubes 14 and 15 sealed with brass plugs (immediately below tubes 5 and 6)

<sup>9</sup> Tubes 5, 6, 14 and 15 were plugged at only one end.

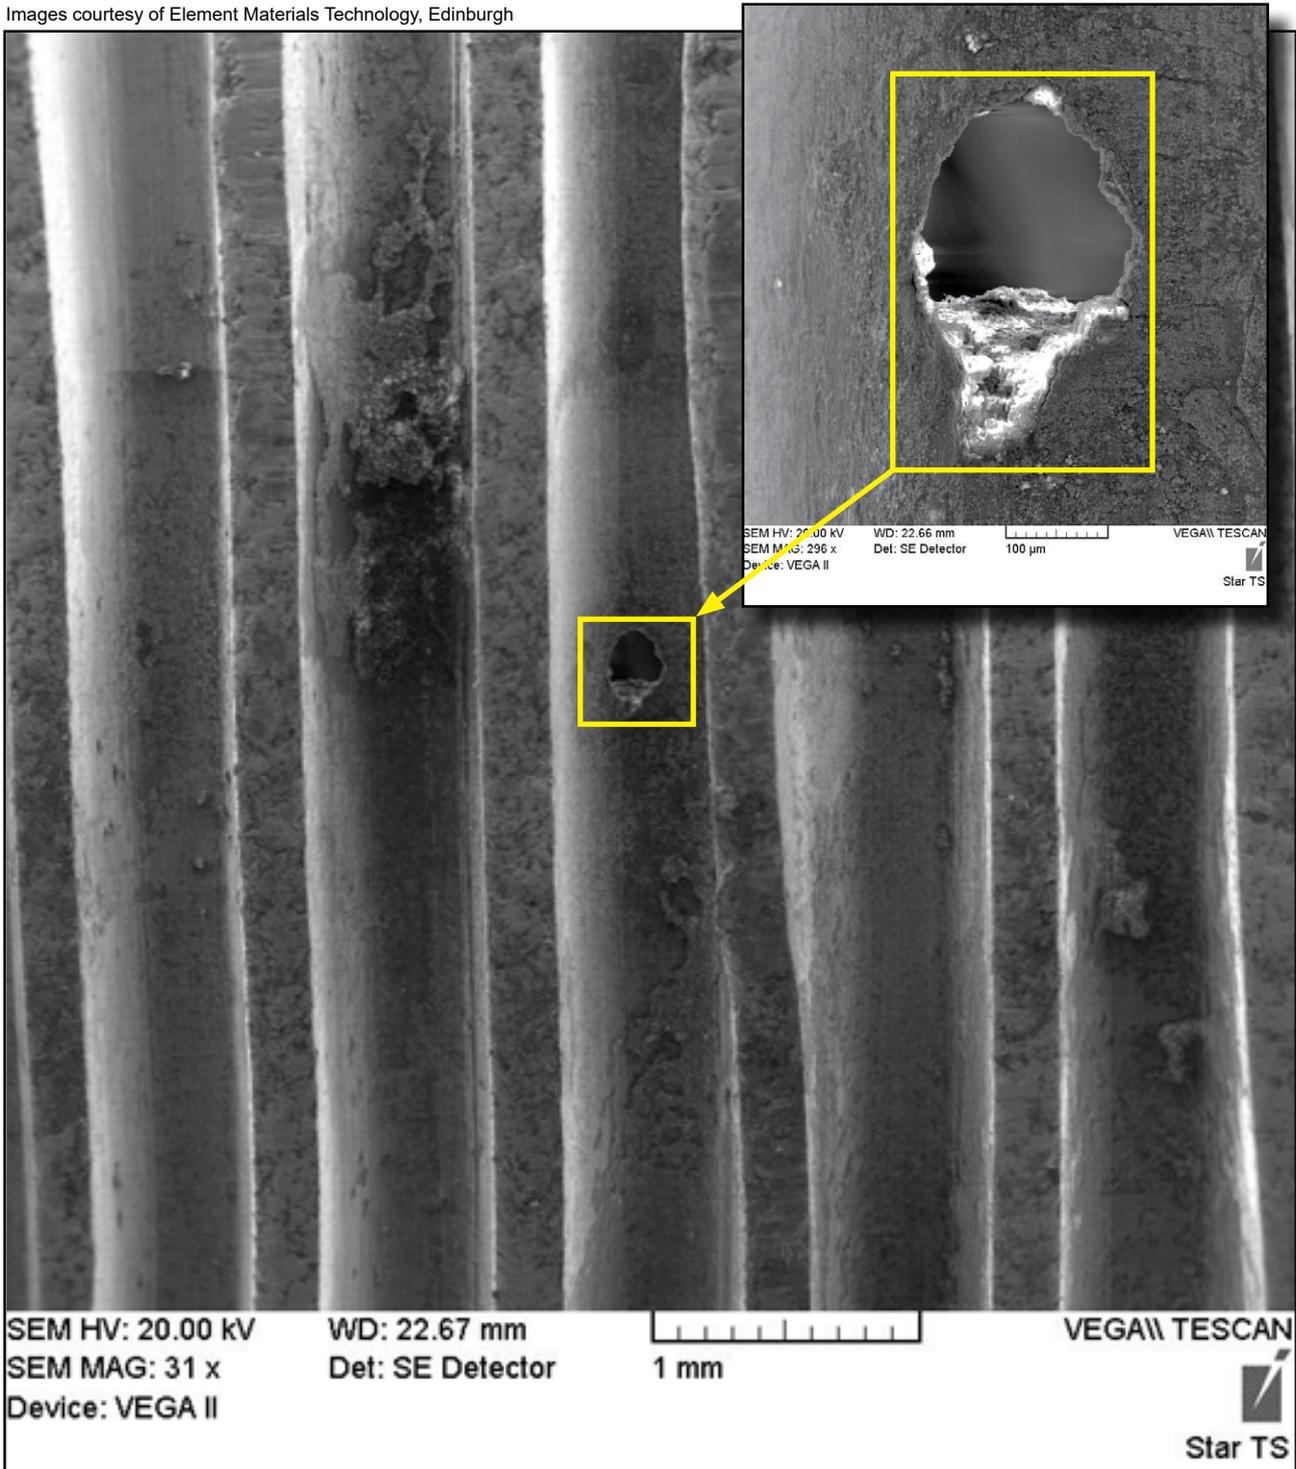
STS subcontracted Element Materials Technology (EMT) of Edinburgh to conduct metallurgical examination and test of tubes 5, 13, 60 and 71 that had failed leak tests on board and had been extracted from the starboard evaporator. These tests identified the presence of pinholes and cracks in the tubes (**Figure 6**) and EMT's report concluded that *'the failure of the tubes was attributable to pitting and cracking caused by intergranular corrosion which initiated in the tube bores.'*

**Figure 6:** Microscopic examination of failed heat exchanger tubes with detail inset

- *While corrosion was the key factor in the failure...the EMT report provides further evidence that there was internal pressure applied ...at the point of failure. The extent of corrosion at the point of failure was such that only a relatively small pressure difference would be needed to cause it.*

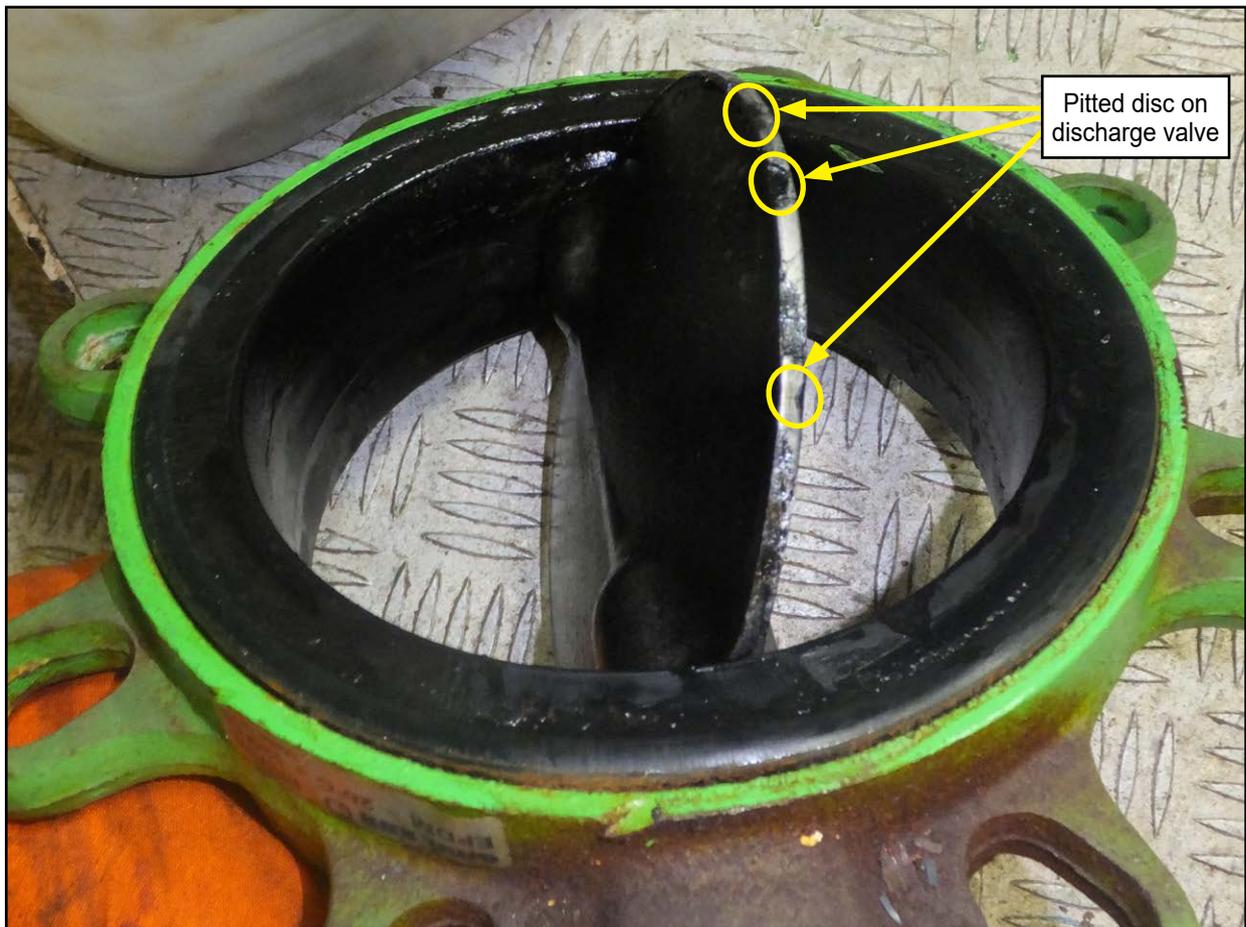
STS also removed the aft centre RSW tank's seawater inlet and return isolation valves for inspection and testing. Visual inspection of the pump discharge isolating valve for the aft centre RSW tank identified that its disc was damaged by significant notches around the edge (**Figure 7a**). Visual inspection of the pump suction valve for the aft centre RSW also showed a significant notch on the disc edge (**Figure 7b**). Visual inspection of the isolating valves for the other RSW tanks did not reveal significant disc damage.

- *The most direct route for R22 gas from the top starboard evaporator to any of the RSW Tanks was via a common manifold line that also had other top (pump discharge) isolating valves connecting it to the other aft tanks (**Figure 8**). It is my opinion that R22 was only seen in the middle aft tank as, although closed at the time of the incident, the top (pump discharge) isolating valve provided the path of least resistance to the R22. This was probably due to the extent of damage seen on its disc edge compared to the other adjacent valves.*

**Figure 7a:** Aft centre RSW pump discharge isolating valve showing significant notches on disc edge

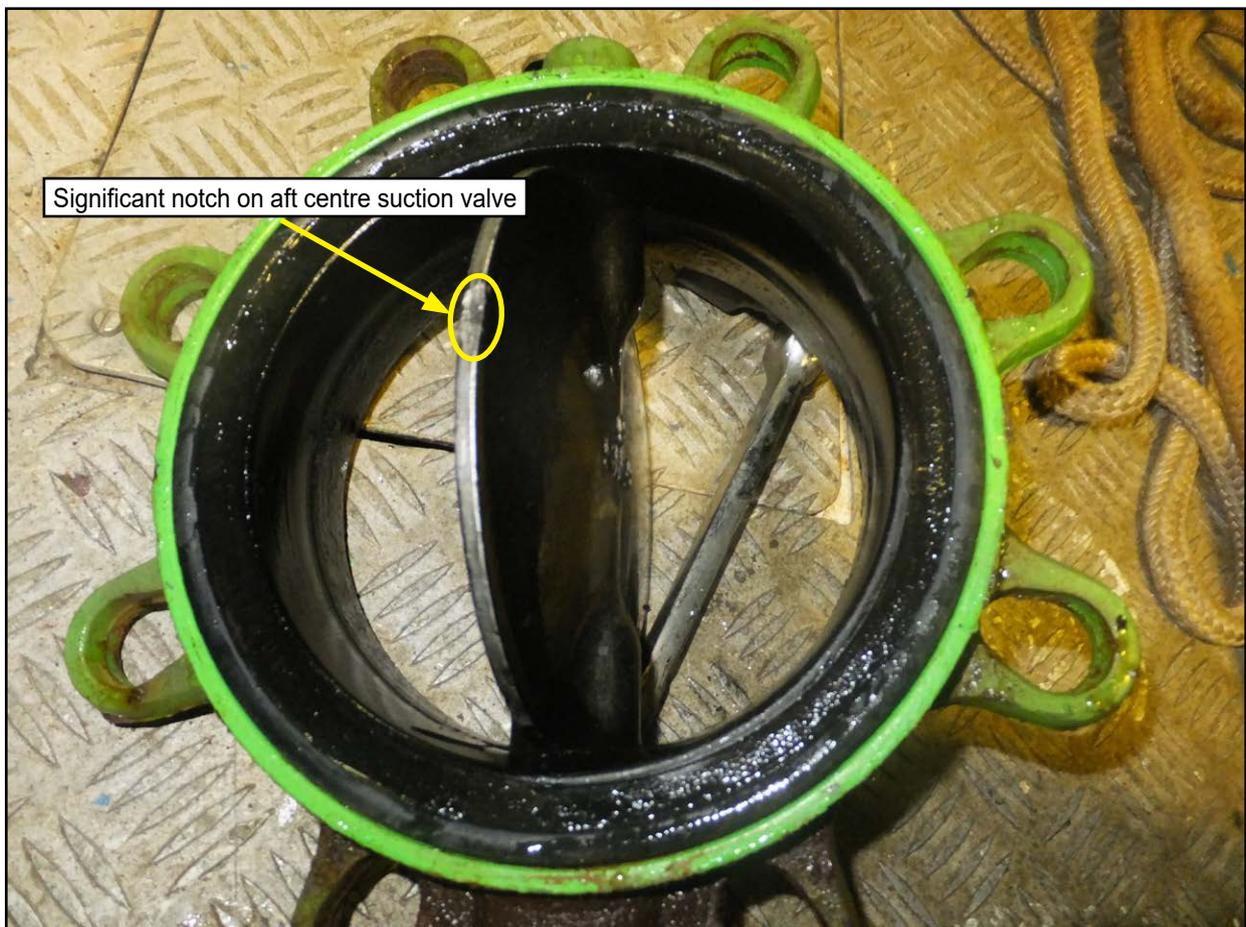
**Figure 7b:** Aft centre RSW pump suction isolating valve showing a single significant notch on disc edge

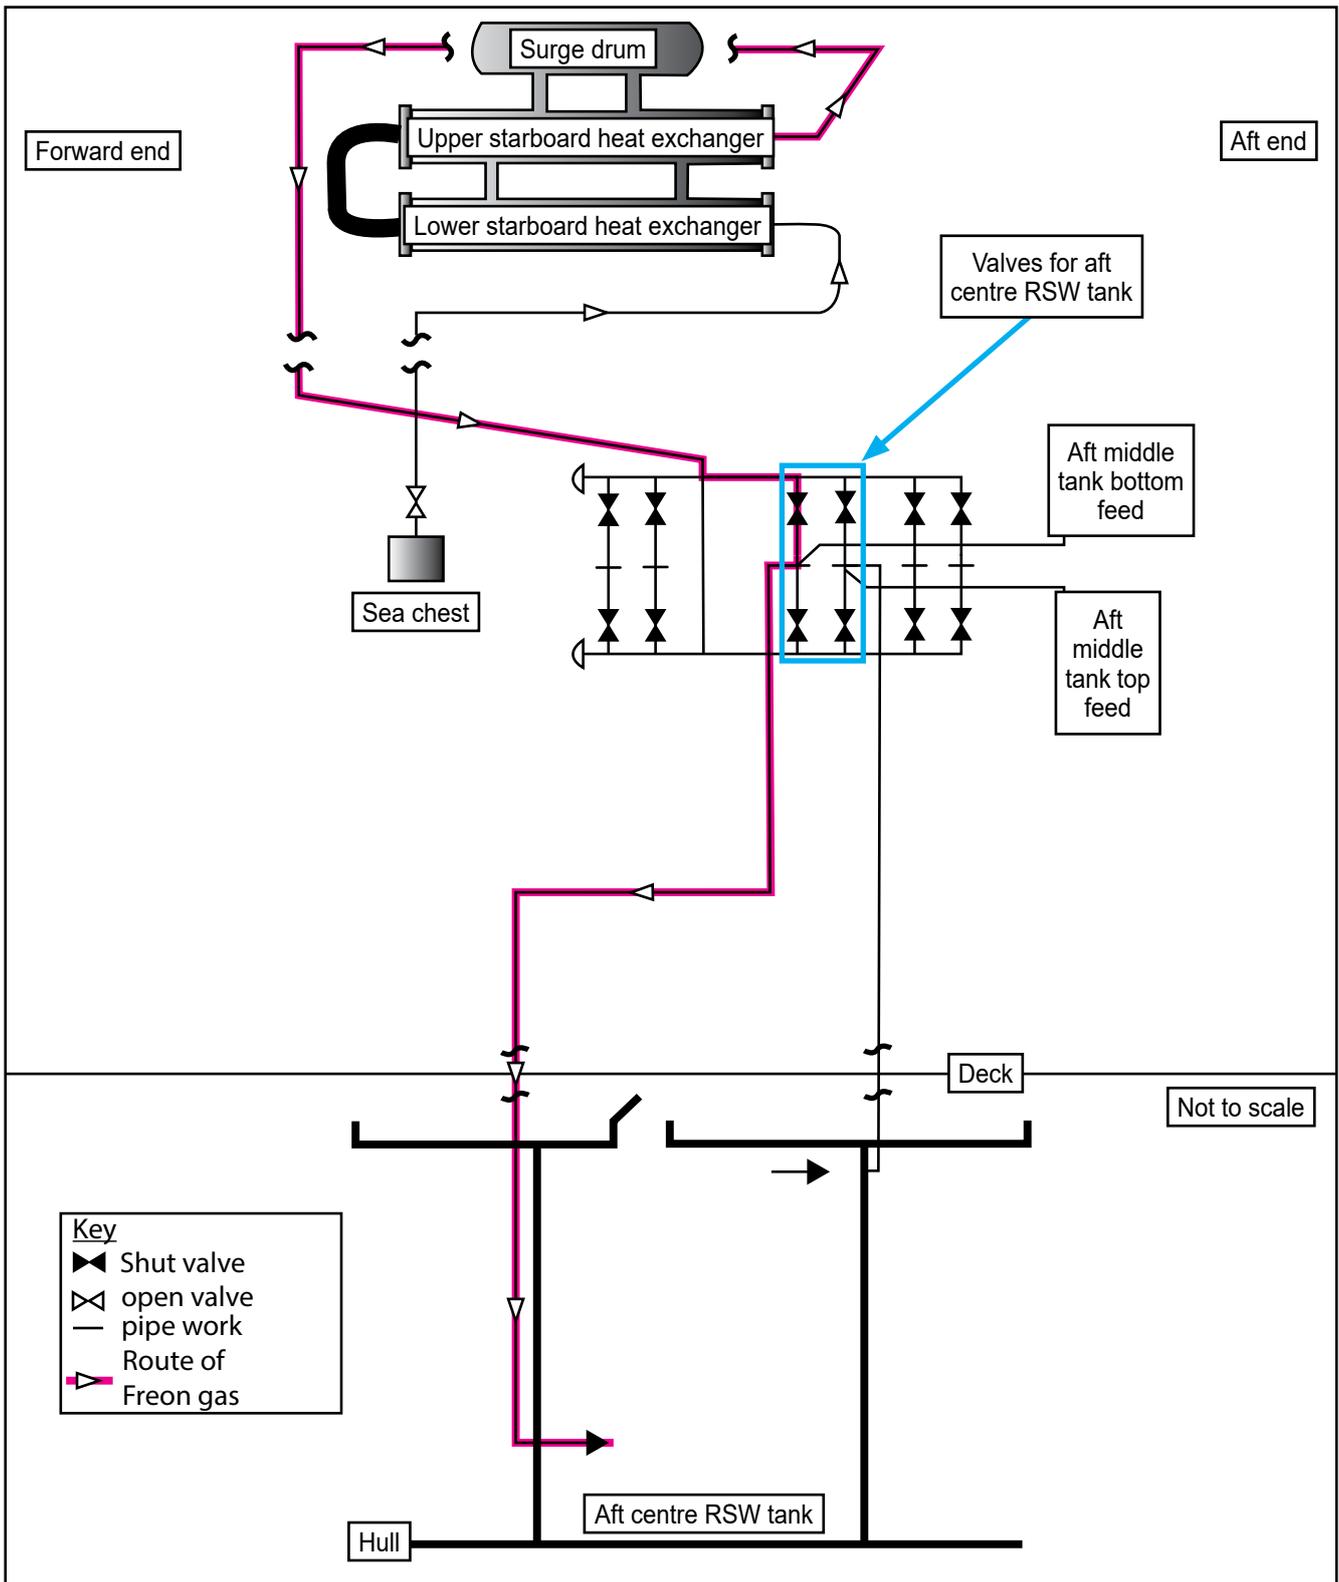
**Figure 8:** Schematic diagram of *Sunbeam's* RSW system highlighting the freon gas' route through the RSW system into the aft centre RSW tank

STS's technical analysis demonstrated that there was a credible pathway for the Freon gas to escape out of the refrigeration plant and into the aft centre RSW tank. First, the Freon leaked through the corroded and failed tubes of the starboard evaporator into the RSW system pipework. The denser than air Freon gas then descended down into the aft centre RSW tank via damaged non-gastight seawater isolation valves (**Figure 8**). With the tank empty of water over the weekend, there was also sufficient time for the Freon gas to build up to a point where the displacement of oxygen meant that the atmosphere could not support life.
