# Rail Accident Report

**Near miss between a passenger train and cars at Norwich Road level crossing, New Rackheath, Norfolk  
24 November 2019**

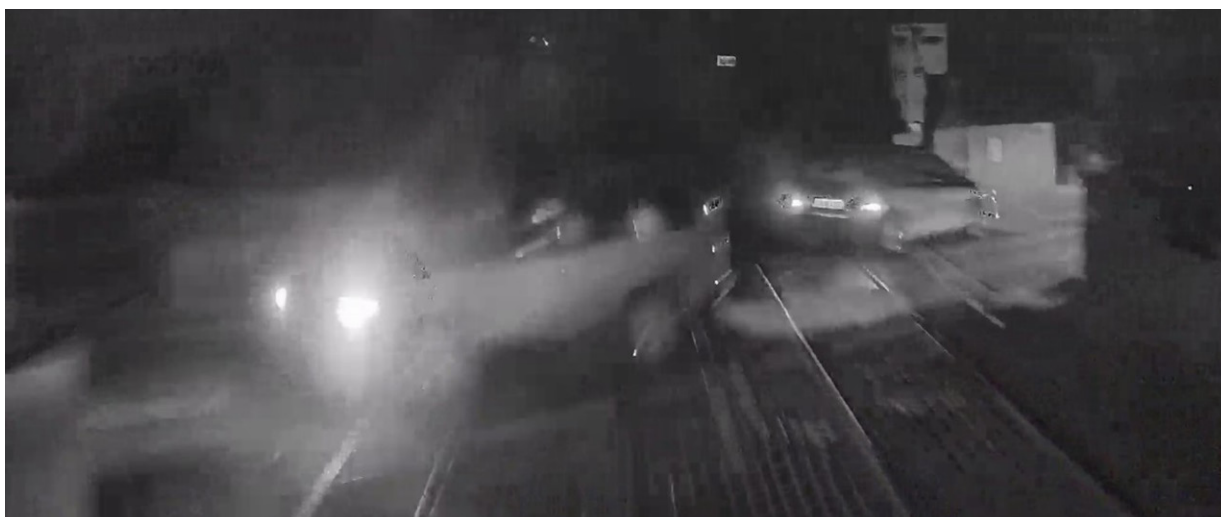
Figure 4: Vehicles crossing ahead of the train (courtesy of Greater Anglia)

- 28 Eight seconds after the barriers started to rise, and just before the train reached the crossing, the amber road traffic lights came on as the level crossing warning sequence restarted. The train missed the rear of the vehicle travelling from right to left by less than half a second (figure 4).

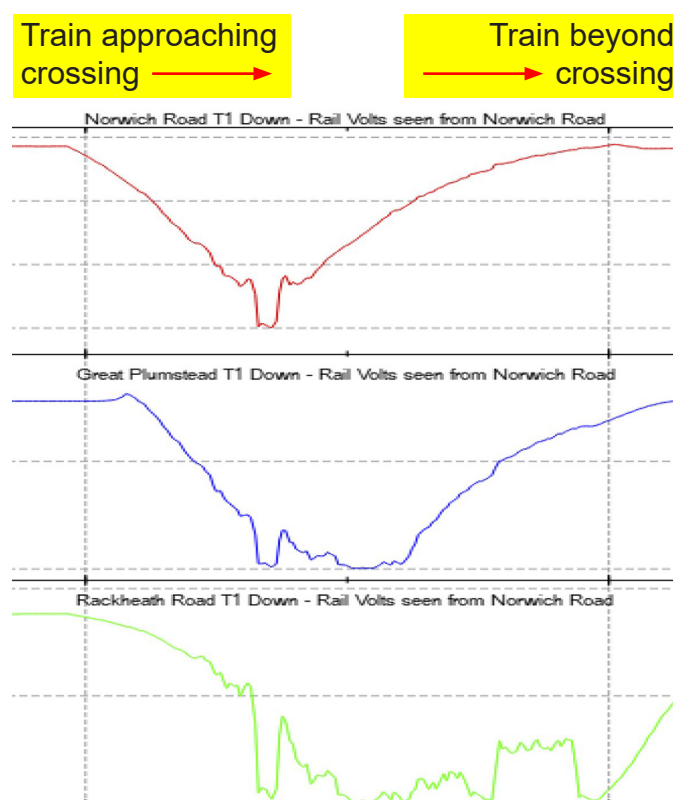
Figure 7: Voltage response with sporadic changes in resistance (courtesy of Atkins)

- 55 The monitoring undertaken by Atkins (paragraph 34) found that the predictor system equipment was working correctly, but that in some instances the electrical response of the system to approaching trains indicated that they were not making a consistent electrical contact between the running rails. On some days, as many as 67% of trains registered an inconsistent pattern of electrical contact with the rails. The number of trains with such patterns declined after 20 December. The last recorded inconsistent pattern was recorded on 22 December on the up line and 28 December on the down line.

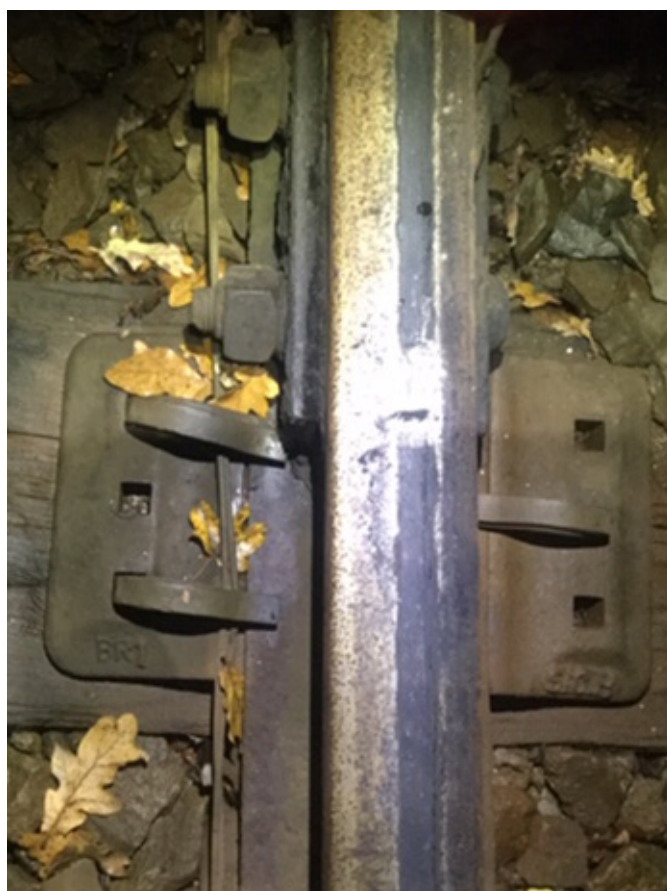
*Figure 8: The railhead on approach to Norwich Road after the incident on 24 November 2019 (courtesy of Network Rail)*

72 Photographs taken by Network Rail of the track on approach to the crossing on the evening of the incident, show a dark coating on parts of the rails (figure 8). Although some of this contamination was taken from the surface of the railhead, Network Rail did not preserve any samples (for reasons which RAIB has not been able to establish), so no analysis of the material was possible.

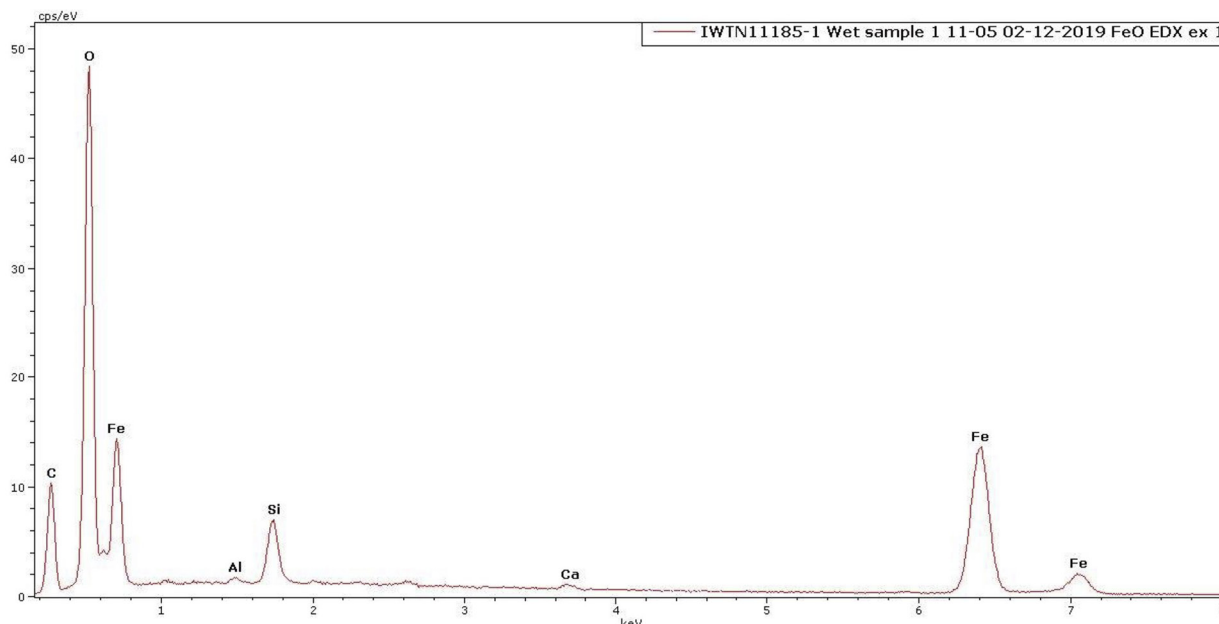
Figure 9: The chemical analysis of railhead contamination samples taken on 2 December at Rackheath Road (courtesy of Intertek)

- 73 Analysis of samples taken from the rail on 2 December 2019 on the approach to Rackheath Road level crossing reported that the sample's principal constituent was microscopic carbon-based residue, but it was not possible to establish the origin of this material. There was also some iron oxide and silica material present (figure 9), which were likely to have been from rust and sand.

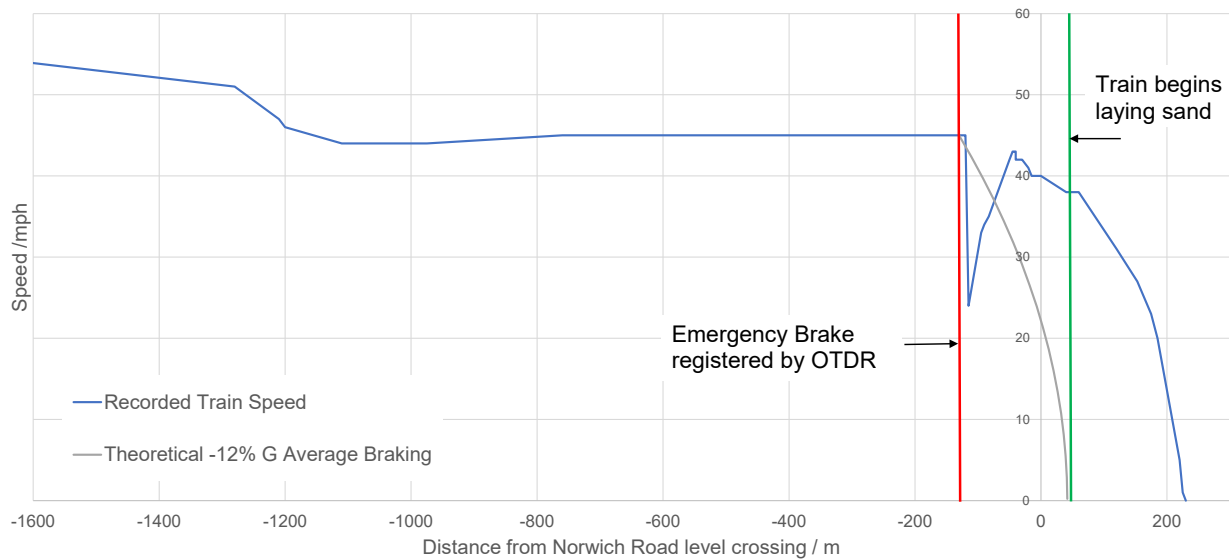
Figure 10: Recorded speed of the incident train from the limit of approach to Norwich Road level crossing until its stopping position, around 230 metres past the crossing

- 76 At the time of the incident, evidence of low adhesion, almost certainly caused by railhead contamination, is provided by analysis of the train's speed and distance covered (figure 10). Data extracted from the OTDR shows that after the driver applied the emergency brake, the train achieved an average deceleration rate of only 2.2% g for the first 190 metres, with considerable wheel slide protection (WSP) activity registered for all 12 axles. In full emergency braking, a modern train would be expected to achieve a deceleration rate of up to 12% g. During this period the speed recorded by the OTDR was erratic, indicating that wheel slide was occurring on the speed-recording axle.

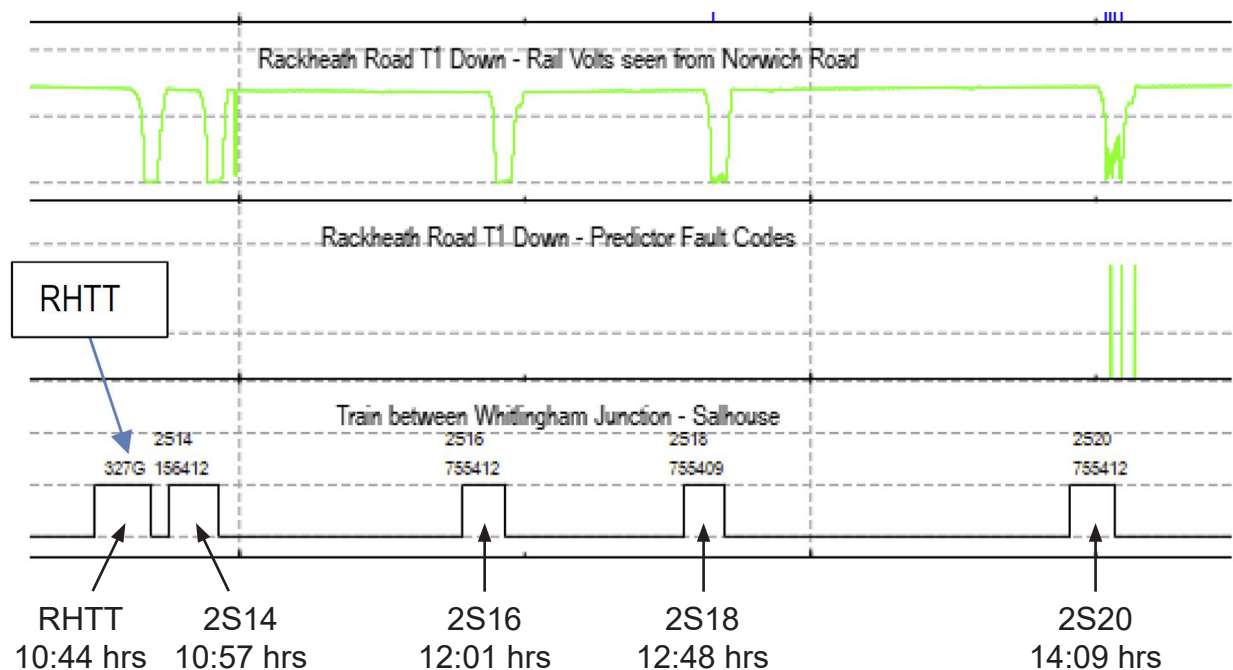
Figure 11: Changes in voltage response after passage of RHTT (courtesy of Atkins)

- 77 Once the train started depositing sand on the rails (see paragraph 121), the deceleration improved to an average rate of 9.3% g for the remaining 170 metres until the train came to a stand.
- 78 When an enhanced RHTT schedule was introduced after the incident, testing by Atkins found that the predictor crossings were more likely to behave normally for a short period after this train ran (figure 11). During this period the surface of the railhead would be damp, which would increase the mobility of the surface contaminants, meaning that the contamination was more likely to be displaced by the train's wheels (paragraph 70).

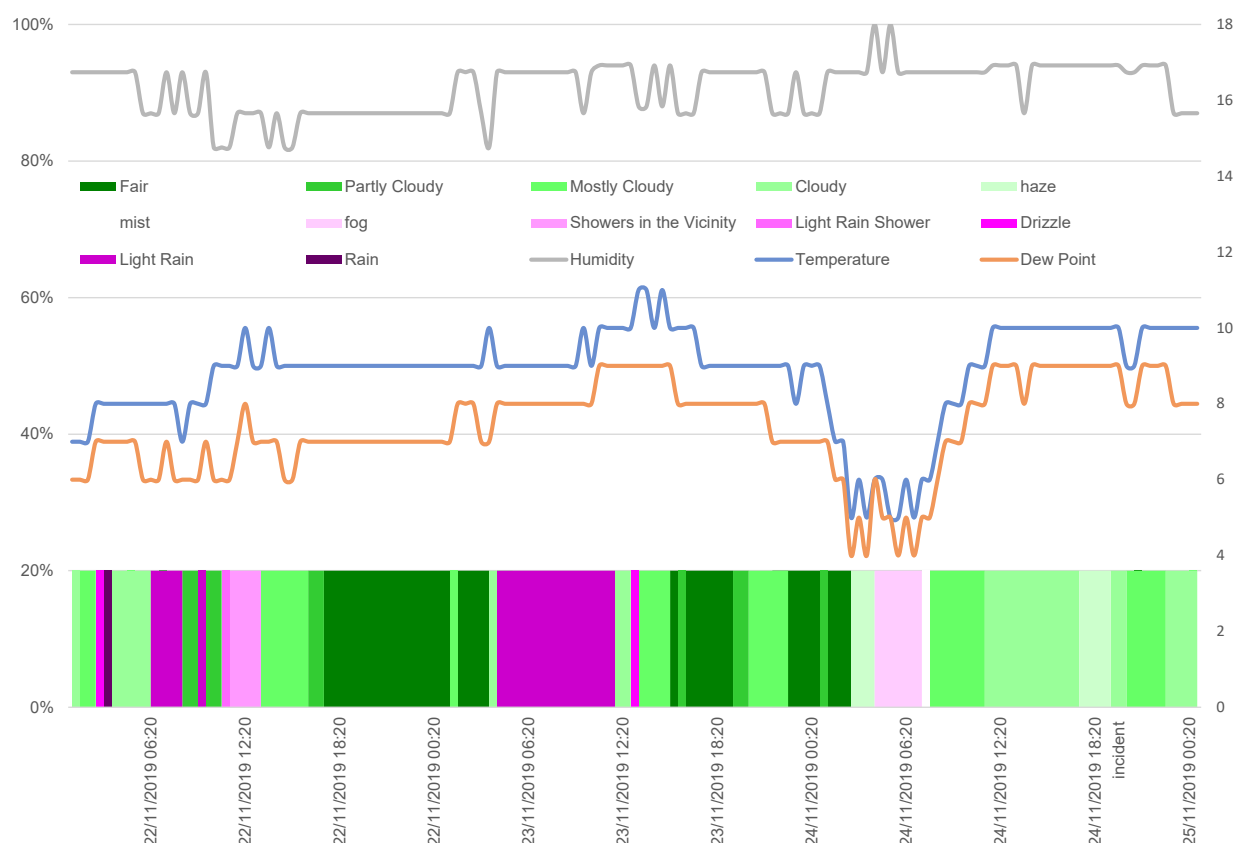
Figure 12: Temperature, dew point and humidity in the 48 hours prior to the incident, taken at Norwich airport, around 6.5 km (4 miles) from Norwich Road level crossing

79 Weather records show that there was no measurable rainfall in the 48 hours before the incident. This is significant because moisture would have helped to keep the film of contaminant mobile and able to be displaced by train wheels. Instead, the moisture levels in the Norwich area during the two days before the incident were consistent with previously damp leaves adhering to rails and then drying to form a film of electrically insulating contamination (figure 12).

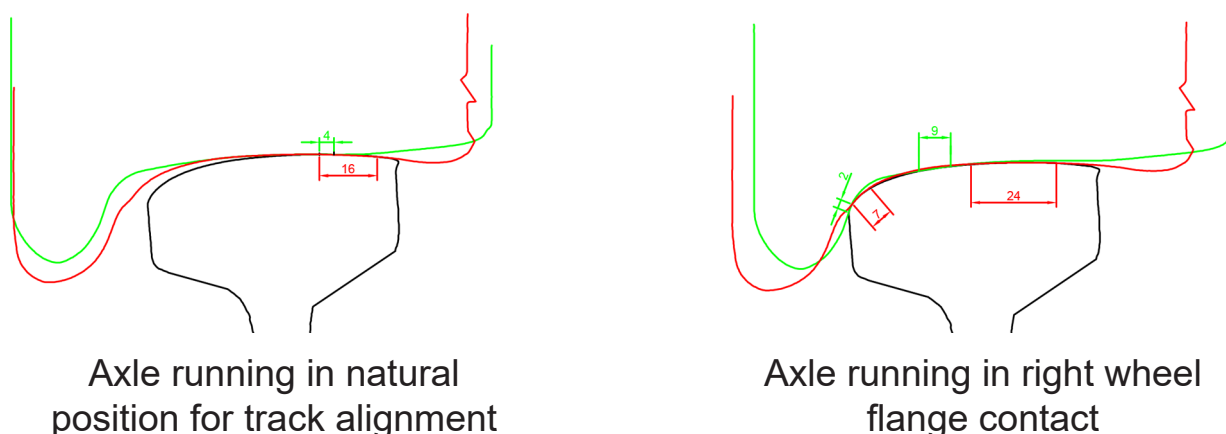
Figure 13: Outlines of the class 755 (green) and class 153 (red) wheel on the rail profile on approach to Norwich Road crossing

- The new class 755 units would ride on a band around 4 mm wide near the centre of the railhead if the wheelset was centred on the track, as would be expected on the straight track in this area. If the wheelset were making flange contact with either rail, there would be two narrow contact points, to the inside of the centre of the railhead and at the bottom of the running edge (figure 13).

- The worn class 153 wheelset would ride on a band around 16 mm wide from the centre to the outside of the railhead if the wheelset was centred on the track, and would make contact across most of the railhead surface from the running edge outwards if in flange contact.

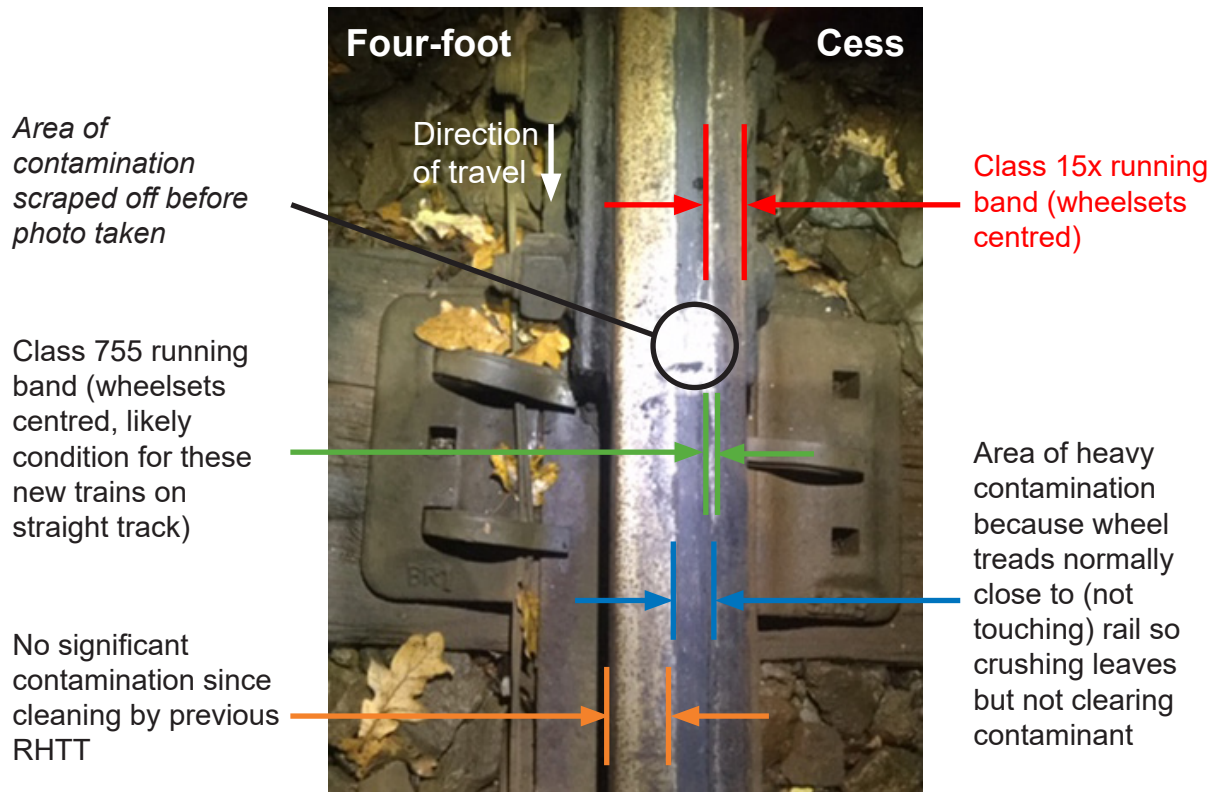
Figure 14: Railhead on the night of the incident with positions of contact patches for class 755 and other stock

- 92 The photographs taken by Network Rail on the night of the incident show a narrow clear metal running band on the railhead consistent with the contact patch observed for class 755 trains (paragraph 91), and there was also a partially clean area consistent with class 153 and other older stock running (figure 14). The area to the inside of the centre of the railhead shows heavy contamination.

- 94 However, if a train is running on a narrow contact patch, only a small contaminated area of railhead can impede electrical connection. It is also the case that even if a good electrical contact is being made on a narrow running band, small, expected, lateral movements by the train's wheels will generally result in the contact patch moving onto adjacent contaminated parts of the railhead. Even though the class 755 trains had more wheelsets than units previously using the line, this does not appear to have improved the electrical contact.
