**SERIOUS INCIDENT**

<b>Aircraft Type and Registration:</b>	Agusta A109E, G-ETPJ	
<b>No &amp; Type of Engines:</b>	2 Pratt & Whitney Canada PW206C turboshaft engines	
<b>Year of Manufacture:</b>	2004 (Serial no: 11173)	
<b>Date &amp; Time (UTC):</b>	2 July 2020 at 1510 hrs	
<b>Location:</b>	Boscombe Down Airfield, Wiltshire	
<b>Type of Flight:</b>	N/A	
<b>Persons on Board:</b>	Crew - None	Passengers - None
<b>Injuries:</b>	Crew - N/A	Passengers - N/A
<b>Nature of Damage:</b>	Localised overheating and burning	
<b>Commander's Licence:</b>	N/A	
<b>Commander's Age:</b>	N/A	
<b>Commander's Flying Experience:</b>	N/A	
<b>Information Source:</b>	Aircraft Accident Report Form and further enquiries by the AAIB

**Synopsis**

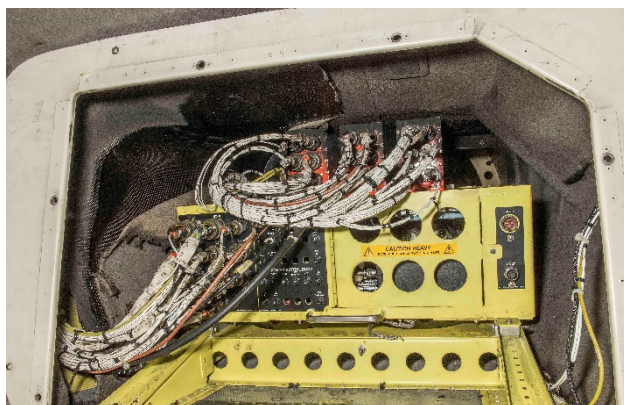
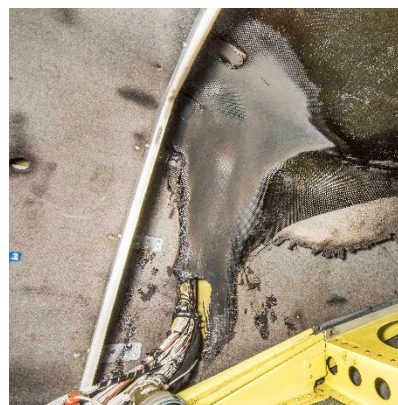
**Figures 1 and 2**

Upon opening the baggage bay the crew noticed a burning smell and, with the assistance of the engineer, they removed the panel to access the rear equipment bay. They found a '*smouldering fire*', which self-extinguished before the arrival of the airfield fire service (Figures 1 and 2).

Overheat damage before and after FTI crate removal  
(Note: the panel between the baggage bay and rear equipment bay has been removed)

The damage was most severe where electrical cables entered the equipment bay through an aperture in the adjacent structure. A single cable was found to be chafed and it was apparent that the exposed conductor had been arcing with the equipment bay liner, which was manufactured from a composite material. The cable connected the battery and FTI busbars and the circuit was protected by a 10 Amp CB. This was the CB that tripped in-flight.

The investigation established that the electrical power supply cable between the battery busbar and the FTI busbar chafed against the equipment bay liner causing a short-circuit, arcing, and the CB to trip.

The equipment bay liner was melted and burned, and the operator concluded that it was probable that fire damage occurred in-flight, assisted by airflow entering the bay through the cable aperture. If a protective strip had been installed, as required by the design change, this should have prevented the cable damage.

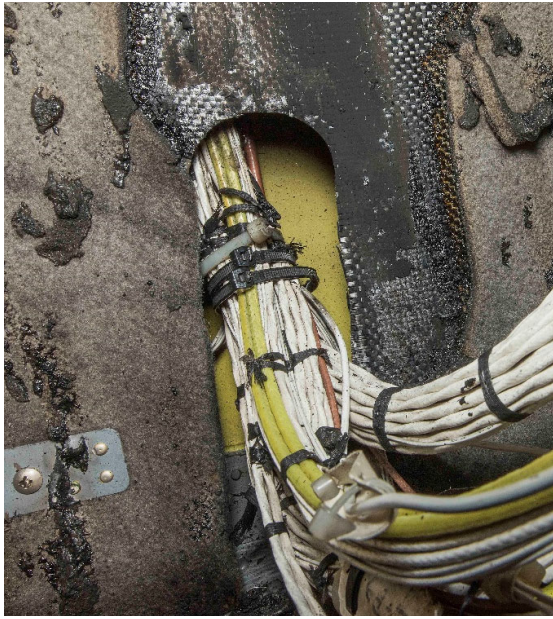
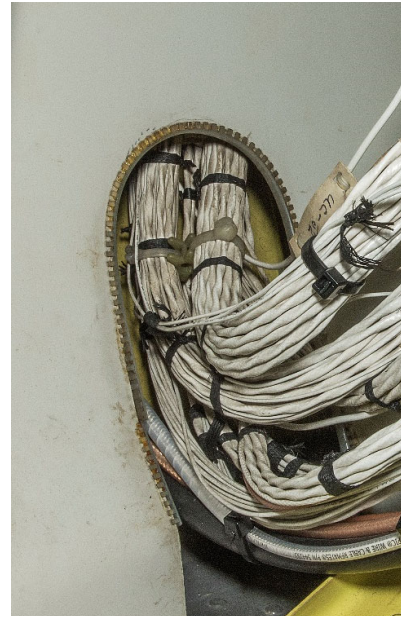
**Figures 3 and 4**

The installation drawings depicted a protective strip around the periphery of the aperture to ensure that the cables did not chafe against the adjacent structure. When the helicopter was examined after the incident it was apparent that the protective strip was missing.

The operator owned another Agusta 109 (G-ETPI), which was equipped with a similar FTI installation. This helicopter was checked, and the protective strip was found correctly embodied (Figures 3 and 4).

Note: lack of protective strip on G-ETPJ (left image)  
and protective strip as fitted to G-ETPI (right image)
