Report on the investigation of
the capsize and full inversion of the self-righting keelboat

RS Venture Connect sail number 307

resulting in the death of a disabled sailor
on Windermere, Cumbria

12 June 2019

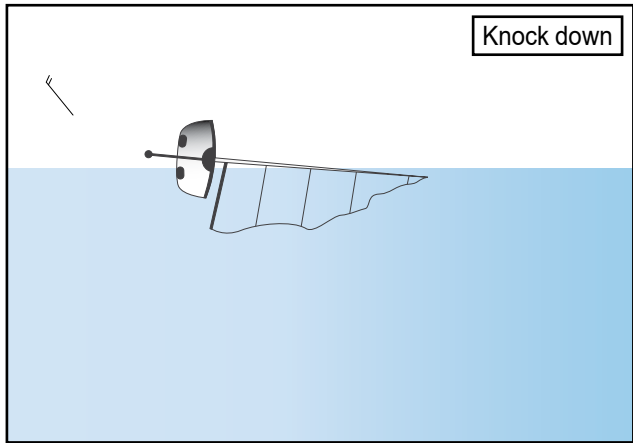
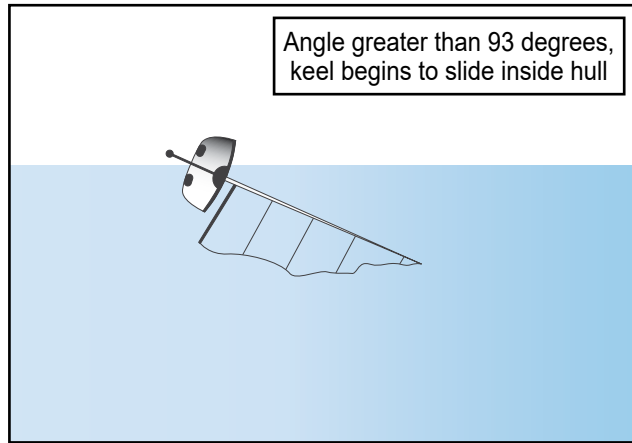
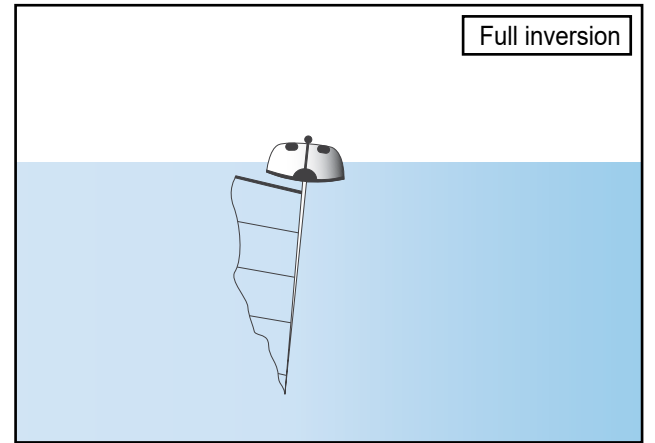
Figure 4: Diagram of inversion

After a few seconds on its side, *RSVC 307* inverted completely (**Figure 4**). As it did so, Stephen and his crewman were caught under the boat's upturned hull. Almost immediately, the crewman pushed himself out of his seat and swam clear as his lifejacket automatically inflated. Once clear, he could not see Stephen and realised that he must be trapped under the upturned hull. Knowing that there would be very little space for an air pocket, the crewman took hold of the port side of the boat and tried to lift its gunwale.

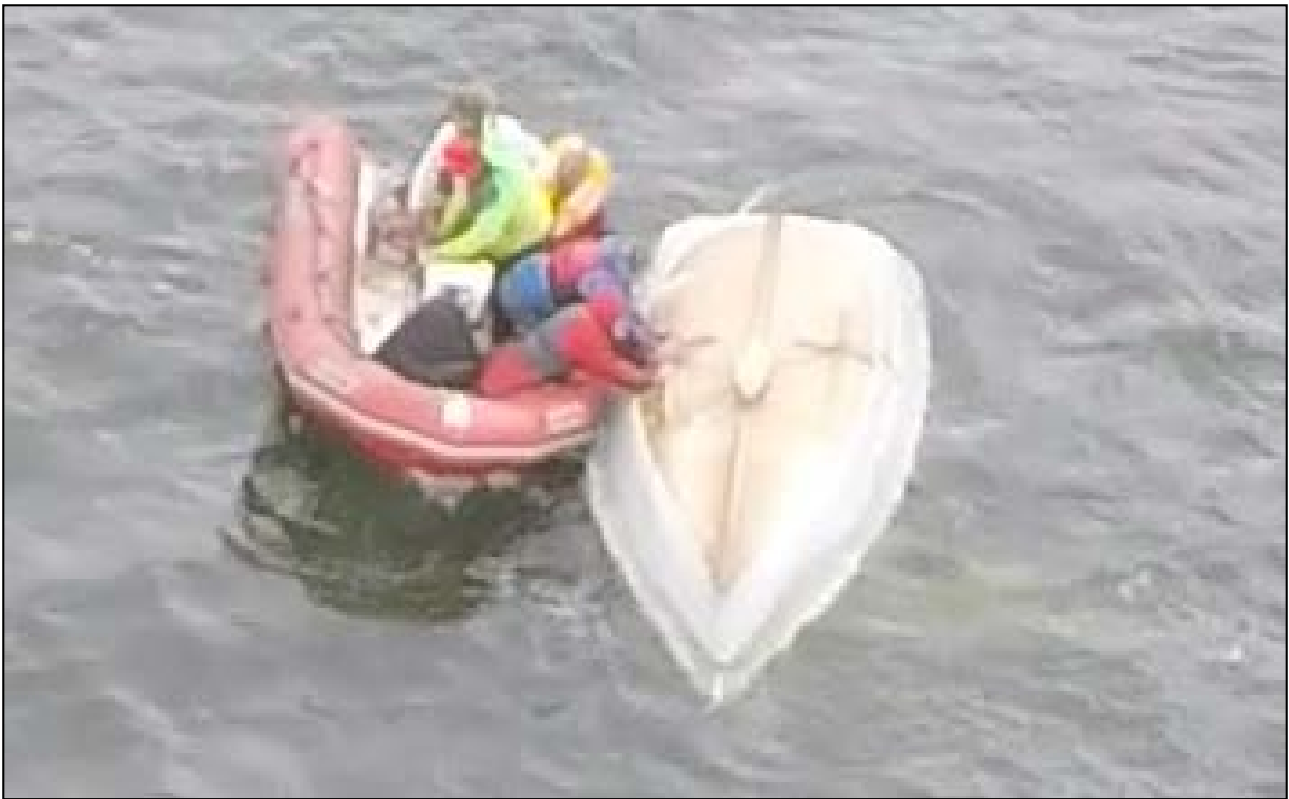
Figure 6: Lifting the portside – still from drone footage

RIB was then driven astern, pulling *RSVC 307* upright and releasing Stephen from beneath its hull. Stephen's lifejacket had inflated but he was floating face down in the water and not moving.

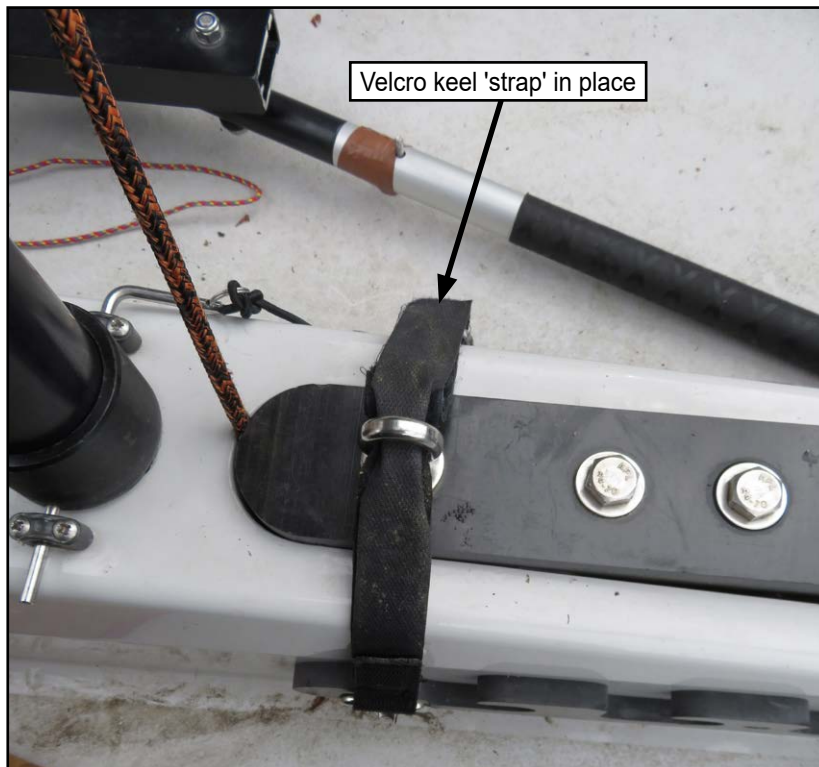
Figure 8: The Velcro™ keel strap

The RS Venture Connect's keel had a bulb weighing 125kg, and was housed in a sleeve that allowed it to be retracted for transport, or deployed when sailing. When *RSVC 307* was not in use, it would be moved to a shallower berth, which required the keel to be raised. When deployed the keel should have been locked in place using the boat's Velcro™ restraint strap (**Figure 8**). When an RS Venture Connect is knocked down and capsizes onto its side, the weight of the extended keel bulb should create a righting moment sufficient to cause the boat to return upright.

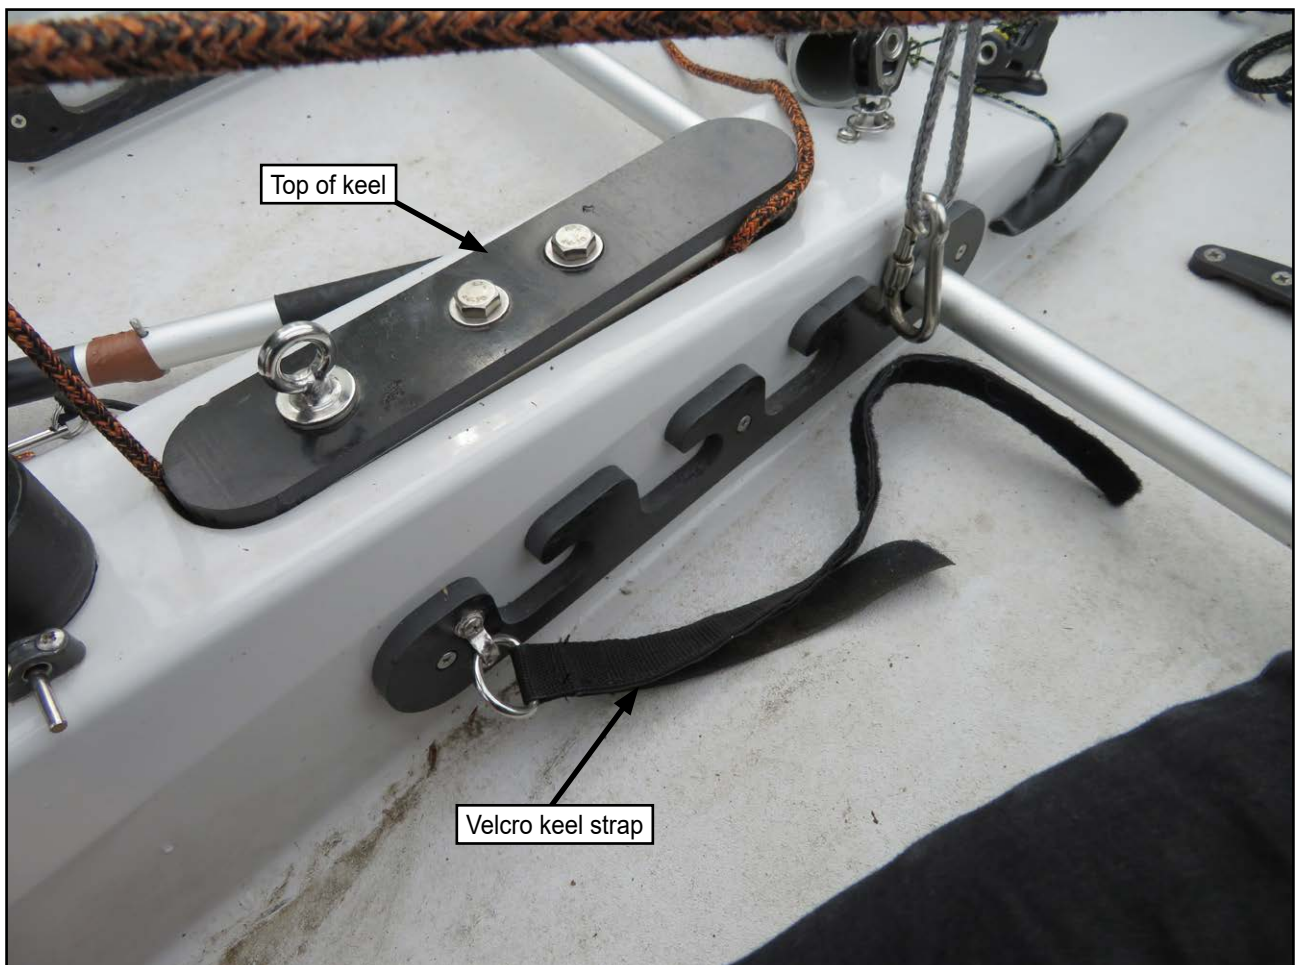
Figure 9: *RSVC 307's* keel strap as found after the accident (note: jib sheet caught in keel housing as the boat was righted)

RSVC 307's keel retracted when the boat was knocked down because the keel strap was not fitted in accordance with the manufacturer's Rigging Guide.

involved in the rigging or use of the boat on the day of the accident, were aware of the keel strap's function or of its importance. Therefore, it is very unlikely that this strap had ever been rigged to secure the keel.

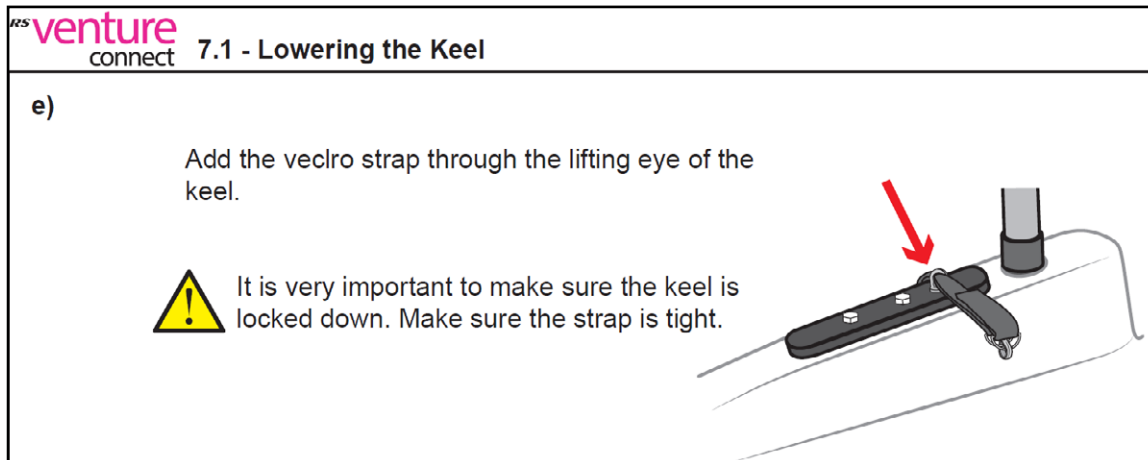
Figure 16: Extract from the RS Venture Connect Rigging Guide

This RS Venture Connect Rigging Guide included guidance on how to fit the keel strap, and warned of the importance of doing so (**Figure 16**). Blackwell Sailing did not have a downloaded copy of the Rigging Guide at the time of the accident.
