SERIOUS INCIDENT

Aircraft Type and Registration:	Beech 200 Super King Air, G-FSEU	
No & Type of Engines:	2 Pratt & Whitney Canada PT6A-41 turboprop engines	
Year of Manufacture:	1978 (Serial no: BB-331)	
Date & Time (UTC):	28 February 2020 at 1415 hrs	
Location:	Doncaster – Sheffield Airport	
Type of Flight:	Commercial Air Transport	
Persons on Board:	Crew - 2	Passengers - None
Injuries:	Crew - None	Passengers - N/A
Nature of Damage:	Flap motor burnt out	
Commander's Licence:	Commercial Pilot's Licence	
Commander's Age:	35 years	
Commander's Flying Experience:	856 hours (of which 393 were on type) Last 90 days - 18 hours Last 28 days - 2 hours	
Information Source:	Aircraft Accident Report Form submitted by the pilot and further enquiries by the AAIB

Synopsis

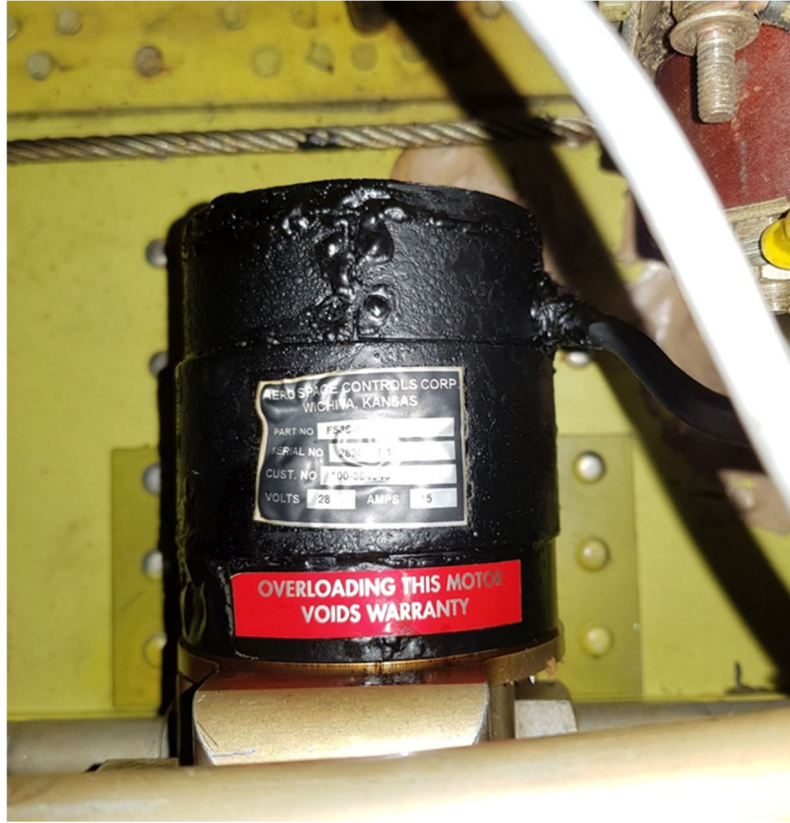
Figure 1

Examination of the aircraft, by the operator's engineers, discovered evidence of heat damage and a burnt smell from the flap motor (Figure 1). A check of the flap motor CB was carried out and was found to be intermittent in operation.

Flap motor showing evidence of damage due to overheating

The maintenance organisation believed that wear in the flap cam and link-arm assembly prevented the flap UP limit switch from operating when the flaps retracted. As a result, electrical power was continuously supplied to the motor, which overheated, emitting fumes and smoke into the cabin. Normally, the CB would operate to protect the motor; however, it is likely that an intermittent fault meant it did not initially trip.
