**SERIOUS INCIDENT**

<b>Aircraft Type and Registration:</b>	Sportstar Max, G-TMAX	
<b>No &amp; Type of Engines:</b>	1 Rotax 912ULS2 piston engine	
<b>Year of Manufacture:</b>	2010 (Serial no: 2010 1305)	
<b>Date &amp; Time (UTC):</b>	25 May 2020 at 1340 hrs	
<b>Location:</b>	White Ox Mead Farm Airstrip, near Bath, Somerset	
<b>Type of Flight:</b>	Private	
<b>Persons on Board:</b>	Crew - 1	Passengers - 1
<b>Injuries:</b>	Crew - None	Passengers - None
<b>Nature of Damage:</b>	Propeller damaged	
<b>Commander's Licence:</b>	Private Pilot's Licence	
<b>Commander's Age:</b>	73 years	
<b>Commander's Flying Experience:</b>	287 hours (of which 120 were on type) Last 90 days - 5 hours Last 28 days - 2 hours	
<b>Information Source:</b>	Aircraft Accident Report Form submitted by the pilot, and further enquiries by the AAIB

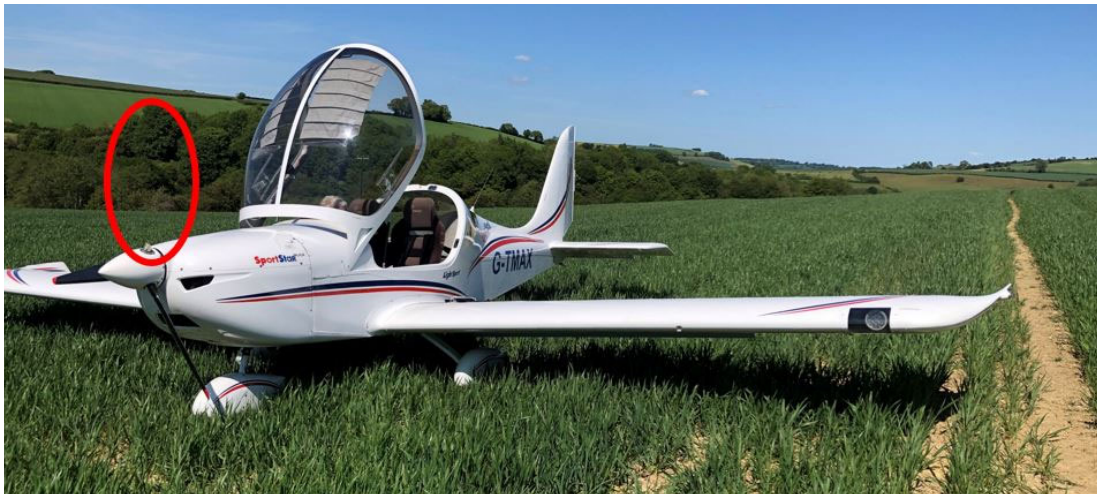
**Figure 1**

At approximately 200 ft agl the pilot selected a crop field, which was into wind and had an upslope, and made a successful forced landing (Figure 1). No additional damage was

G-TMAX following the propeller blade detachment (missing blade position circled in red)
