**ACCIDENT**

<b>Aircraft Type and Registration:</b>	Mainair Blade 912, G-BZNS	
<b>No &amp; Type of Engines:</b>	1 Rotax 912UL piston engine	
<b>Year of Manufacture:</b>	2001 (Serial no: 1263-1000-7-W1057)	
<b>Date &amp; Time (UTC):</b>	17 September 2020 at 1530 hrs	
<b>Location:</b>	Athey's Moor Airfield, Northumberland	
<b>Type of Flight:</b>	Private	
<b>Persons on Board:</b>	Crew - 1	Passengers - None
<b>Injuries:</b>	Crew - None	Passengers - N/A
<b>Nature of Damage:</b>	Damaged beyond economic repair	
<b>Commander's Licence:</b>	National Private Pilot's Licence	
<b>Commander's Age:</b>	48 years	
<b>Commander's Flying Experience:</b>	85 hours (of which 55 were on type) Last 90 days - 41 hours Last 28 days - 19 hours	
<b>Information Source:</b>	Aircraft Accident Report Form submitted by the pilot and further enquiries by the AAIB

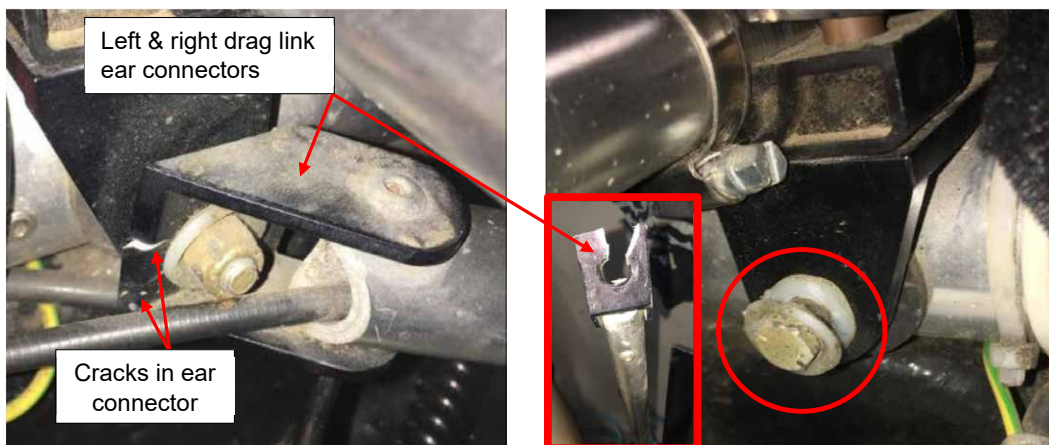
**Figure 2**

Visual inspection revealed the right drag link bar ear connection to the fuselage pod had failed. Cracks were also found on the left drag link bar ear connection, (Figure 2).

Left drag link ear connection showing cracks and the failed right drag link ear connection

A BMAA article by Roger Patrick (2020) 'Now see ear', *Microlight Flying*, December 2020 briefly describes this incident and reminds owners to check the drag link connections carefully during their pre-flight checks.
