## ACCIDENT

| <b>Aircraft Type and Registration:</b> | Savannah VG, G-CGTV | |
| <b>Location:</b> | Scurf Dyke Farm, near Driffield, Yorkshire | |

## Synopsis

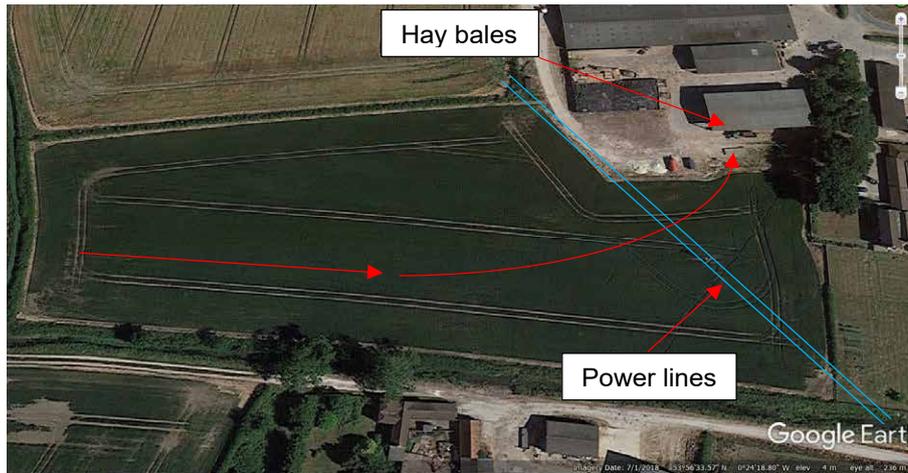
The pilot had prepared for a local evening flight from his home farm strip to Beverley Airfield and after completing the pre-flight checks, he lined the aircraft up on an easterly heading to take off into a light wind. The farm strip was approximately 220 m long, dry, cut-grass pasture with power lines at the eastern end and farm buildings to the north (Figure 1). With the flaps set to the normal takeoff configuration of 20°, he commenced the takeoff roll. Approximately two thirds along the ground roll, the pilot reported that he felt one of the main wheels strike a bump which caused his knee to touch the flap lever. The flaps then deployed to full flaps of 40°. The aircraft started to climb at very low speed and was close to stalling. To avoid a stall, the pilot lowered the nose, but was conscious that he needed to maintain enough height to avoid the power lines at the end of the strip. Having cleared the power lines he reported that he felt the left wing starting to stall and so applied left rudder and lowered the nose further. The aircraft veered to the left and struck a stack of hay bales at approximately 10 m above the ground. It then struck the ground tail first before coming to rest. The pilot was able to turn off the fuel before exiting the aircraft with only minor injuries.

**Figure 1**  
Accident site

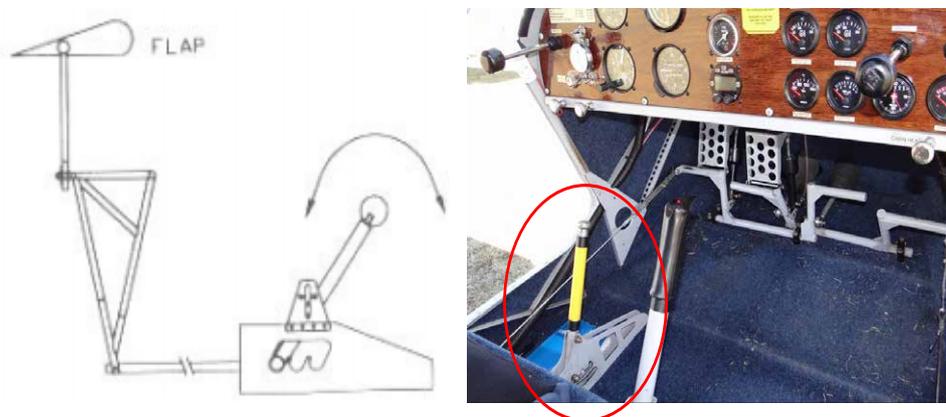
The Savannah VG is fitted with full wingspan trailing edge flaperons with 0°, 20° or 40° settings. They are operated by a lever on the cockpit floor between the legs of the left seat pilot (Figure 2). The lever has a locking button on the top which engages with a detent for each setting. The Pilot's Operating Handbook (POH) states that with the standard take off procedure with flaps 20° the aircraft lifts off between 26 to 30 kt and the Take Off Distance Required (TODR) to clear a 50 ft obstacle is 228 m. The pilot had practiced a full-flap take off once before with an instructor and in the POH is noted: "*The short take off procedure [Flaps 40°] is a very delicate maneuver [sic]. It is suggested to practice it with an instructor before attempting it.*" The stall speed is 26 kt with flaps fully extended and 30 kt with flaps retracted. The pilot stated that in flight when extending the flaps, it is necessary to overcome the aerodynamic loads, however on ground, the flaps will fully extend under their own weight.

**Figure 2**  
Flap system – lever and linkage

During the takeoff ground roll with the aircraft approaching flying speed, the pilot stated that the aircraft struck a bump and he inadvertently moved the flap lever. No defect was identified in the flap mechanism and due to the low aerodynamic loads, they deployed to flaps 40°. This would have created a sudden increase in lift and drag and reduced the stall speed. The manufacturer has highlighted in the POH that taking off with flaps 40° should be handled delicately and that the lift off and stall speeds are very similar. The pilot had practiced rejected takeoff manoeuvres to the right and straight ahead, but not to the left. The sensation of a left-wing stall resulted in the pilot turning to the left and he realised he would strike the hay bales or the farm buildings (Figure 3).

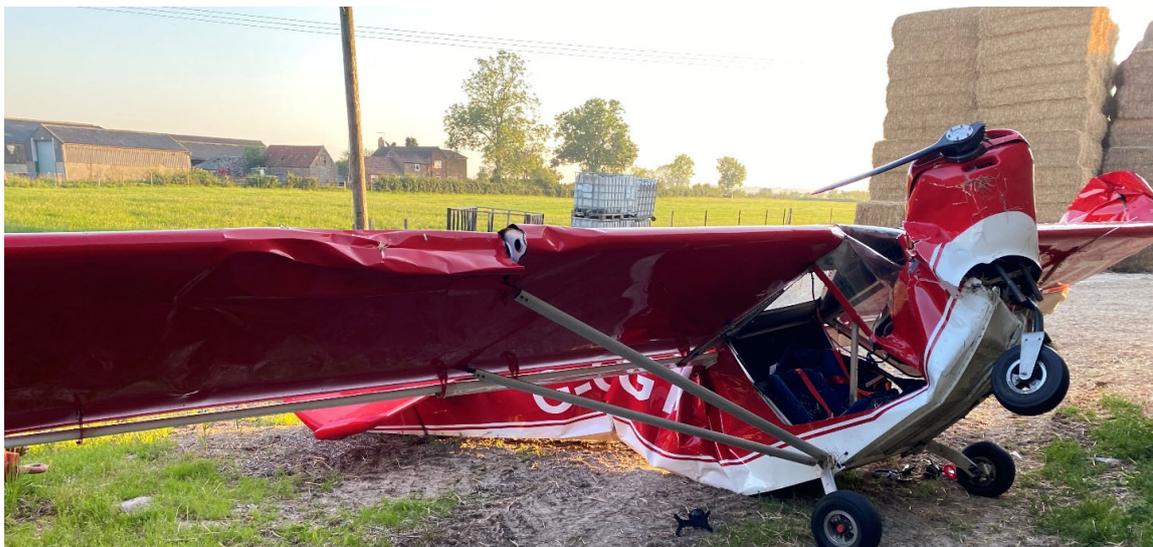
**Figure 3**

The POH states that 228 m is required to clear a 50 ft obstacle. The strip length was approximately 220 m and the height of the power lines was approximately 20 ft. However, in this case, due to the orientation of the power lines, the Take Off Run Available (TORA) decreased as the aircraft turned to the left after takeoff. The CAA "SafetySense leaflet 12 Strip Flying" highlights the hazards of flying from private strips.

G-CGTV and accident site
