## ACCIDENT

<b>Aircraft Type and Registration:</b>	Wingcopter 178 Heavylift (UAS, registration n/a)	
<b>No &amp; Type of Engines:</b>	4 Scorpion SII-4035 560 KV brushless DC motors	
<b>Year of Manufacture:</b>	2020 (Serial no: SN-0084)	
<b>Date &amp; Time (UTC):</b>	4 September 2020 at 1415 hrs	
<b>Location:</b>	Mayfield Farm, Ilsley Road, Compton, Newbury	
<b>Type of Flight:</b>	Training	
<b>Persons on Board:</b>	Crew - N/A	Passengers - N/A
<b>Injuries:</b>	Crew - N/A	Passengers - N/A
<b>Nature of Damage:</b>	Damaged beyond economical repair	
<b>Commander's Licence:</b>	Other	
<b>Commander's Age:</b>	24 years	
<b>Commander's Flying Experience:</b>	108 hours (of which 13 were on type) Last 90 days - 14 hours Last 28 days - 4 hours	
<b>Information Source:</b>	Aircraft Accident Report Form submitted by the pilot

## Synopsis

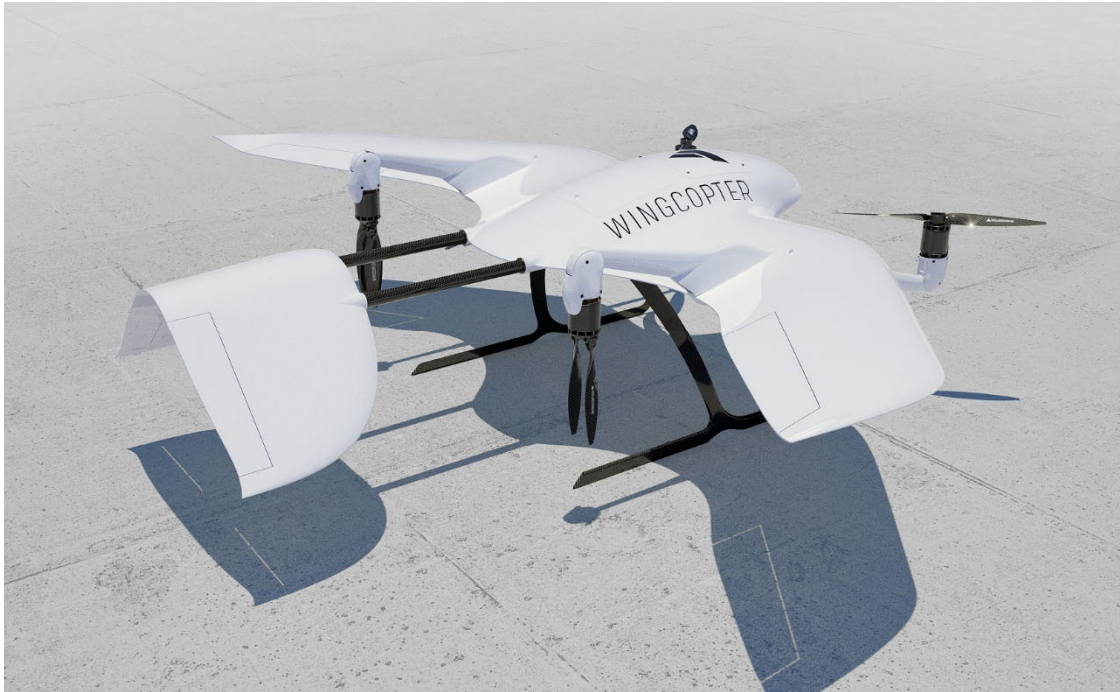
**Figure 1**

Wingcopter 178 Heavylift with propellers positioned in 'hover mode'

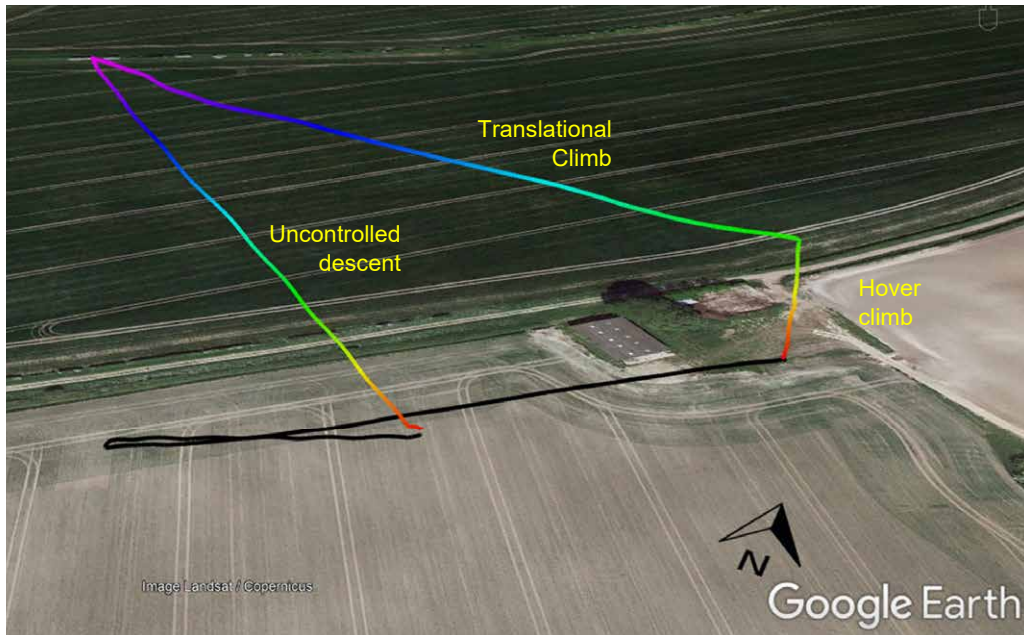
**Figure 2**

Recorded data from the aircraft shows that it initially climbed vertically to approximately 35 m agl before continuing a programmed translational climb in 'hover mode' to the south west (Figure 2). After 72 seconds, whilst approaching 100 m agl, and having travelled 188 m, the aircraft rolled and pitched to the right and became temporarily inverted. It righted itself, but was unable to maintain control, descending rapidly whilst spinning in a clockwise direction. The RP reported that it was evident that one of the motors had lost propulsion. He attempted to gain control of the aircraft by switching to manual control, but this was unsuccessful.

Oblique view of the aircraft's flight profile  
© Google 2020, Image © Landsat / Copernicus
