SERIOUS INCIDENT

Aircraft Type and Registration:	Cessna Citation CJ1+, N680KH	
No & Type of Engines:	2 Williams FJ44-1AP turbofan engines	
Year of Manufacture:	2008 (Serial no:525-0680)	
Date & Time (UTC):	13 April 2019 1422 hrs	
Location:	Bournemouth Airport	
Type of Flight:	Private	
Persons on Board:	Crew - 1	Passengers - 3
Injuries:	Crew - None	Passengers - None
Nature of Damage:	None reported	
Commander's Licence:	Airline Transport Pilot's Licence	
Commander's Age:	73 years	
Commander's Flying Experience:	4,400 hours (of which 3,200 were on type) Last 90 days - 17 hours Last 28 days - 13 hours	
Information Source:	AAIB Field investigation

Synopsis

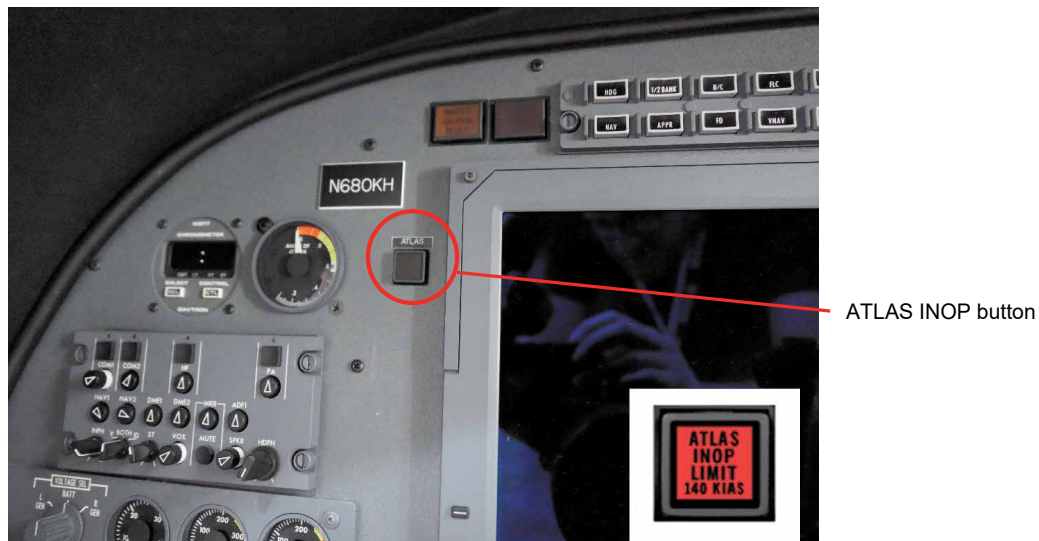
Figure 2

The pilot recalled feeling light vibration, then a button on the left of the instrument panel labelled 'ATLAS' illuminated (Figure 2), displaying the text 'ATLAS INOP LIMIT 140 KIAS' in red. At 1418:39 hrs, when the aircraft was around 6 nm east of the airport, at 3,000 ft amsl and 258 KIAS, the aircraft rolled left with a rate the pilot described as "very quick"⁴. ATC described N680KH turning "sharply... left and descending" (Figure 3)⁵. As it rolled through 45° the autopilot disengaged automatically.

ATLAS INOP button in N680KH, inset representation of button when illuminated

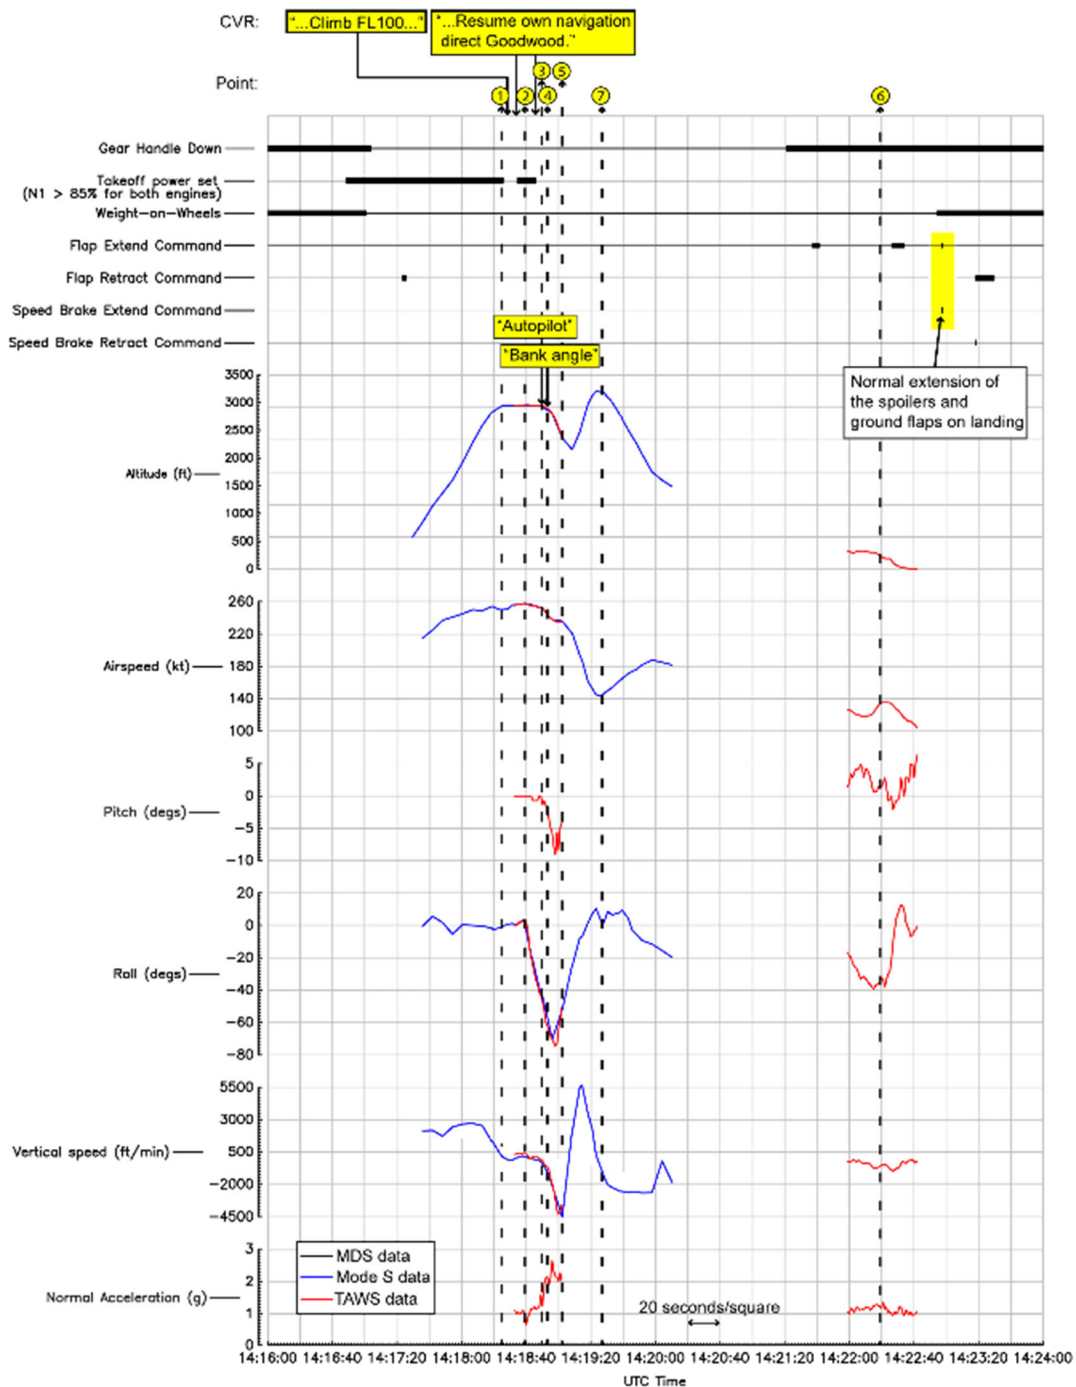
Figure 5
Summary plot of recorded information

Data for the incident flight showed that after takeoff from Bournemouth the aircraft briefly levelled at approximately 3,000 ft¹³, with a pitch attitude of 0° at between 250 KIAS and 260 KIAS (between Point 1 and 2 on Figure 5). The aircraft then began to roll to the left at approximately 4° per second (Point 2 on Figure 5). Data from the CVR shows the pilot acknowledged an ATC clearance shortly afterwards and recorded data shows the revised climb altitude being selected. Eleven seconds later, the aircraft rolled through approximately 45°. The excessive roll caused the autopilot to disconnect automatically and was accompanied by an aural disconnect warning that was audible on the CVR. At this time the recorded pitch angle markedly decreased to 9° nose down (Point 3 on Figure 5). As bank angle exceeded 60° a bank angle alert¹⁴ was generated (Point 4 on Figure 5) and a sharp increase in normal acceleration was recorded which reached +2.65 g. The bank angle reached a maximum of 75° left wing down, 19 seconds after the onset of the roll (between Point 4 and 5 on Figure 5), although the rate of descent

continued to increase and reached 4,500 ft/min (Point 5 on Figure 5), when the aircraft's airspeed was 235 kt.

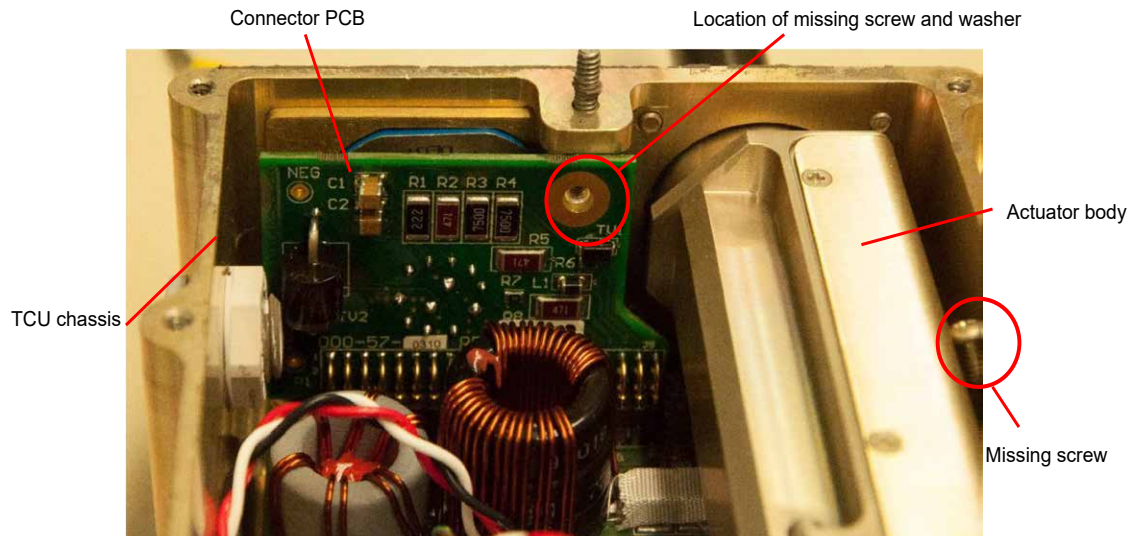
Figure 11

When the unit was shaken, before removing the cover, something rattled inside. Opening the unit revealed that the screw and washer which attached and earthed the electrical connector printed circuit board to the unit's chassis were missing. Both the screw and washer were found within the chassis¹⁶ (Figures 11 and 12).

TCU s/n 1015 showing where the crew should have been, and where it was found.

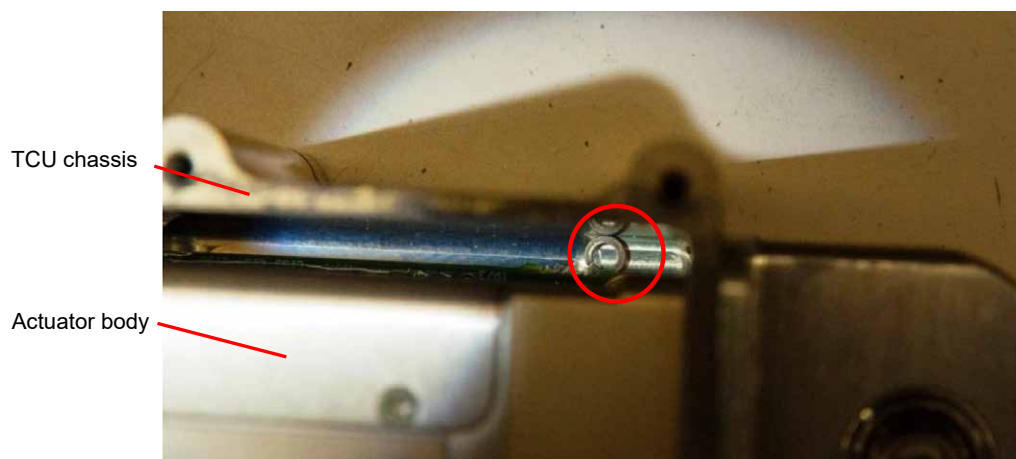
Figure 12

TCU s/n 1015 showing location missing washer was found

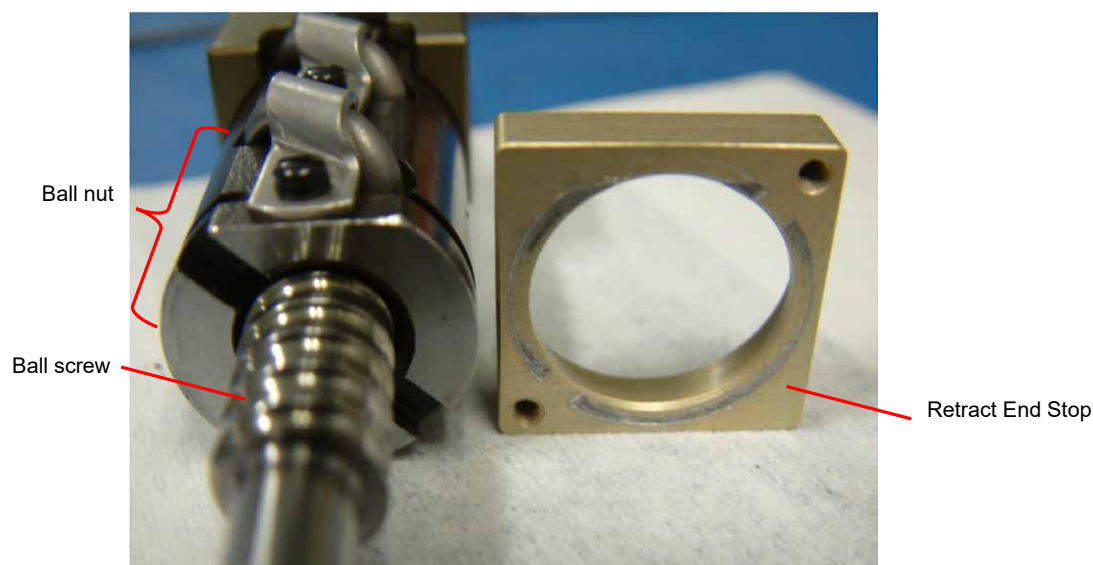
Figure 13

Damage in the actuator retract end stop (Figure 13) and thrust pack carrier was consistent with them being struck by the ball nut that travels with the actuator arm. There was some resistance when the ball nut was separated from the thrust pack carrier, which was determined to be the cause of the actuator being locked in the retract position. The impact marks on the retract end stop, and witness marks on the thrust pack carrier, indicated that the ball screw nut had struck the stop and thrust pack carrier with some force. The impact marks in the stop were 0.012 inch deep. This damage probably occurred during the trouble shooting activity when the aircraft was on the ground.

TCU s/n 1015 impact marking from actuator ball screw against retract end stop
(retract end stop turned to show impact mark next to contact point on ball nut)

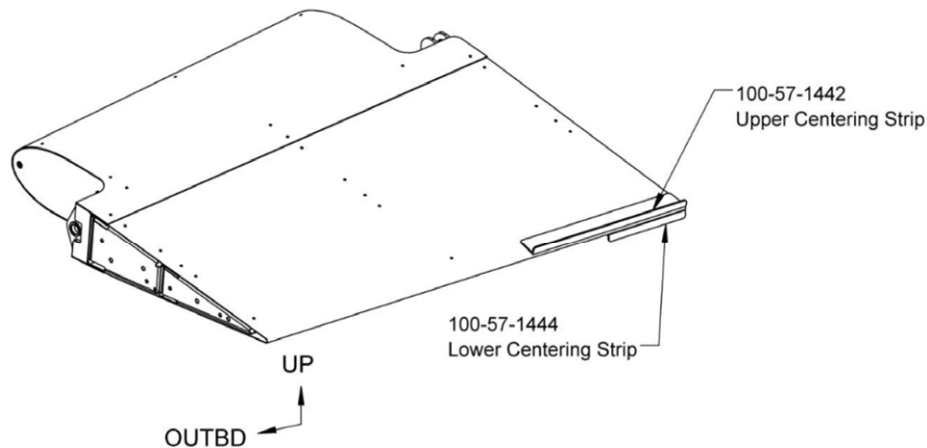
Figure 17

The modification documentation stated that there had been three uncommanded roll events relating to system failures. Due to the aerodynamic overbalance of the TACSs, it was possible for them to remain deployed if they were not faired when the TCUs were de-powered.

Centering strips introduced via Service Bulletin CAS/SB1475 issue A
