ACCIDENT

Aircraft Type and Registration:	Pitts S-2A Pitts Special, G-ODDS	
No & Type of Engines:	1 Lycoming AEIO-360-A1E piston engine	
Year of Manufacture:	1980 (Serial no: 2225)	
Date & Time (UTC):	24 August 2019 at 1304 hrs	
Location:	Stonor, Oxfordshire	
Type of Flight:	Training	
Persons on Board:	Crew - 2	Passengers - None
Injuries:	Crew - 2 (Fatal)	Passengers - N/A
Nature of Damage:	Aircraft destroyed	
Commander's Licence:	Private Pilot's Licence (Class Rating Instructor)	
Commander's Age:	35 years	
Commander's Flying Experience:	Approximately 710 hours (of which about 172 hours were on type) Last 90 days - 35 hours Last 28 days - 12 hours	
Student's Flying Experience:	197 hours (of which 1 hour 25 minutes were on type) Last 90 days - 34 hours Last 28 days - 8 hours	
Information Source:	AAIB Field Investigation

Synopsis

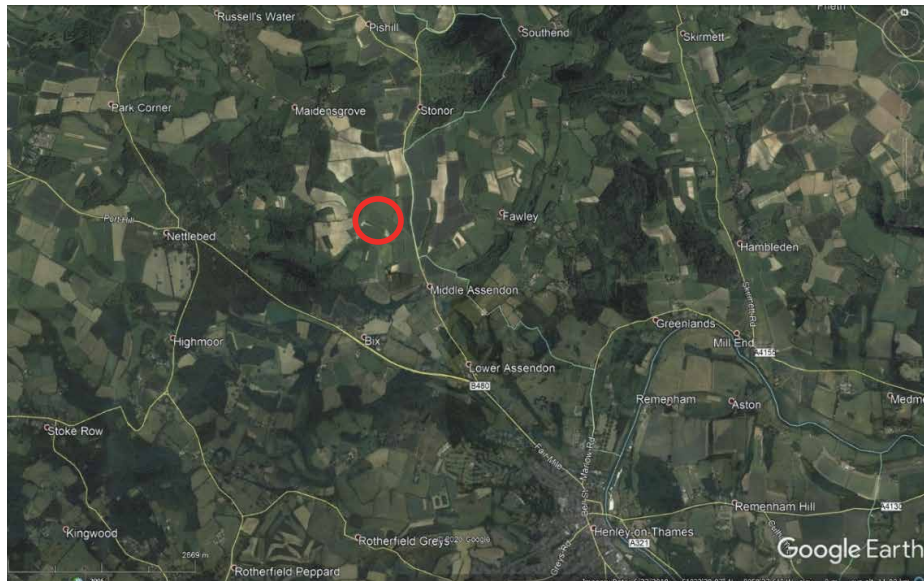
Figure 1
Accident site

The accident site was approximately 1 mile south of Stonor village in an open field with livestock (Figure 1). The aircraft was disrupted, in an upright position and had struck the ground in a steep nose-down attitude. The ground marks showed the first ground contact was made by the leading edge of the right lower wing and the nose of the aircraft. The ground marks were short and although the ground was very hard, the aircraft had not travelled forward after the initial contact. However, there was evidence that the aircraft had moved to the left by approximately 1-2 m with a small rotation to the right which is consistent with spinning with right yaw. Both pilots were restrained within the aircraft but had suffered injuries which were not survivable.

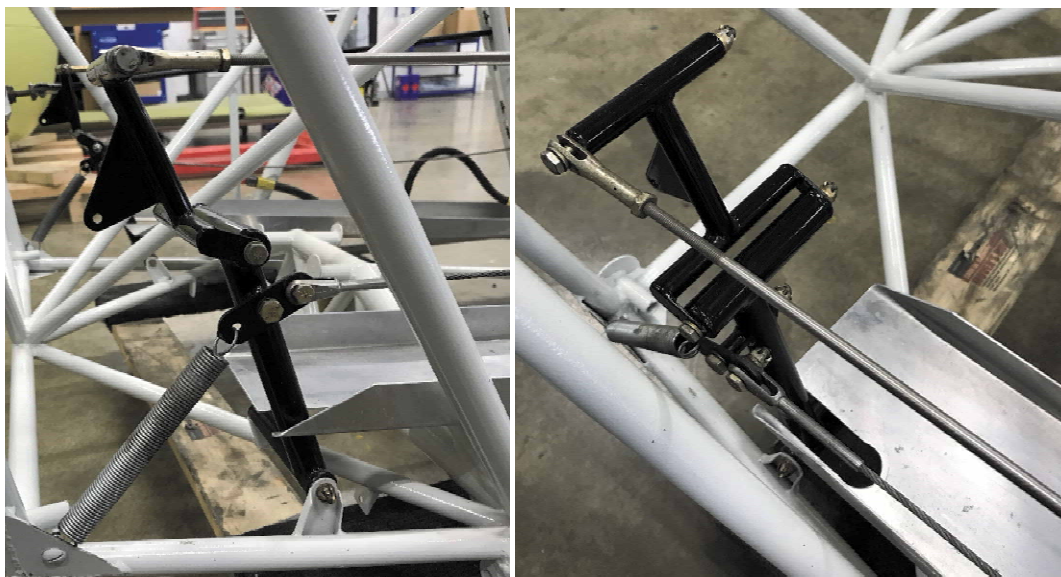
Figure 5

Front rudder and brake pedal and heel tray cut-out (side and top view of exemplar aircraft)

A change of more than 30 mm in the front pedal neutral position when using the devices, caused the retreating pedal to come into contact with the end of the heel tray cut-out, thus preventing full pedal and rudder deflection. In the accident flight configuration (B2+B2), this interference restricted rudder movement by 3° (ie reduced the rudder movement from +/- 30° to +/-27°) and the maximum device setting restricted the rudder by 10° (from +/- 30° to +/-20°). In April 2019, the aircraft had a 50-hour maintenance check and, during the check, the devices were found already fitted to the rudder cables. While inspecting the rudder travel, the engineer noticed that there was a 6 mm gap between the rudder lever and the fuselage stop when the pedals were at the limit of their travel. This 6 mm gap at the rudder stop equated to approximately 3° of rudder travel. The devices were removed, and it was noted in the maintenance documentation that '*Non-approved rudder cable devices found fitted. Once removed rudder travel then is satisfactory*'. There was no discussion about this note between the operator and the maintenance organisation.

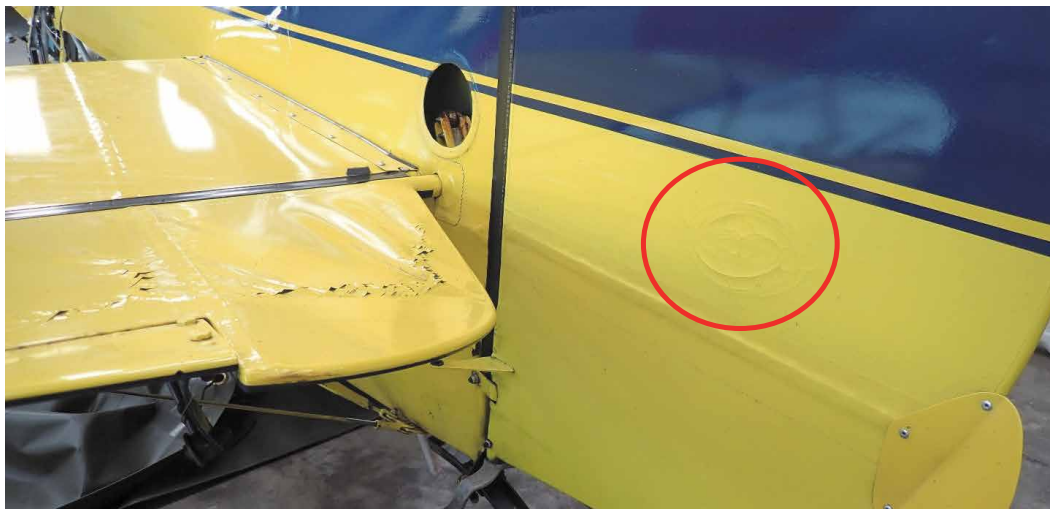
Figure 6

All the control cables were inspected and found intact. However, the control column in the rear cockpit had become detached near the hinge point. It was observed that there was impact damage to the left rudder surface (Figure 6) with corresponding damage to the left elevator. The rudder stops were present and undamaged, and the trim tab was set to neutral.

Elevator and rudder damage (circled)

It is considered that, at the time of impact, the rudder was in the neutral position or towards the right. The contact damage on the left side of the rudder and the deformation to the left elevator would require a significant impact force. The left rudder stop was intact, and, after the accident, it was not possible to move the rudder far enough to touch the elevator, therefore the rudder must have deformed. The lightweight rudder is stiff, and it would need a lot of momentum to deform significantly which could not be achieved if the rudder was against the left stop. If the pedals were holding the rudder neutrally or to the right, it is still possible for the rudder to move. As the fuselage deformed during the impact, the bending would have released the tension in the rudder cables, thereby allowing free movement of the rudder.

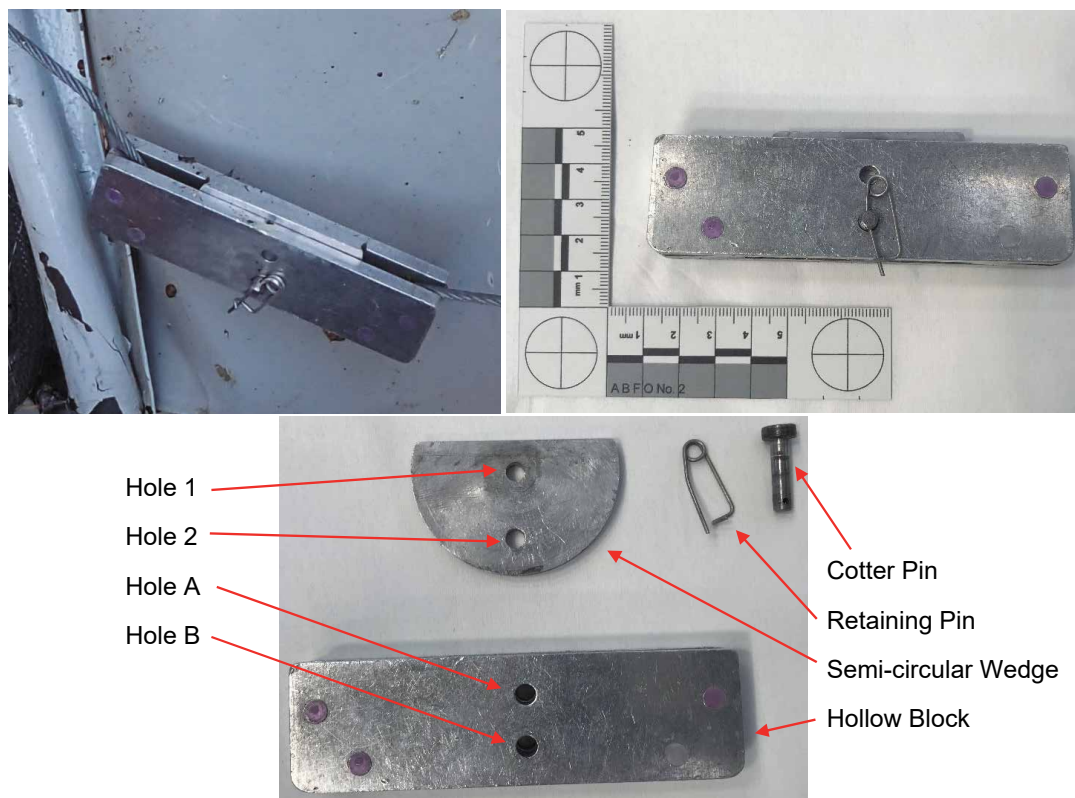
Figure 7

During the initial examination of the aircraft at the accident site it was noted that there were four unidentified devices fitted onto the rudder cables. They were left in place for further examination at the AAIB facilities. A device was fitted on each of the cables between the forward and rear rudder pedals and on the cables aft of the rear rudder pedals. After removal, it could be seen that each device constituted an aluminium block, aluminium semi-circular wedge, steel cotter pin and steel retaining pin (Figure 7) with the forward devices a matching pair and the aft pair matching. Each pair was similar in construction and design however there were some minor dimensional differences.

Rudder cable device shown in situ,
removed for examination and constituent parts

When fitted, they effectively shorten the cable by diverting it around the semi-circular wedge. In the block and the wedge, are two cotter pin holes (Figure 7) that make it possible to install the devices in different configurations. Each configuration will shorten the cable by a different amount. Table 1 shows some of the configurations and the effect they had on the rudder pedal neutral position, in terms of movement towards the seat. The aircraft was in configuration B2+B2 for the accident flight.

The fitting of these devices to the aircraft changes the definition of the rudder system as specified in the aircraft type design documentation submitted at the time of certification. The Certification of Airworthiness for G-ODDS was issued by EASA and the installation of these devices should have been achieved by an approved design change to the type design in accordance with EASA part 21.A.91 '*Classification of changes to type design*'⁵. The AAIB was unable to find an approved modification for the fitting of these devices to the aircraft rudder cables, and the aircraft manufacturer confirmed that there was no such modification or Supplemental Type Certificate modification.

The fitting of such devices should be an EASA approved modification so that their operation and effects can be tested and documented. The investigation was unable to locate any approval for a modification to fit these devices. It was noted during a maintenance check that the devices, which were fitted at the time, restricted the rudder travel by 3° (10% of travel).

Unapproved devices, which adjusted the rudder pedal positions, were found on the rudder cables but were unlikely to have impeded the recovery from the spin.

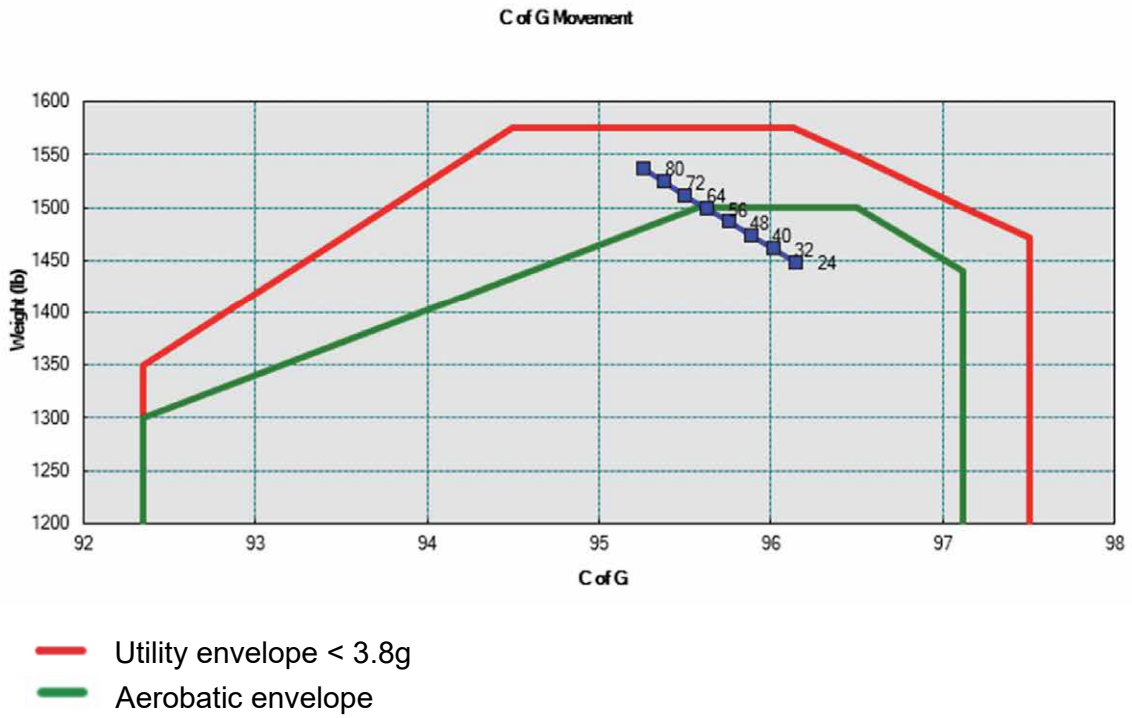
Figure 9
Commander's Weight and Balance spreadsheet

The operator had created a spreadsheet to calculate aircraft weight and C of G position. A copy of the spreadsheet was obtained from the commander's computer. The total aircraft weight used in that copy was 1,097 lb and a C of G position 88.00 inches aft of the datum. The operator stated that the figures '*were supplied with the aircraft and were in the tech log at the time of purchase*'. These figures came from weighing the aircraft in 2005.

Following the fitting of a new propeller, the aircraft was reweighed in 2007 and its mass had increased to 1,124 lb and the C of G position had moved further aft to 89.79 inches aft of datum. The operator stated they were unaware of the most recent weight report at the time of the accident and only found the most recent weight and balance report after the event. In addition, the pilots' weights used in the calculations were significantly less than their actual weights; the commander's weight was underestimated by 6.35 kg (14 lb) and the student's weight by 9.98 kg (22 lb). The source of these figures is unknown. A copy of the Weight and Balance calculation believed to have been used by the commander prior to the accident flight is shown in Figure 9. The numerals on the blue line corresponds to a range of possible fuel quantities in litres.

The use of incorrect figures could have misled the commander into thinking that the aircraft was within its flight envelope for the planned sortie. Figure 10 shows a more accurate result with figures from the most recent weight and balance report. The actual pilot weights, the weights of the additional seat cushions and the miscellaneous equipment found in the aft cockpit locker have also been included.

- The use of spreadsheets has been discontinued and Aircraft Flight Manual (AFM) weight and balance charts are used instead. A current weight and balance report is now included in the aircraft technical log.
- The operator has circulated the AFM weight and balance charts together with current weight and balance reports to all instructors.
- Scales are now provided so pilots can weigh themselves. The operator has found large discrepancies between given and actual weights among its pilots and no longer accepts assumed or estimated weights.

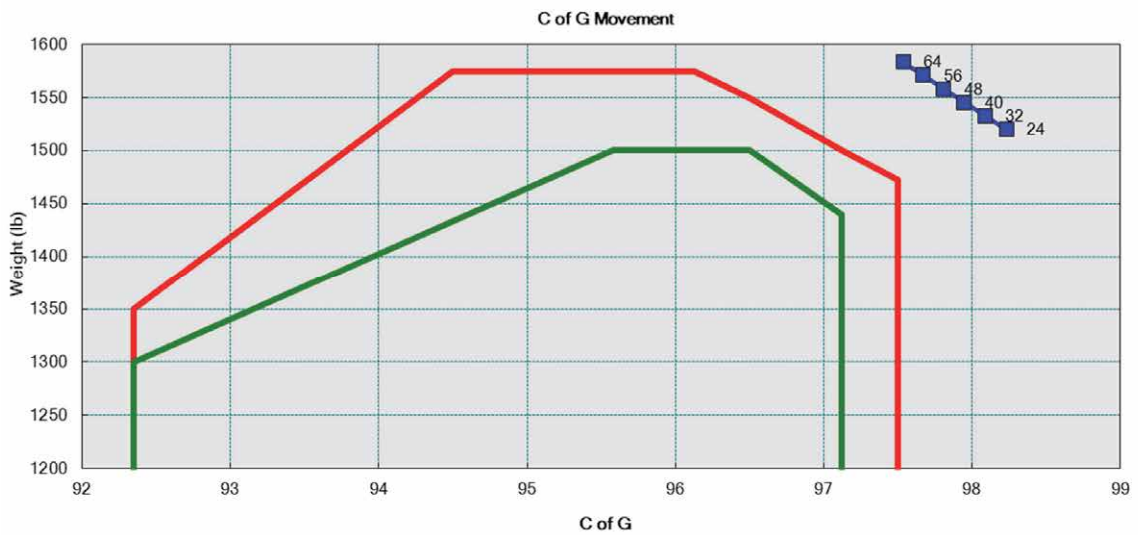
Figure 10
Revised Weight and Balance spreadsheet

With these figures the aircraft was overloaded for both the aerobatic and utility flight envelopes. The most rearward C of G limit for aerobatics is 96.5 inches at a gross weight of 1,500 lb increasing to 97.12 inches at 1,440 lb. For the utility category the limits are 96.13 inches at 1,575 lb increasing to 97.5 inches at 1,472 lb. The aircraft manufacturer stated that the overload condition would not have affected the aircraft's capacity to recover from a spin. Having been advised that, at the time of the accident, G-ODDS's C of G position was further aft than the limit, the manufacturer stated that:

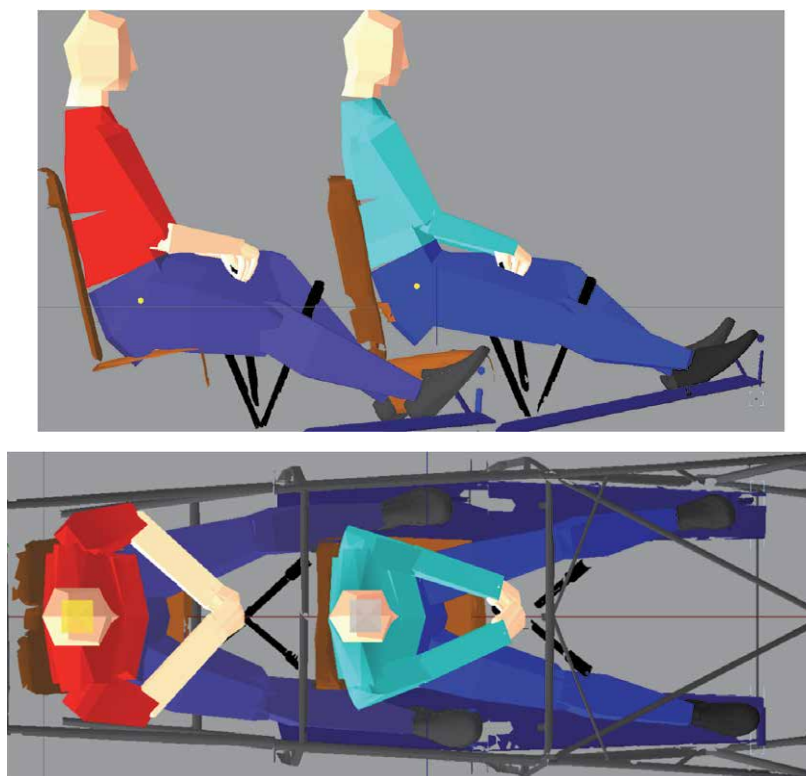
Figure 14

Right rudder pedals full forward without the devices fitted
(brake pedals omitted for clarity)

The assessment showed that the commander was unlikely to have been able to move the pedal to this position because the leg is fully extended with only the tip of the toes in contact with the pedal. The student was likely to have had better foot contact on the pedal and the leg is only slightly bent, but this position may have been uncomfortable due to the additional seat cushions digging into the thigh and the front seat back on the inside of the calves. The assessment showed that the receding pedal position was unlikely to pose a problem for either pilot to exert the force necessary to return the rudder to the neutral position.

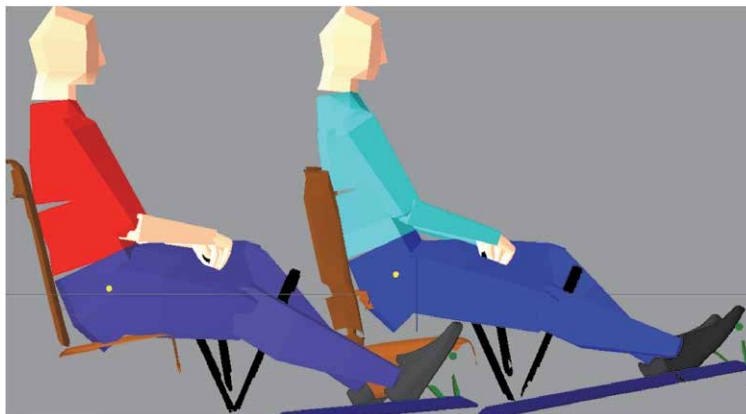
Figure 15

With the devices fitted as they were on the accident flight (Figure 15), the assessment showed that the commander would be able to reach the extreme of pedal travel more easily. Full extension of their leg was still required but instead of the toe, the ball of their foot would likely have been on the pedal affording more control.

Right rudder pedals fully forward with the devices fitted
(brake pedals omitted for clarity)

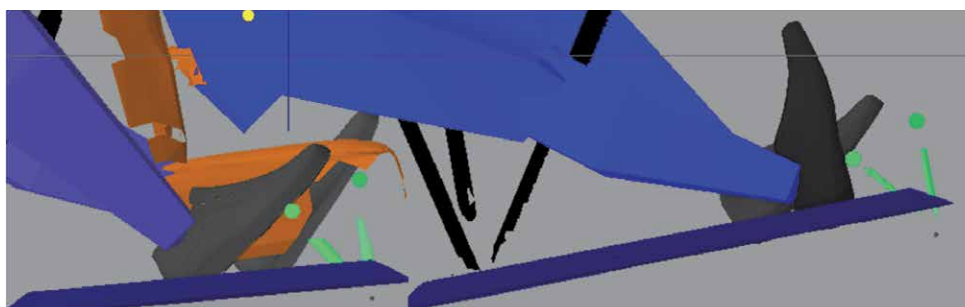
Figure 16

Digital modelling and practical assessment of this scenario was made using the SAMMIE tool and an exemplar aircraft and it was found that it was possible to apply the required rudder input even against a 'locked' straight leg. The commander's joint mobility was explored via digital modelling (Figure 16) and although the ankle is nearing the limits of extreme movement, it is possible for full opposite rudder to be applied. Typically, an external force would be required to extend the ankle to this position but a further 6° of extension is possible in the extreme range.

Commander ankle movement with full opposite rudder
(brake pedals omitted for clarity)
