# Hammersmith Bridge

Review of Recent Documents and  
Summary of Existing Condition

**Prepared for:**

**Prepared by:**

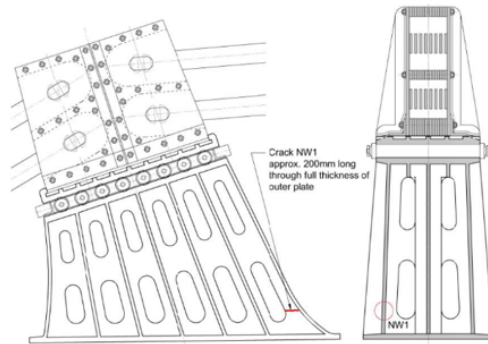
**North West**

April 2019 – Over paint – 1 crack 200mm long

Post April 2019 – Over paint (Eddy current) – 3 cracks

Current (Nov 2020) – Casing removal and blast cleaning not started

1. Complete the removal of the ornamental casing and carry out blast-cleaning and inspection of the NW and SW Pedestals – this is imperative as it will quantify the unknown risks associated with these pedestals. When the north east pedestal was blast cleaned and inspected, further cracks were discovered including NE10. A view was taken at the time of discovery that these additional cracks were historical as they were not visible through the paint. This work must be carried out with due attention to Health and Safety matters.

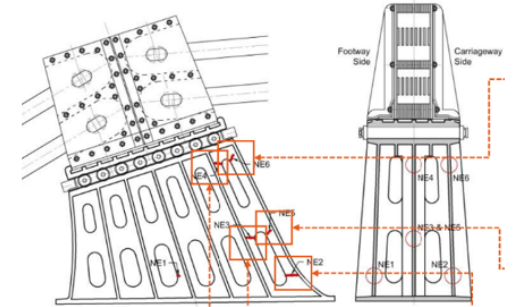
**North East**

Post April 2019 – Over paint (Eddy current)  
– 6 cracks

April 2020 – Post blast clean – 13 cracks 30 to 205mm long. Crack NE10 160mm long.

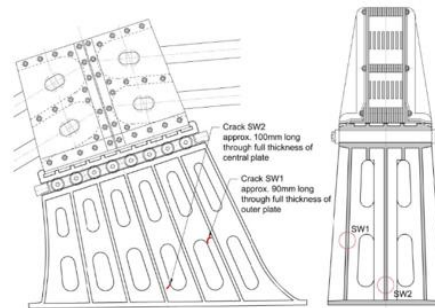
**South West**

April 2019 – Over paint – 2 cracks 90 & 100mm

Current (Nov 2020) – Casing removal and blast cleaning not started

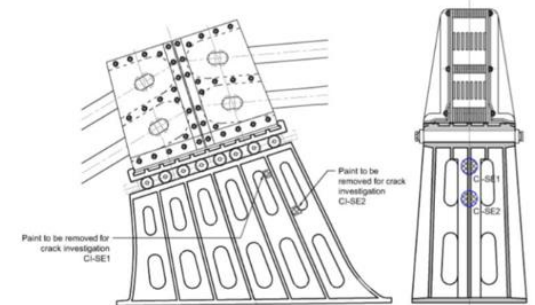
**South East**

April 2020 – Post blast clean – No cracks  
Current (Nov 2020) – Chain tunnel temperature control system being installed

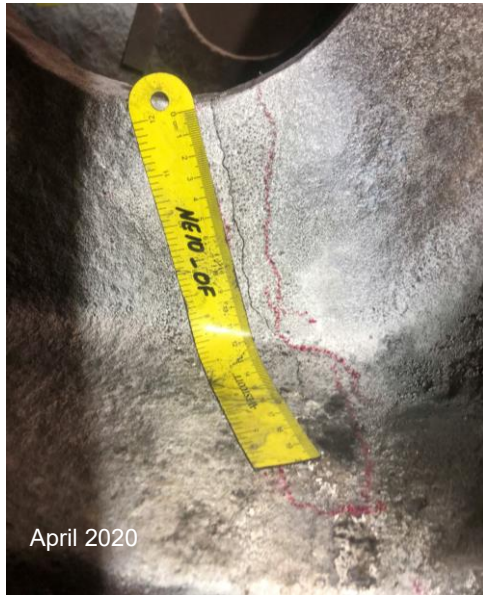
Figure 2.3 – Crack NE10 April 2020 Outside Face

Crack NE10 was identified in the web and was evidenced as being through-thickness and terminating in the fillet region, with a length of about 160mm, as shown below in Figures 2.3 and 2.4.

5. Determine depth of crack at NE10 – AECOM recommends that the depth of crack NE10 is established by using, for example, a pencil grinder. This will help to determine if the crack has gone through the full depth or if it is just a surface crack. This action will also be helpful to establish if the crack has terminated as it moves from the web outstand to the base plate.

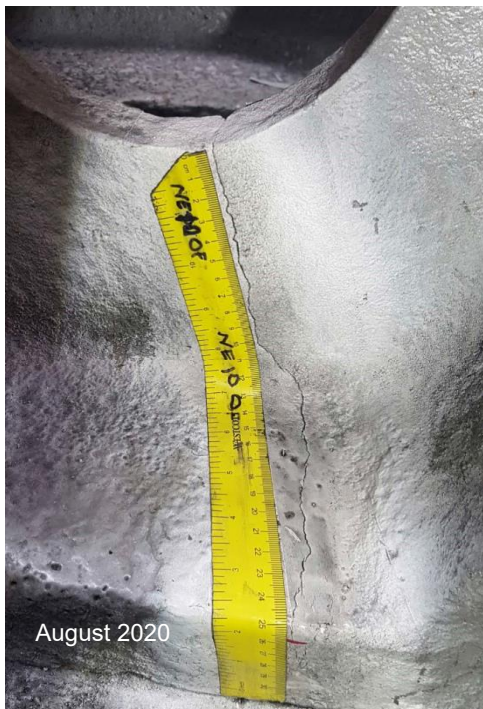
Figure 2.5 – Crack NE10 August 2020 Outside Face  
(source all pictures: MM)

August 2020 – Crack NE10 now 240mm long

Following an acoustic emission alarm on 7 August 2020, an inspection found that crack NE10 had grown on the east side from about 160mm to about 240mm and had reached the edge of the opening in the base plate (Figure 2.5). There was no propagation on the west side. However, it is clear from the photograph that, at the edge of the opening in the base plate, the crack has shallow depth. This strongly suggests that the crack is in fact shallow from the opening edge to the fillet. As the growth of this crack resulted in the complete bridge closure, it is crucial to understand its depth and hence risk it presents. Clearly a shallow crack presents much less risk than a full depth crack.

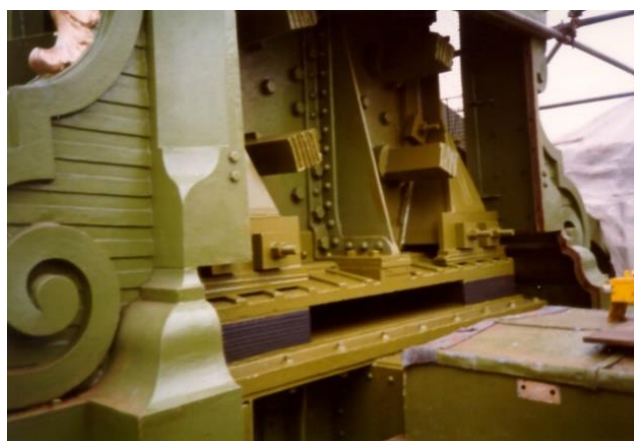
Figure 6.11: Tower top saddle showing replacement elastomeric bearings (Source: AECOM)

The tower saddles are a particular concern as they have limited longitudinal movement capacity. The original rollers were removed and replaced by elastomeric bearings in the 1980s and 1990s, as shown in Figure 6.11 below (picture taken after installation of elastomeric bearings when casing had been removed). With the increased eccentricity of application of load arising from the displaced bearings, there will tend to be an increased moment acting on the towers framed legs, leading to potential overstress.
