Historical Railways Estate

Structure Reference

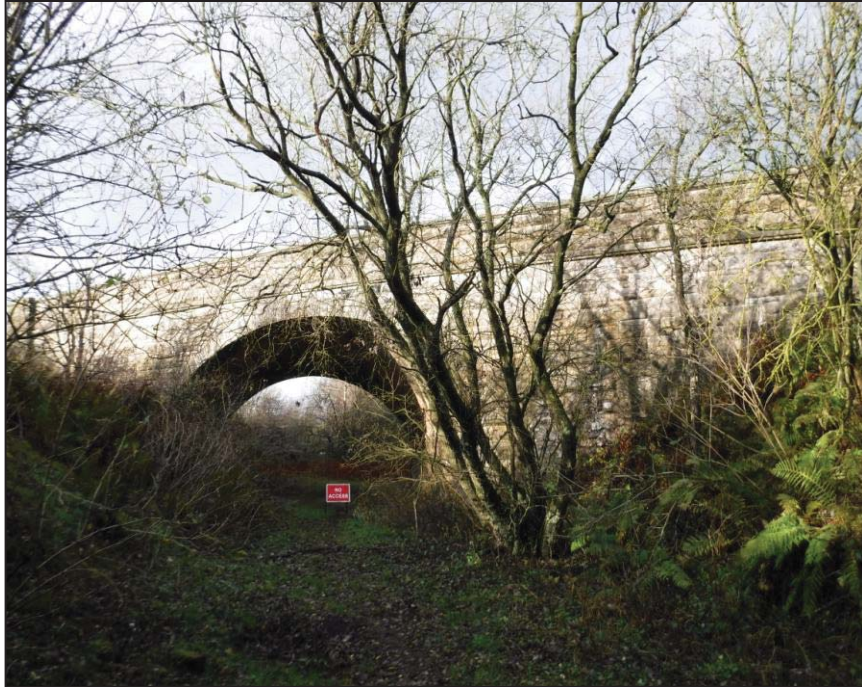
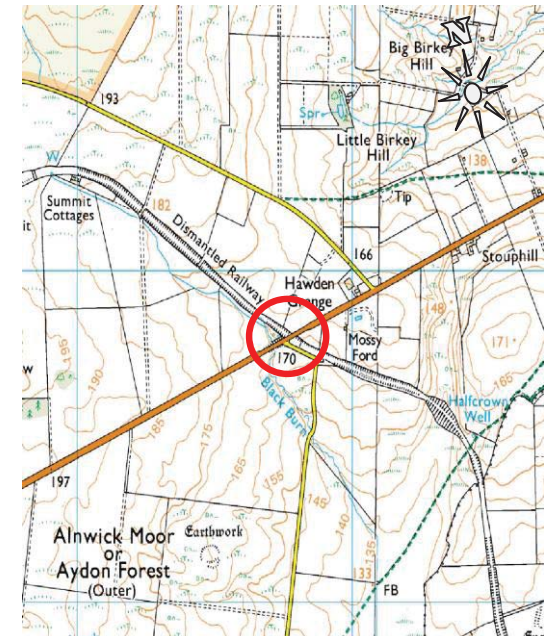
A **Detailed Examination** of this structure has been carried out to establish the condition, identify the nature, severity and extent of defects, ascertain the rate of deterioration by reference to the previous examination reports and identify the scope, extent and urgency of any remedial actions required to ensure the continued safety and long-term integrity of the structure.

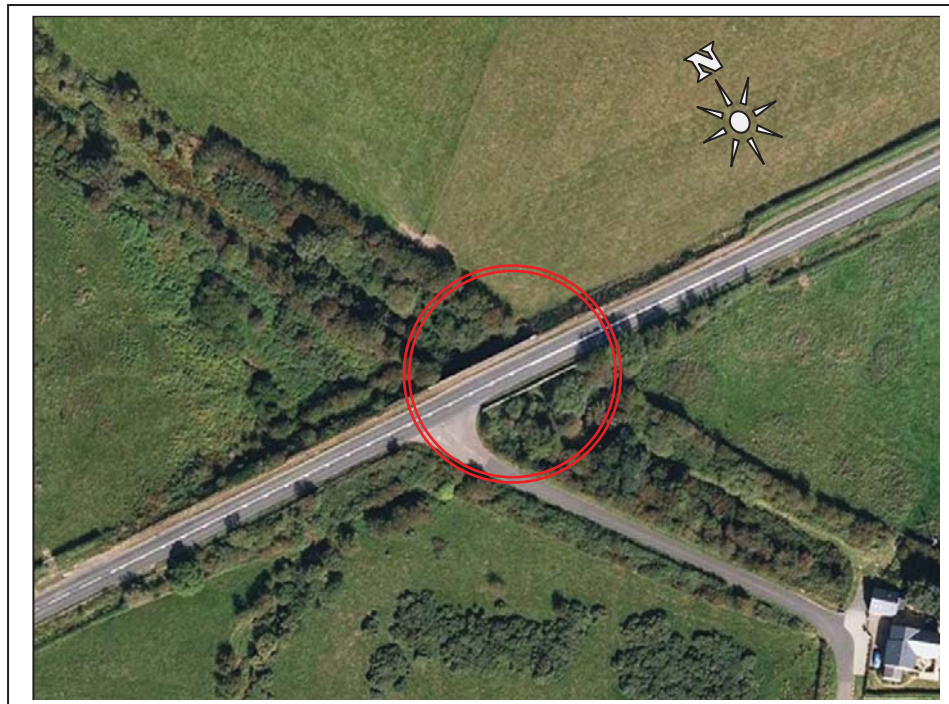
ELR: AKC	Structure No: 95	Mileage: 0m 000ch	Examination date: 28/11/2018
Route: ALNWICK - CORNHILL			OS ref: NU: 158 118
Name: ALNWICK ROAD			Type: OVERBRIDGE

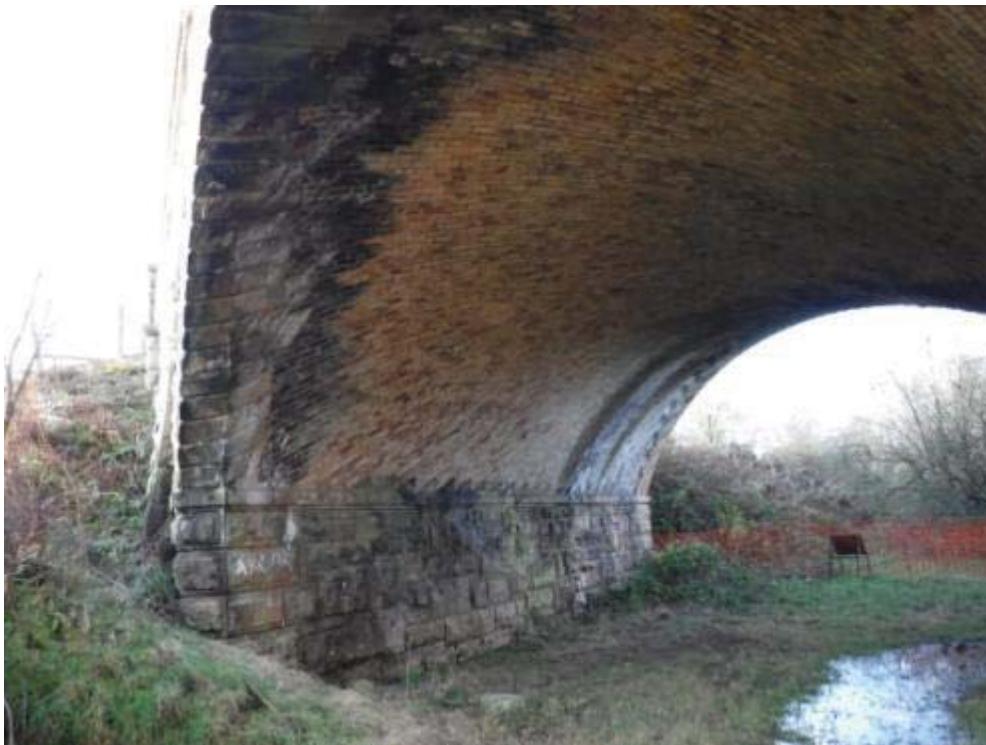
Photo No.8 - Arch ring soffit: Typical example of the condition.

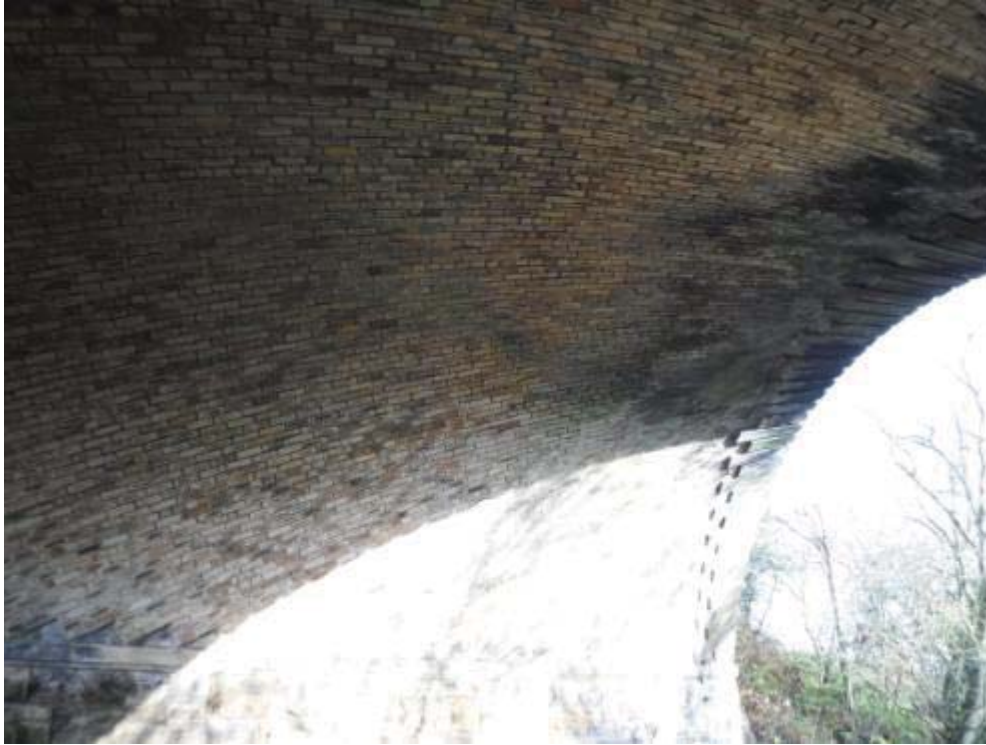
Photo No.9 - Arch ring soffit: Typical example of the condition.

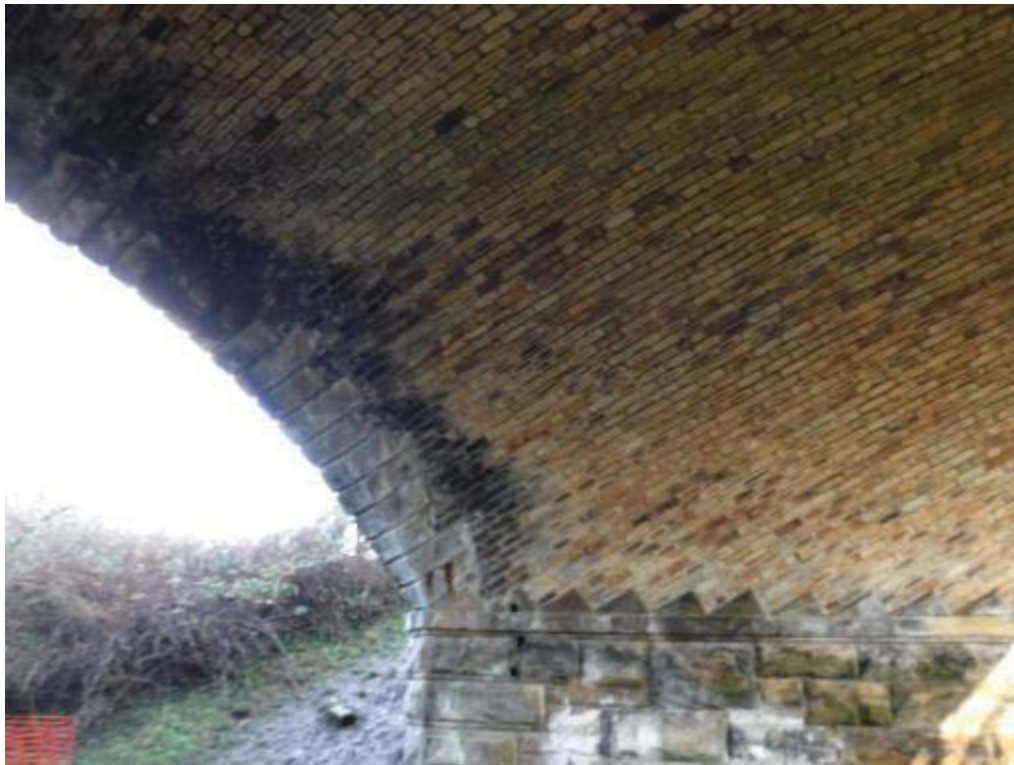
Photo No.10 - Arch ring soffit: Typical example of the condition.

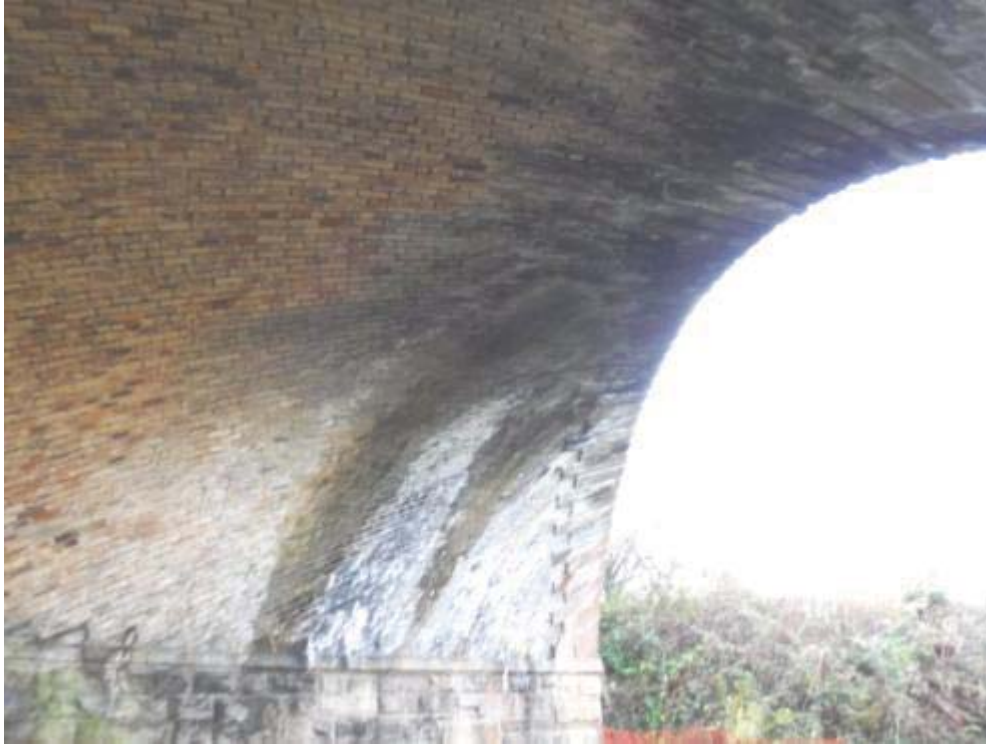
Photo No.11 - Arch ring soffit: Typical example of the condition.

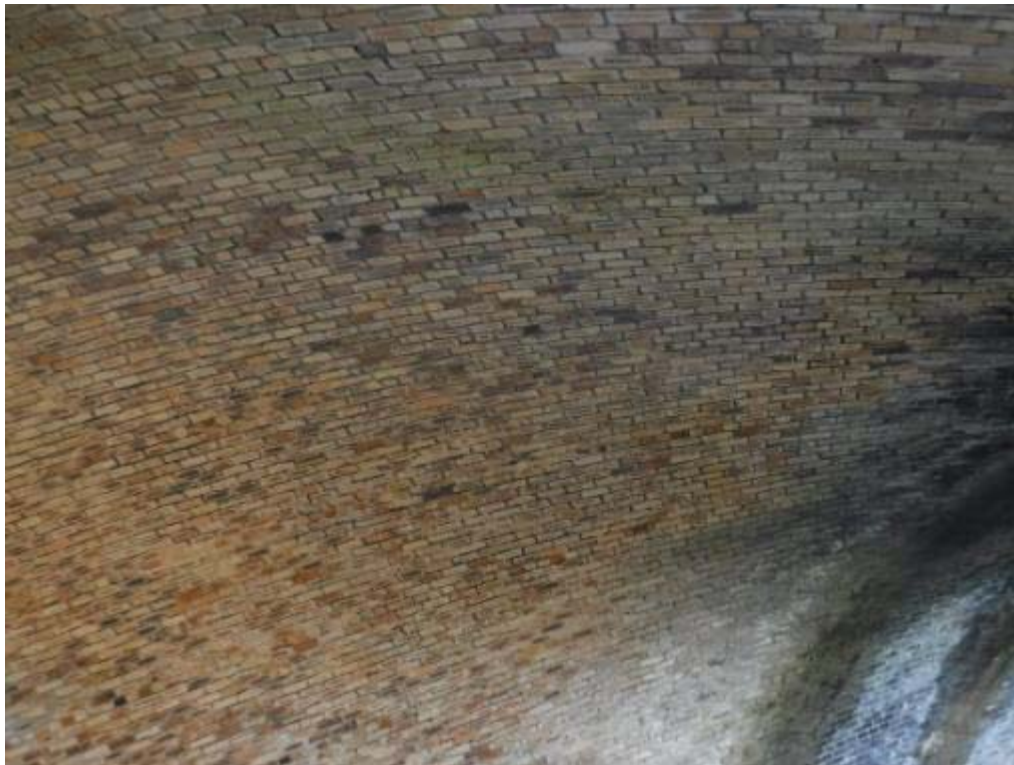
Photo No.12 - Arch ring soffit: Typical example of the condition.

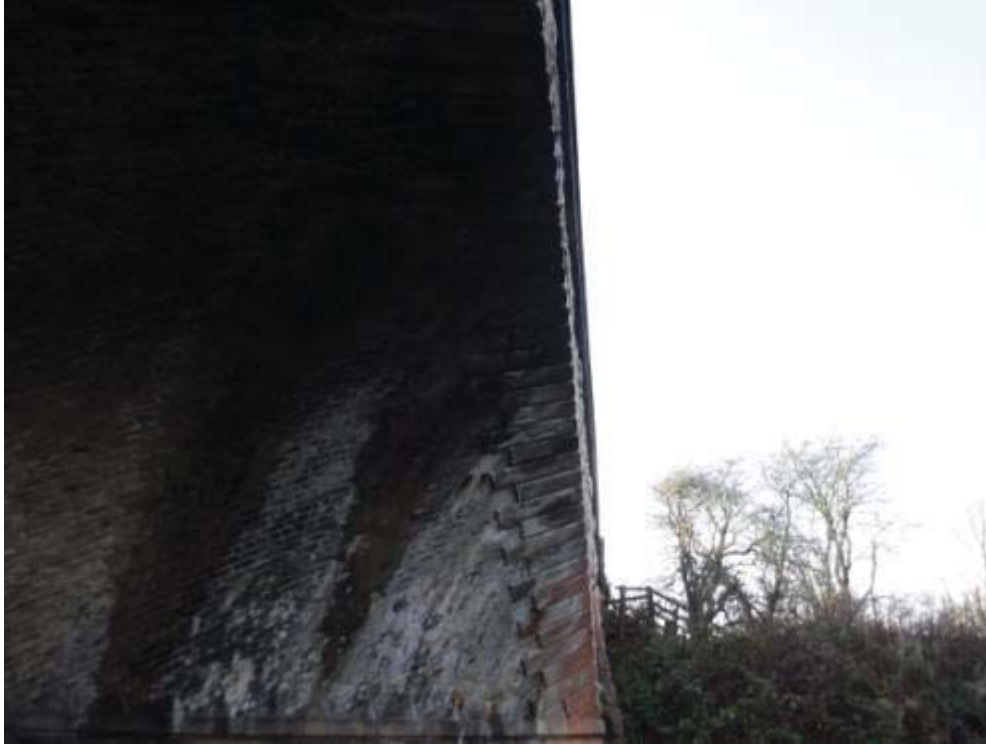
Photo No.13 - Arch ring soffit: Typical example of the condition.

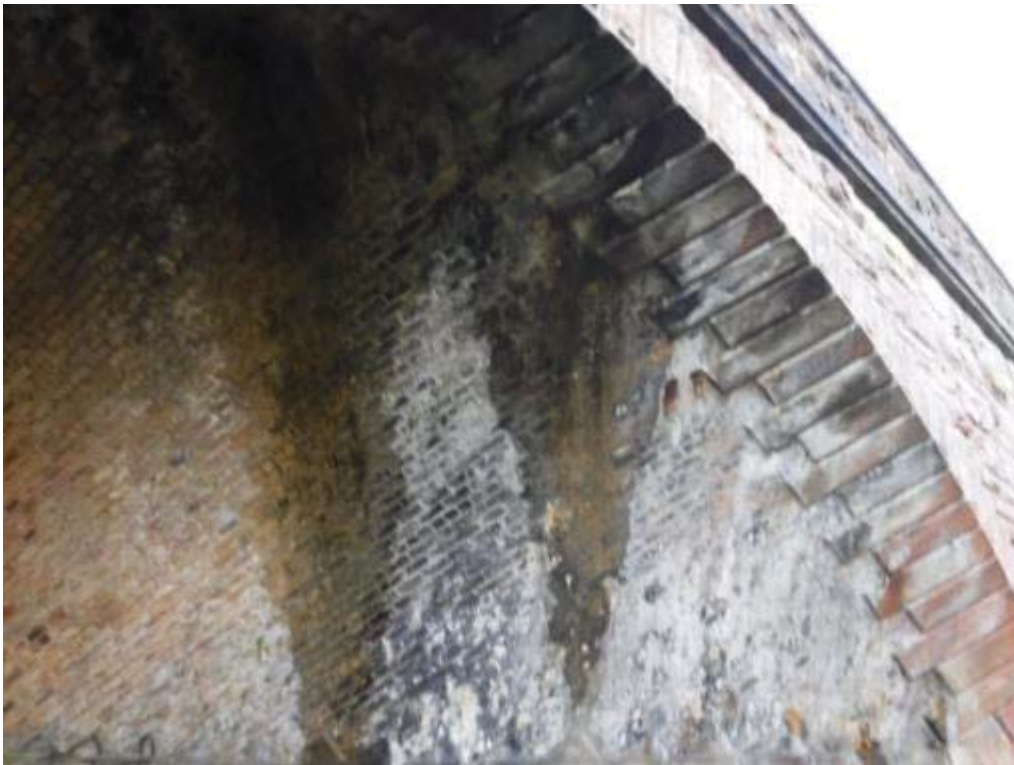
Photo No.14 - Arch ring soffit: Typical example of the condition.

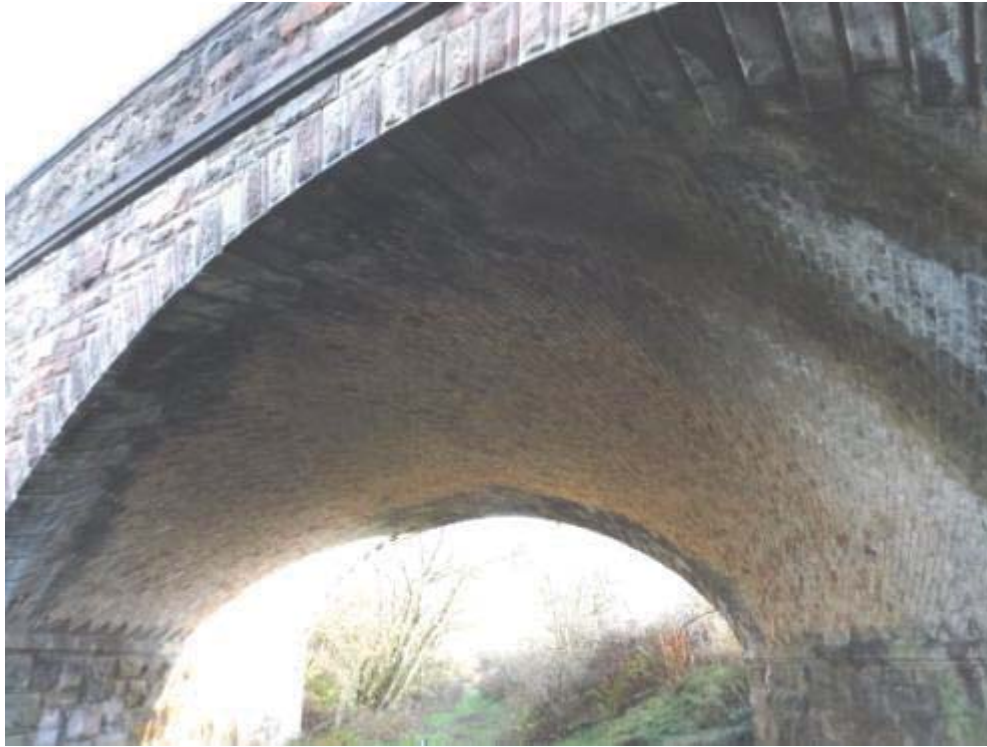
Photo No.15 - Arch ring soffit: Typical example of the condition.

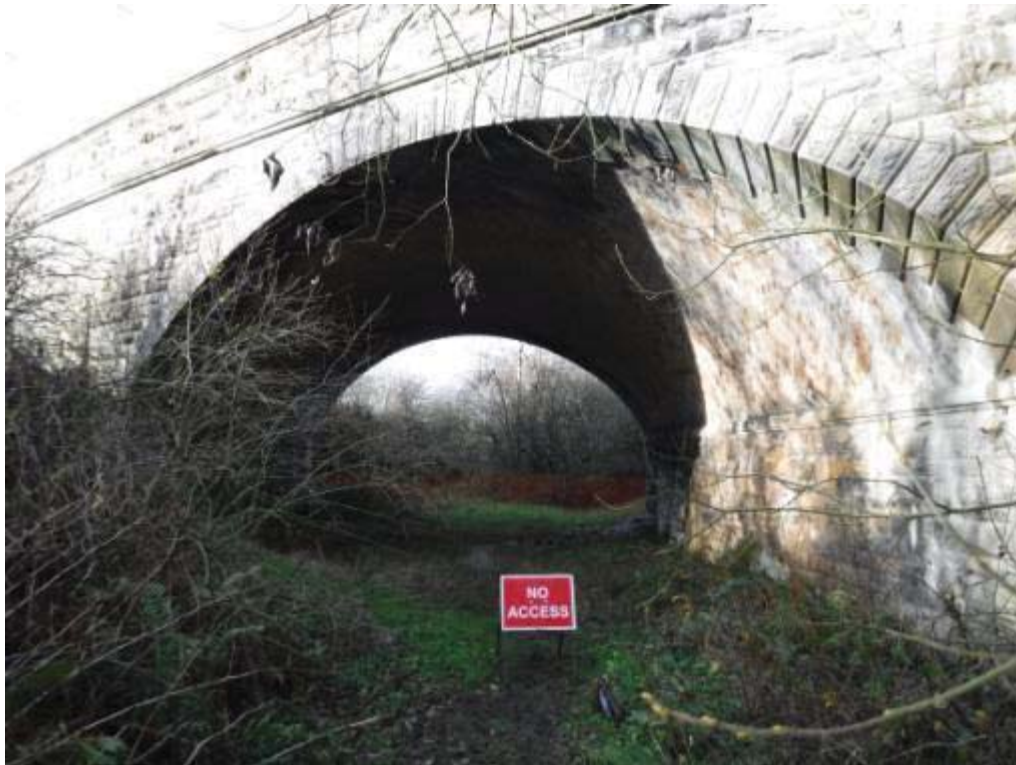
Photo No.16 - South arch ring face: View.

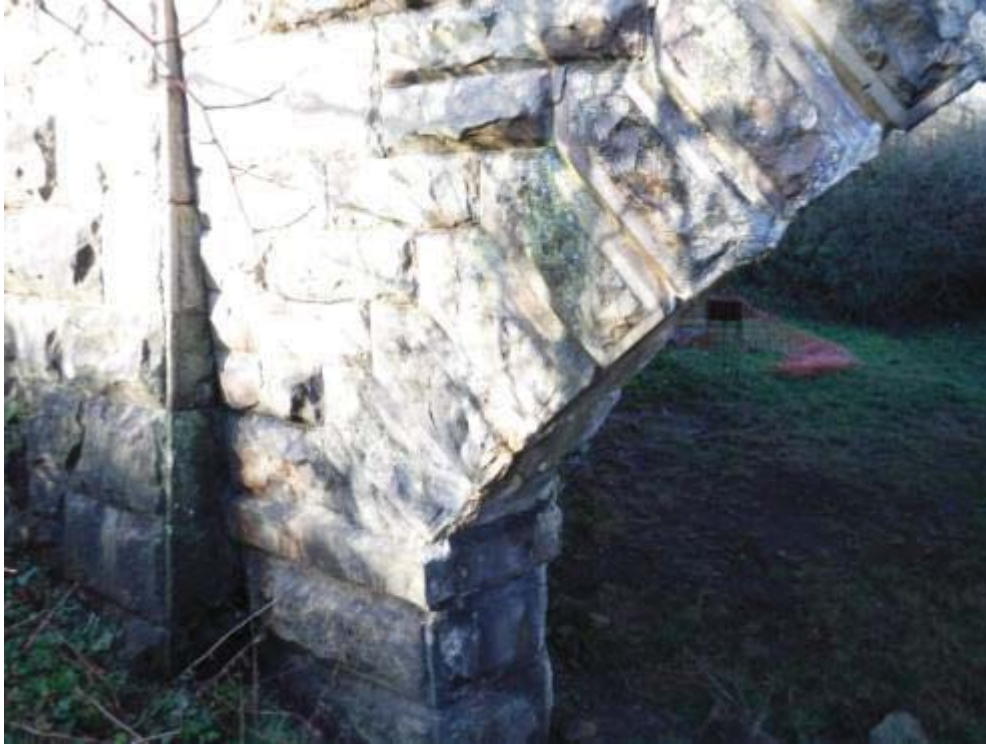
Photo No.17 - South arch ring face: Typical example of the condition.

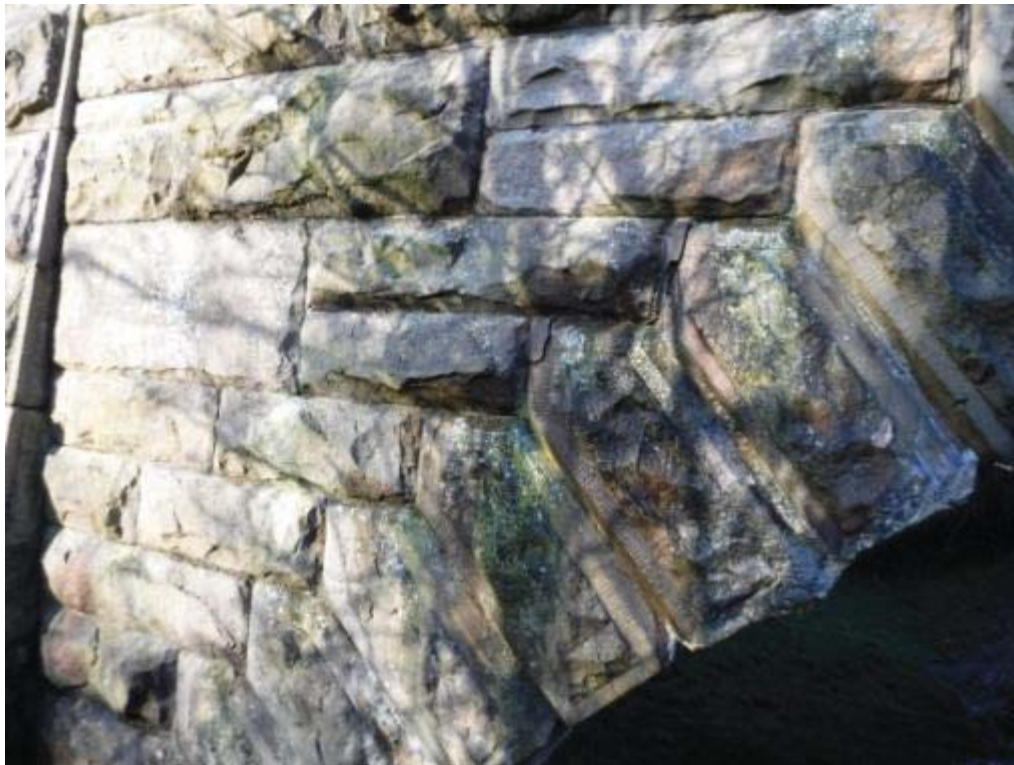
Photo No.18 - South arch ring face: Typical example of the condition.

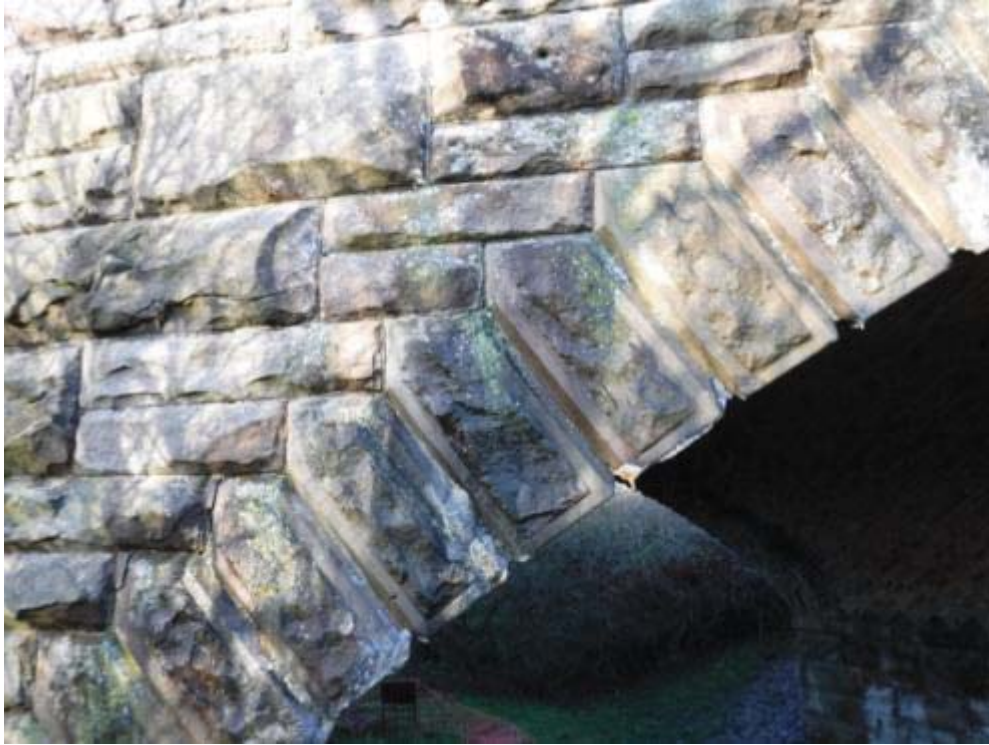
Photo No.19 - South arch ring face: Typical example of the condition.

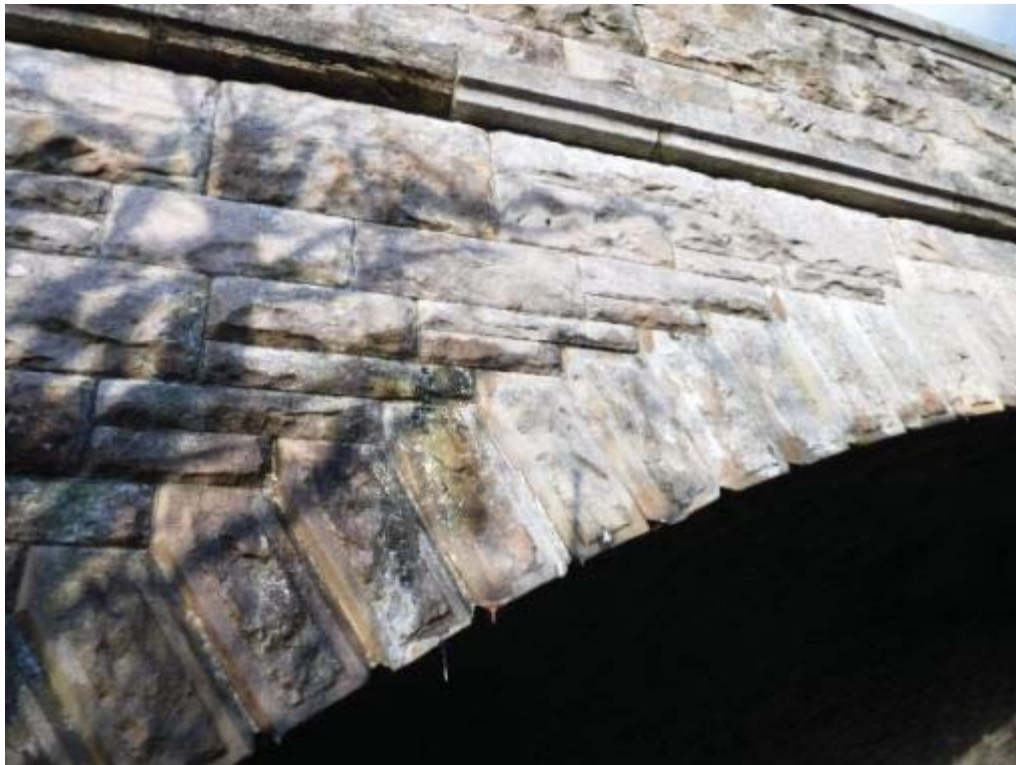
Photo No.20 - South arch ring face: Typical example of the condition.

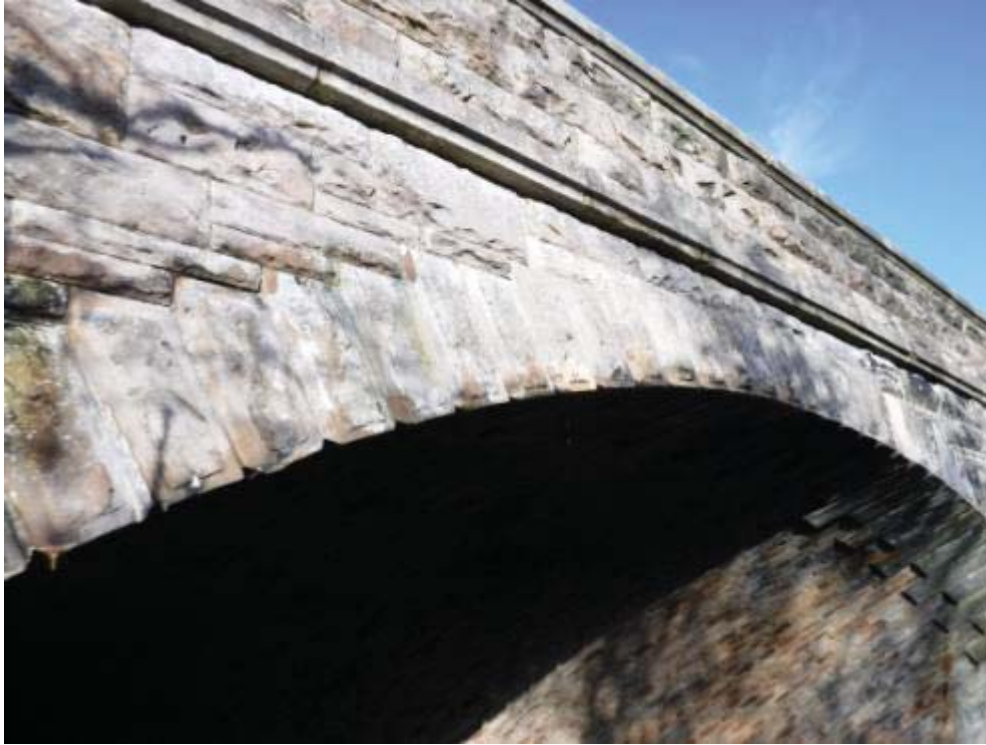
Photo No.21 - South arch ring face: Typical example of the condition.

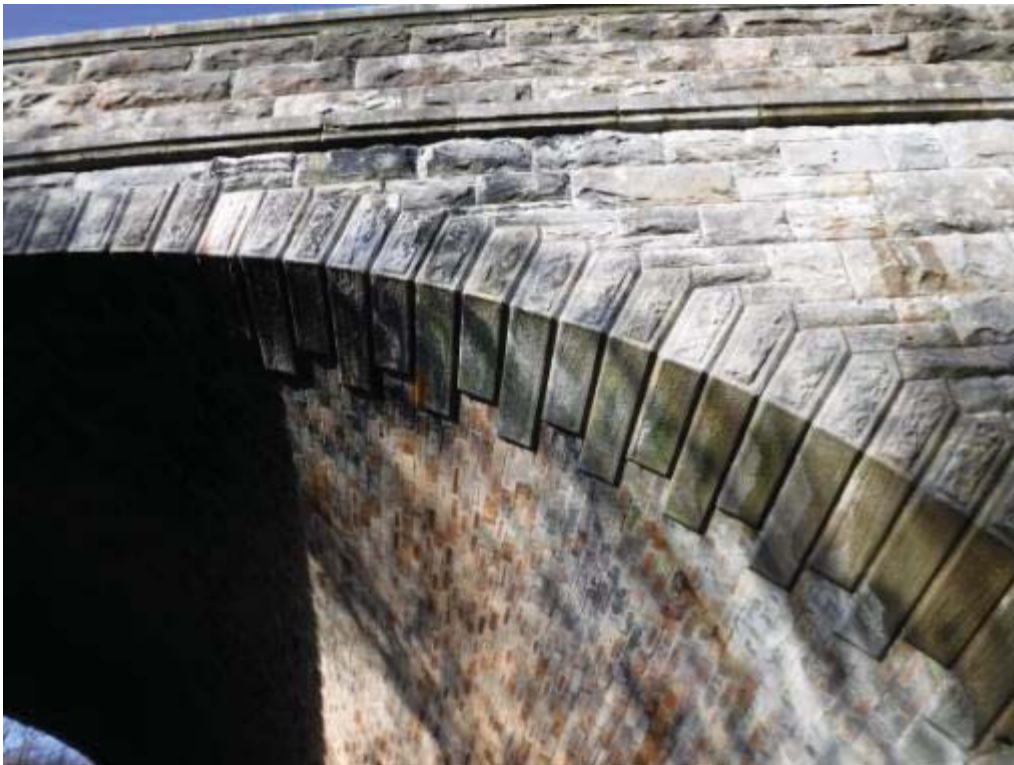
Photo No.22 - South arch ring face: Typical example of the condition.

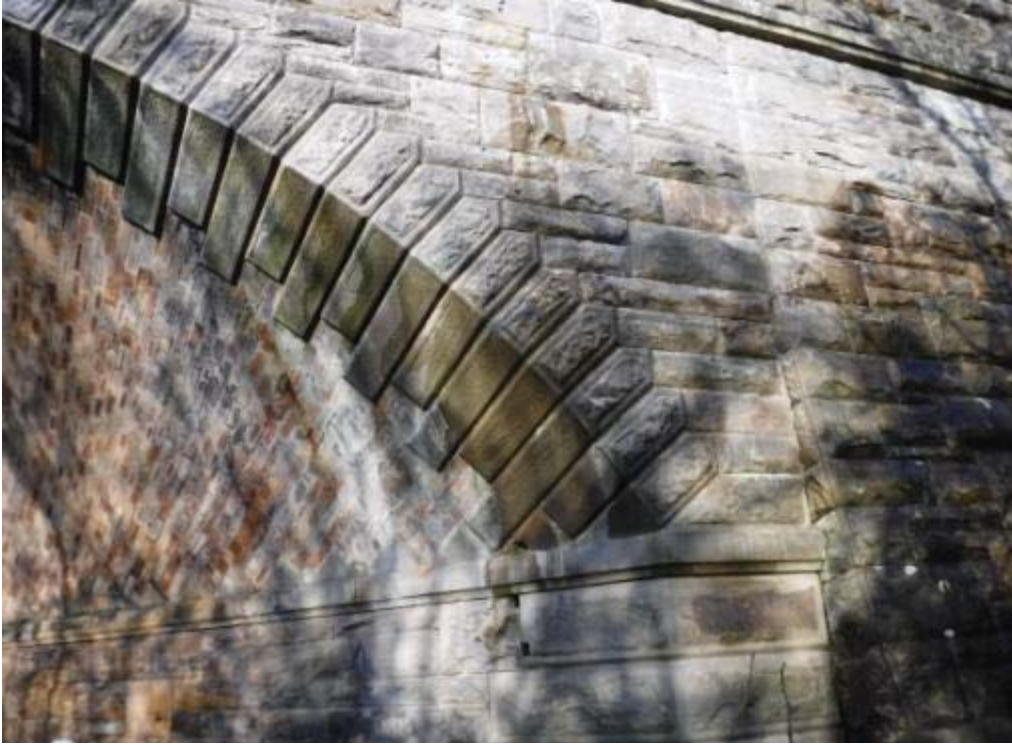
Photo No.23 - South arch ring face: Typical example of the condition.

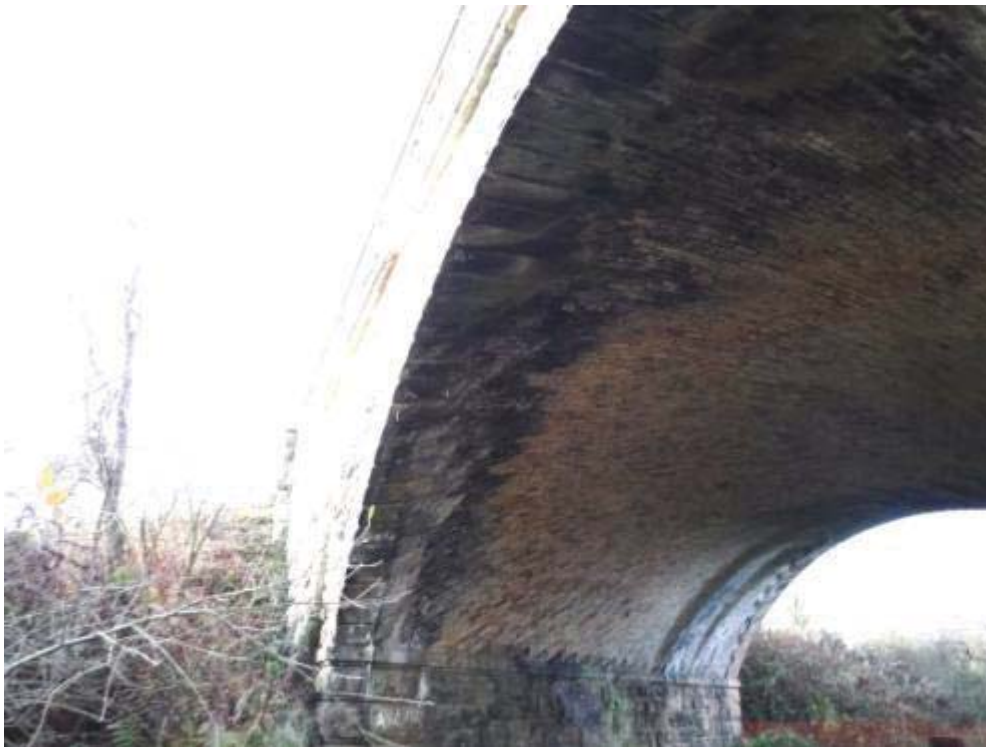
Photo No.24 - South arch ring face: Typical example of the condition of the underside.

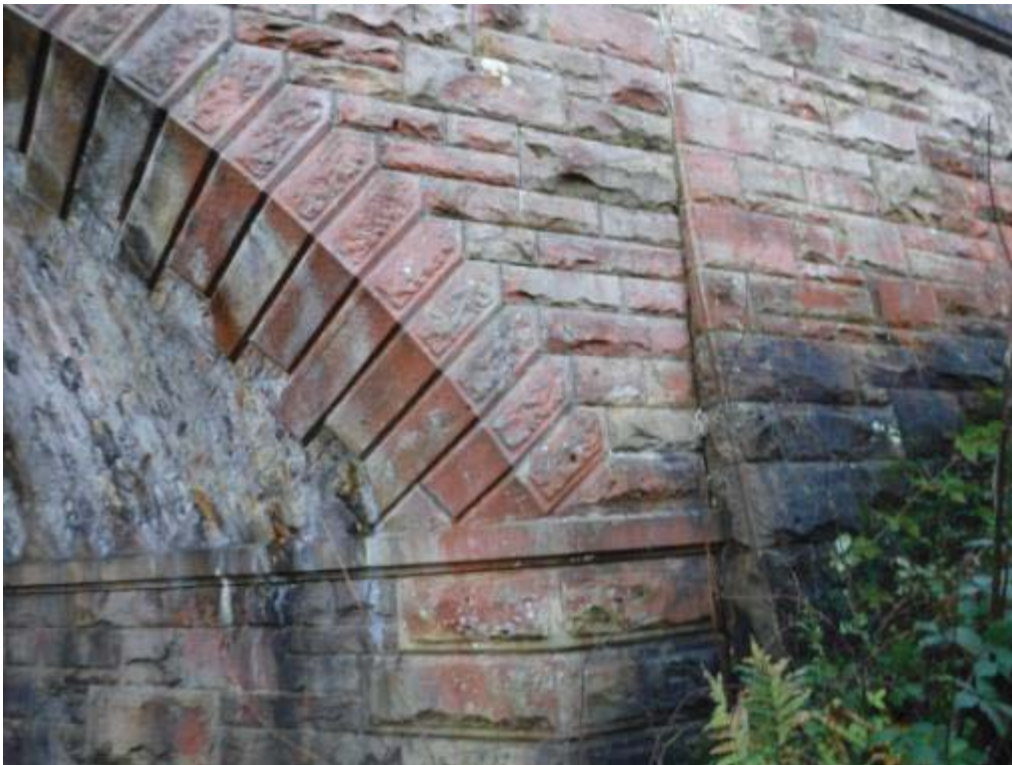
Photo No.26 - North arch ring face: Typical example of the condition.

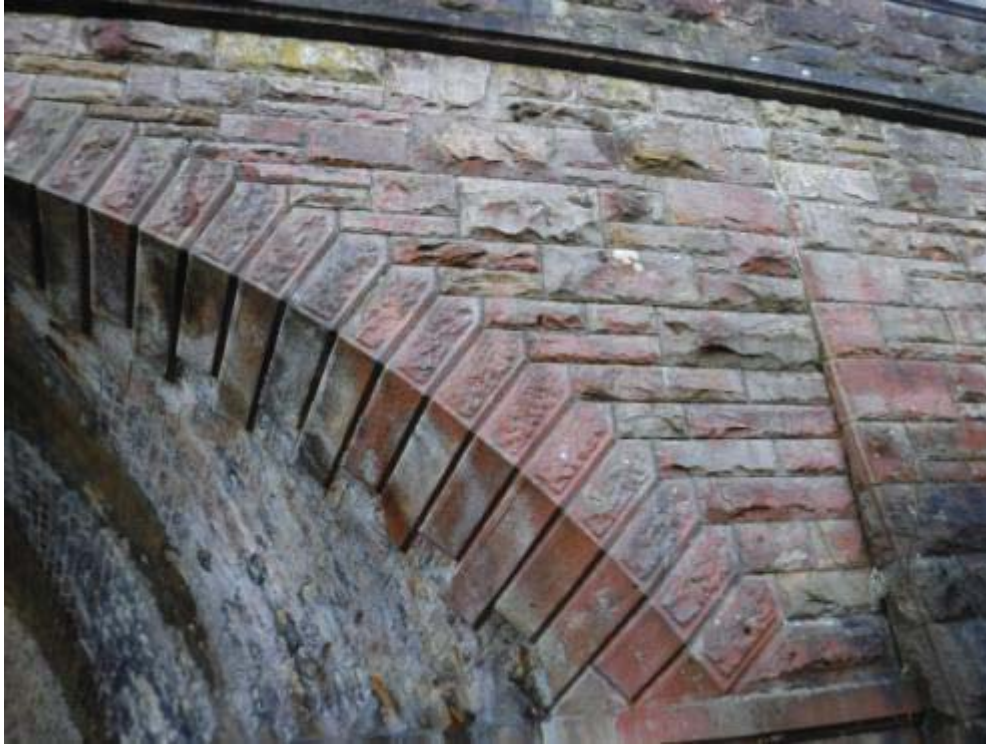
Photo No.27 - North arch ring face: Typical example of the condition.

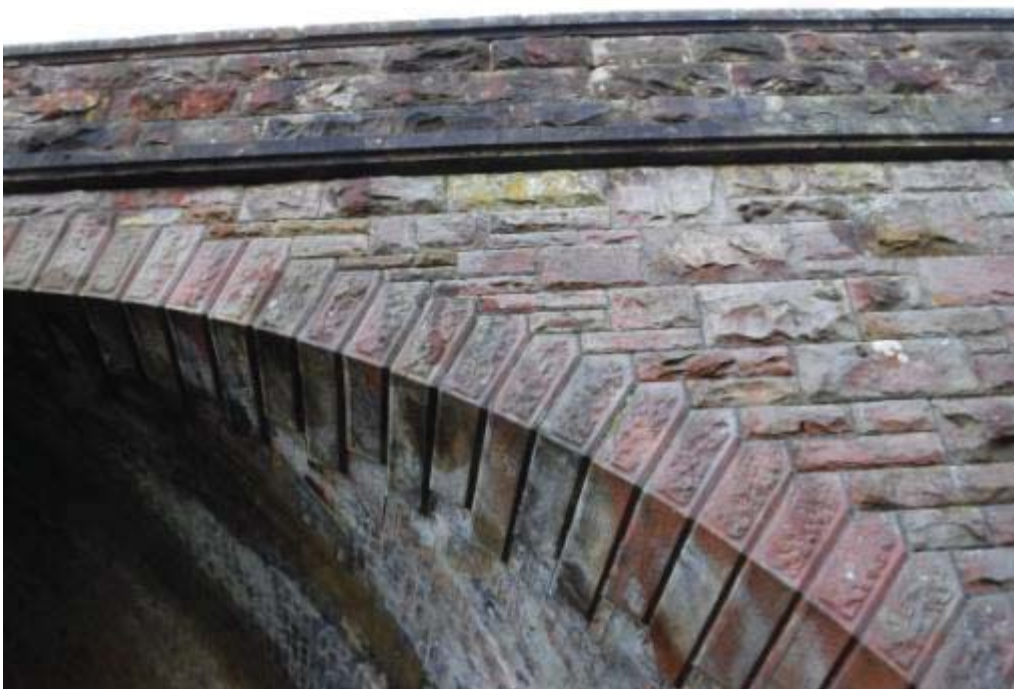
Photo No.28 - North arch ring face: Typical example of the condition.

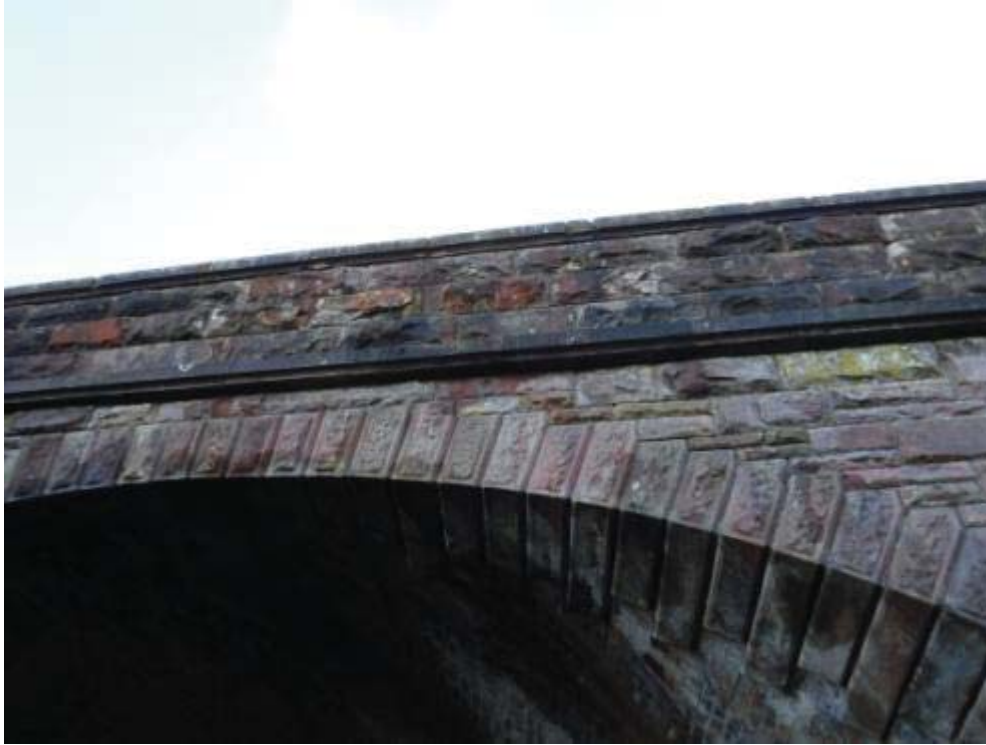
Photo No.29 - North arch ring face: Typical example of the condition.

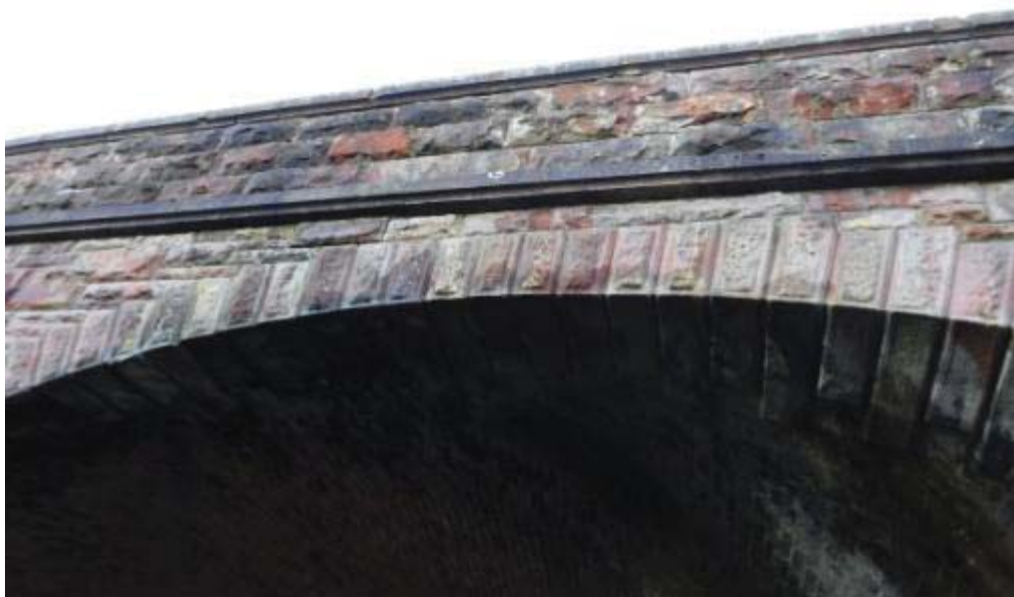
Photo No.30 - North arch ring face: Typical example of the condition.

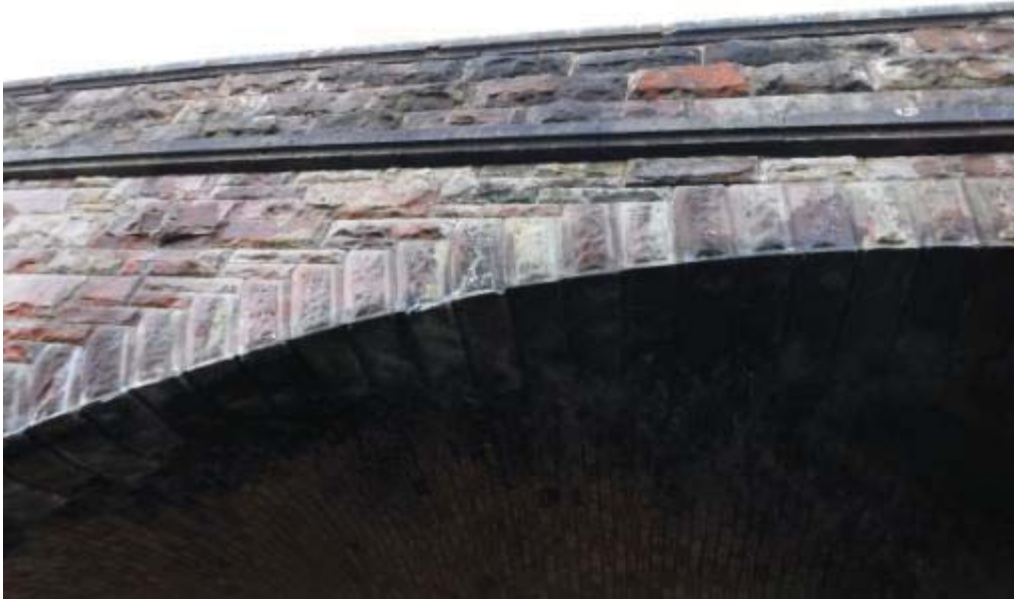
Photo No.31 - North arch ring face: Typical example of the condition.

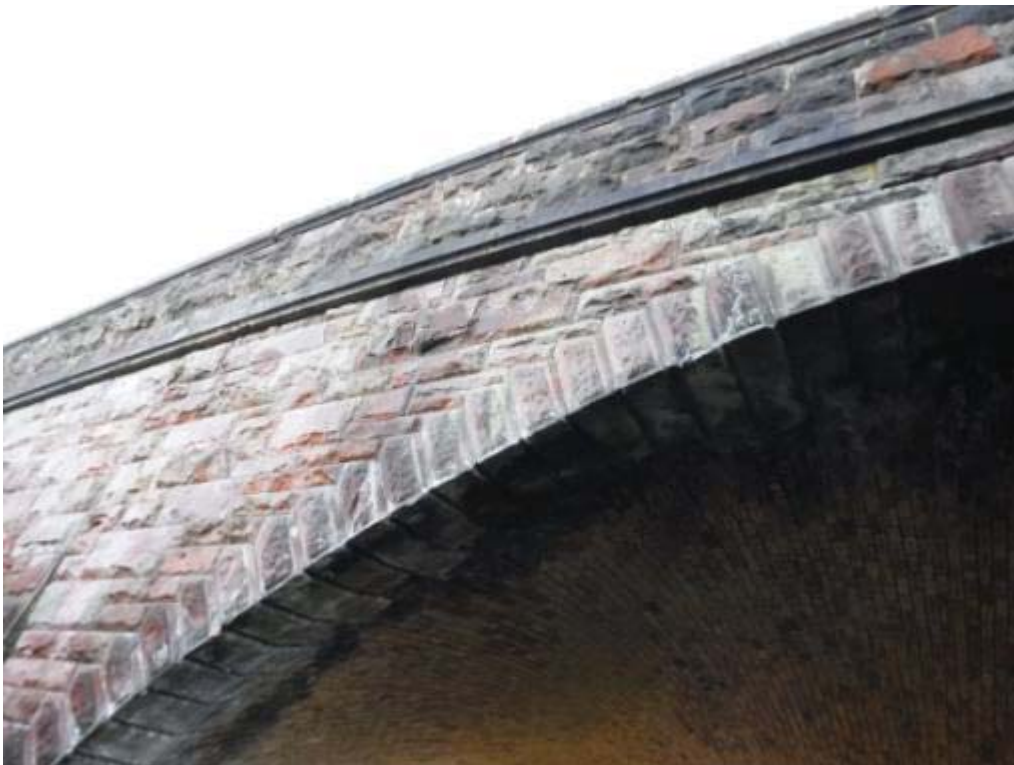
Photo No.32 - North arch ring face: Typical example of the condition.

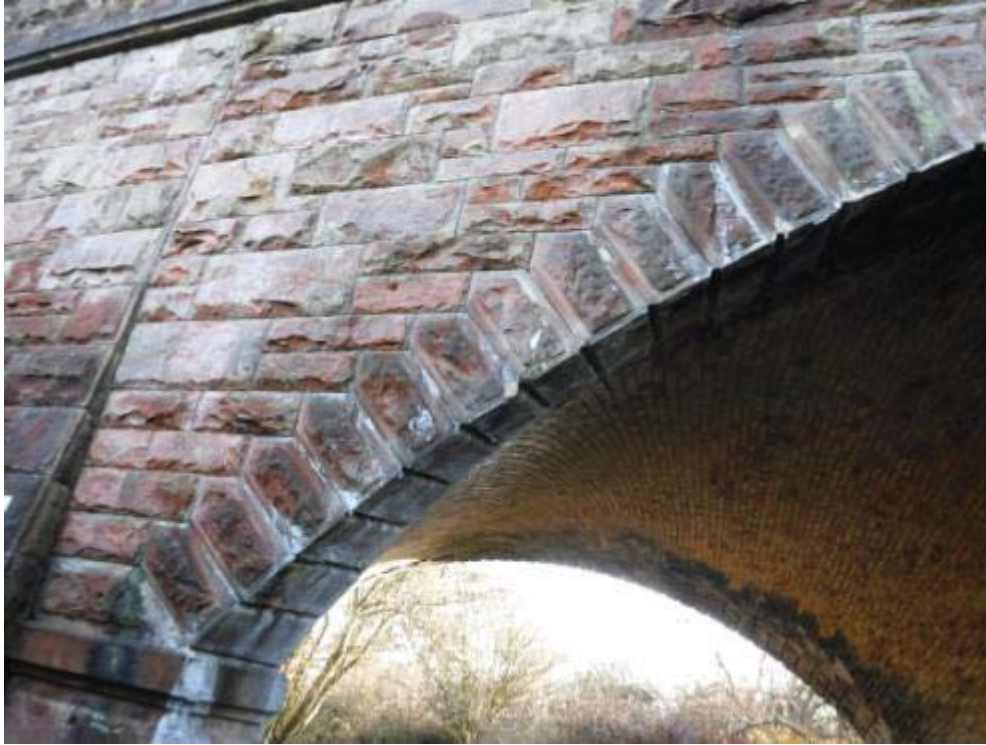
Photo No.33 - North arch ring face: Typical example of the condition.

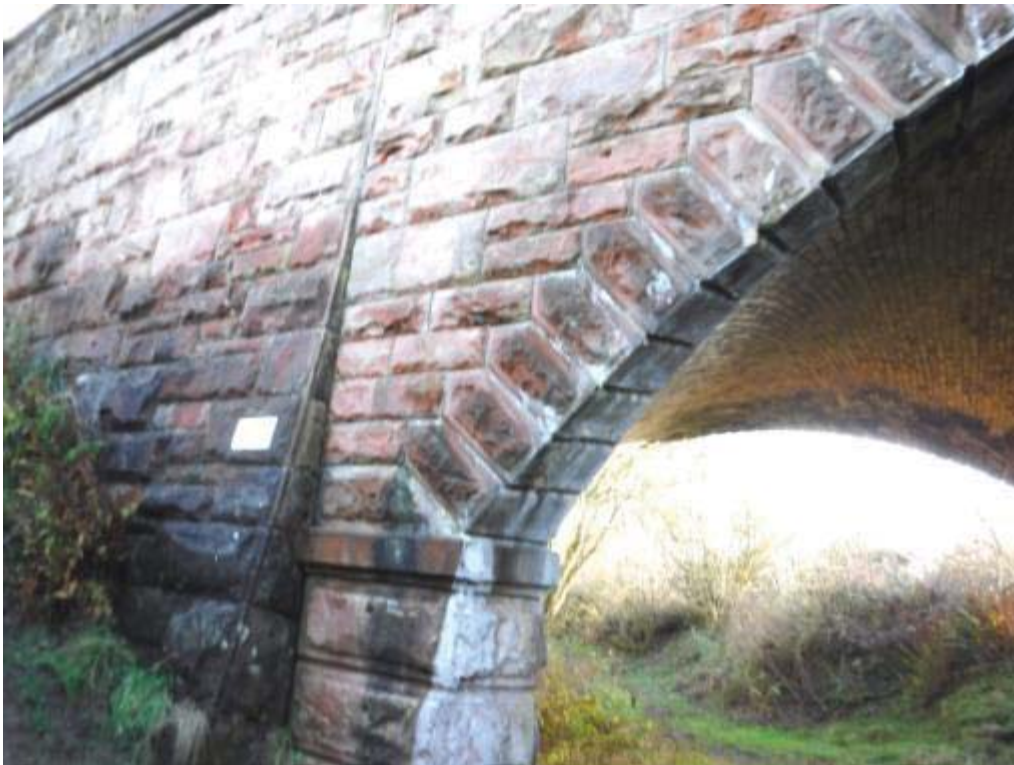
Photo No.34 - North arch ring face: Typical example of the condition.

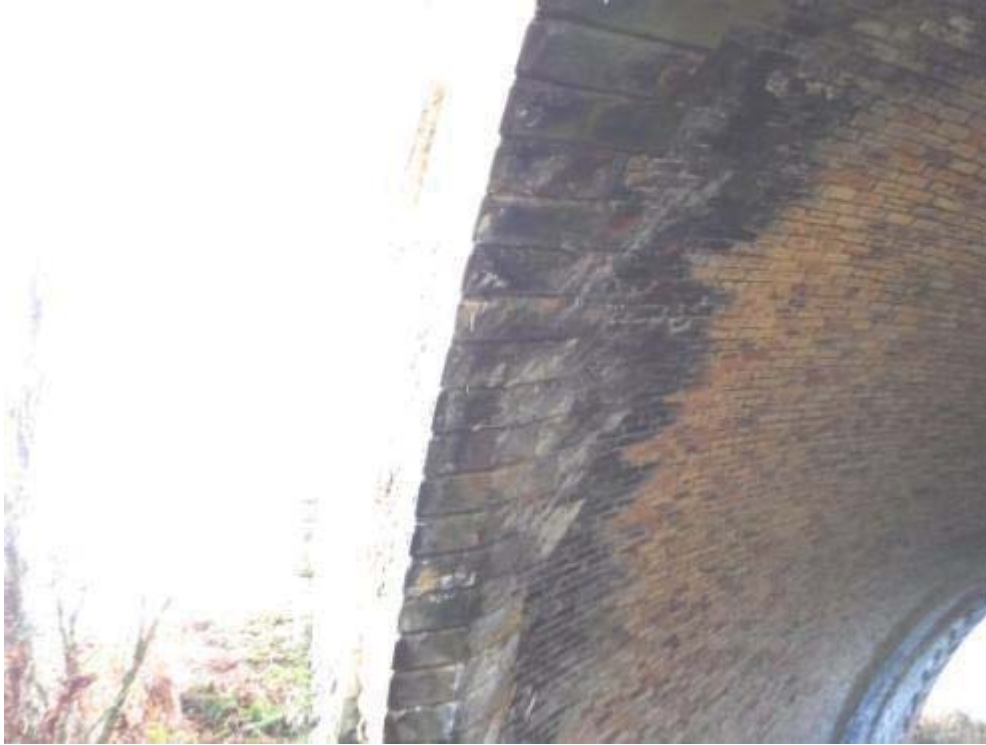
Photo No.35 - North arch ring face: Typical example of the condition of the underside.

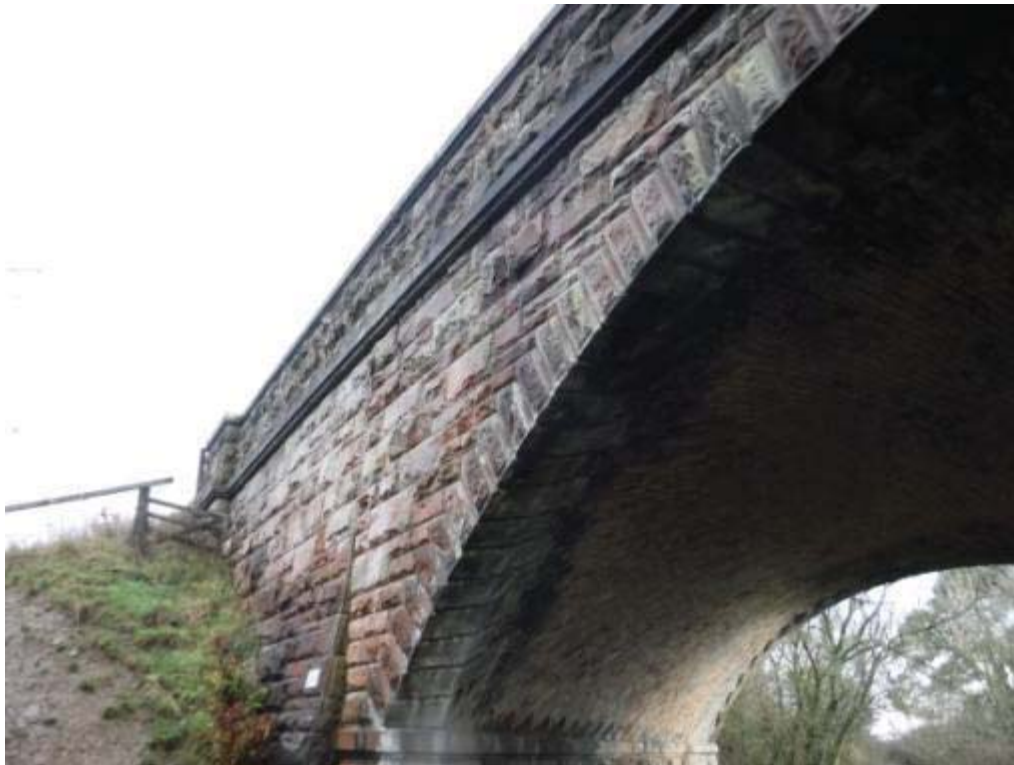
Photo No.36 - North spandrel: N/E view.
