Historical Railways Estate

Structure Reference

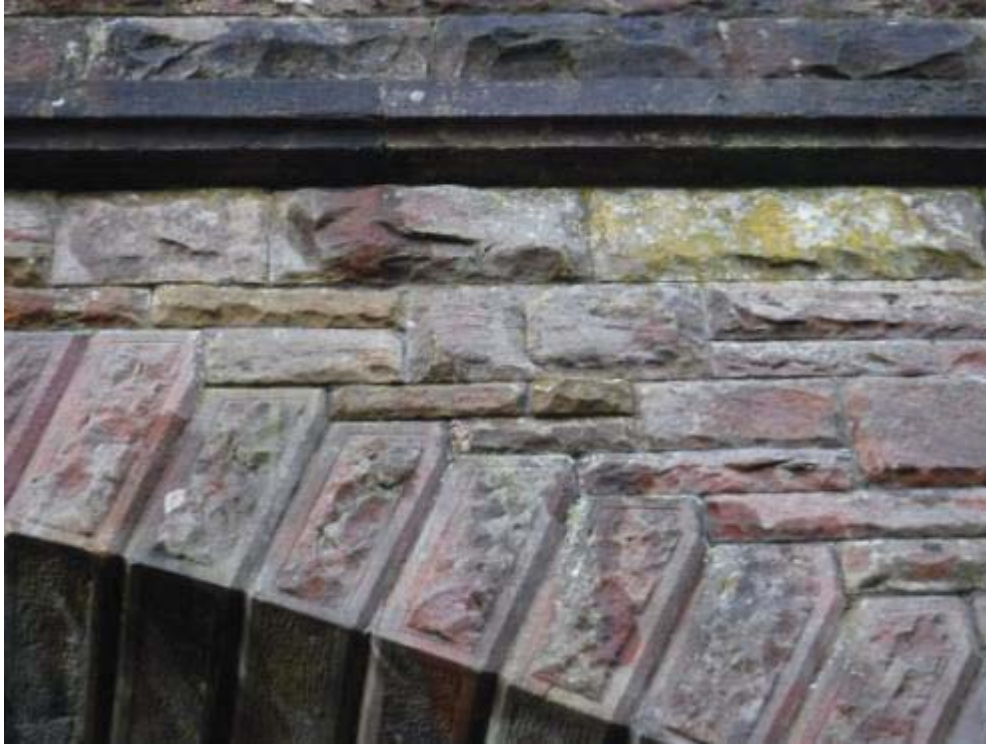
Photo No.39 - North spandrel: Previous stonework repairs at the N/W elevation.

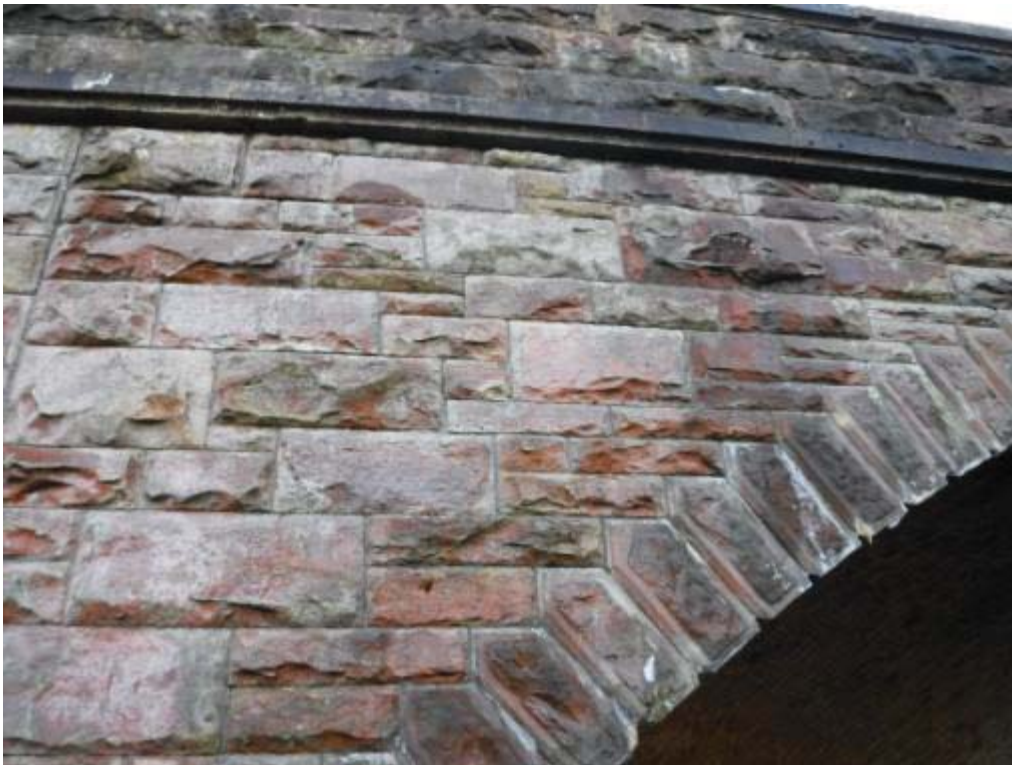
Photo No.40 - North spandrel: Typical example of the condition.

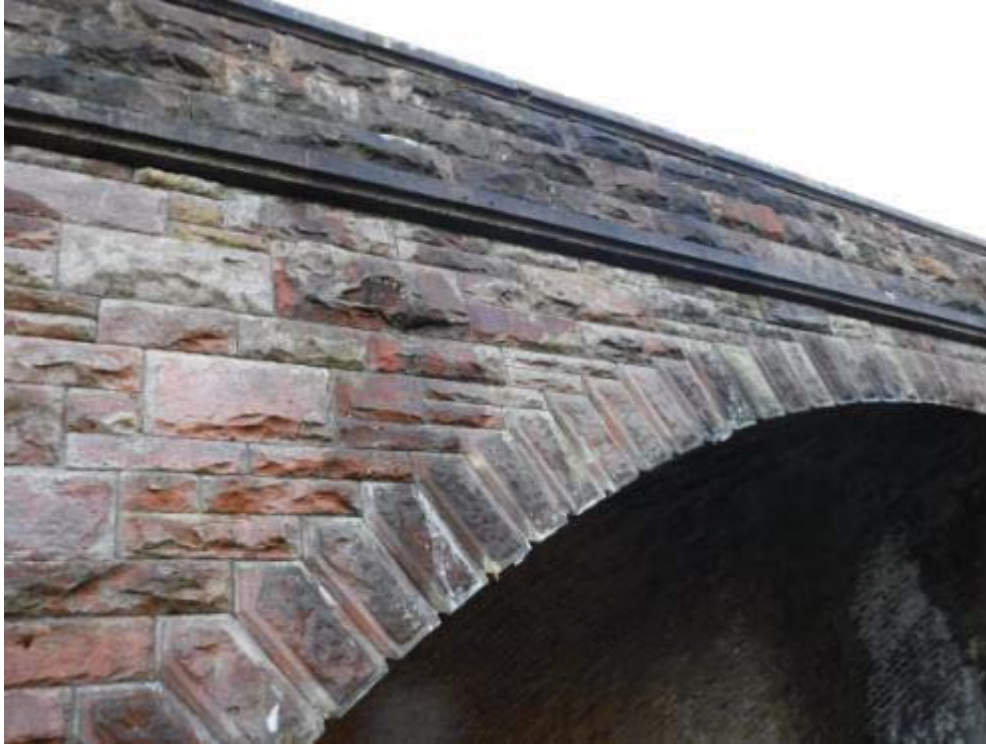
Photo No.41 - North spandrel: Typical example of the condition.

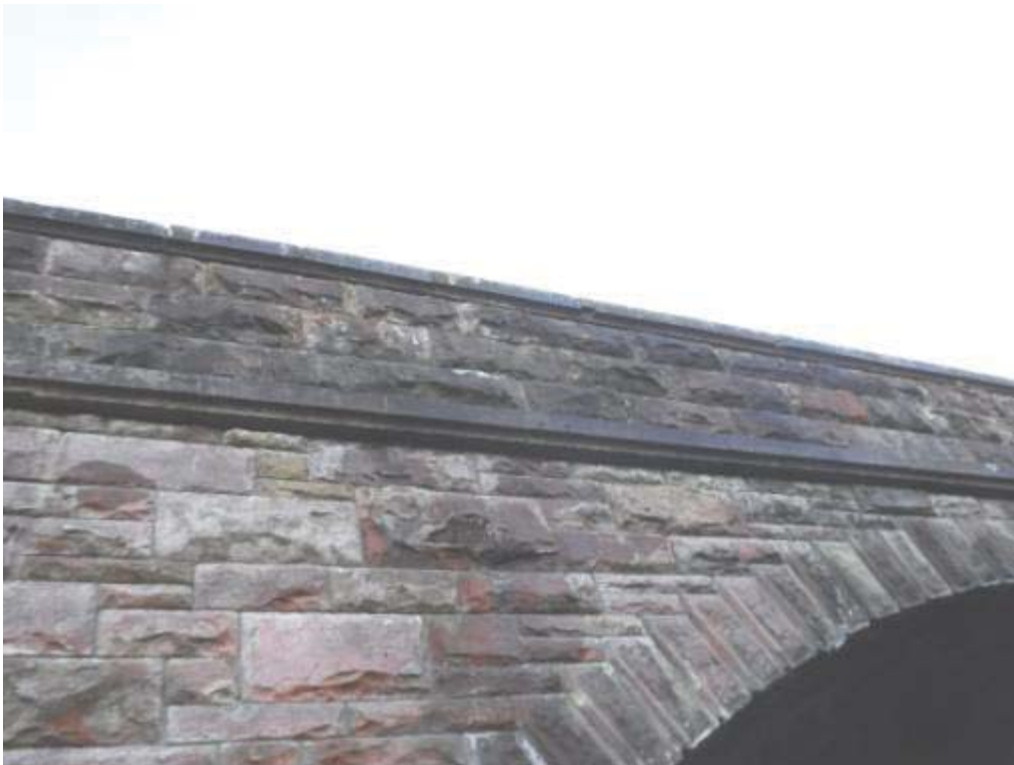
Photo No.42 - North spandrel: Typical example of the condition.

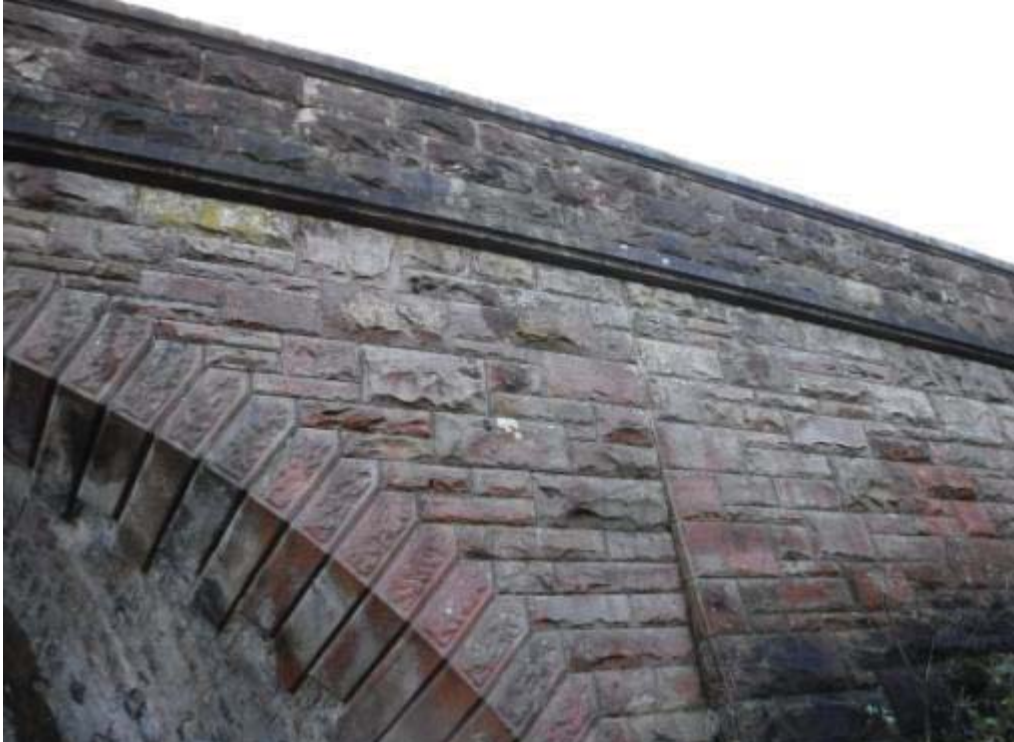
Photo No.43 - North spandrel: Typical example of the condition.

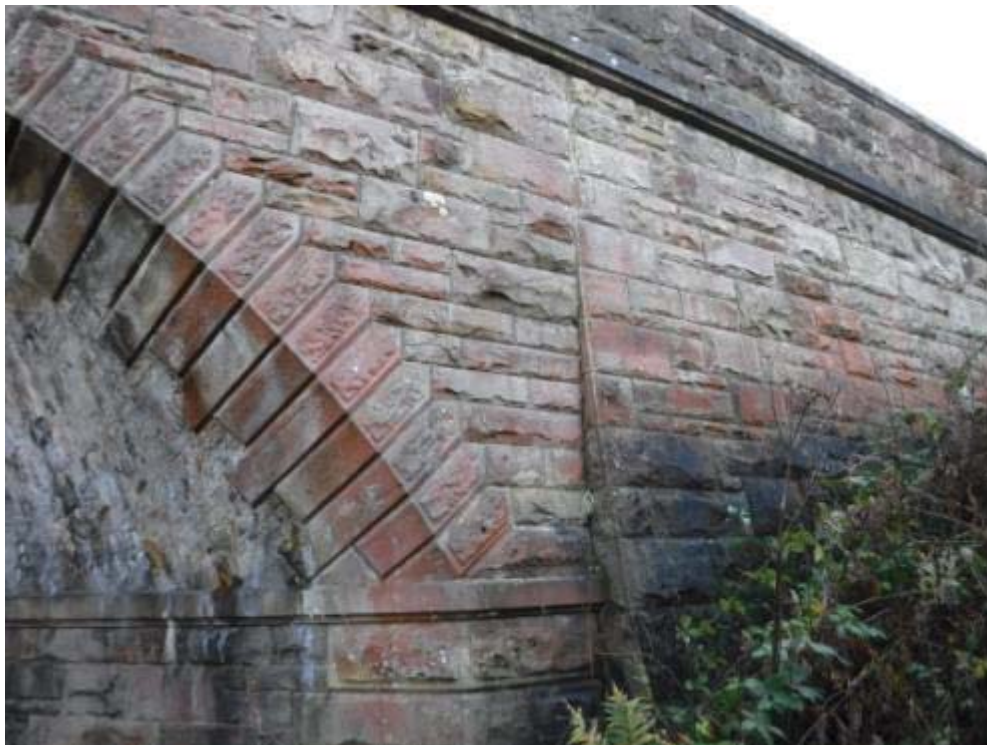
Photo No.44 - North spandrel: Typical example of the condition.

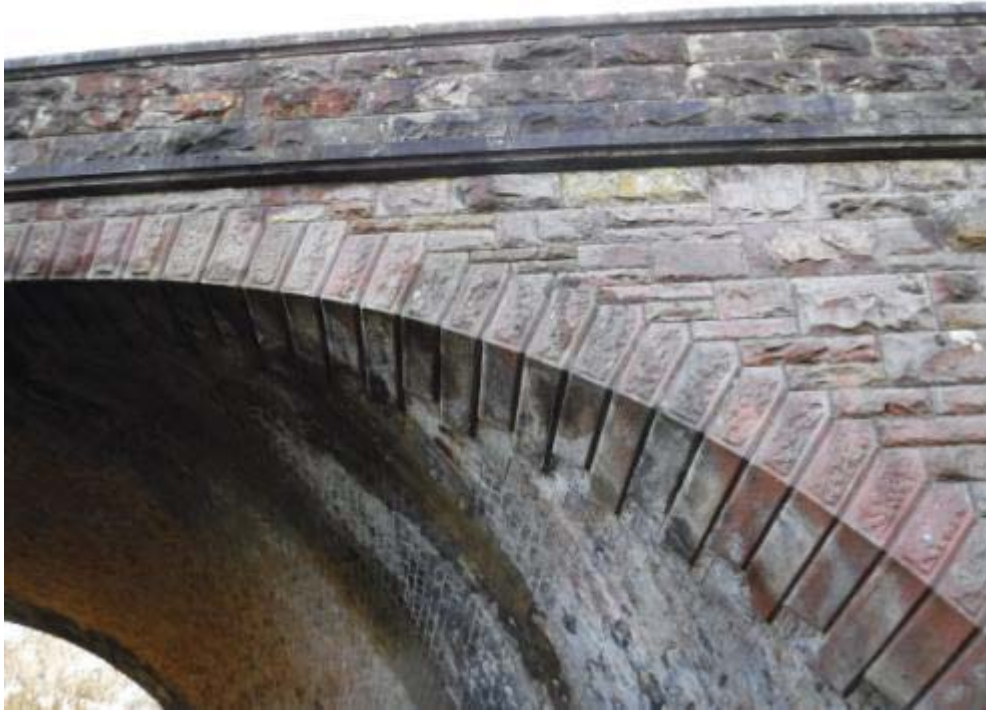
Photo No.45 - North spandrel: Typical example of the condition.

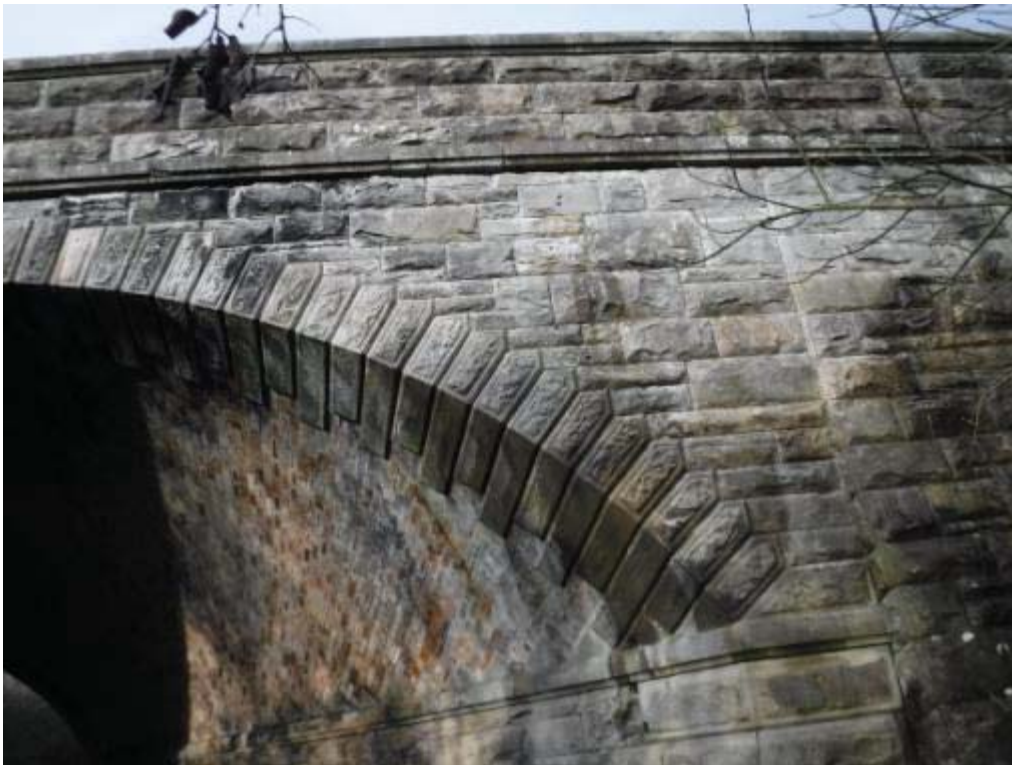
Photo No.46 - South spandrel: S/E view.

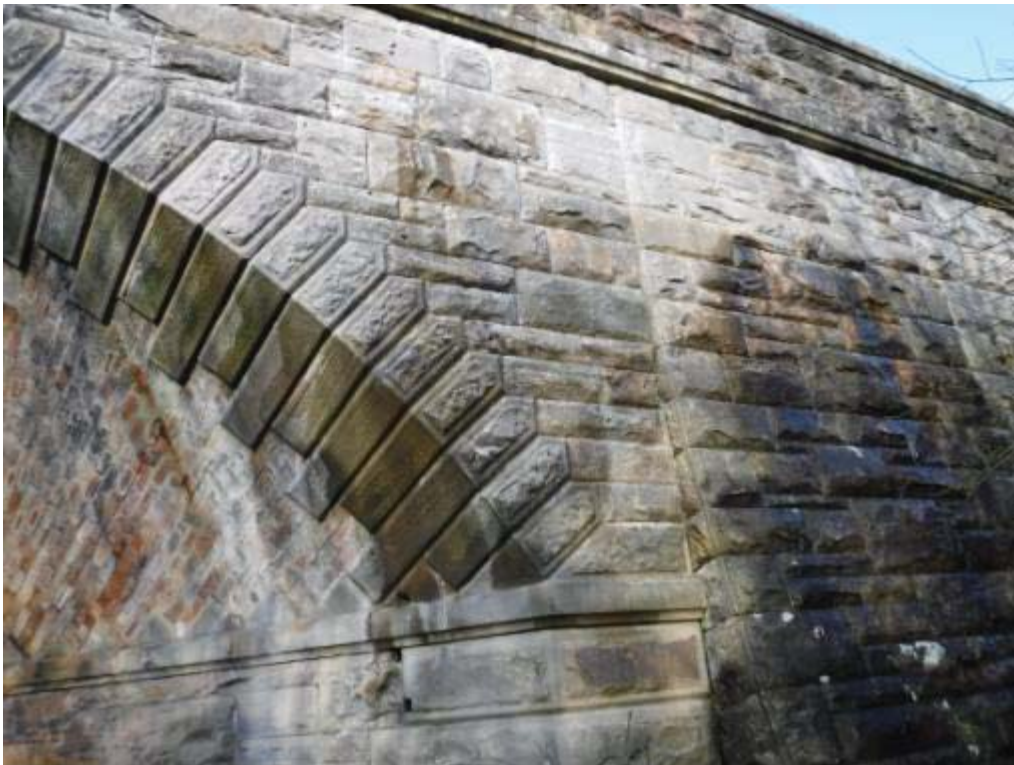
Photo No.48 - South spandrel: Typical example of the condition.

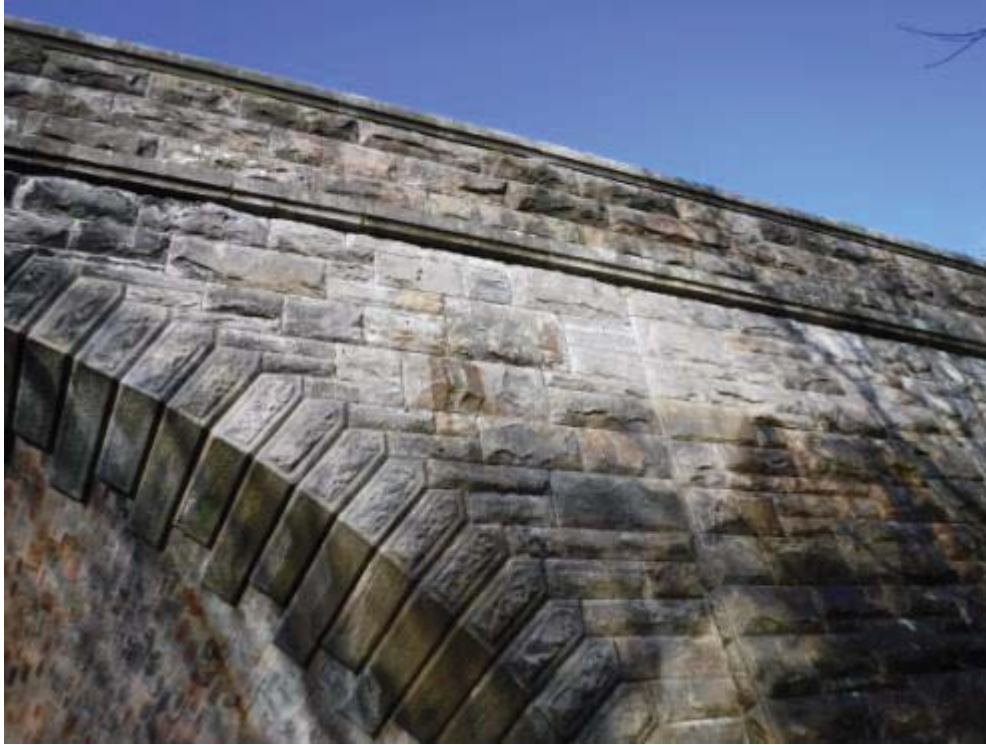
Photo No.49 - South spandrel: Typical example of the condition.

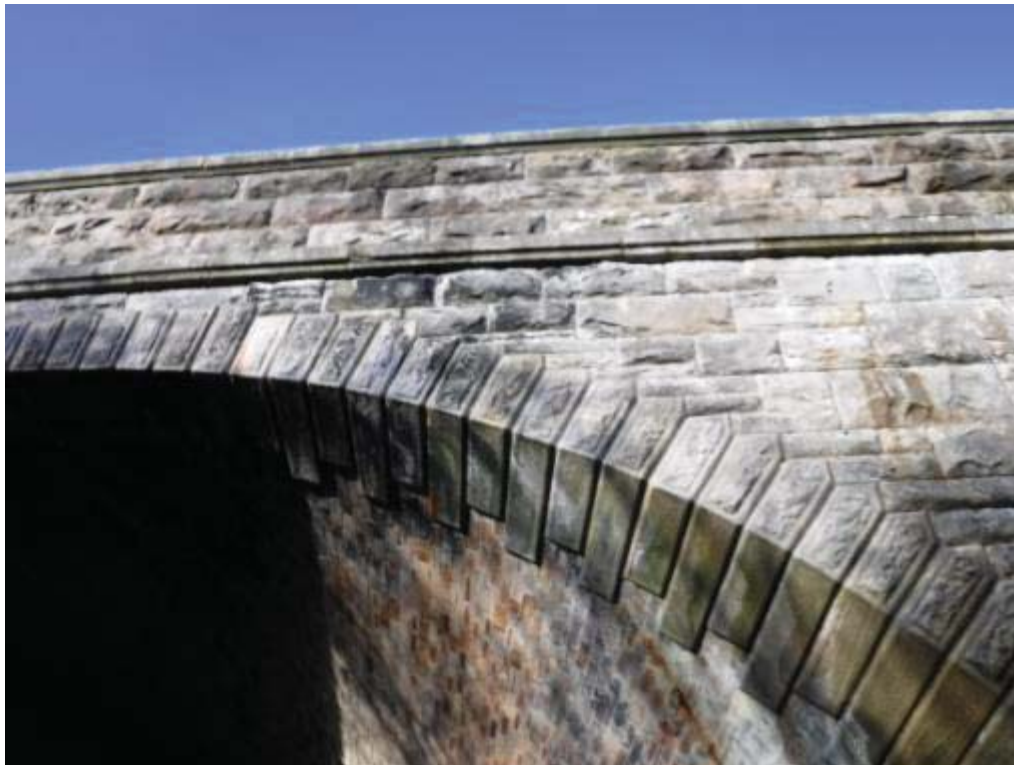
Photo No.50 - South spandrel: Typical example of the condition.

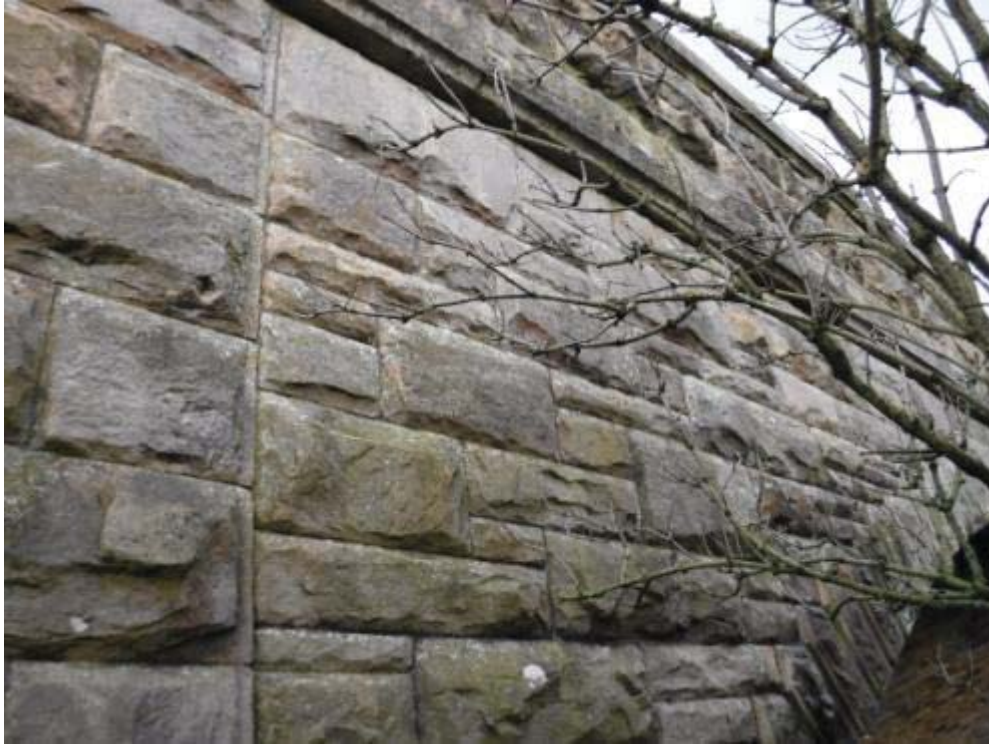
Photo No.51 - South spandrel: Typical example of the condition.

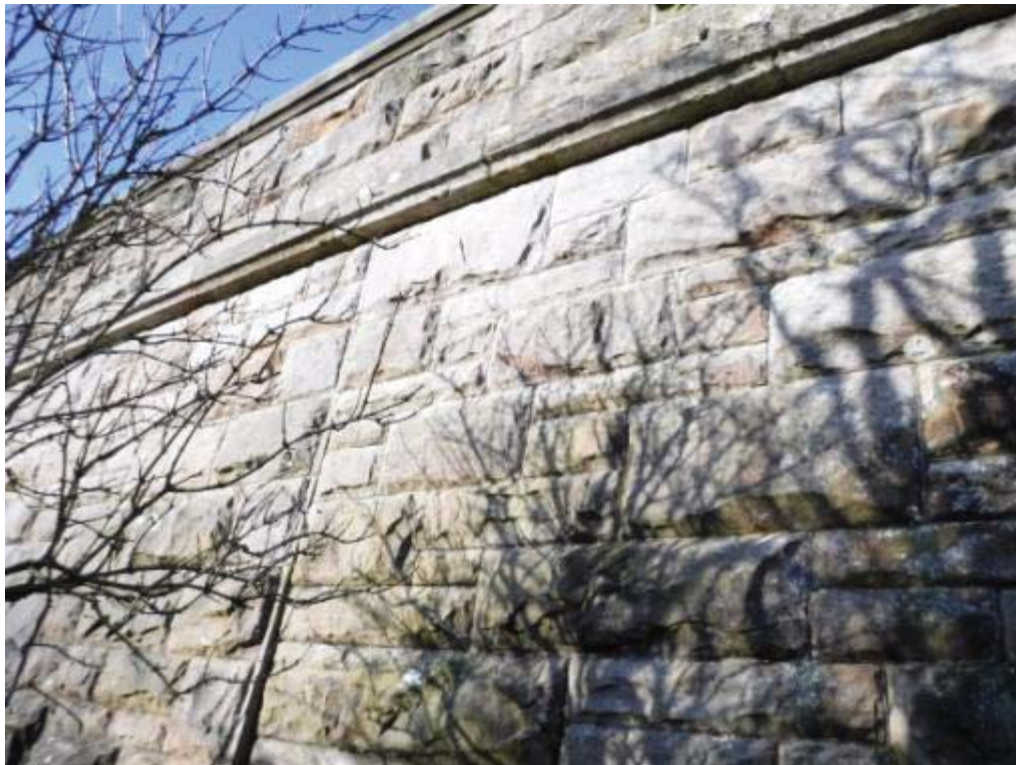
Photo No.52 - South spandrel: Typical example of the condition.

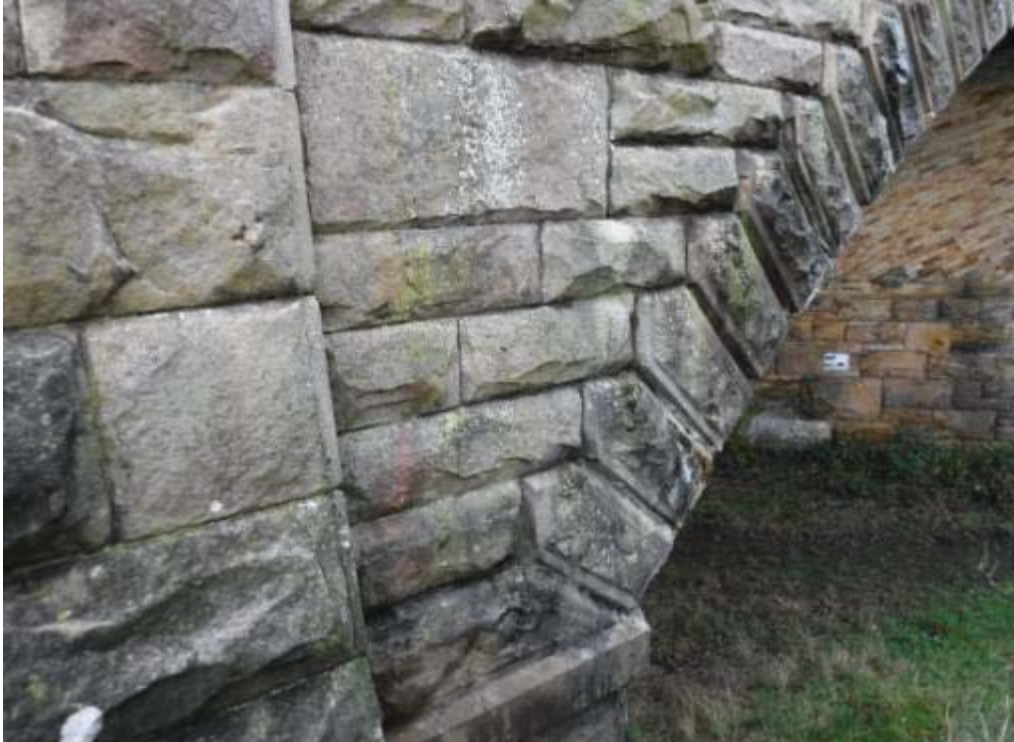
Photo No.53 - South spandrel: Typical example of the condition.

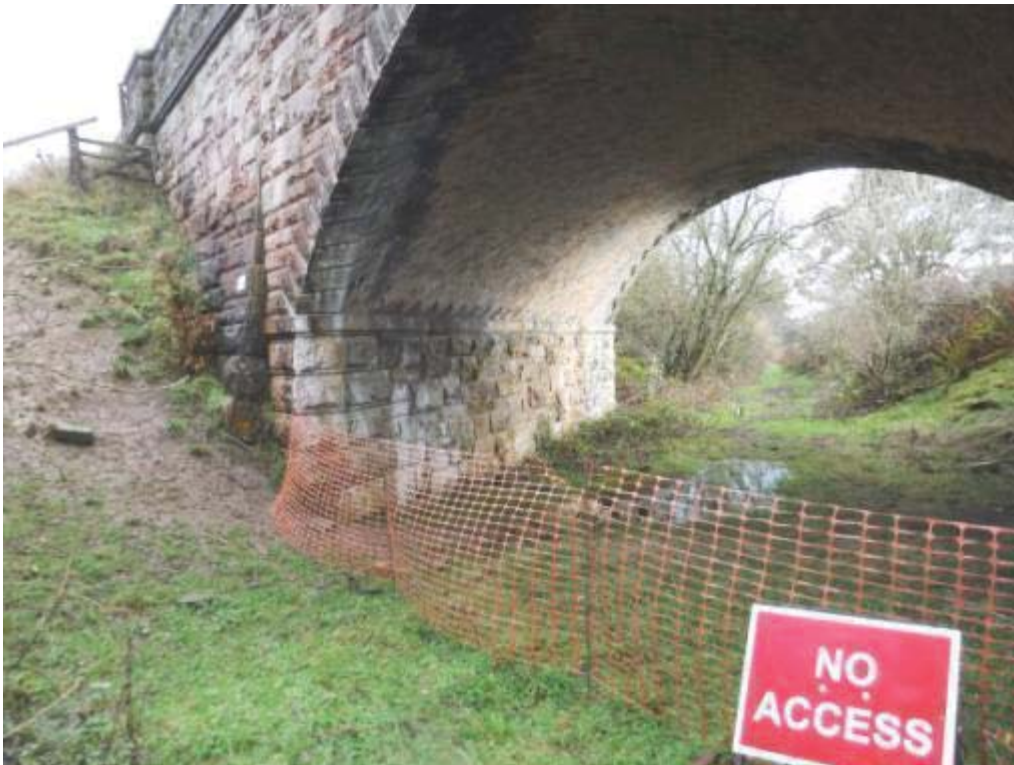
Photo No.54 - East abutment: View.

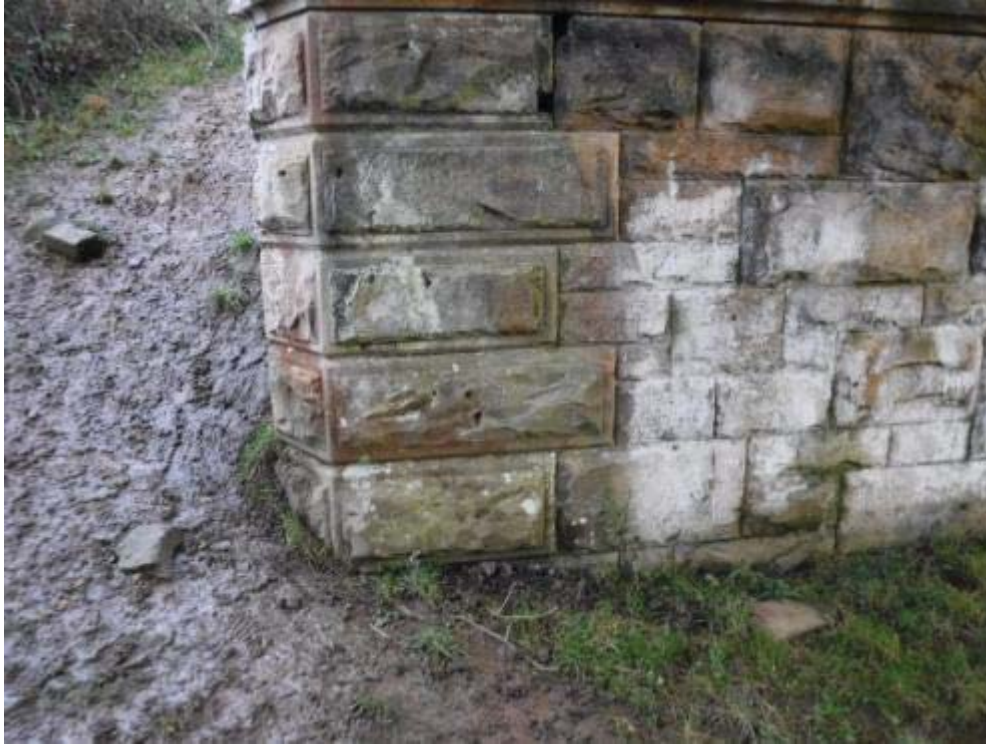
Photo No.57 - East abutment: Typical example of the condition.

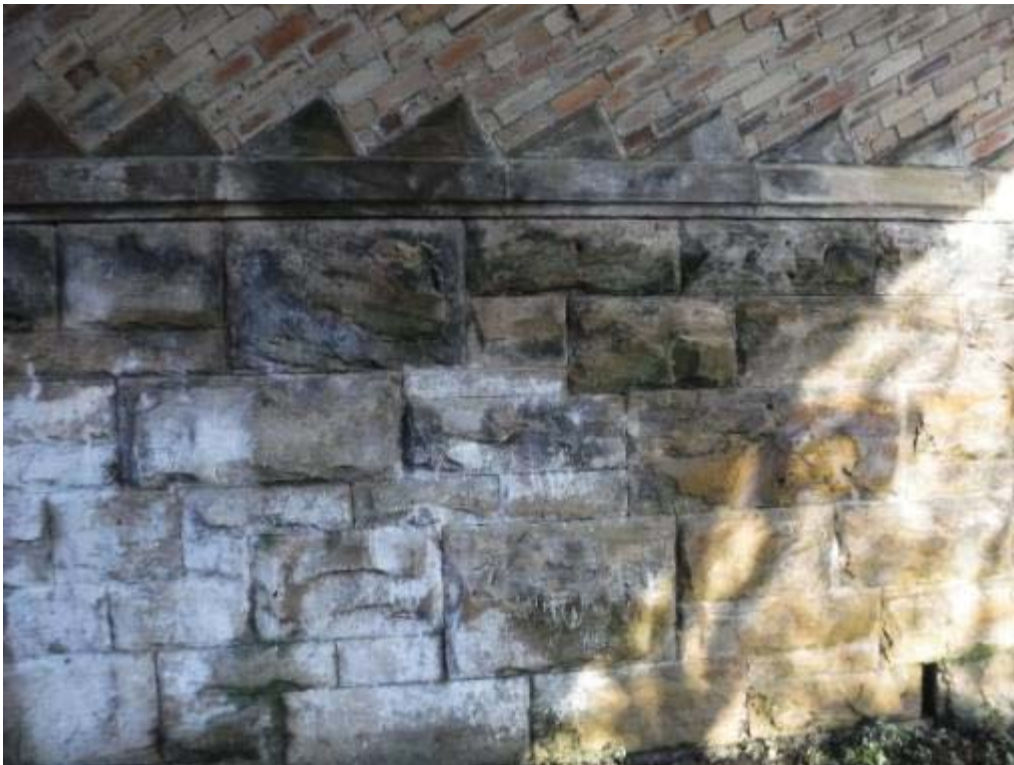
Photo No.58 - East abutment: Typical example of the condition.

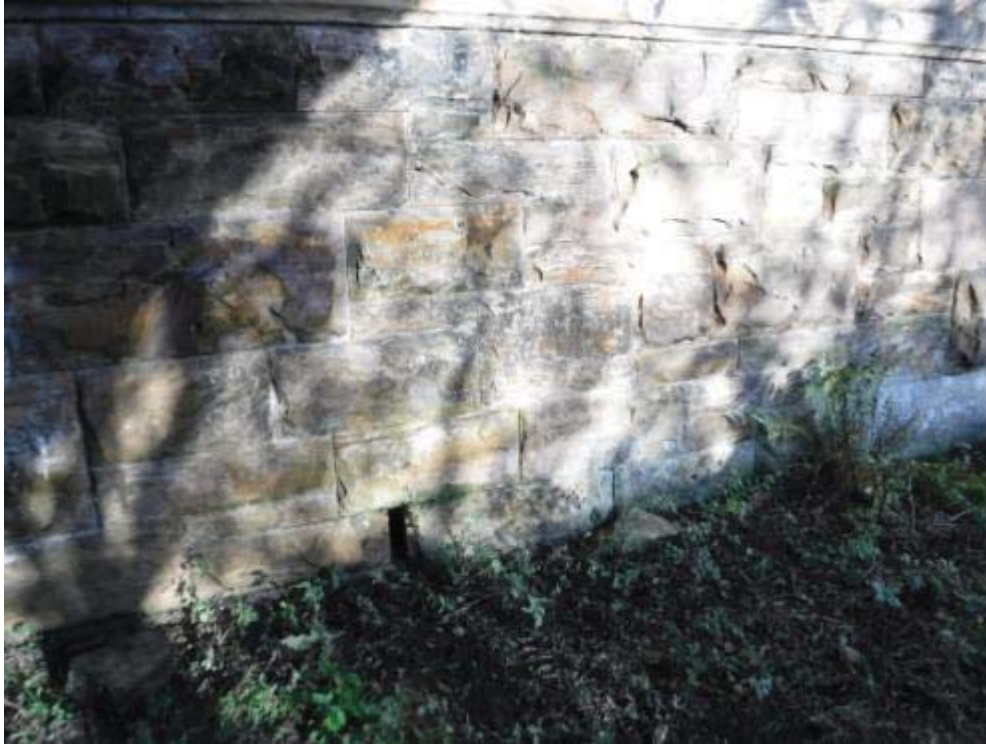
Photo No.59 - East abutment: Typical example of the condition.

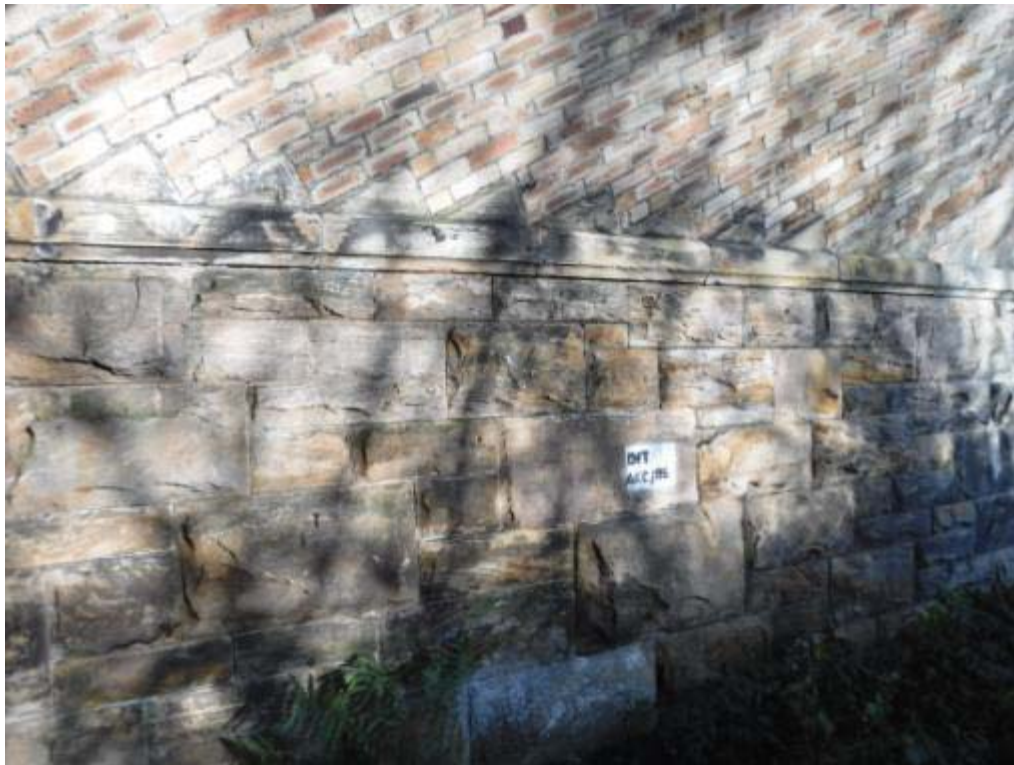
Photo No.60 - East abutment: Typical example of the condition.

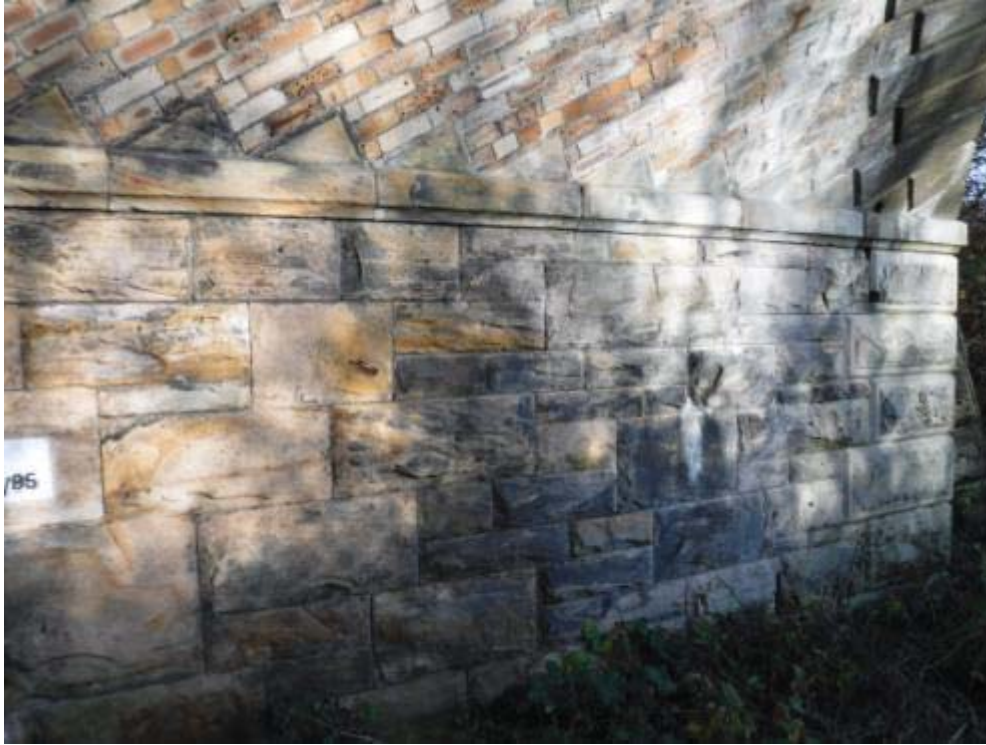
Photo No.61 - East abutment: Typical example of the condition.

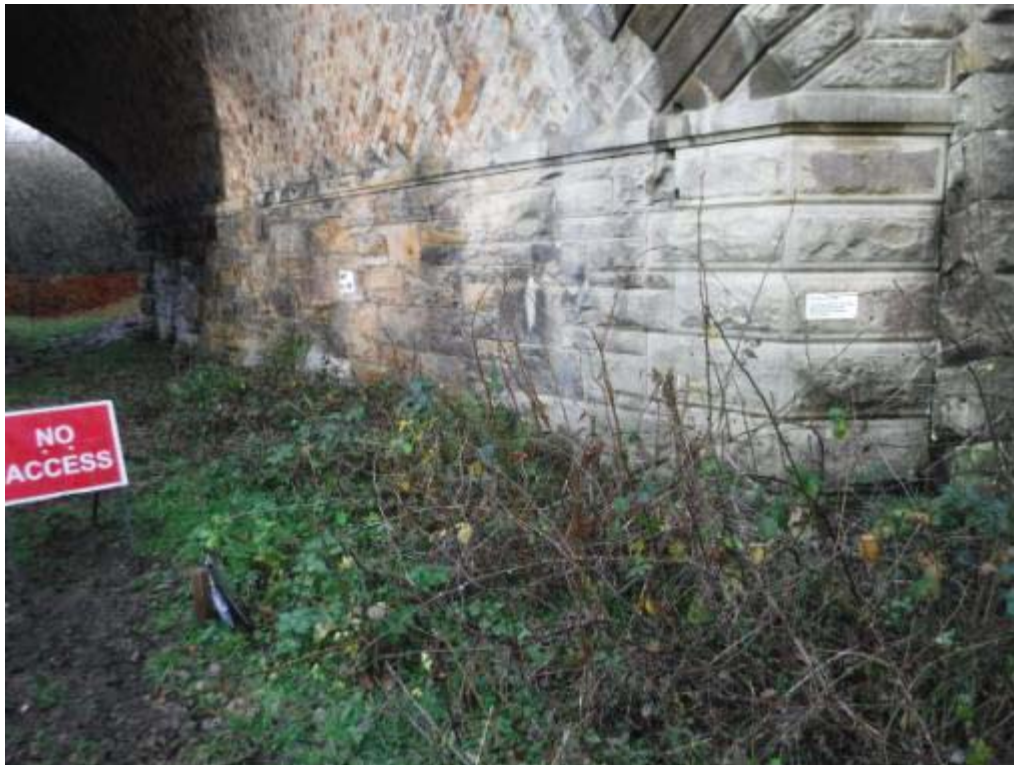
Photo No.62 - East abutment: Typical example of the condition.

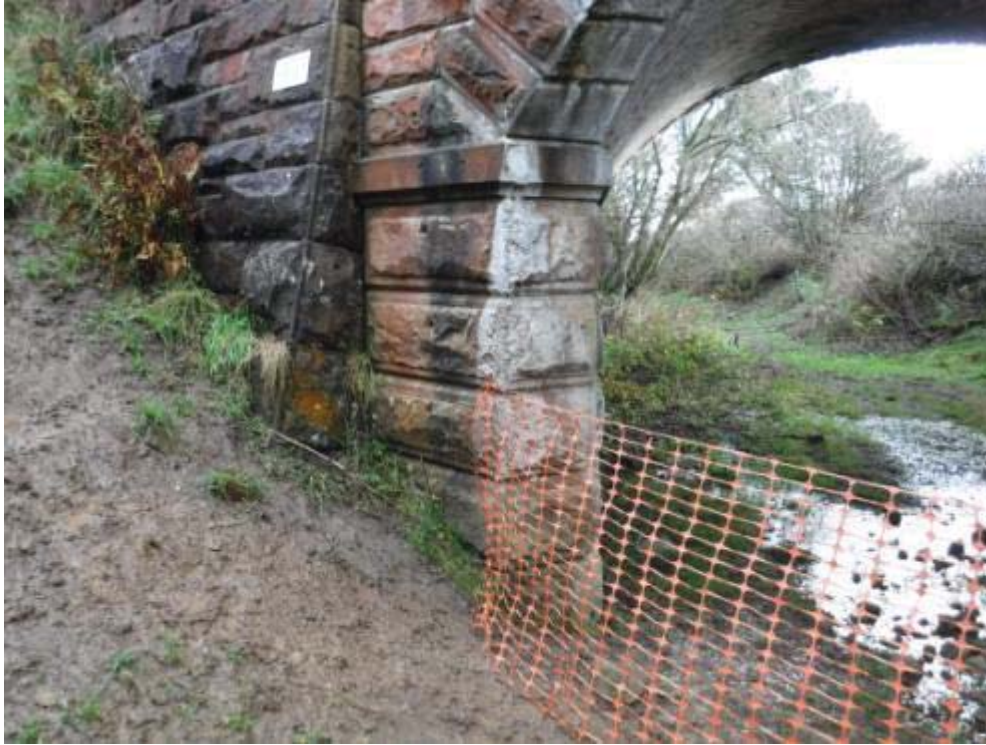
Photo No.63 - East abutment: Typical example of the condition at the N/E return section.

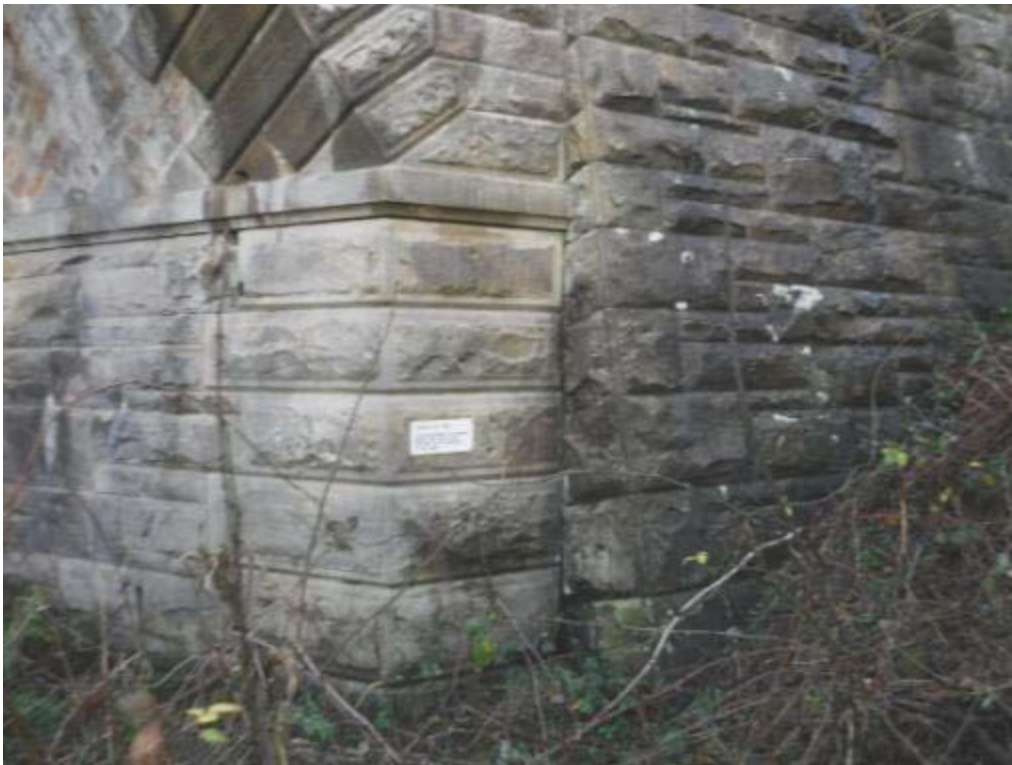
Photo No.64 - East abutment: Typical example of the condition at the S/E return section.

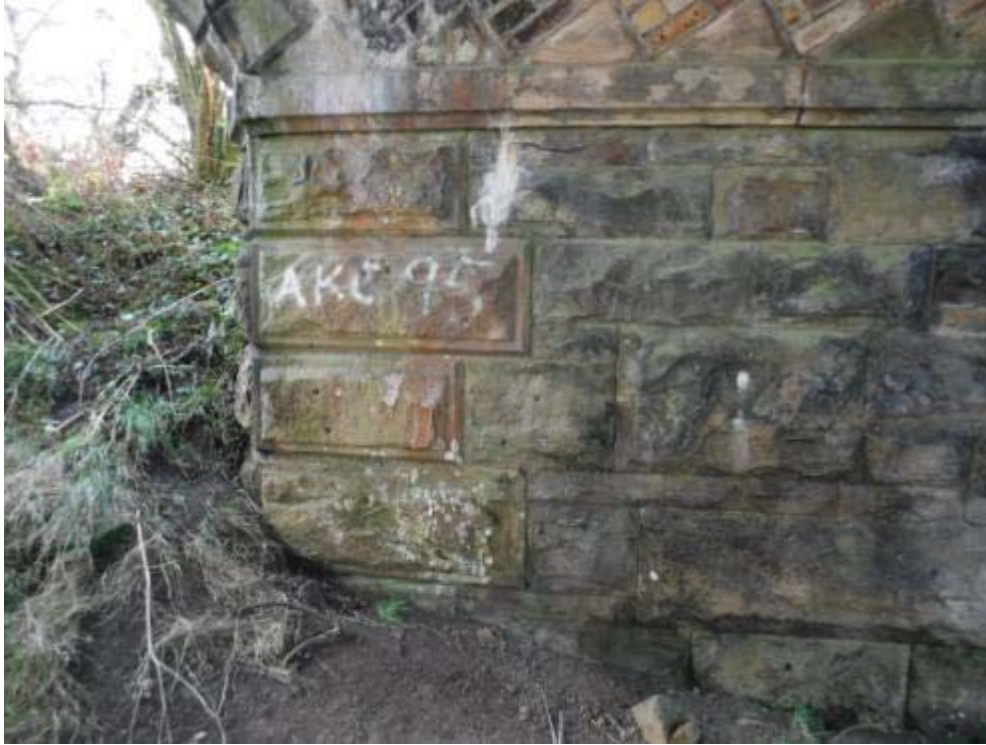
Photo No.67 - West abutment: Typical example of the condition.

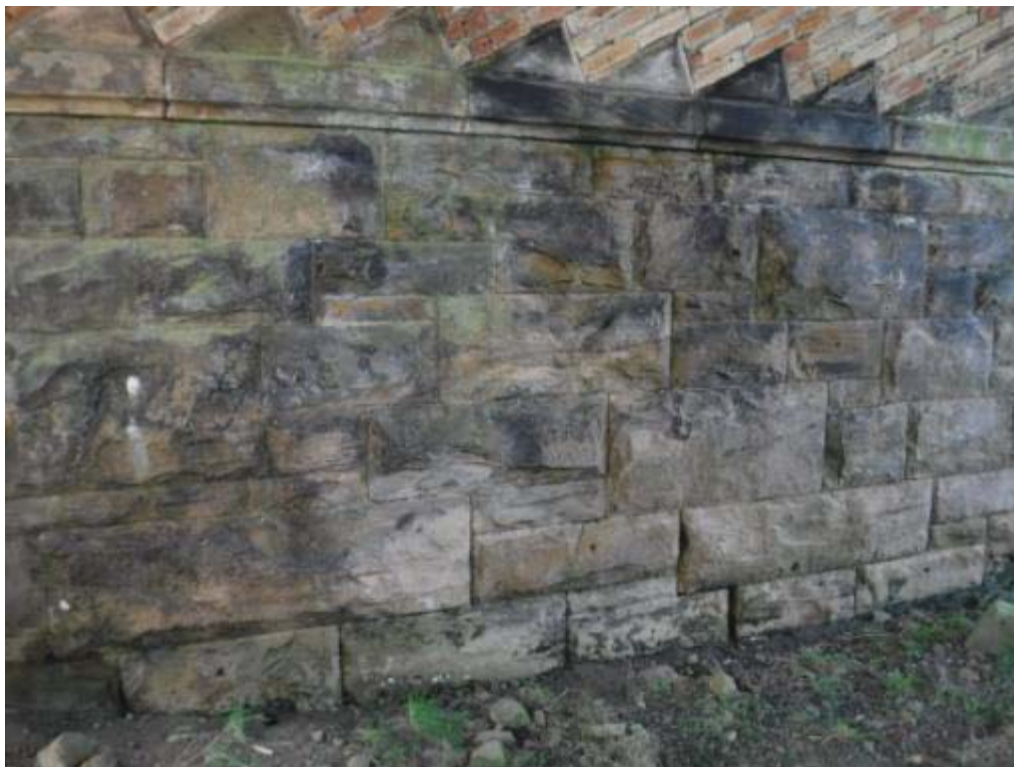
Photo No.68 - West abutment: Typical example of the condition.

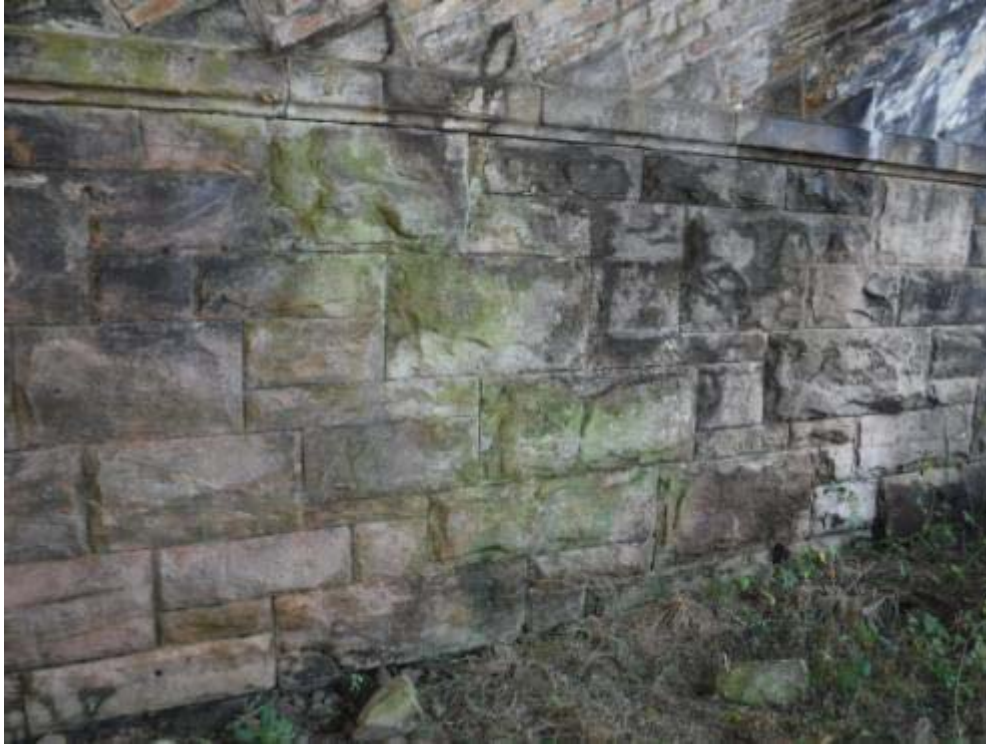
Photo No.69 - West abutment: Typical example of the condition.

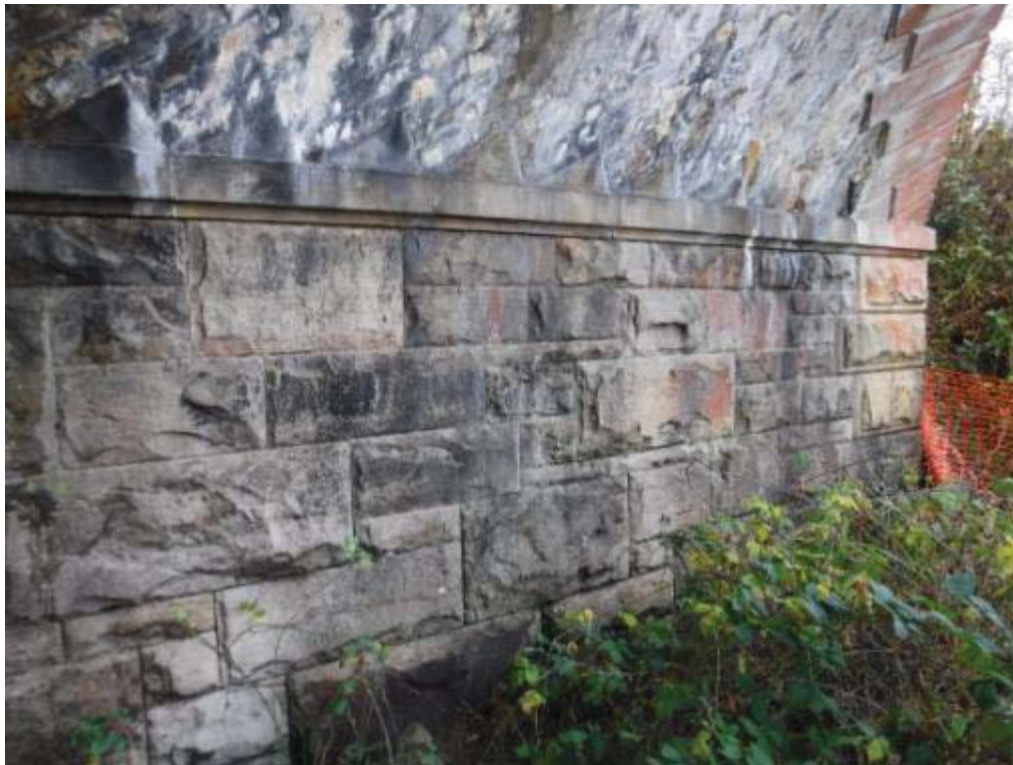
Photo No.70 - West abutment: Typical example of the condition.

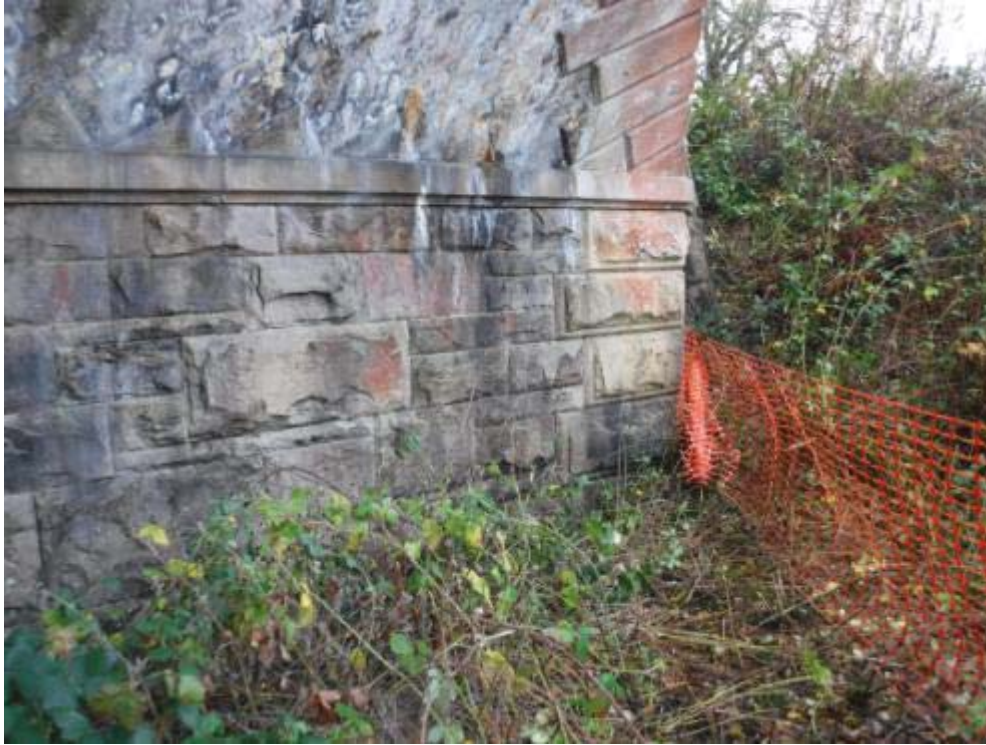
Photo No.71 - West abutment: Typical example of the condition.

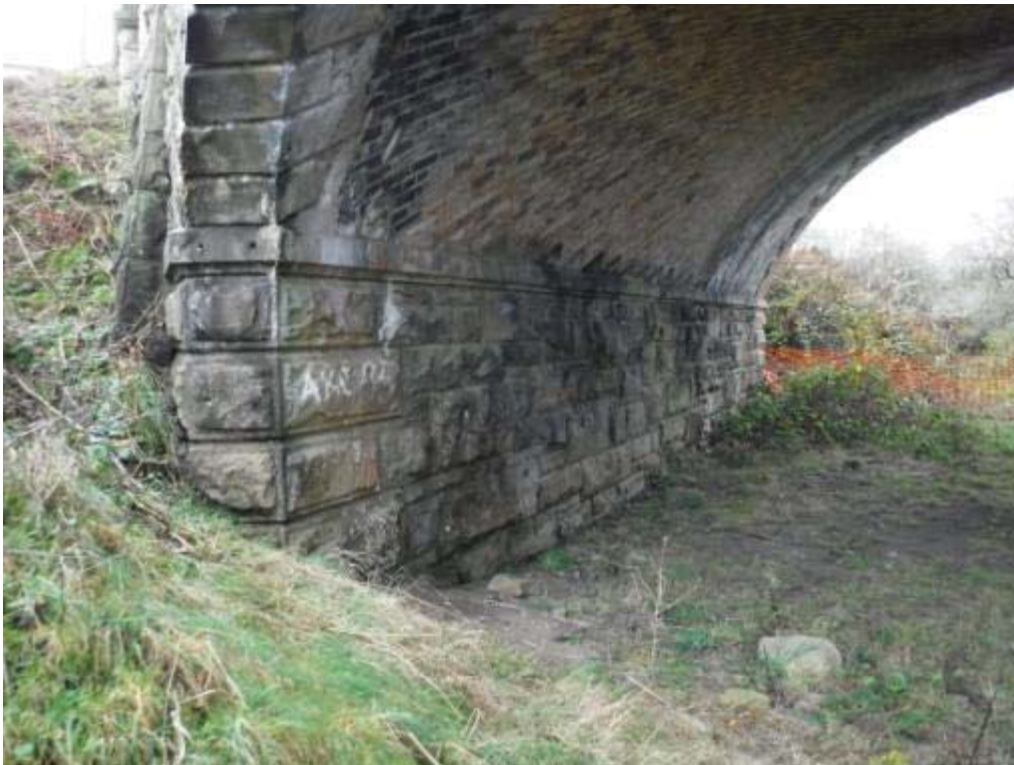
Photo No.72 - West abutment: Typical example of the condition.

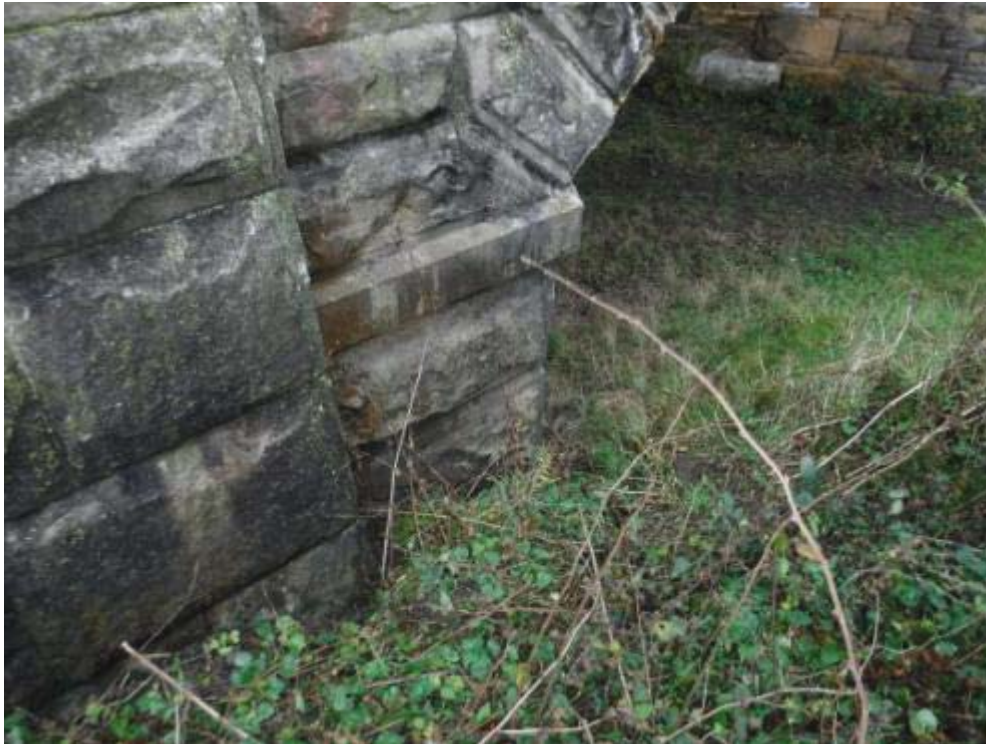
Photo No.73 - West abutment: Typical example of the condition at the S/W return section.
