Historical Railways Estate

Structure Reference

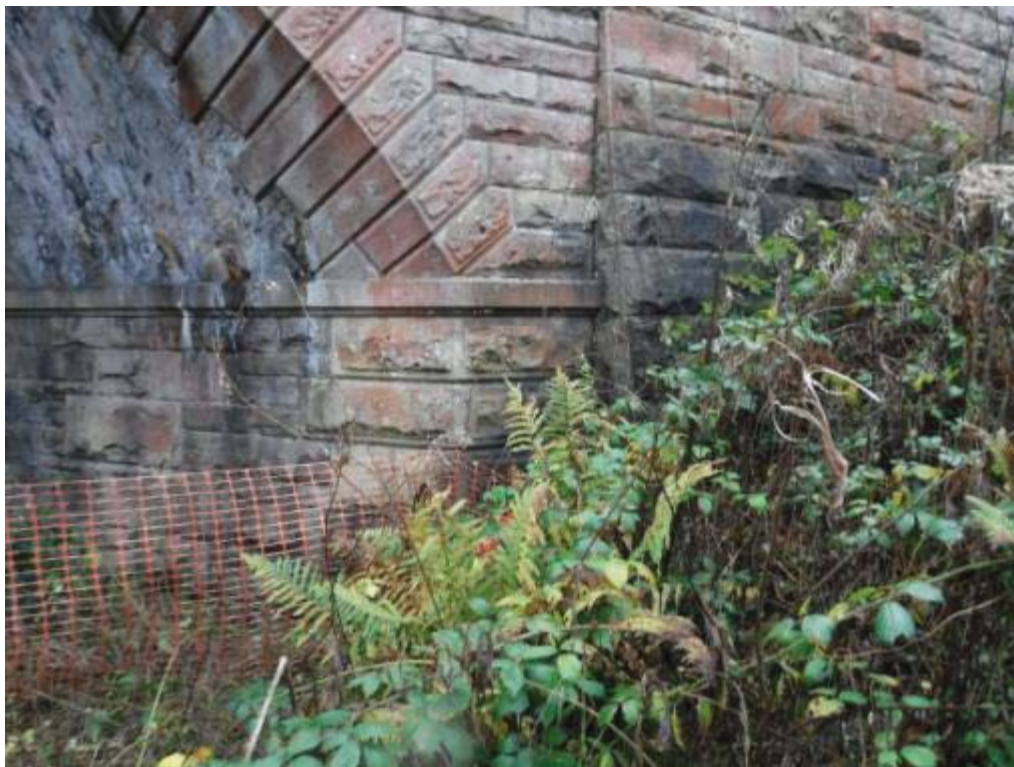
Photo No.74 - West abutment: Typical example of the condition at the N/W return section.

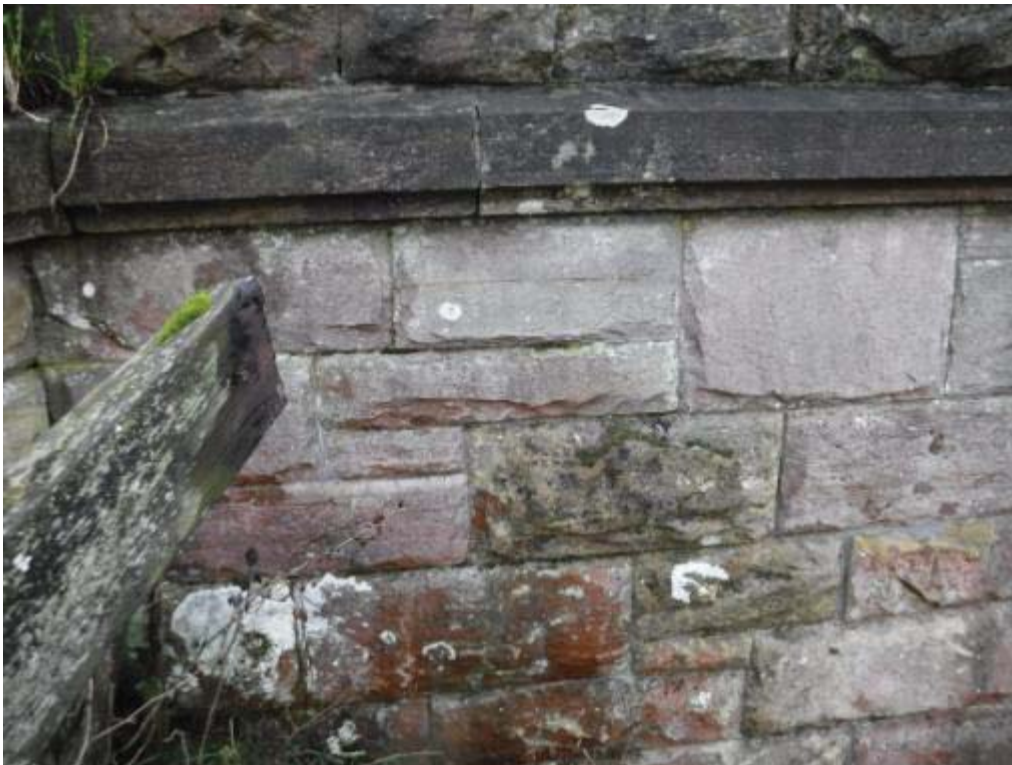
Photo No.76 - N/E wing wall: Typical example of the condition.

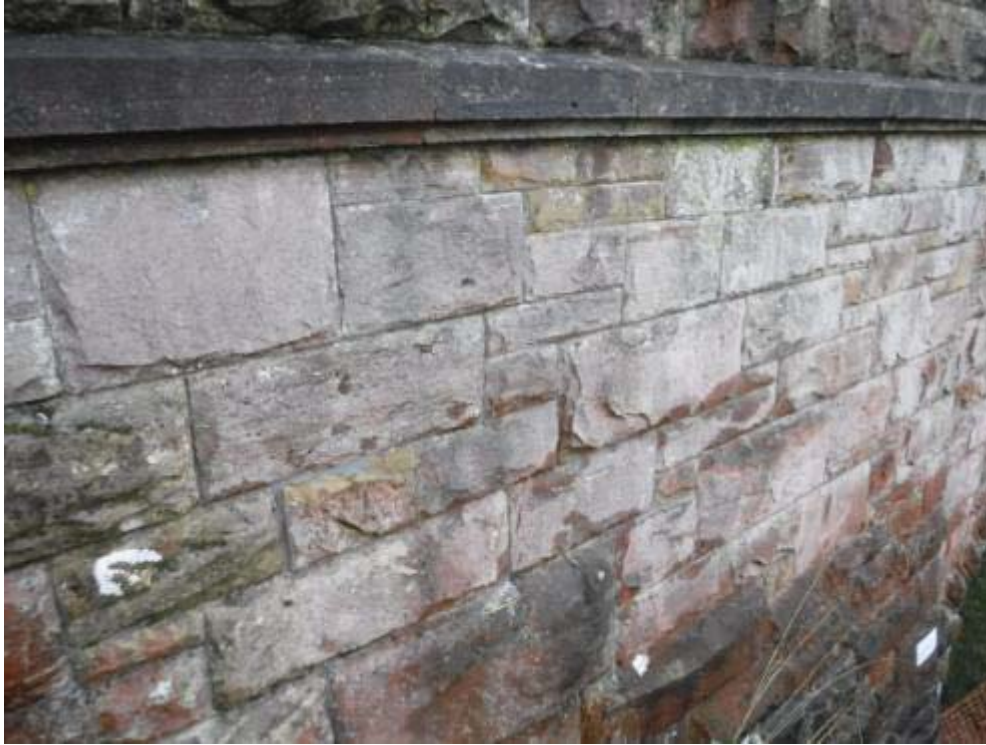
Photo No.77 - N/E wing wall: Typical example of the condition.

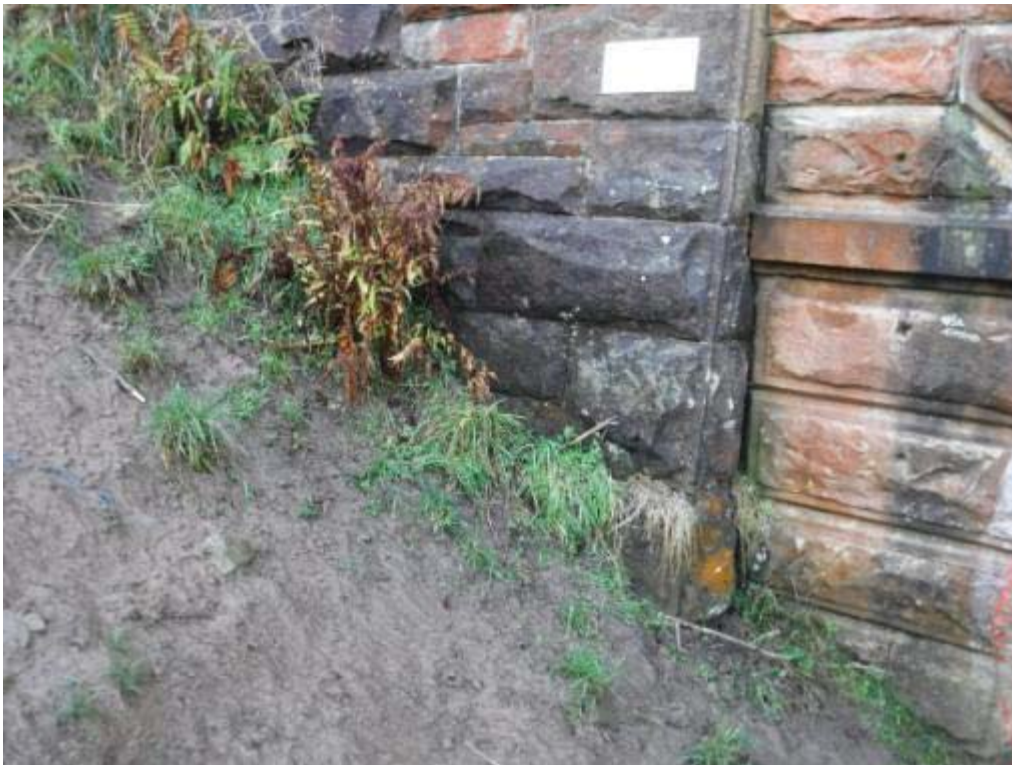
Photo No.78 - N/E wing wall: Typical example of the condition.

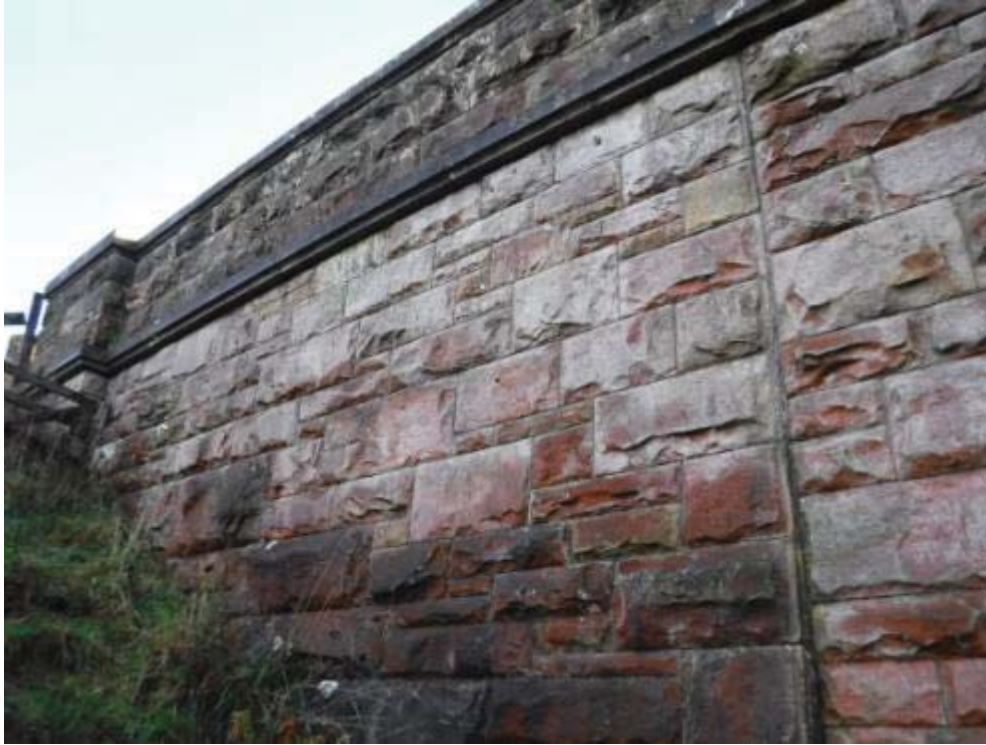
Photo No.79 - N/E wing wall: Typical example of the condition.

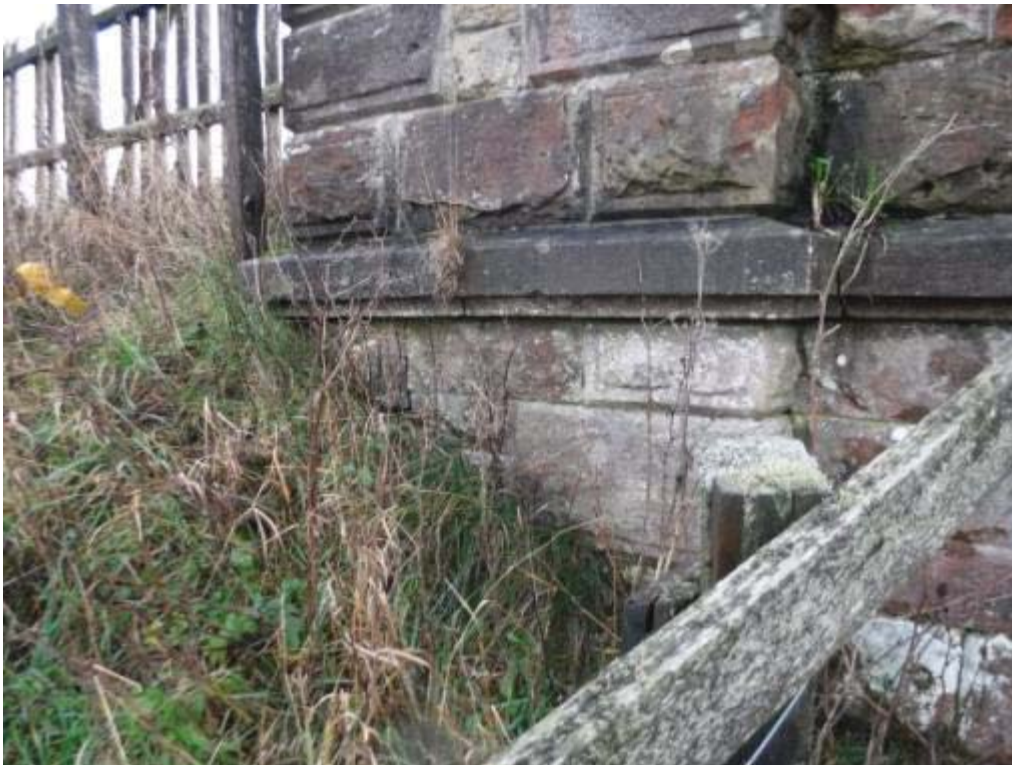
Photo No.80 - N/E wing wall: Typical example of the condition of the newel post.

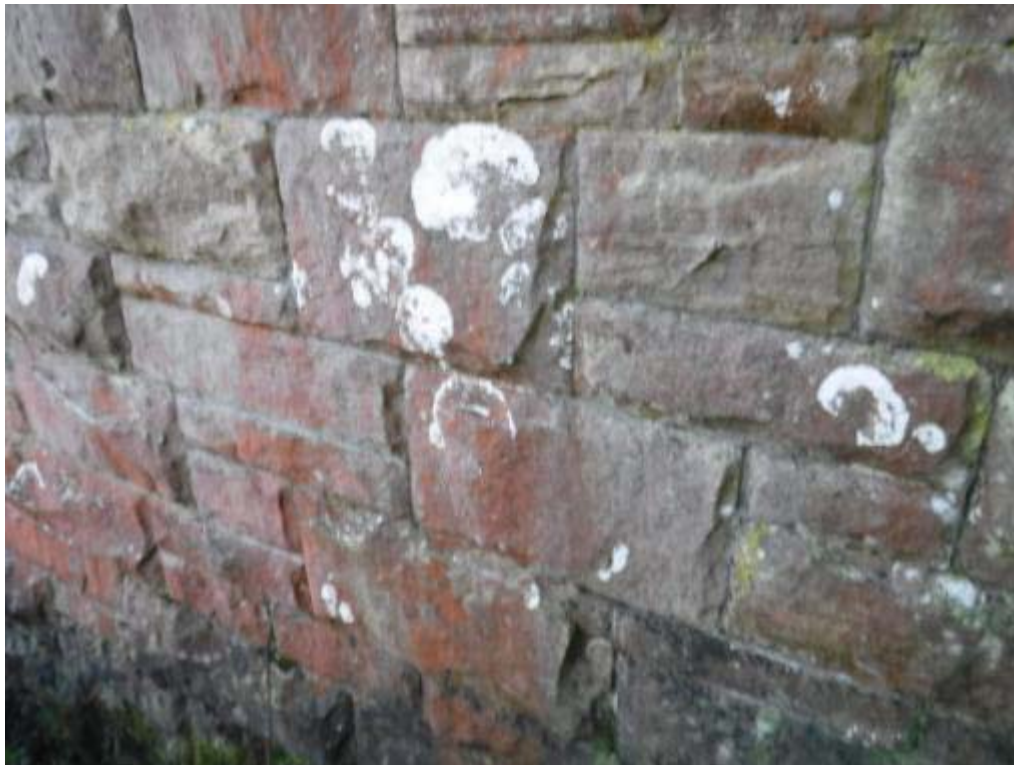
Photo No.82 - N/W wing wall: Typical example of the condition.

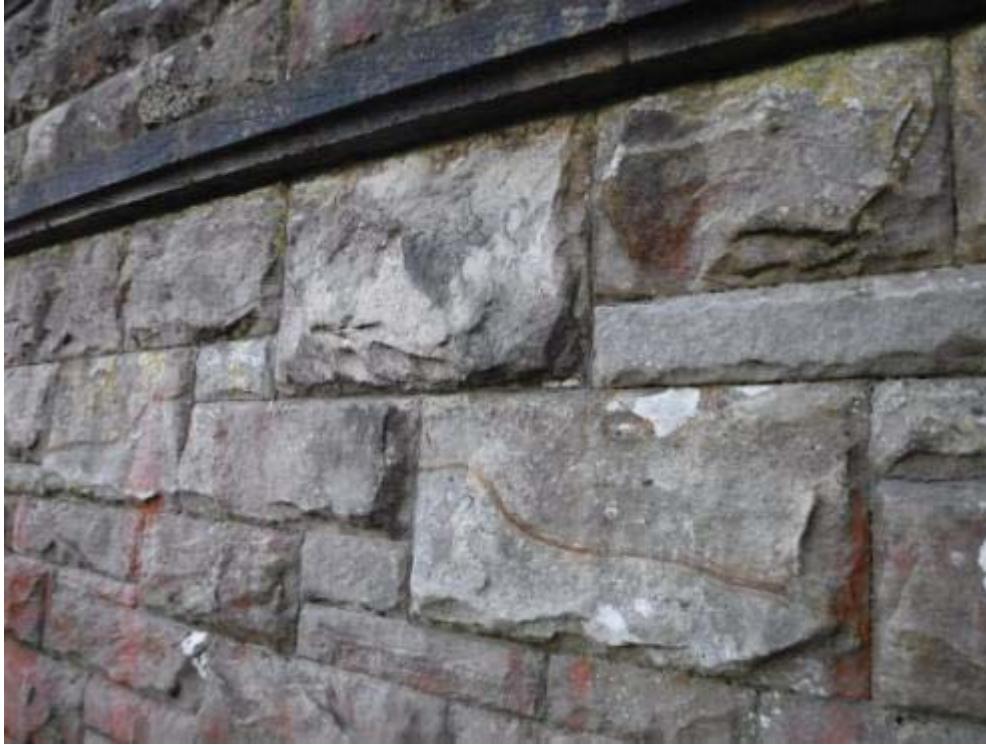
Photo No.83 - N/W wing wall: Typical example of the condition.

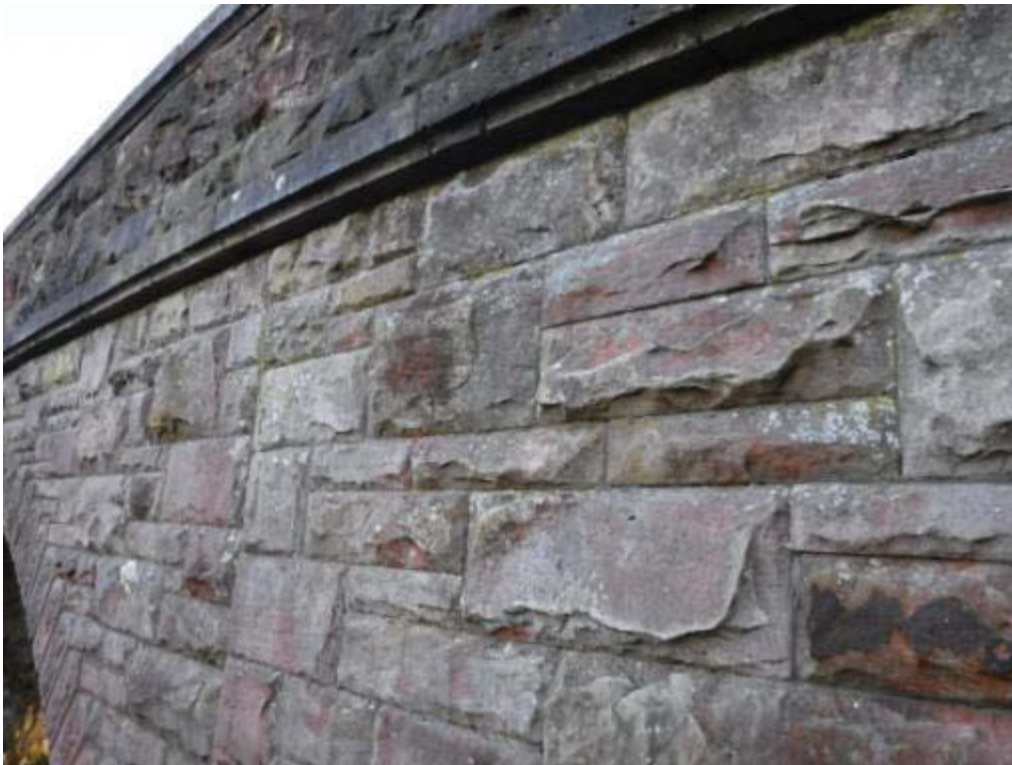
Photo No.84 - N/W wing wall: Typical example of the condition.

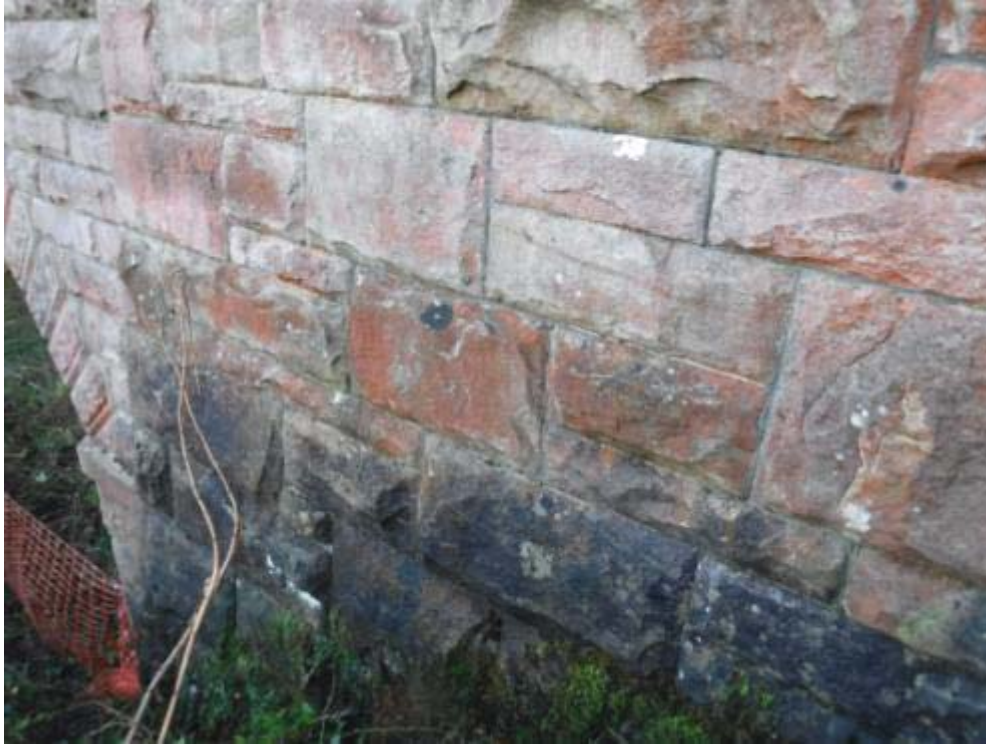
Photo No.85 - N/W wing wall: Typical example of the condition.

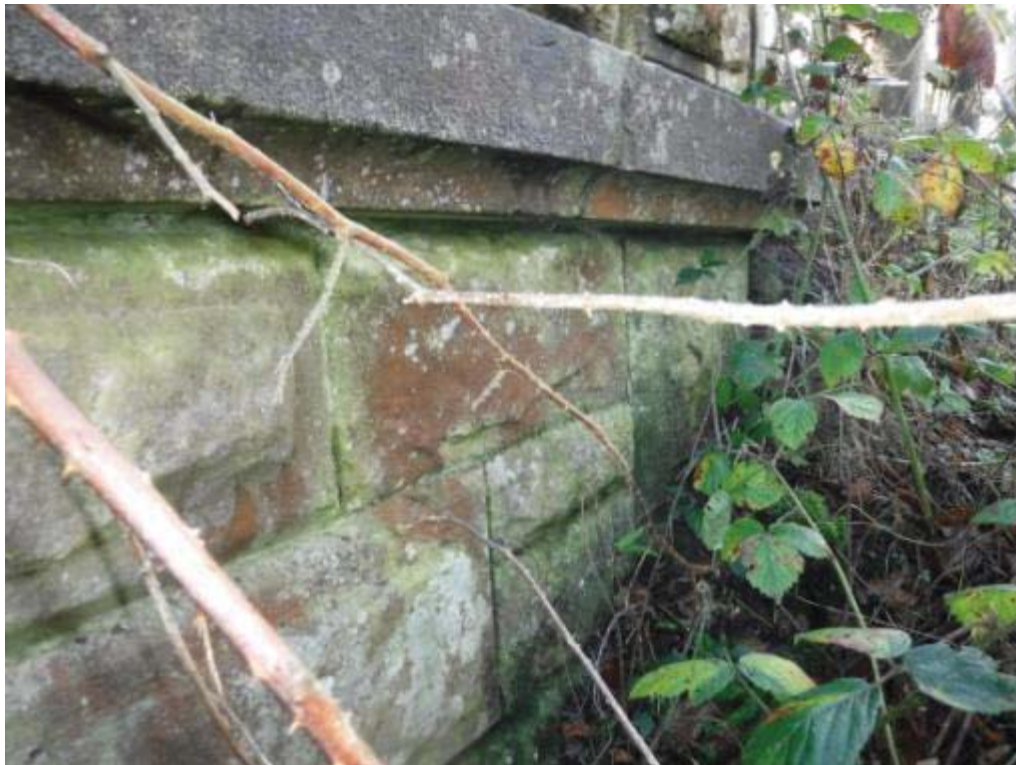
Photo No.86 - N/W wing wall: Typical example of the condition of the newel post.

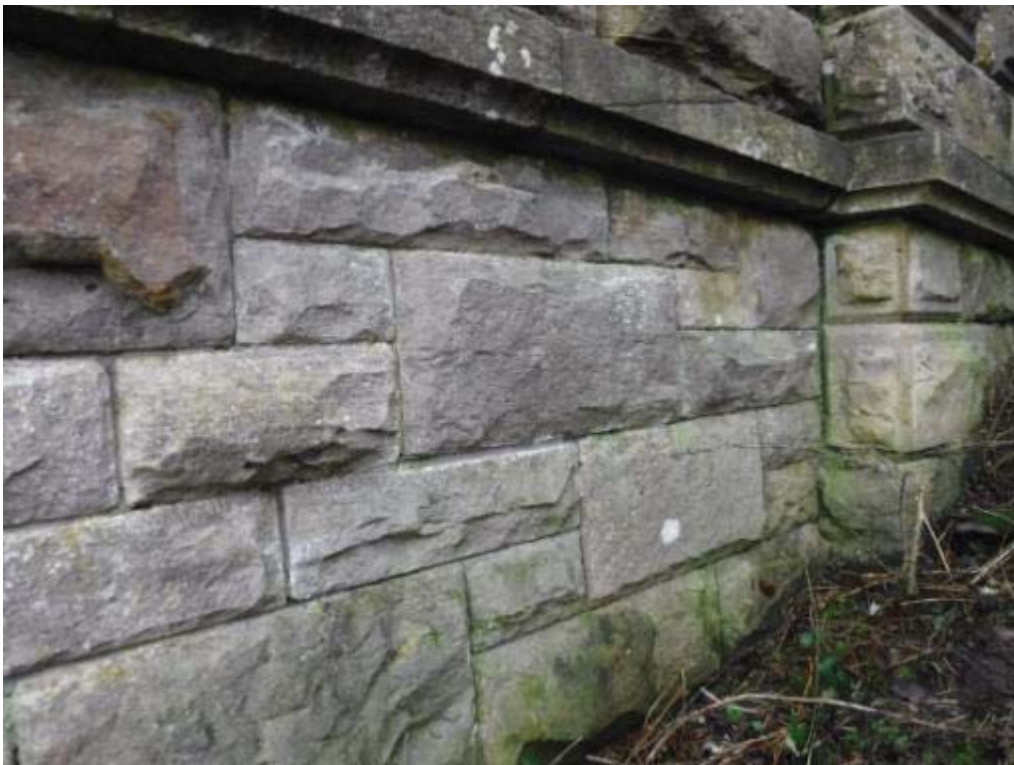
Photo No.88 - S/E wing wall: Typical example of the condition.

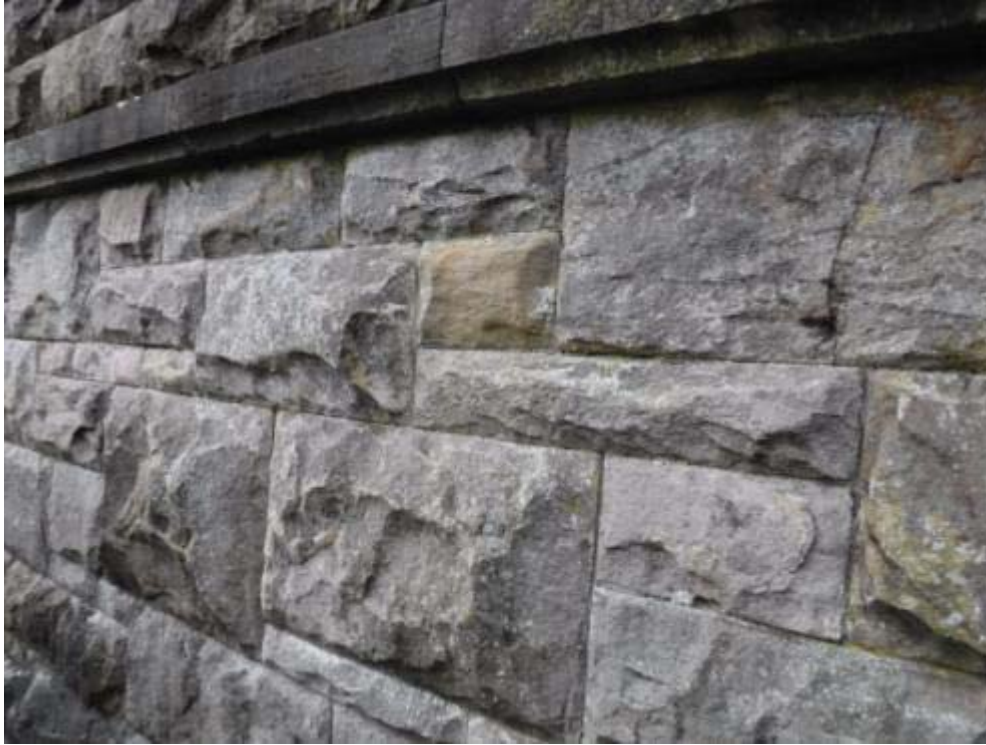
Photo No.89 - S/E wing wall: Typical example of the condition.

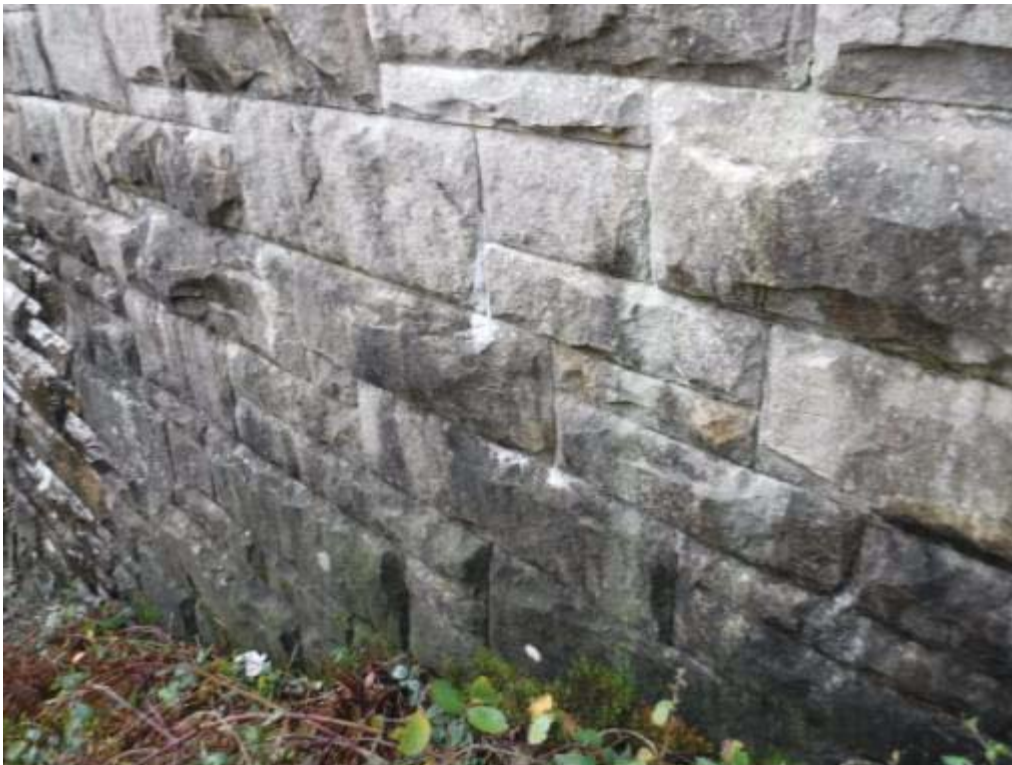
Photo No.90 - S/E wing wall: Typical example of the condition.

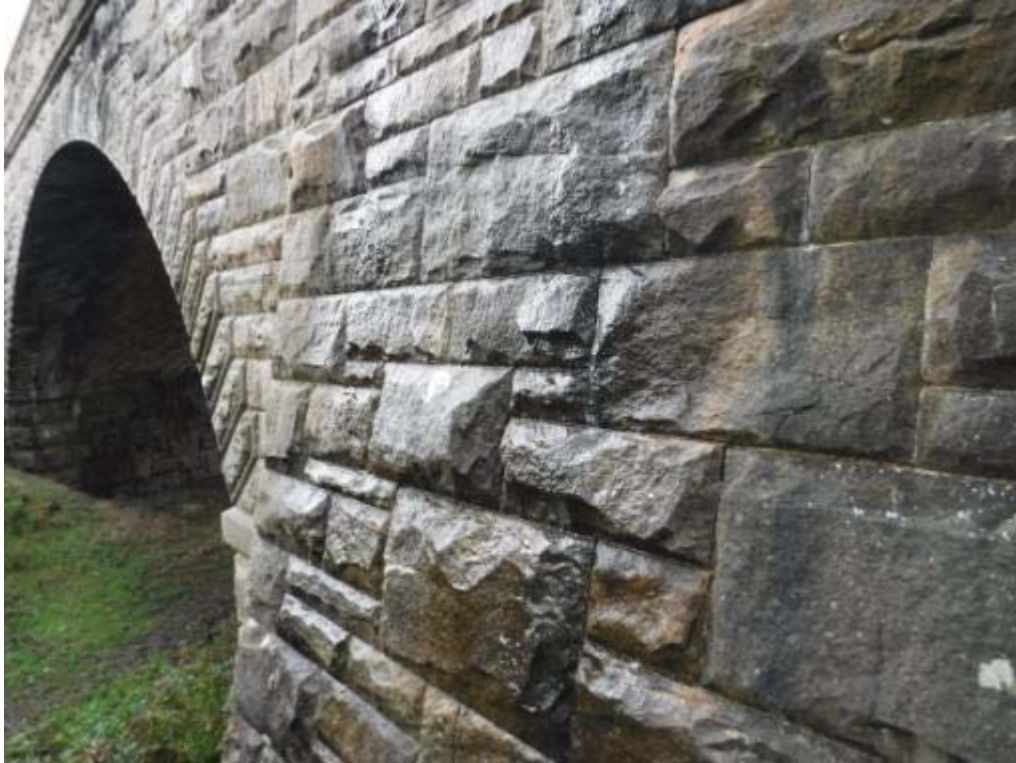
Photo No.91 - S/E wing wall: Typical example of the condition.

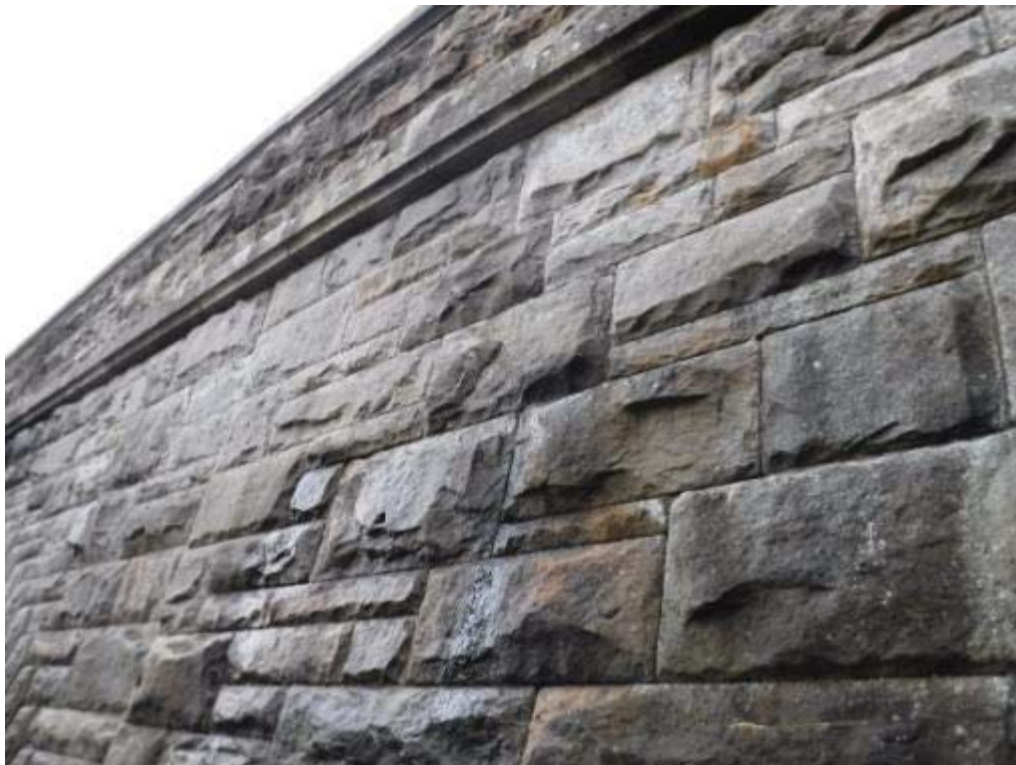
Photo No.92 - S/E wing wall: Typical example of the condition.

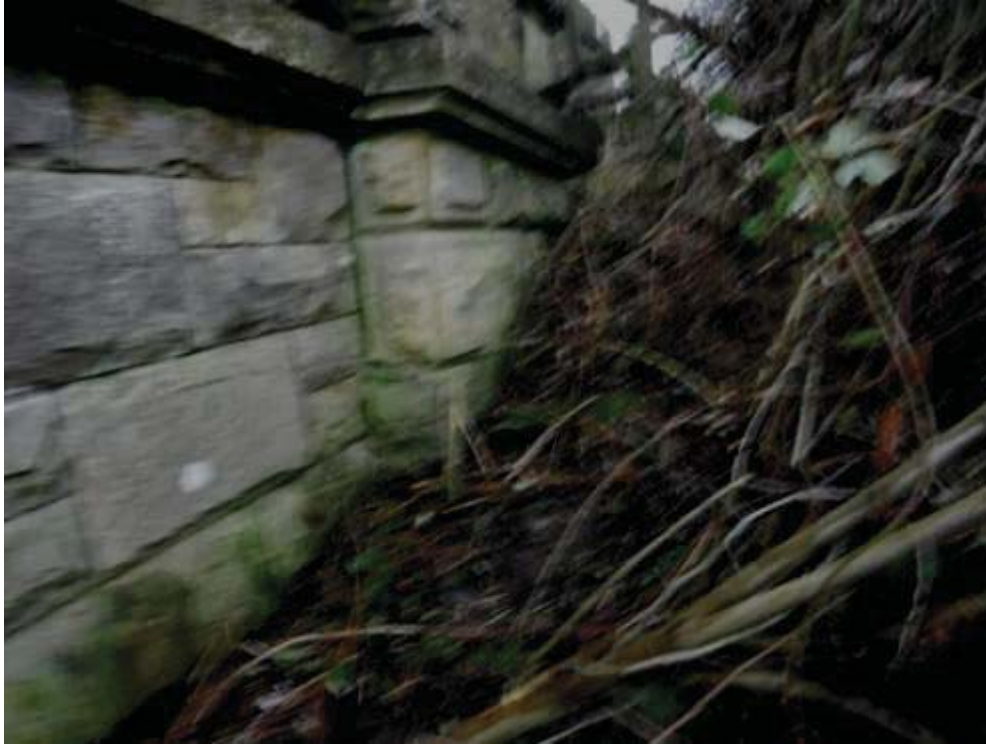
Photo No.93 - S/E wing wall: Typical example of the condition of the newel post.

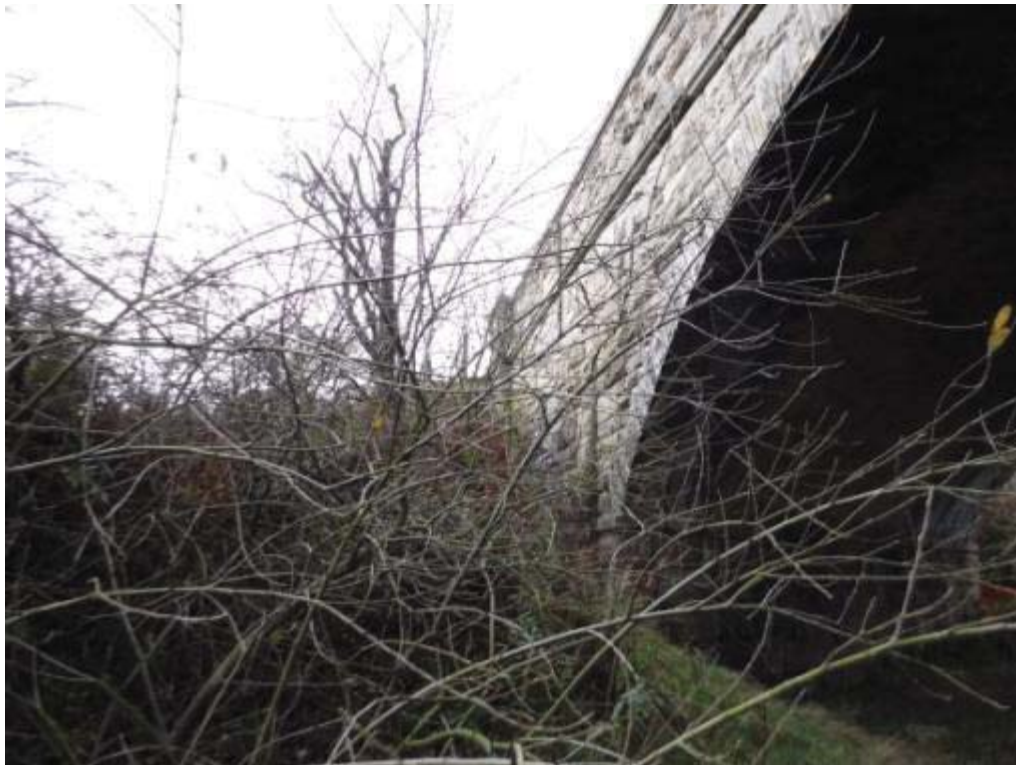
Photo No.94 - S/W wing wall: View

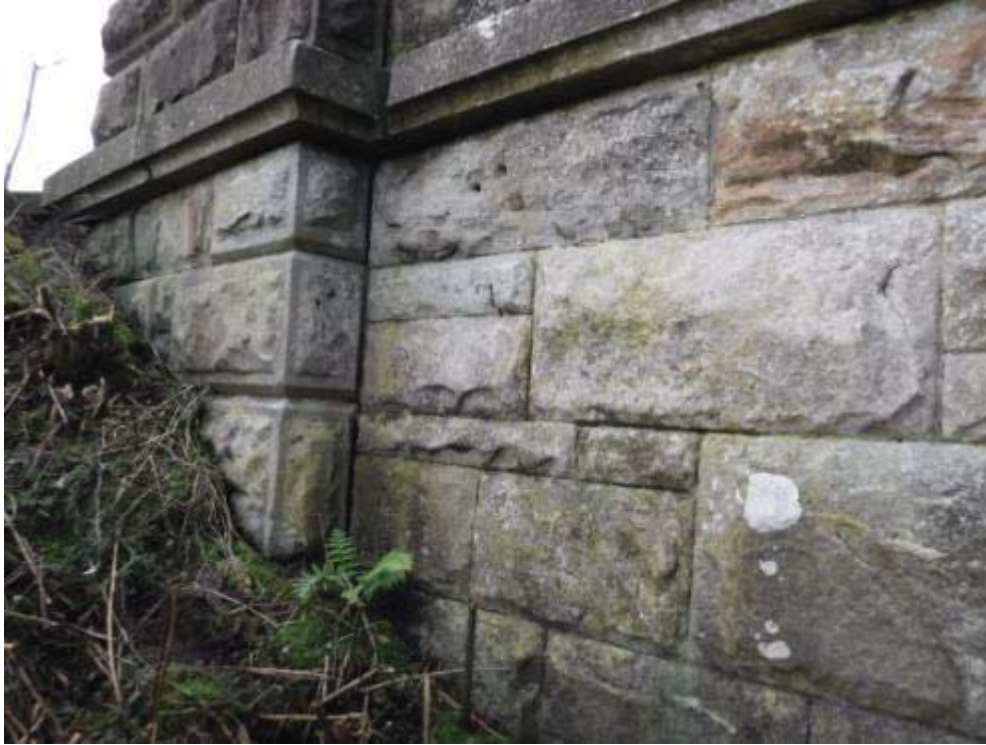
Photo No.95 - S/W wing wall: Typical example of the condition.

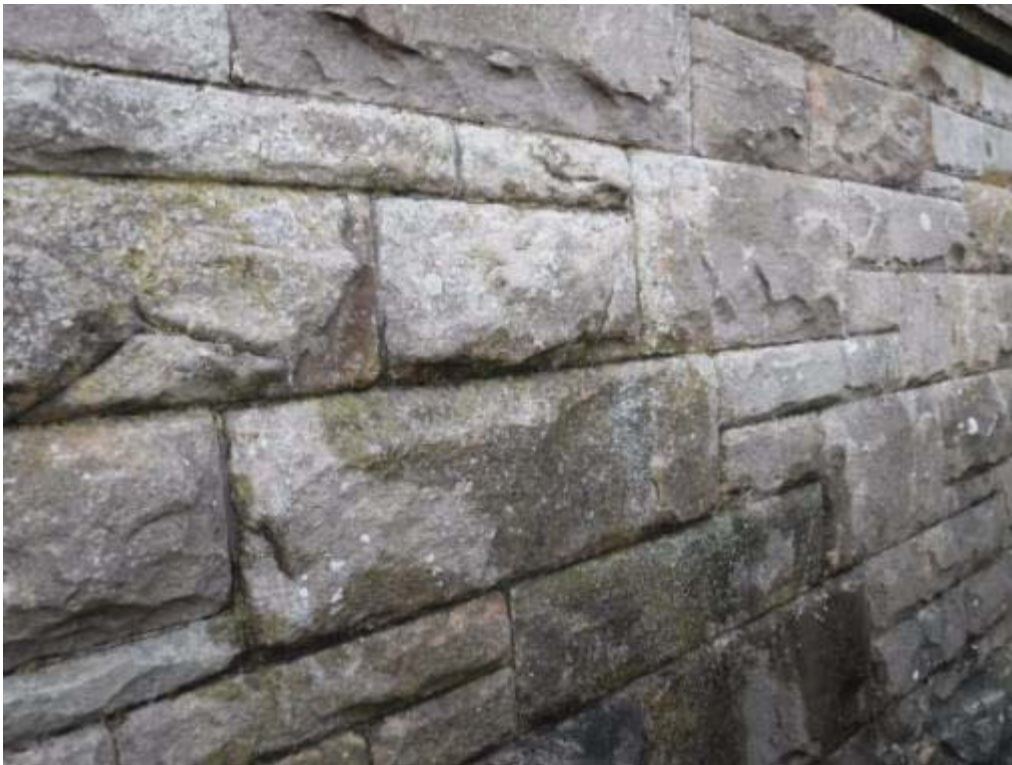
Photo No.96 - S/W wing wall: Typical example of the condition.

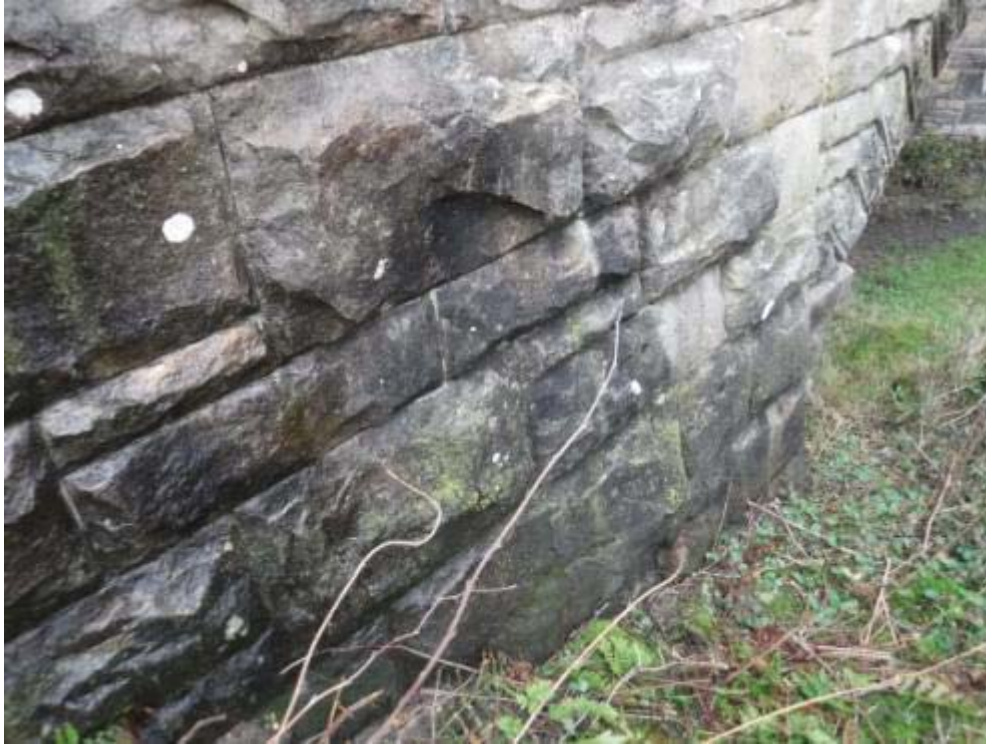
Photo No.97 - S/W wing wall: Typical example of the condition.

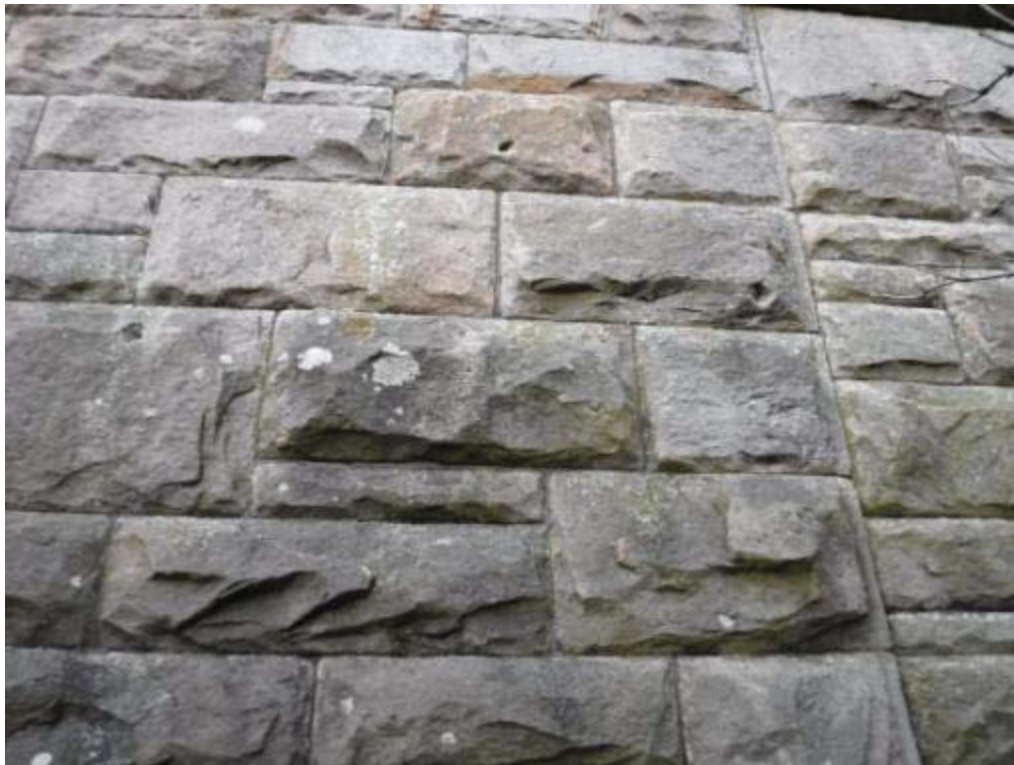
Photo No.98 - S/W wing wall: Typical example of the condition.

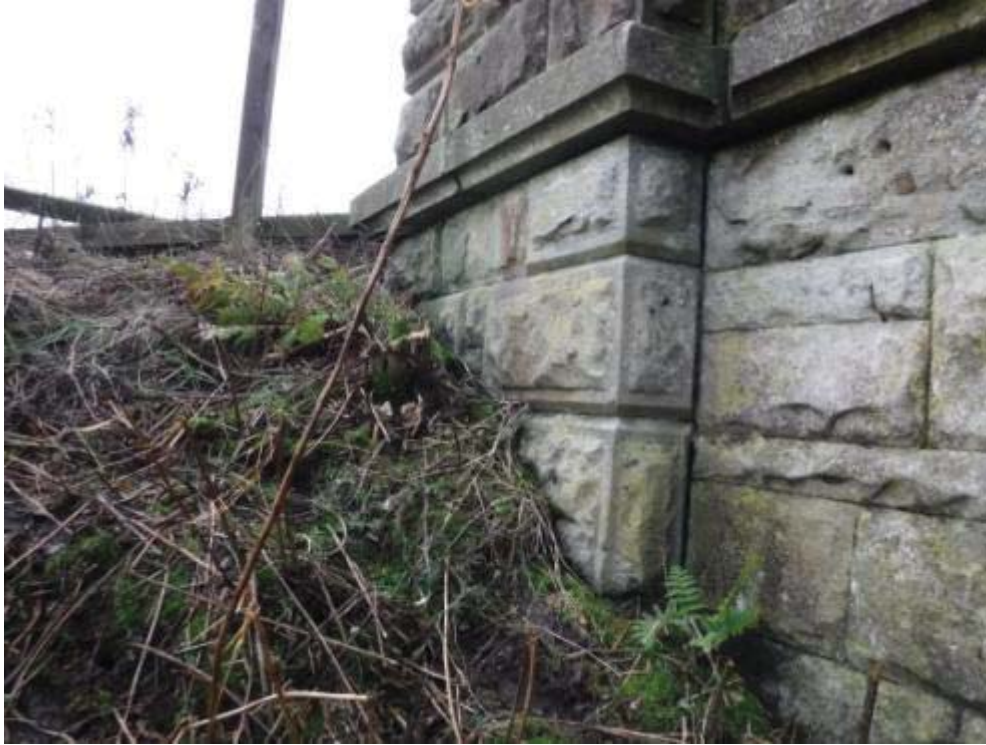
Photo No.99 - S/W wing wall: Typical example of the condition of the newel post.

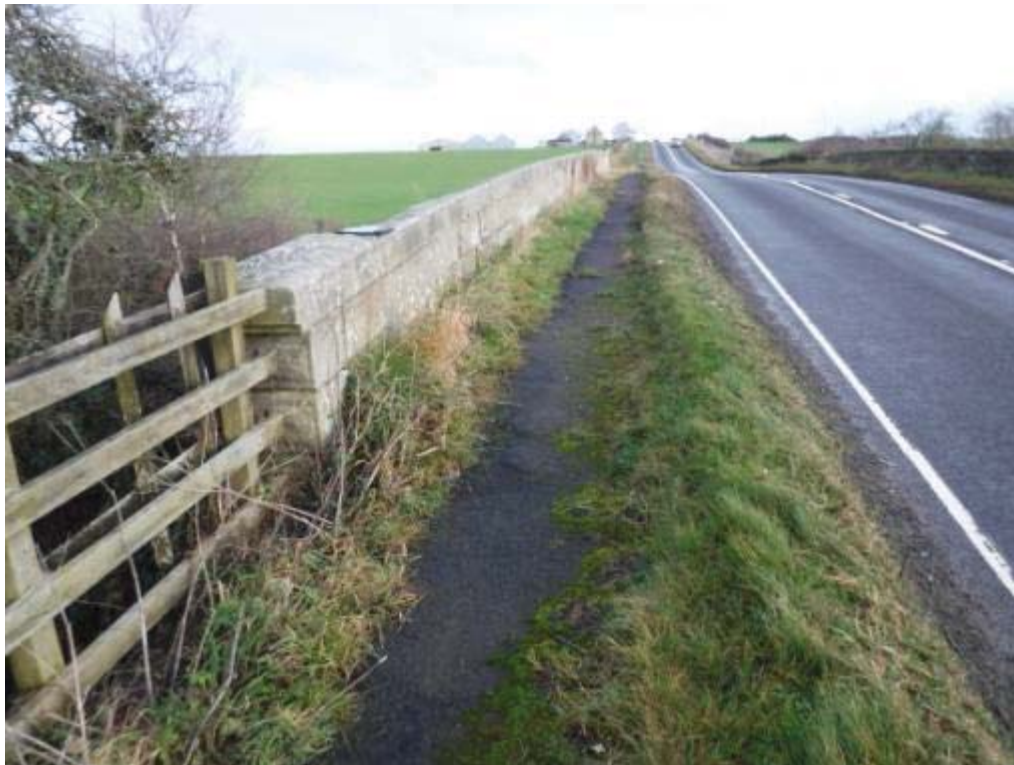
Photo No.100 - North roadside parapet: View.

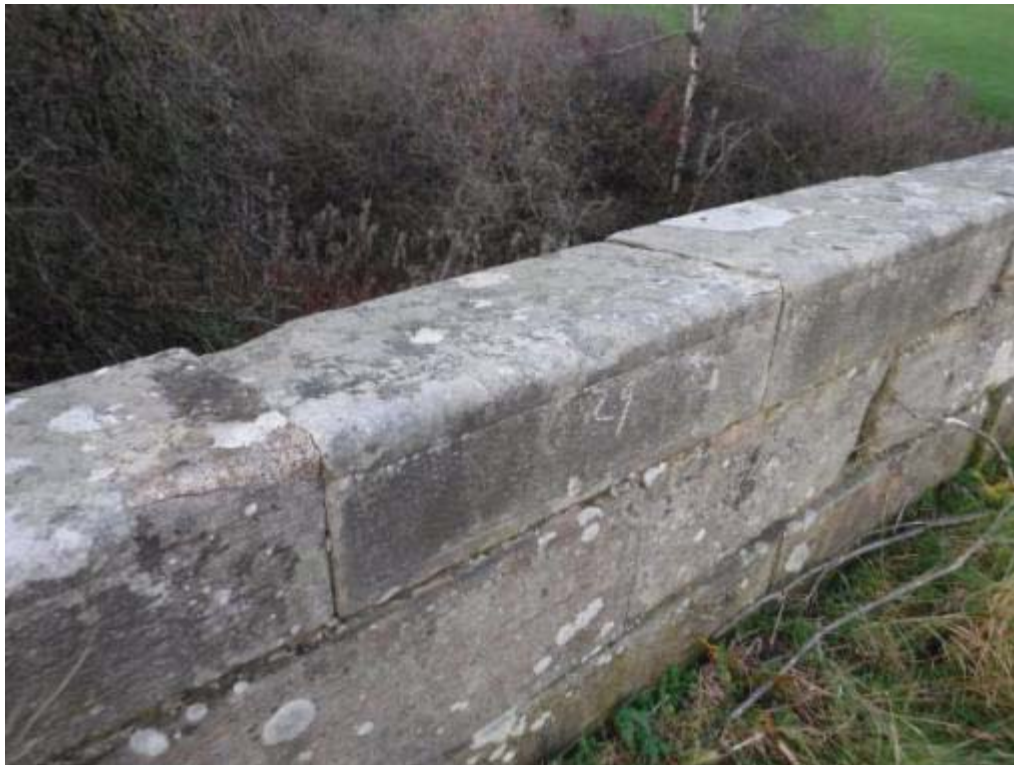
Photo No.104 - North roadside parapet: Fractured coping stone at 2.90m.

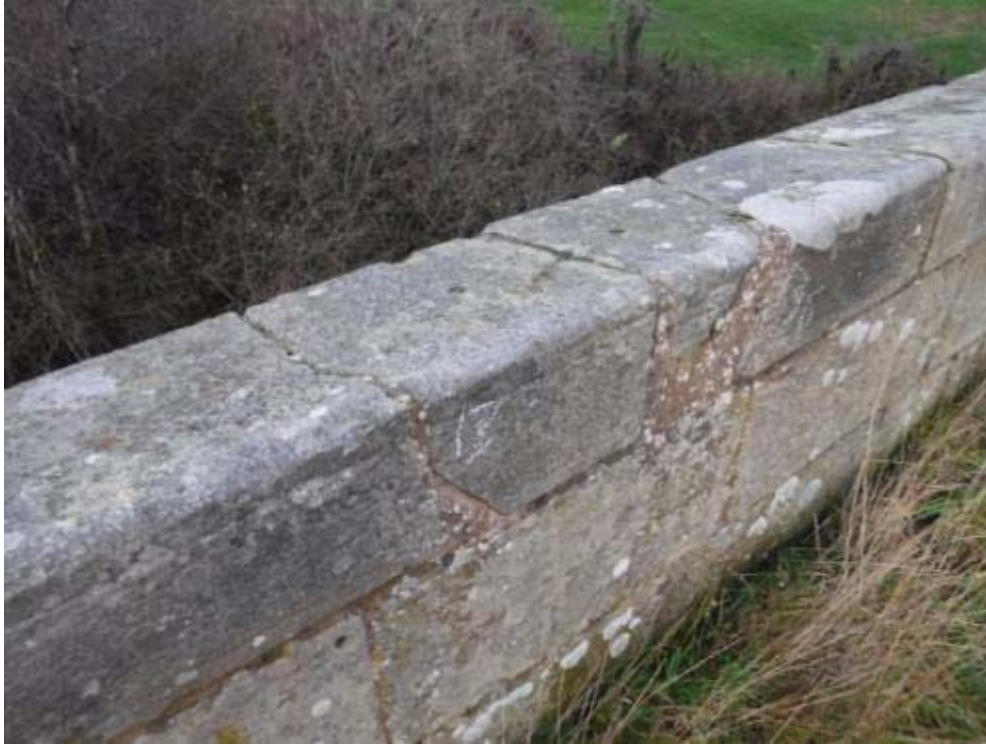
Photo No.105 - North roadside parapet: Fractured coping stones at 13.00m. & 13.60m.

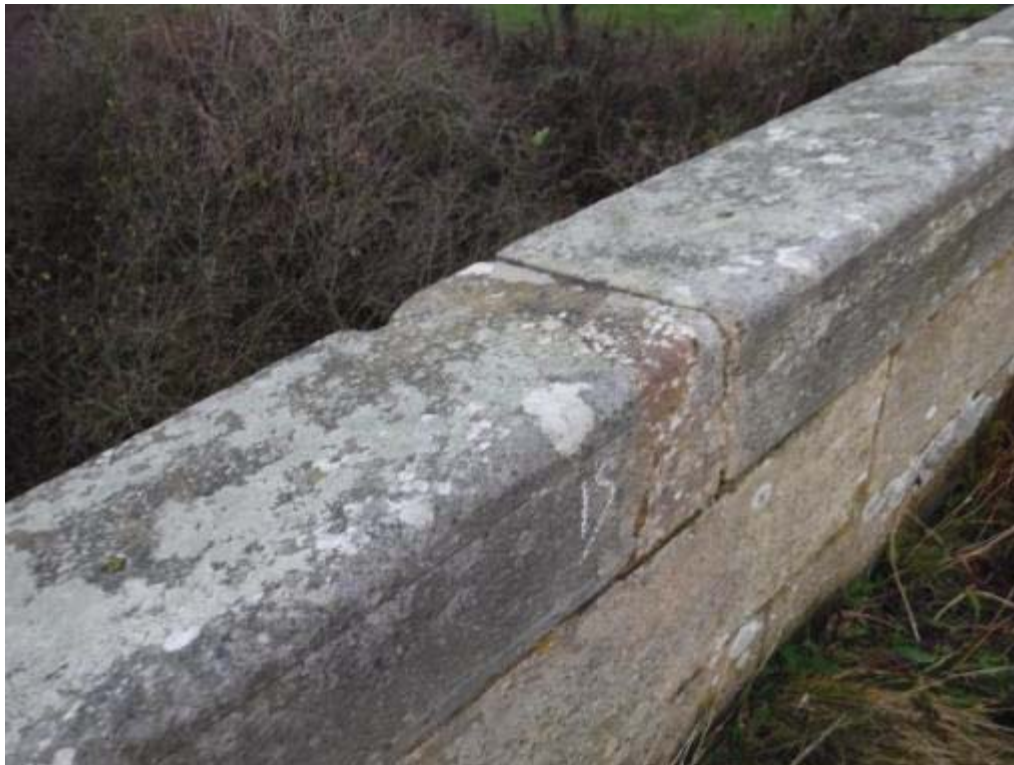
Photo No.106 - North roadside parapet: Fractured coping stone at 15.00m.

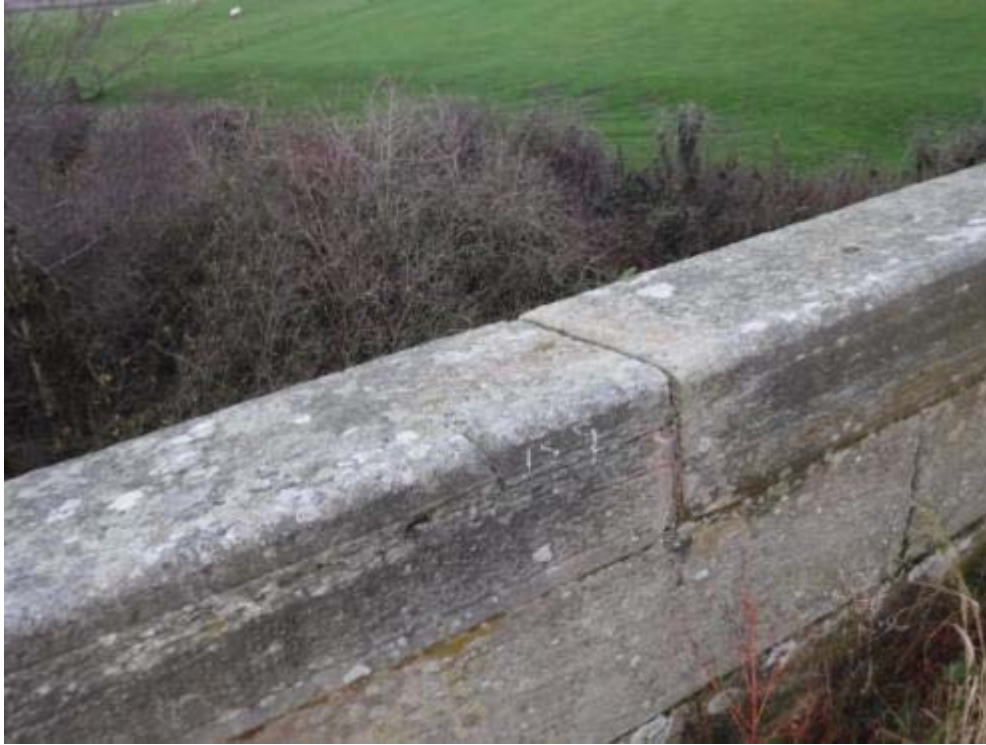
Photo No.107 - North roadside parapet: Fractured coping stone at 15.90m.

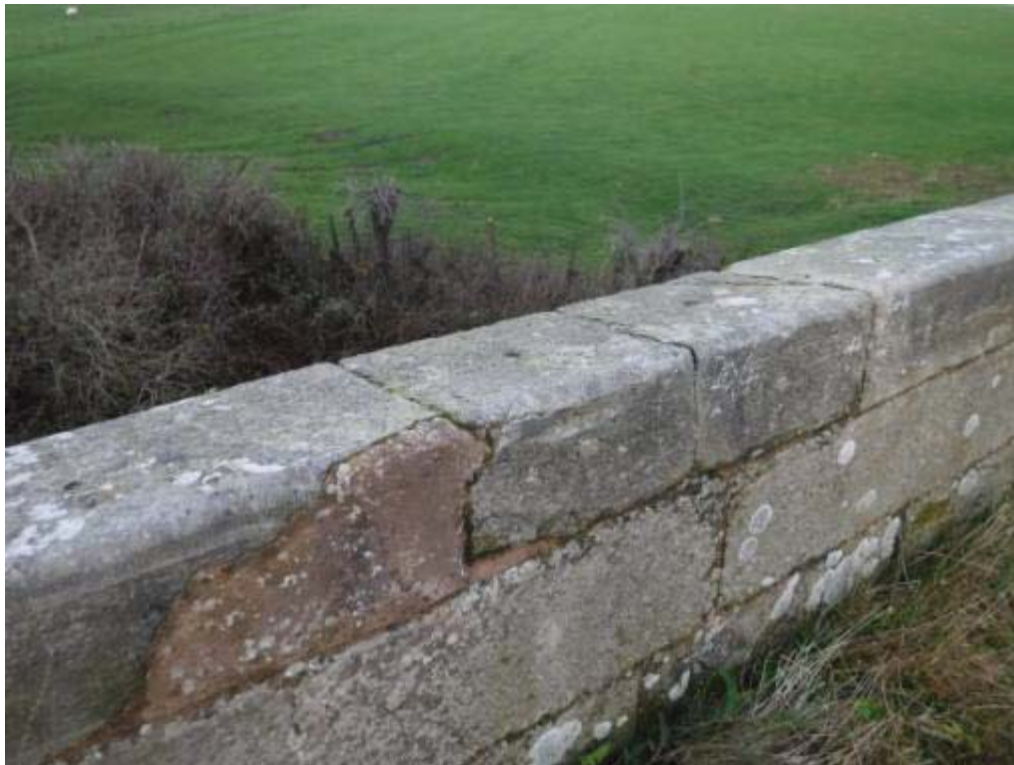
Photo No.108 - North roadside parapet: Fractured coping stone at 20.40m.

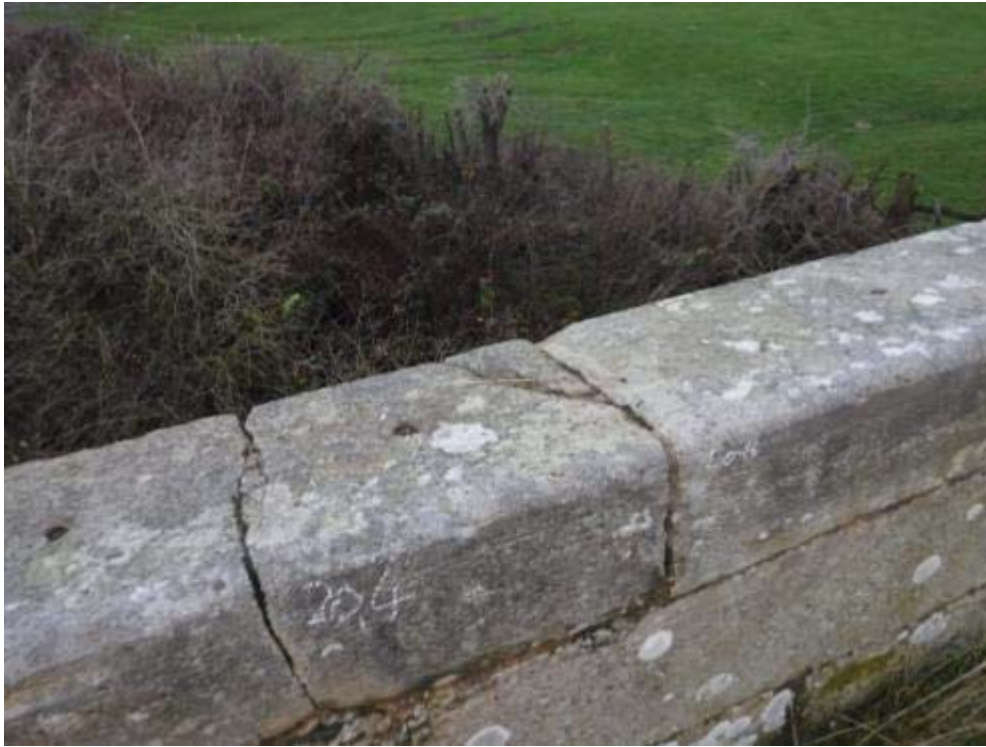
Photo No.109 - North roadside parapet: Fractured coping stone at 20.40m & 20.80m.
