Historical Railways Estate

Structure Reference

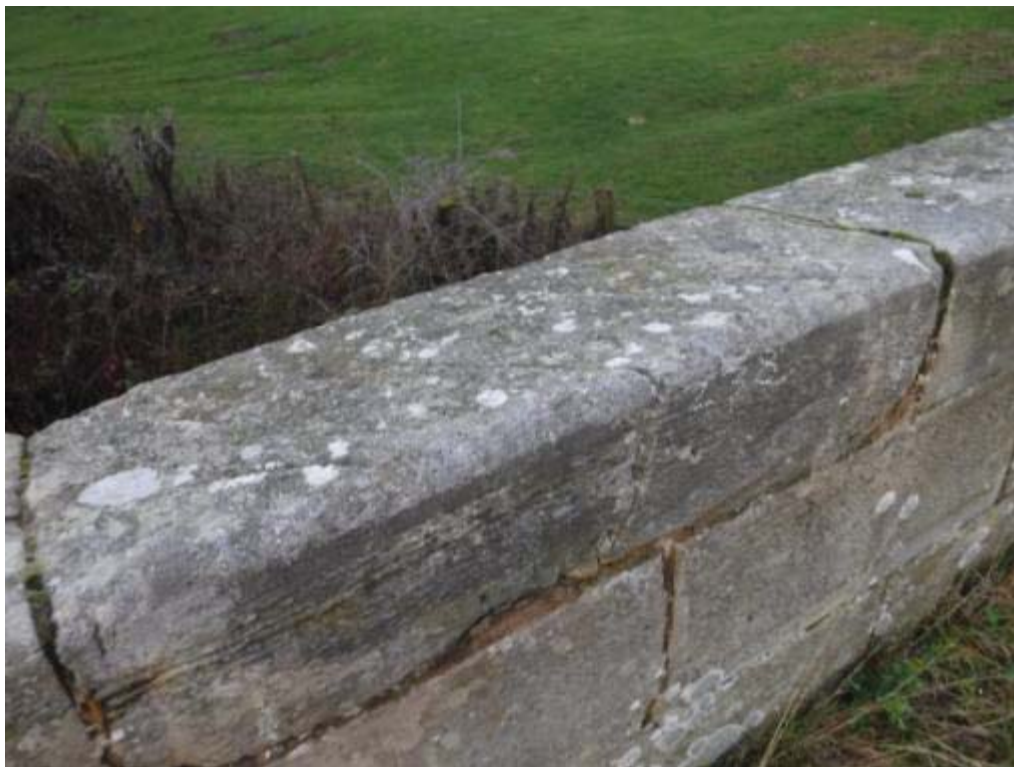
Photo No.110 - North roadside parapet: Fractured coping stone at 23.80m.

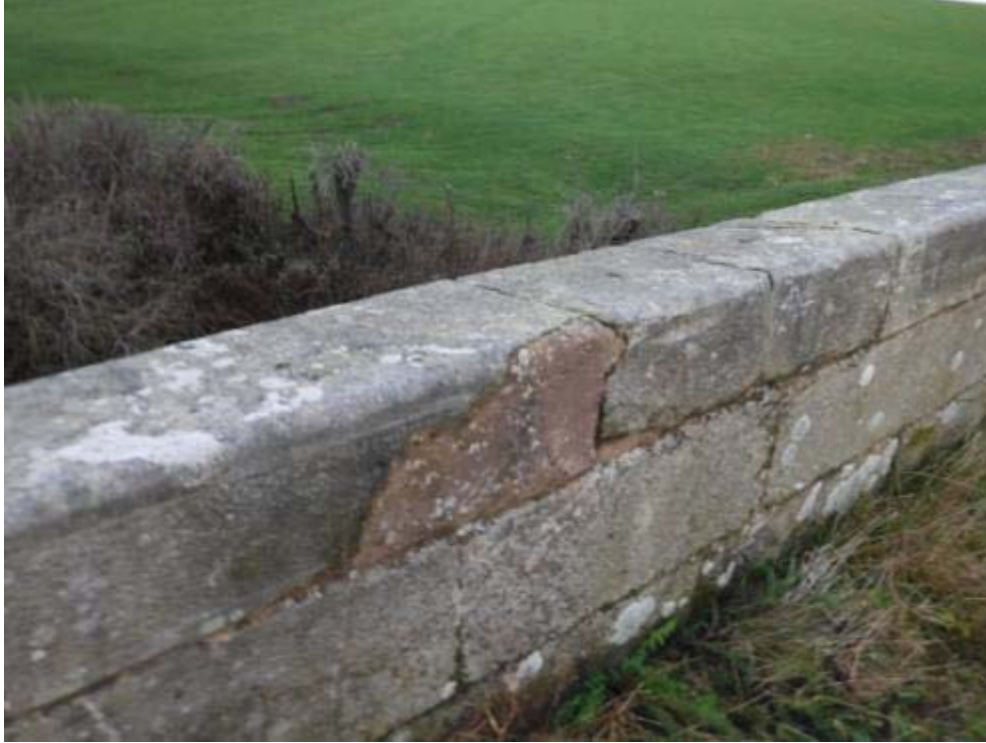
Photo No.111 - North roadside parapet: Previous render repair.

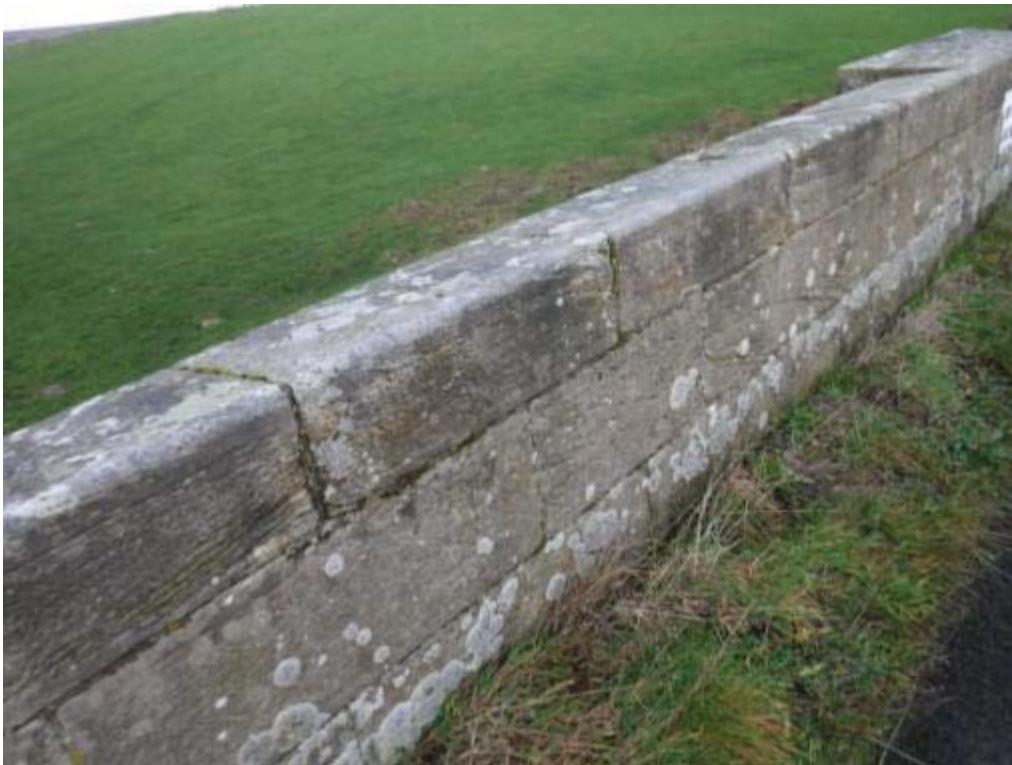
Photo No.112 - North roadside parapet: Typical example of the condition.

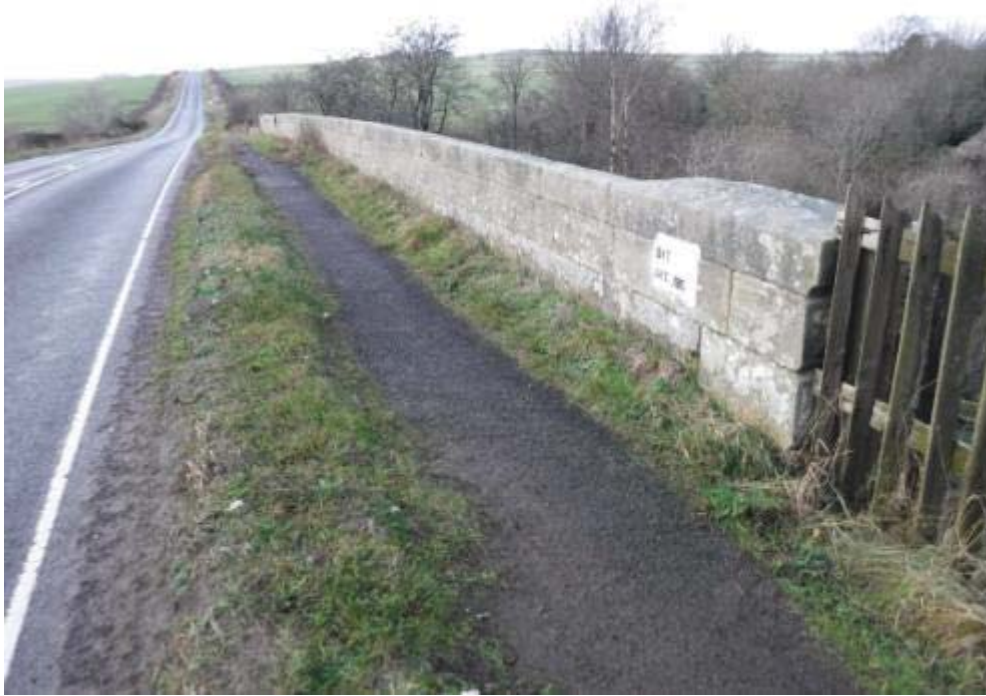
Photo No.113 - North roadside parapet: Typical example of the condition.

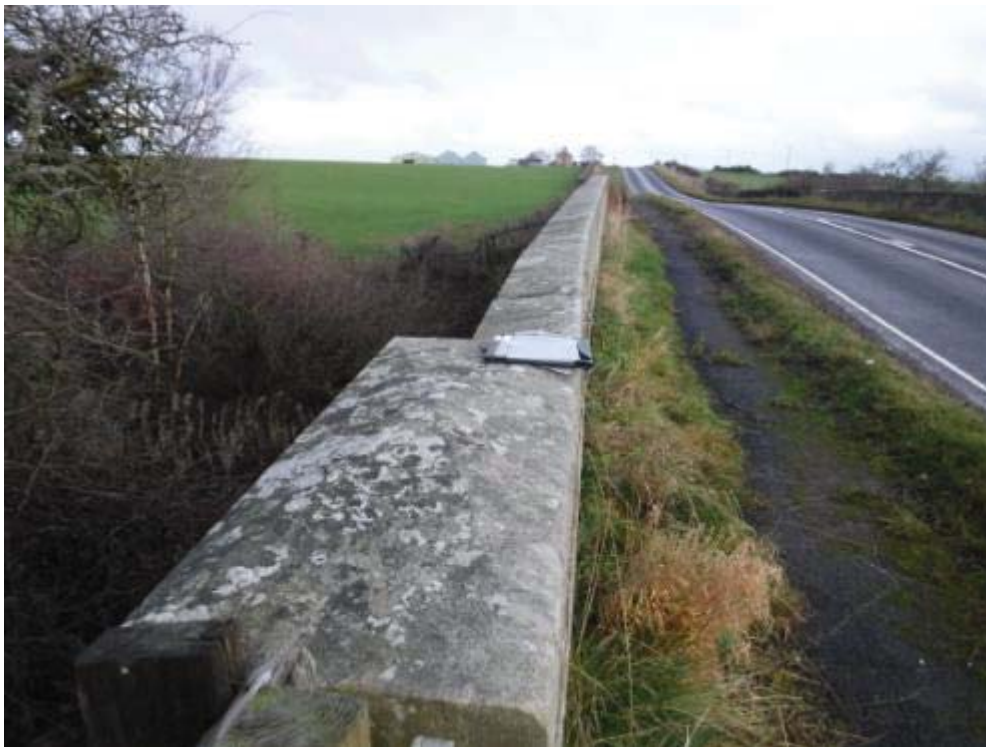
Photo No.114 - Typical example of the alignment & condition of the coping stones.

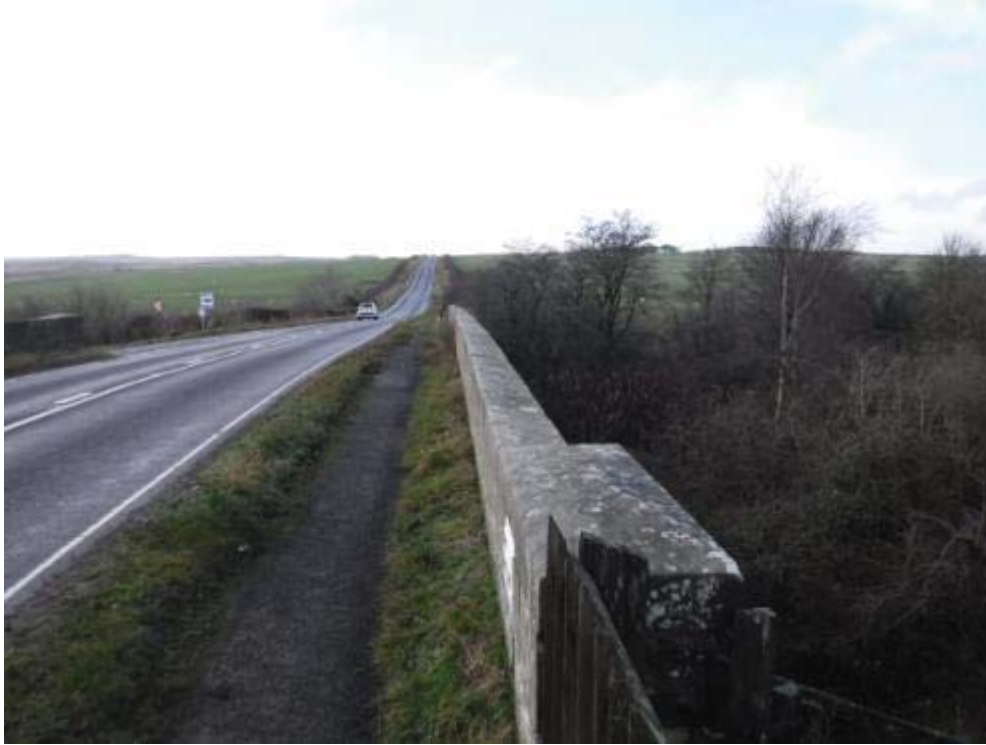
Photo No.115 - North roadside parapet: Typical example of the alignment & condition of the coping stones.

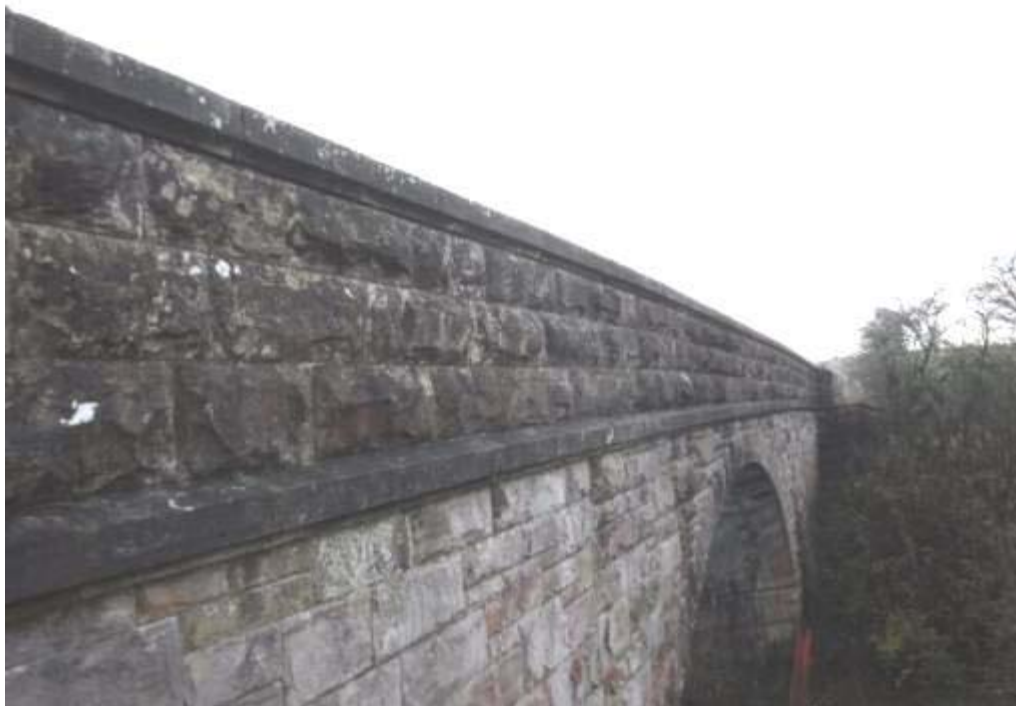
Photo No.116 - North outer parapet: View.

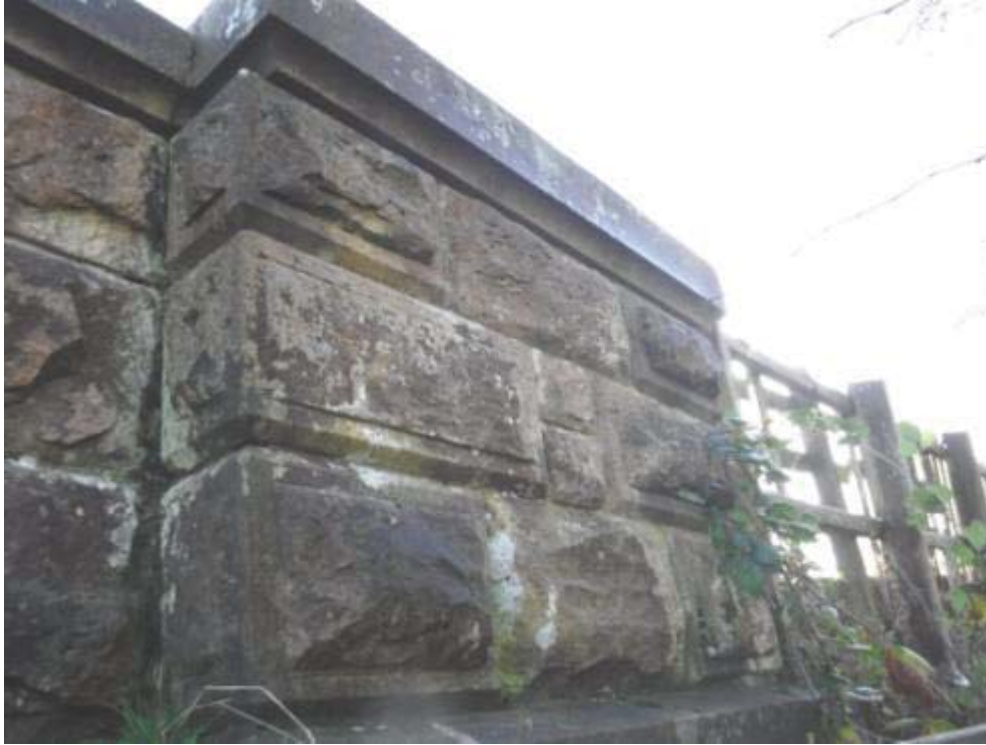
Photo No.117 - North outer parapet: Typical example of the condition of the N/W pilaster.

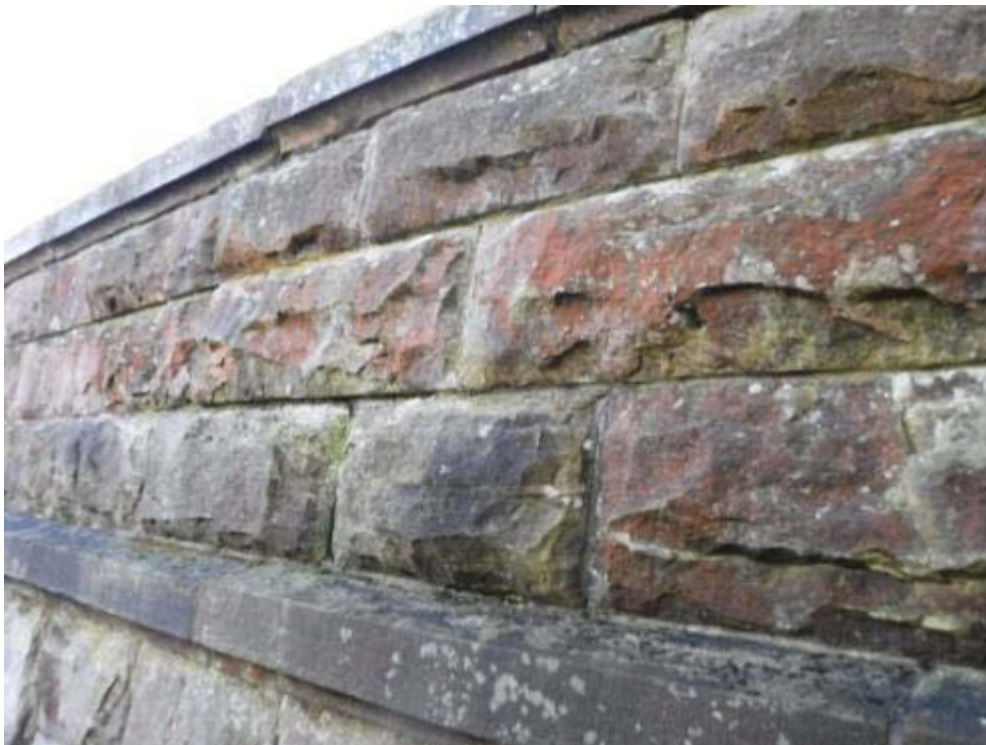
Photo No.118 - North outer parapet: Oversailing stonework at the N/W end.

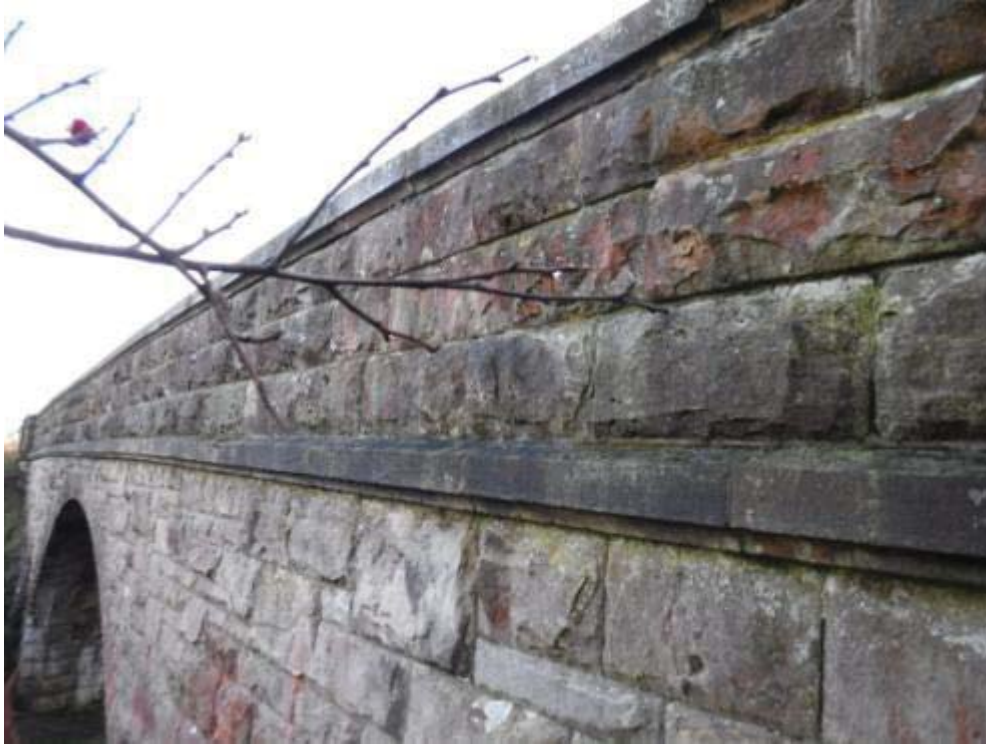
Photo No.119 - North outer parapet: Typical example of the condition.

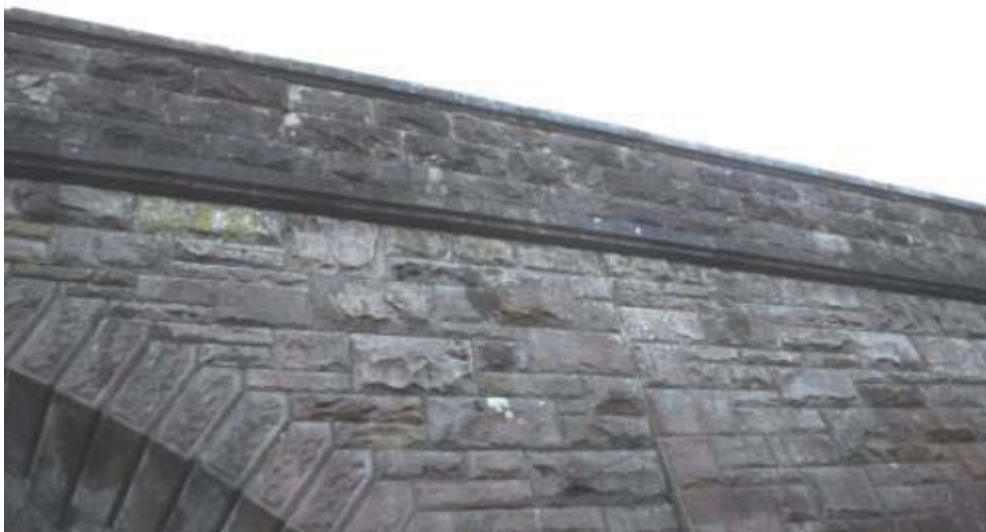
Photo No.120 - North outer parapet: Typical example of the condition.

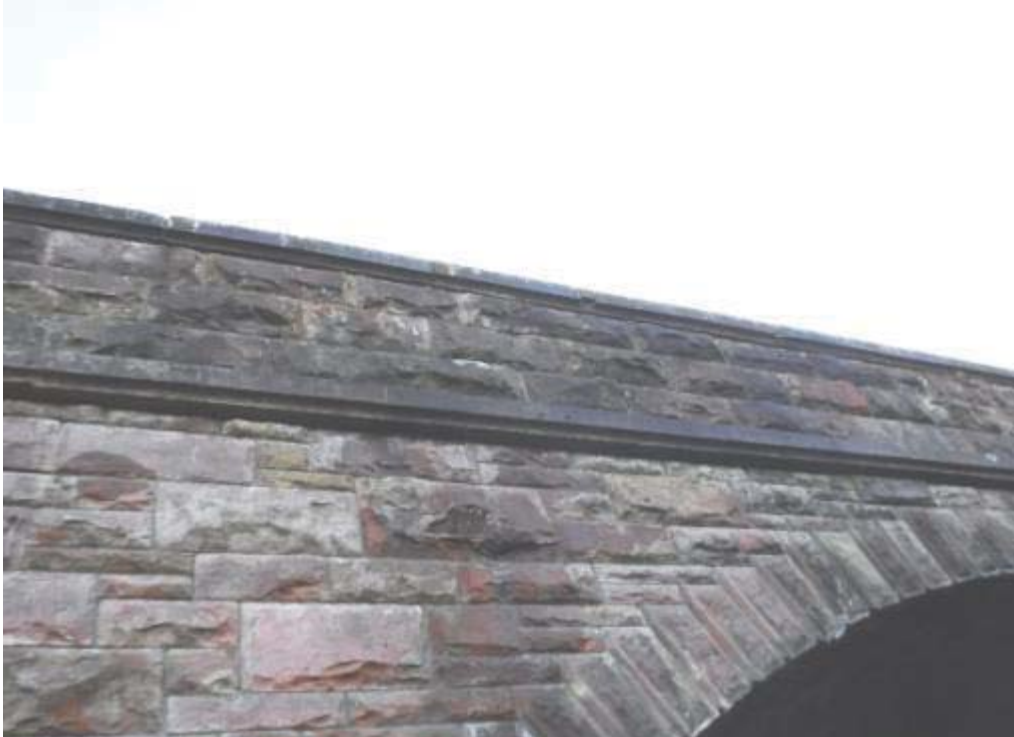
Photo No.121 - North outer parapet: Typical example of the condition.

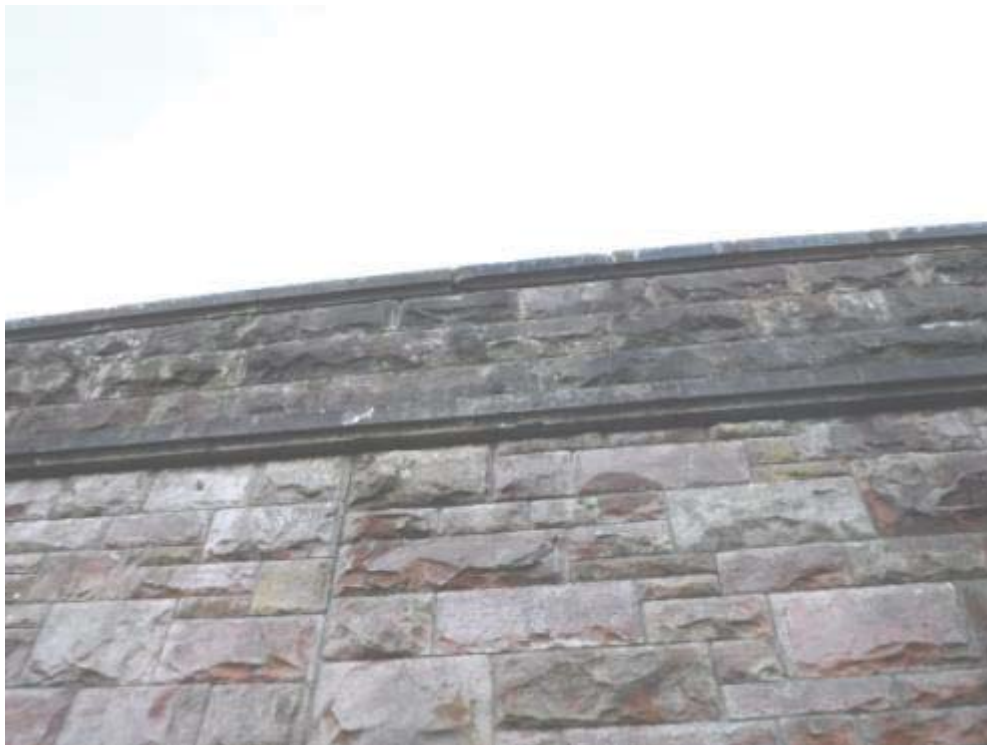
Photo No.122 - North outer parapet: Typical example of the condition.

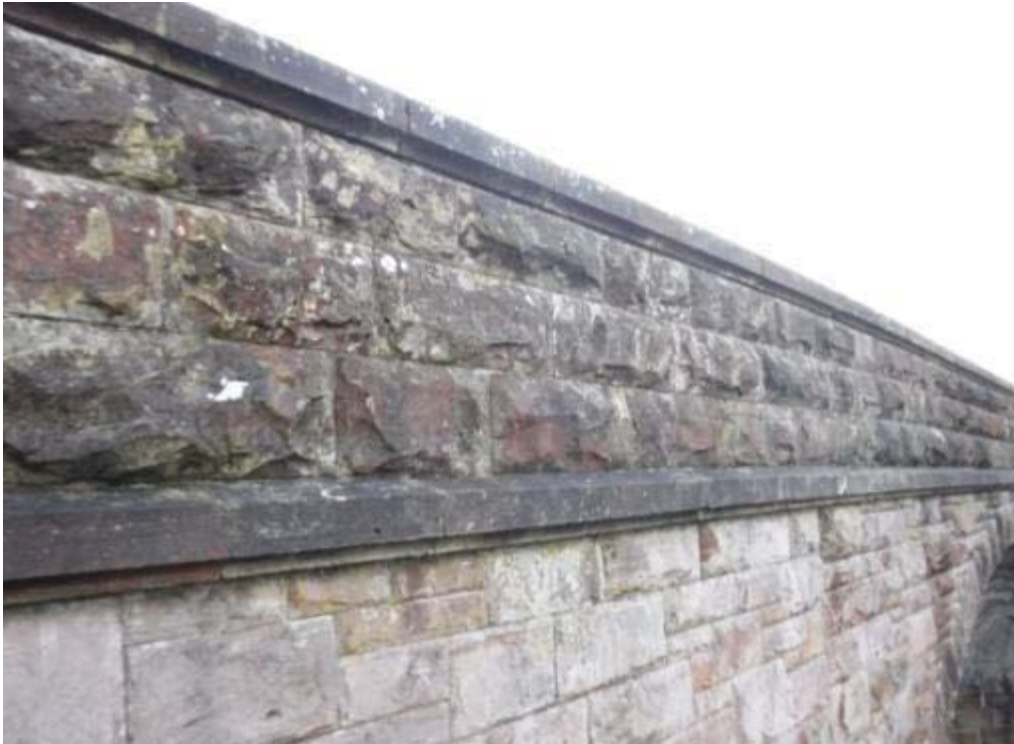
Photo No.123 - North outer parapet: Typical example of the condition.

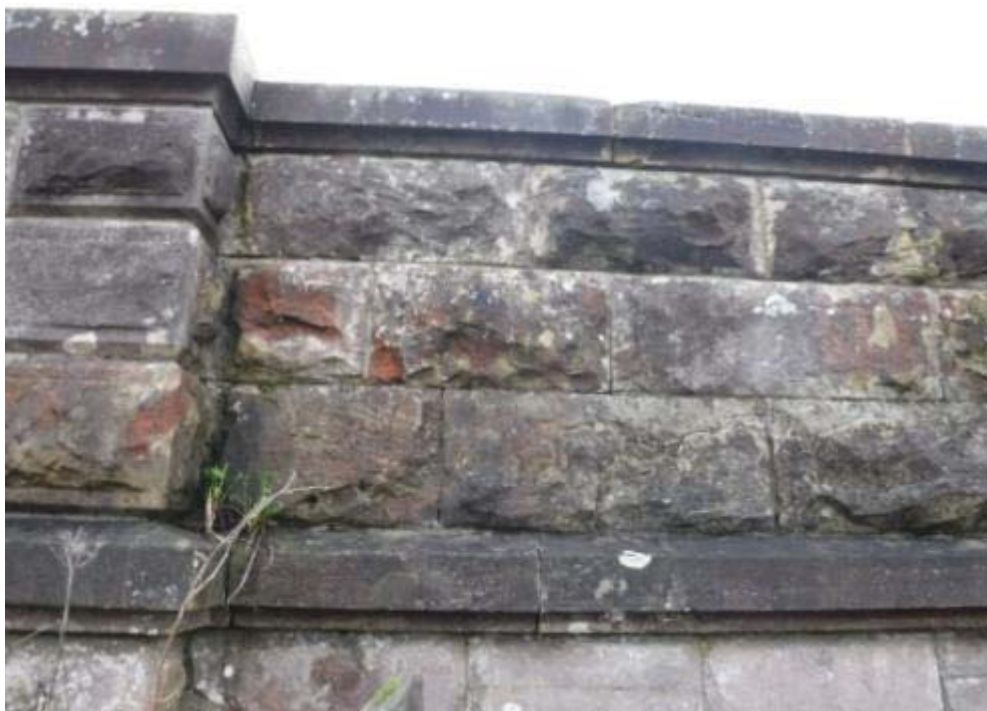
Photo No.124 - North outer parapet: Typical example of the condition.

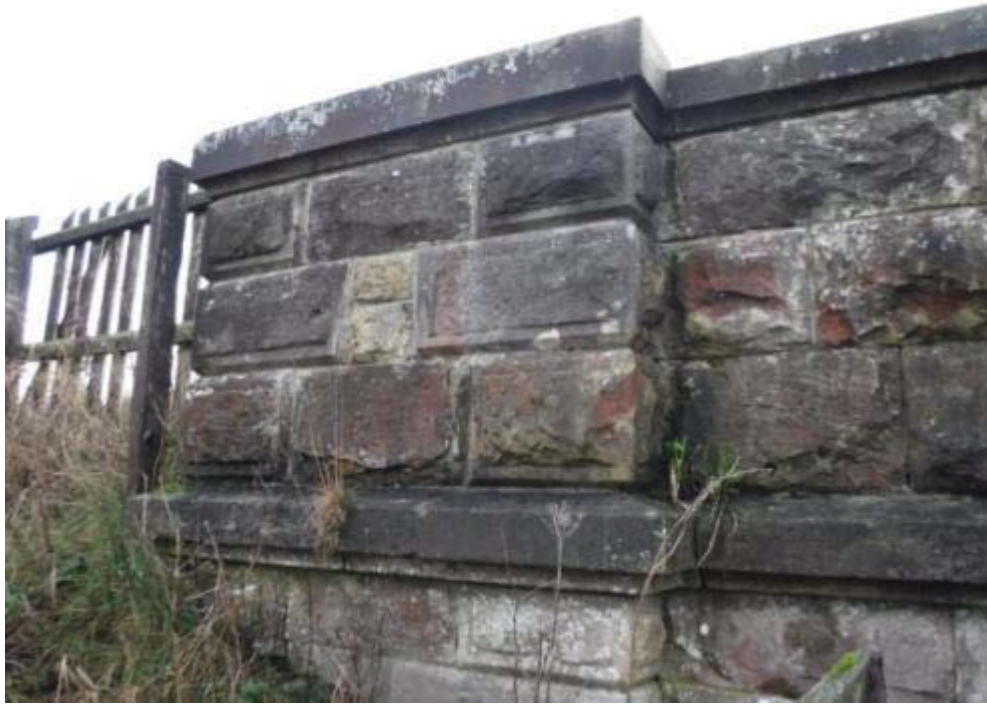
Photo No.125 - North outer parapet: Typical example of the condition of the N/E pilaster.

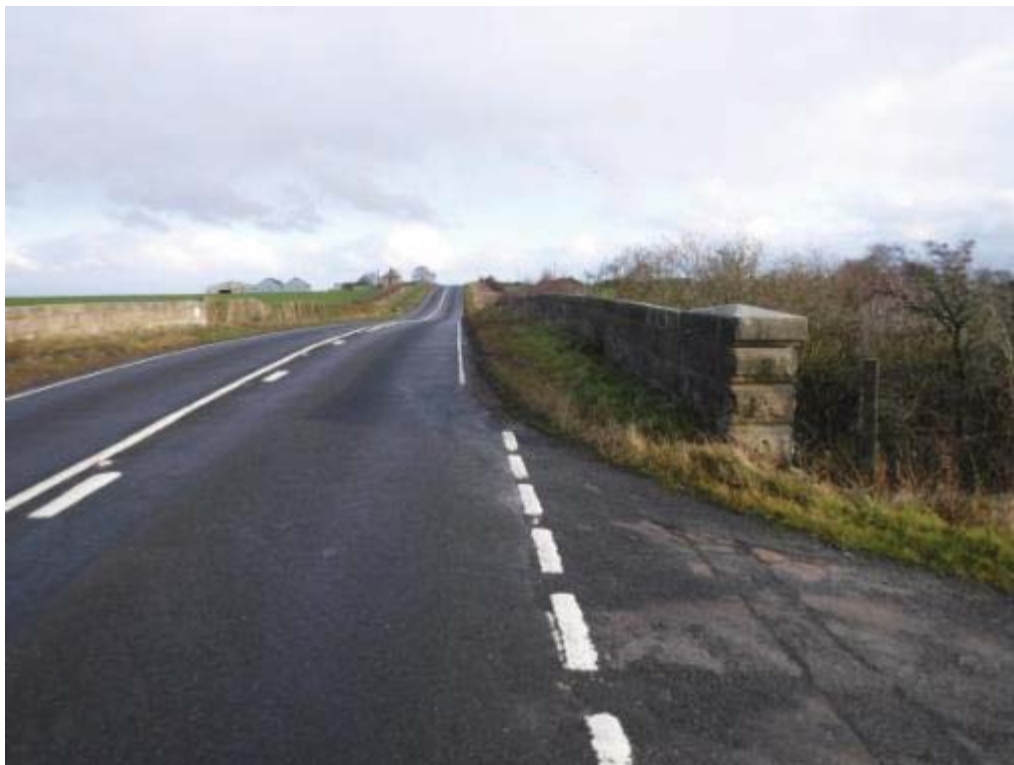
Photo No.126 - South roadside parapet: View.

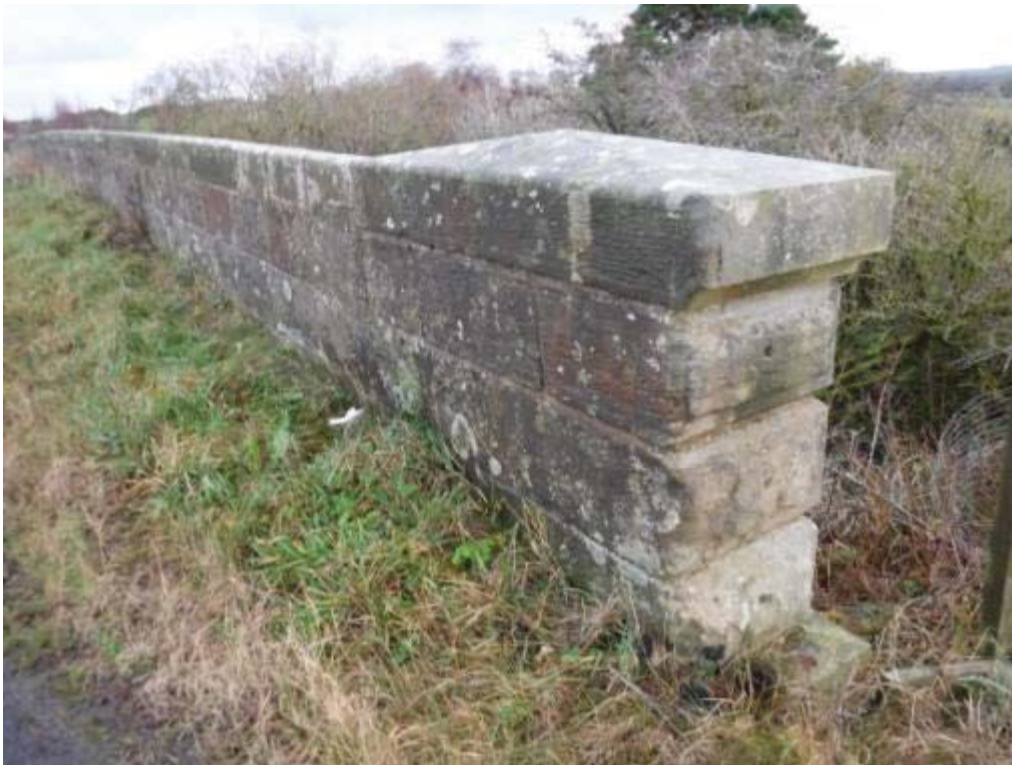
Photo No.128 - South roadside parapet: Previous vehicle impact damage to the S/W pilaster region rebuilt.

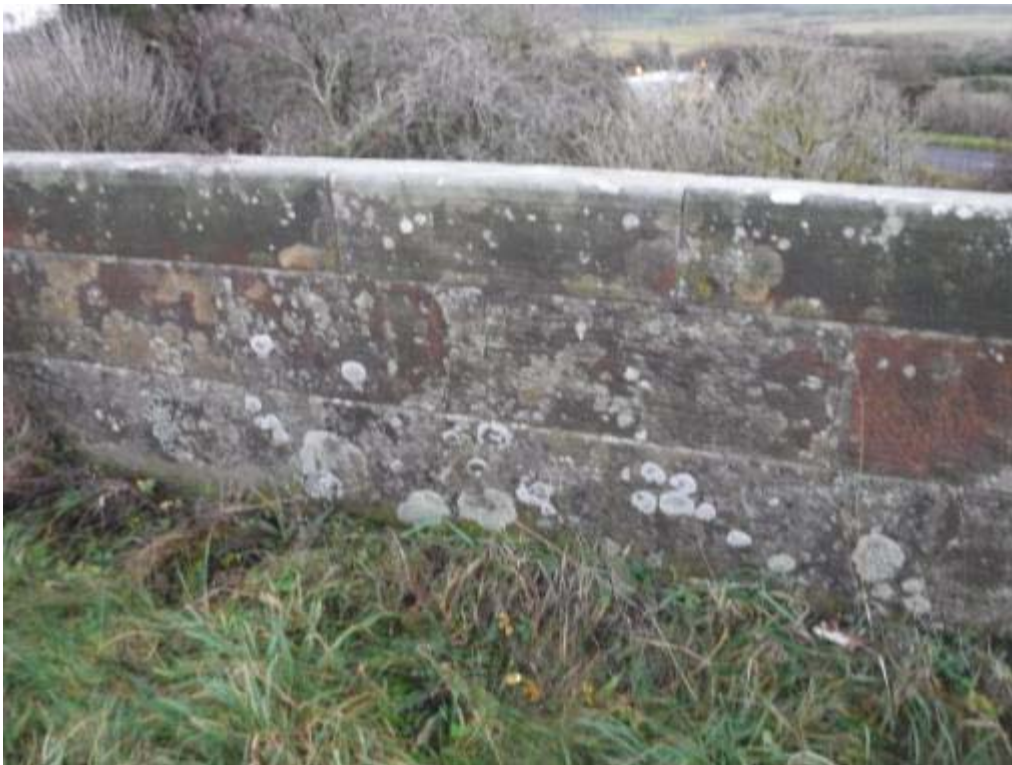
Photo No.130 - South roadside parapet: Typical example of the condition.

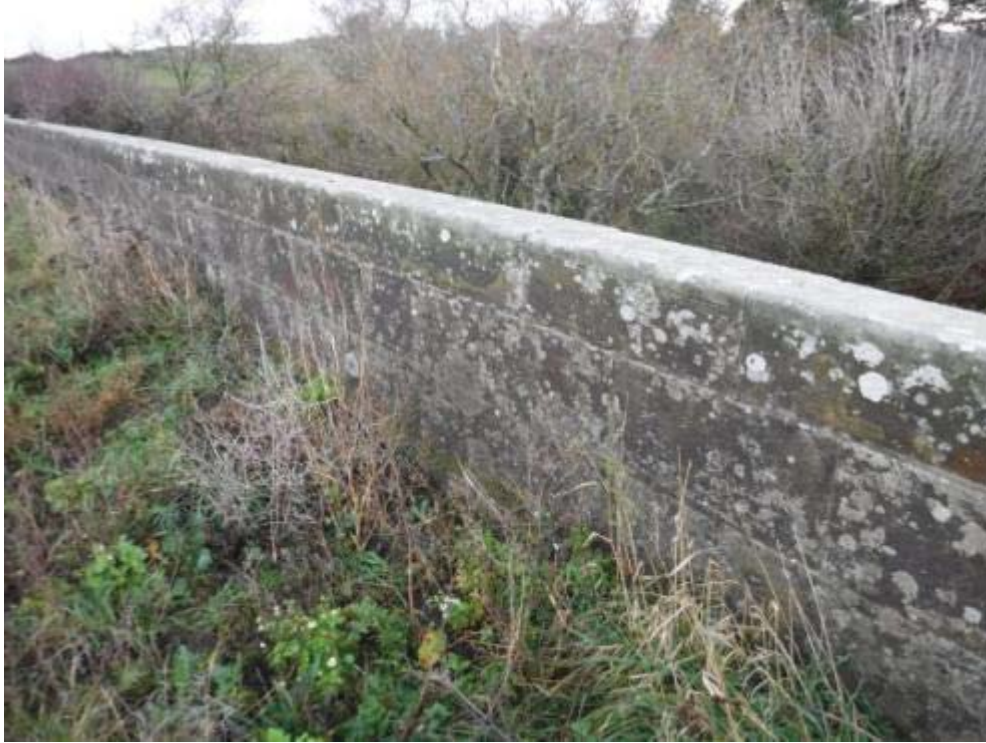
Photo No.131 - South roadside parapet: Typical example of the condition.

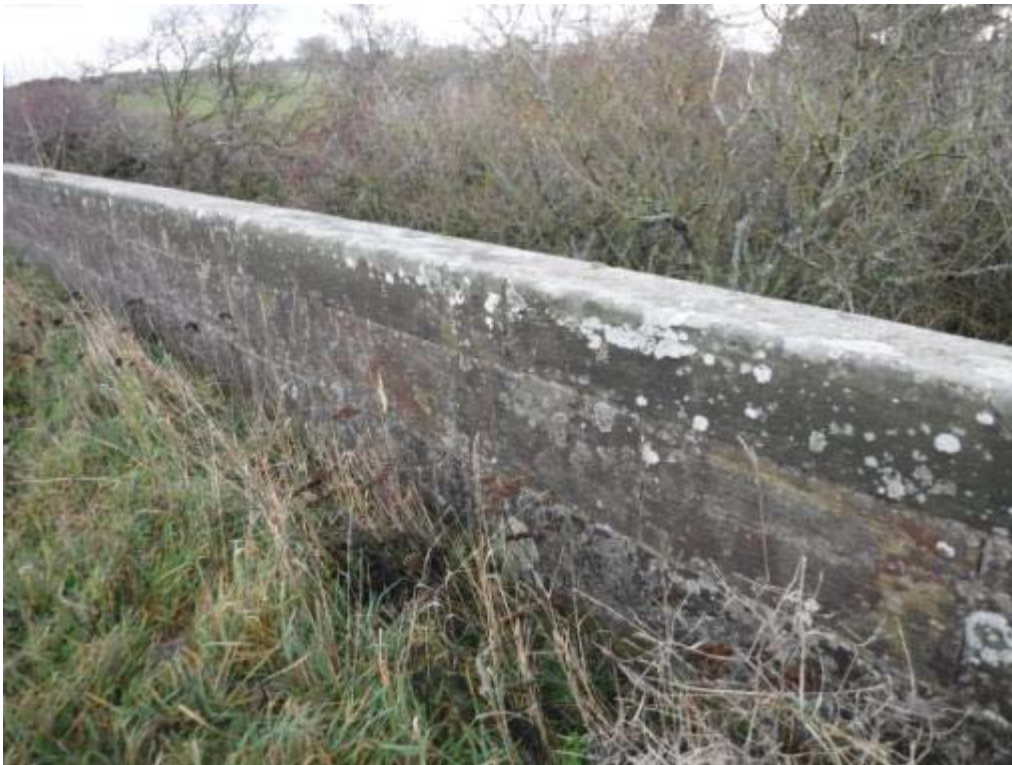
Photo No.132 - South roadside parapet: Typical example of the condition.

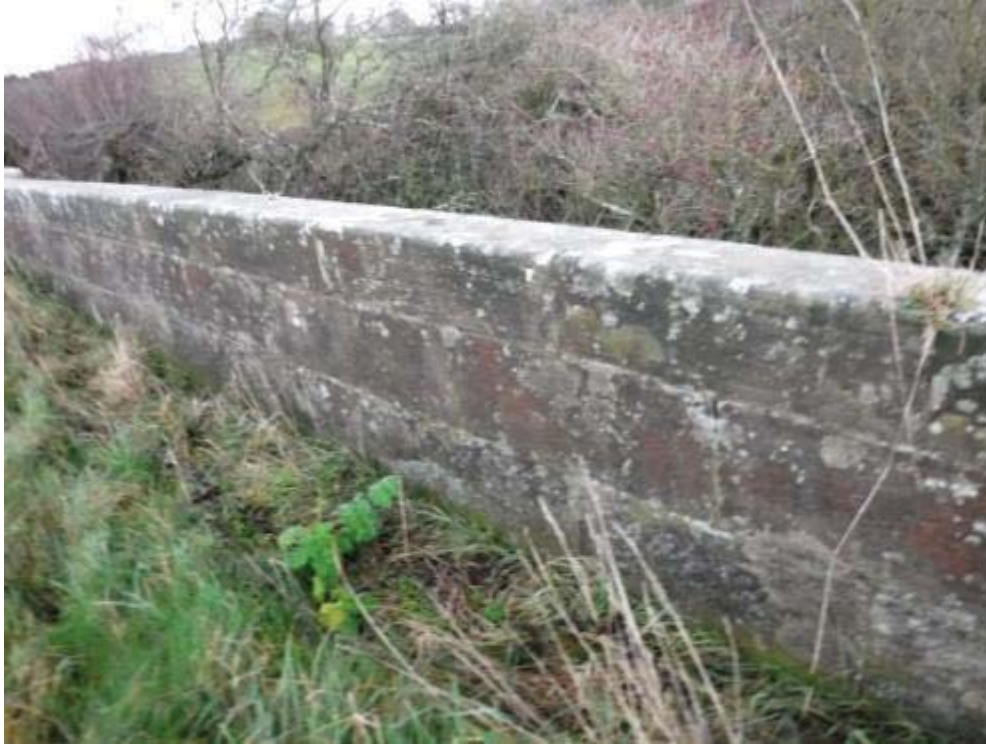
Photo No.133 - South roadside parapet: Typical example of the condition.

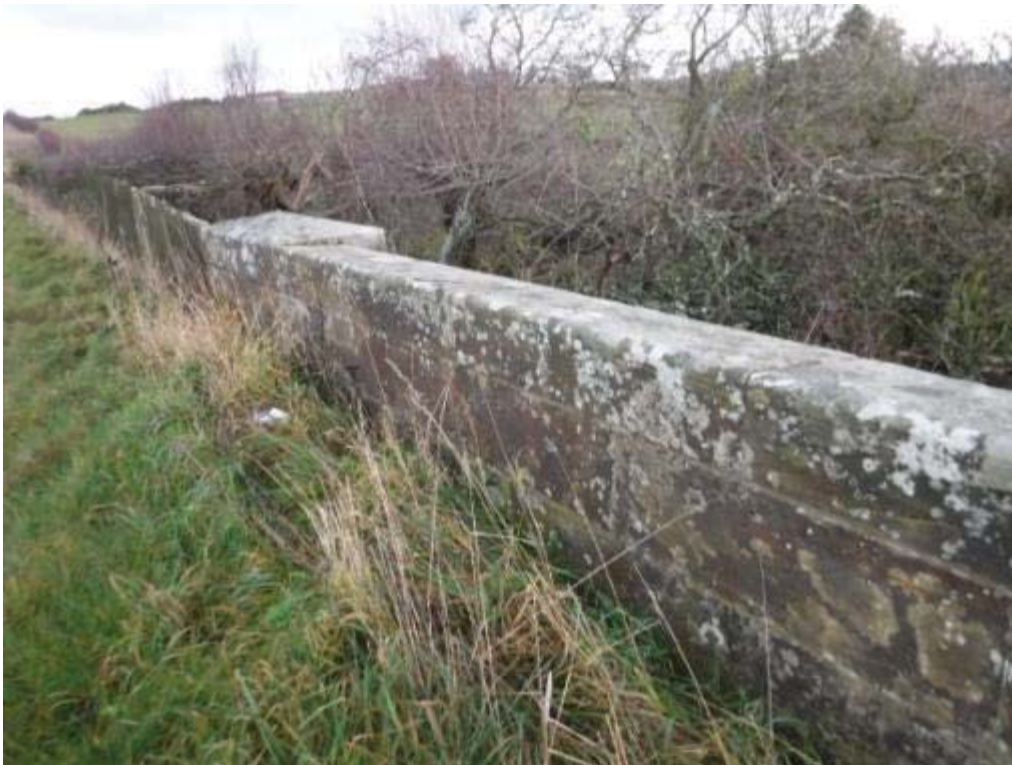
Photo No.134 - South roadside parapet: Typical example of the condition.

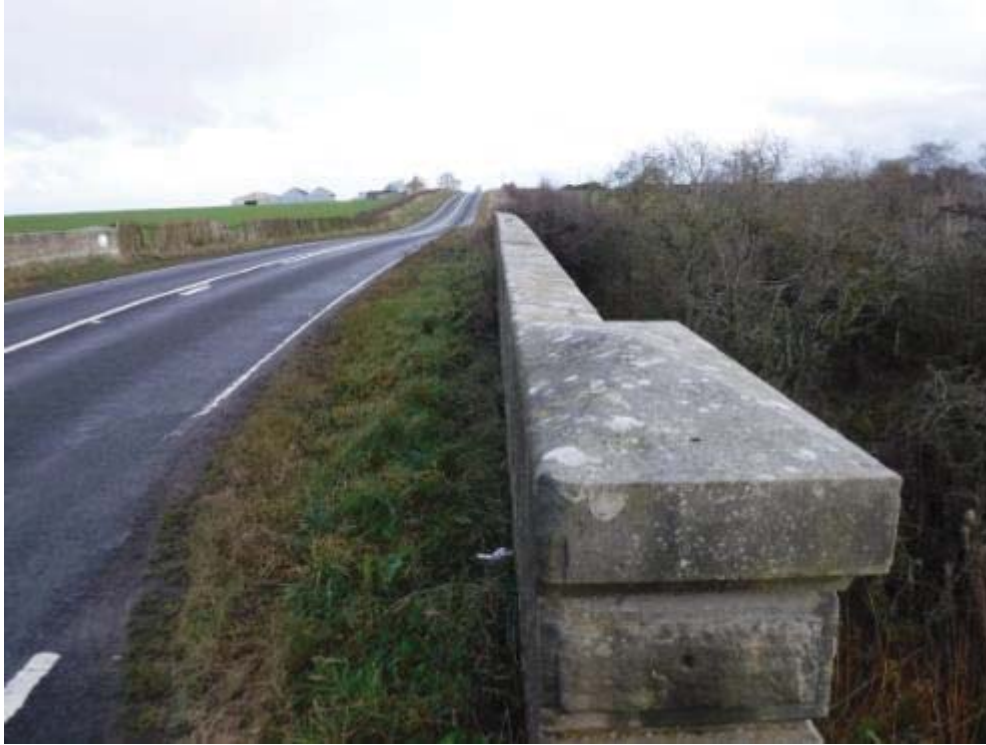
Photo No.135 - South roadside parapet: Typical example of the alignment & condition of the coping stones.

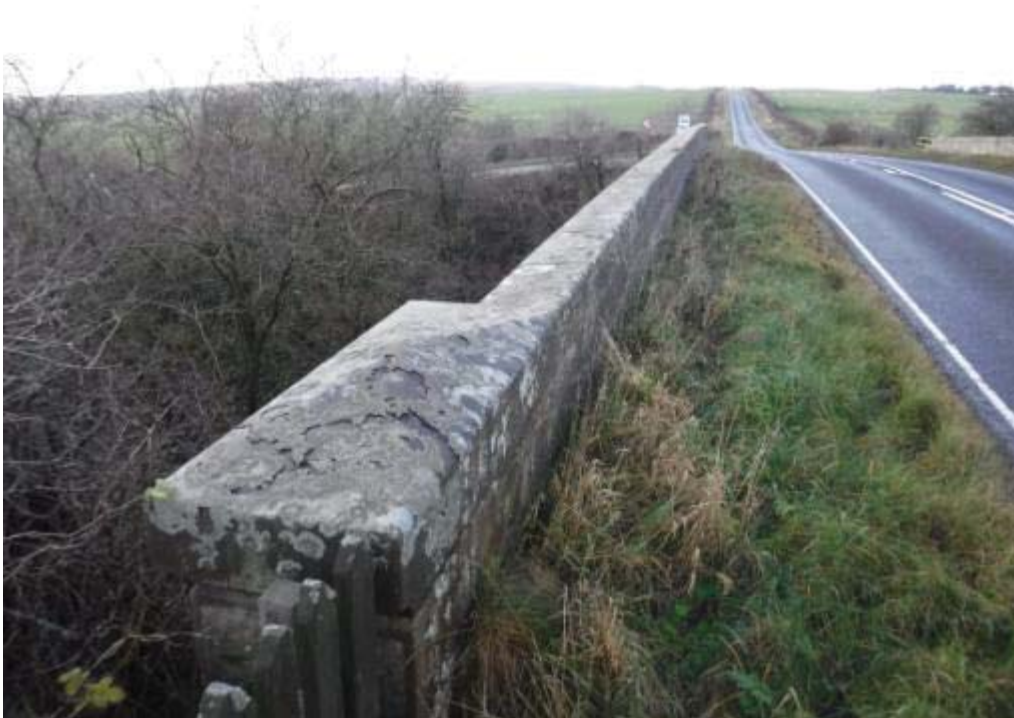
Photo No.136 - South roadside parapet: Typical example of the alignment & condition of the coping stones.

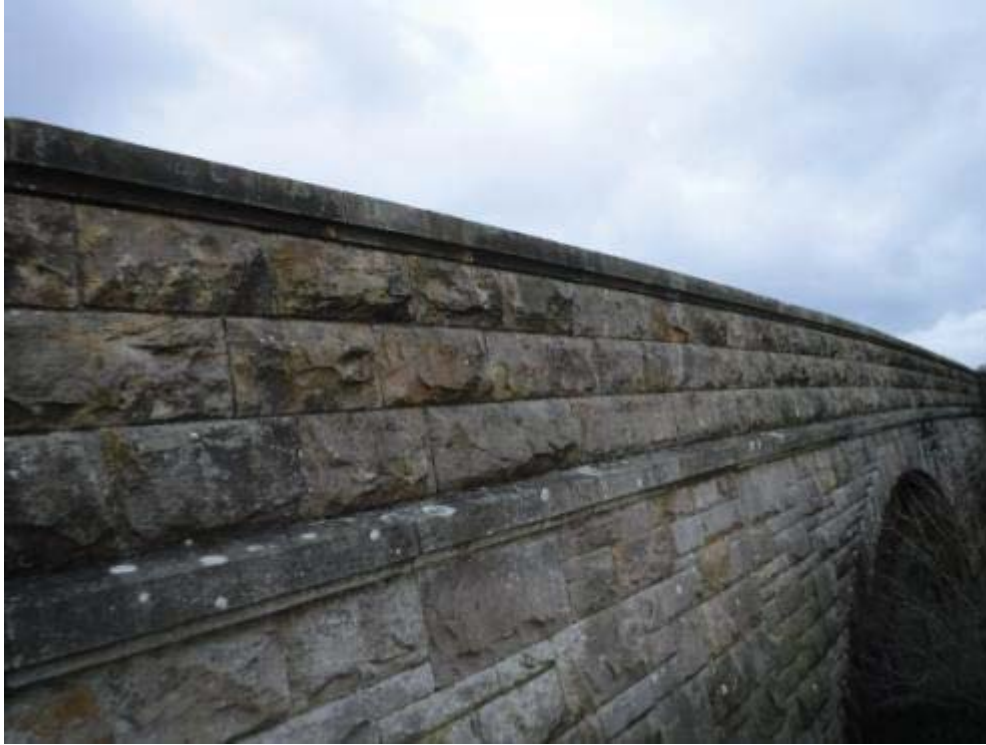
Photo No.139 - South outer parapet: Typical example of the condition.

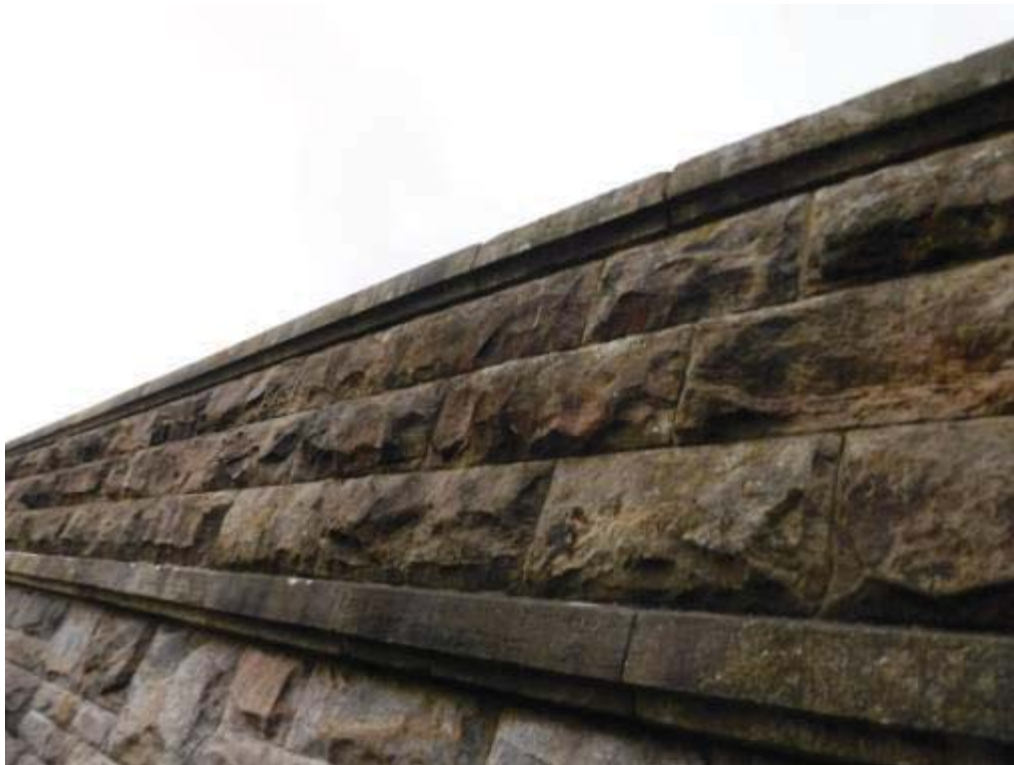
Photo No.140 - South outer parapet: Typical example of the condition.

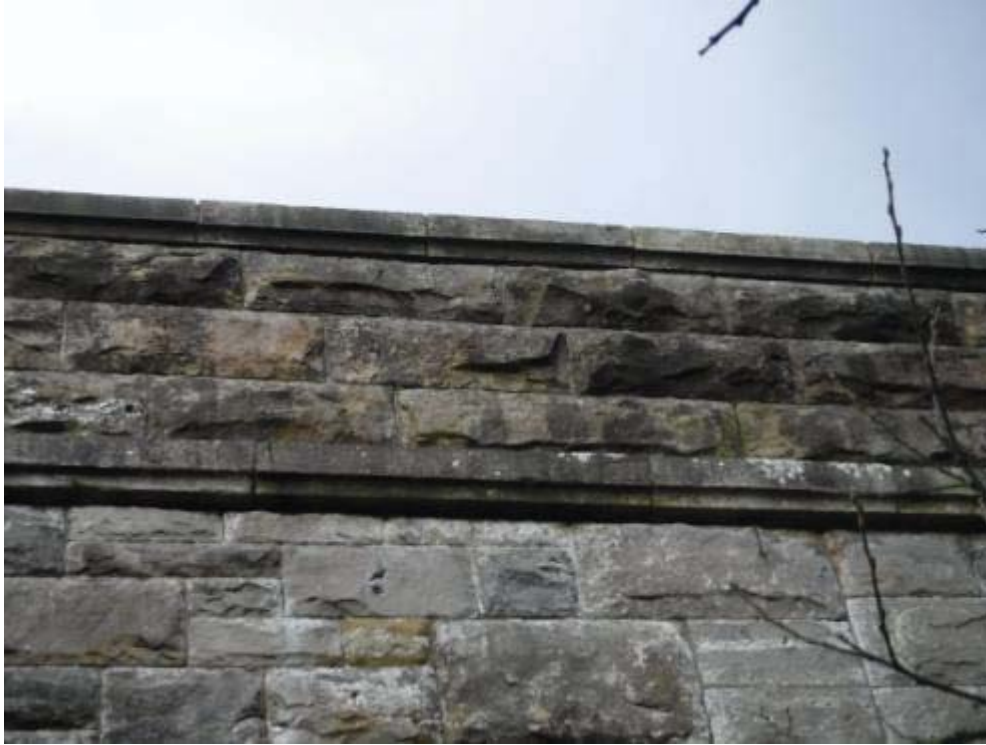
Photo No.141 - South outer parapet: Typical example of the condition.

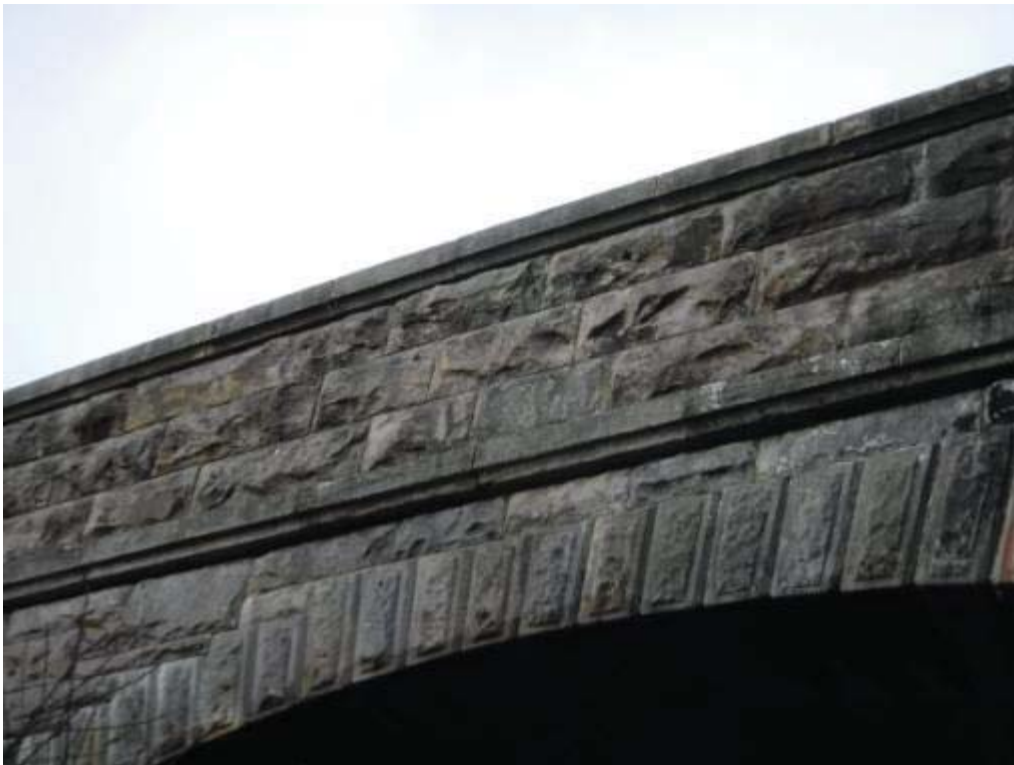
Photo No.142 - South outer parapet: Typical example of the condition.

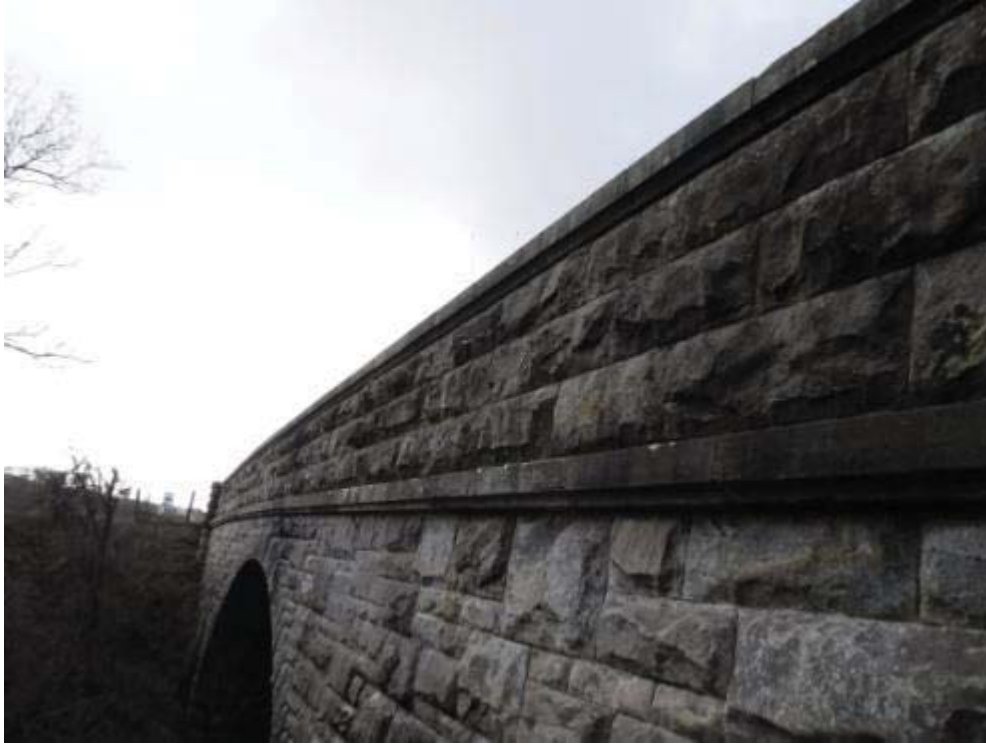
Photo No.143 - South outer parapet: Typical example of the condition.
