Historical Railways Estate

Structure Reference

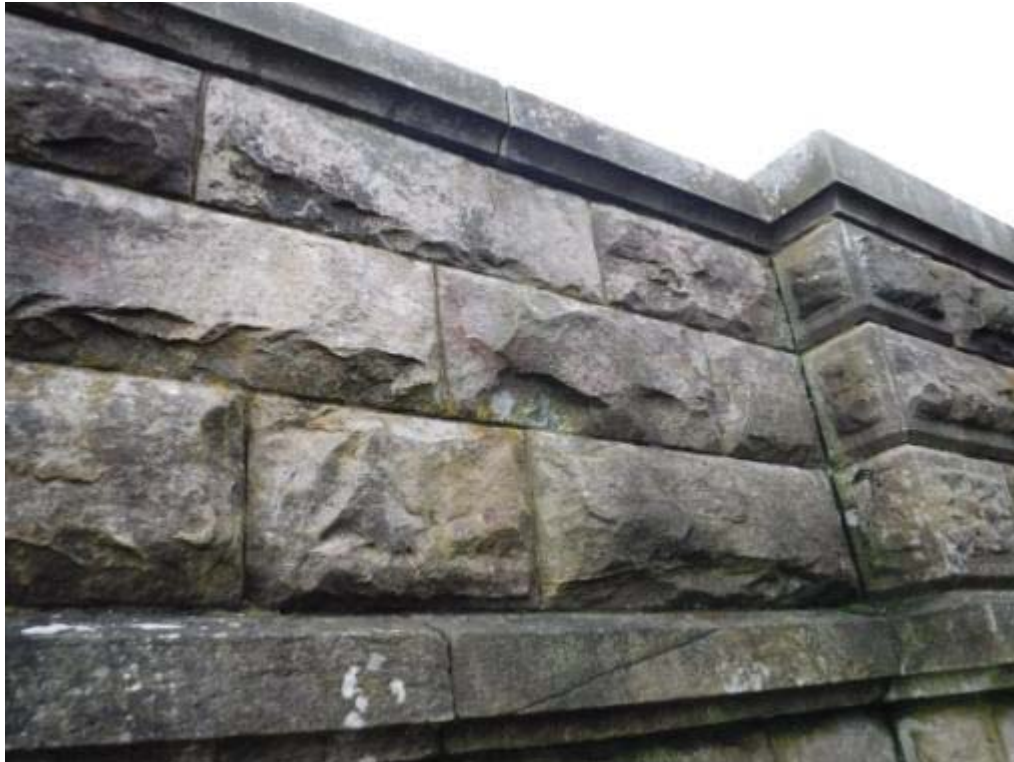
Photo No.144 - South outer parapet: Typical example of the condition.

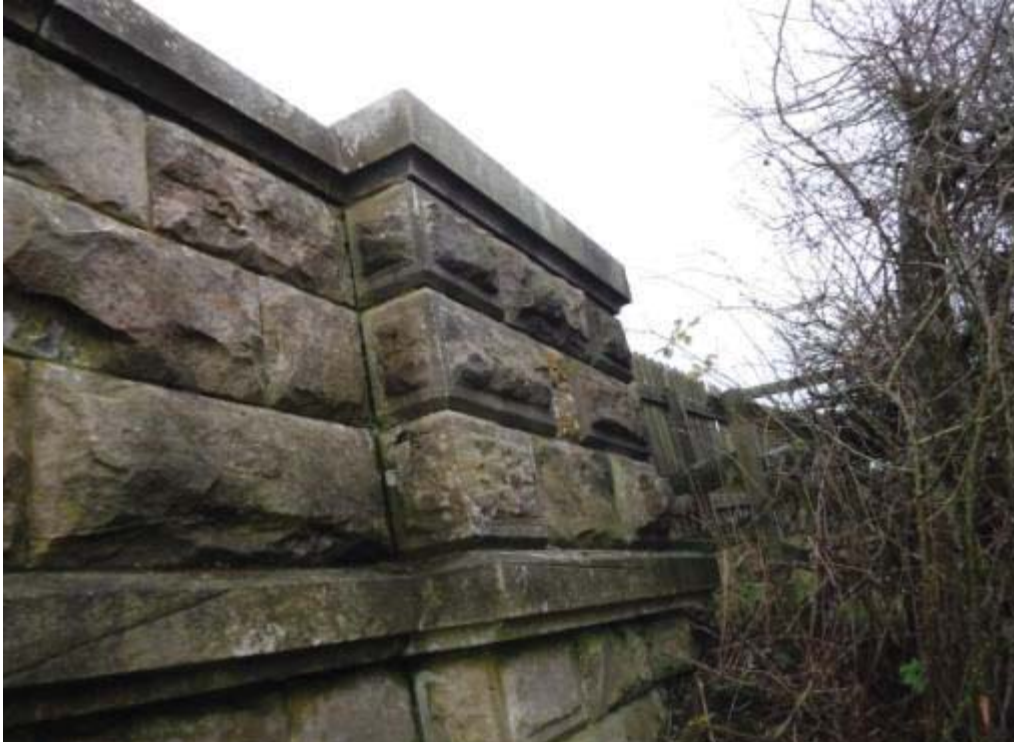
Photo No.145 - South outer parapet: Typical example of the condition of the S/E pilaster.

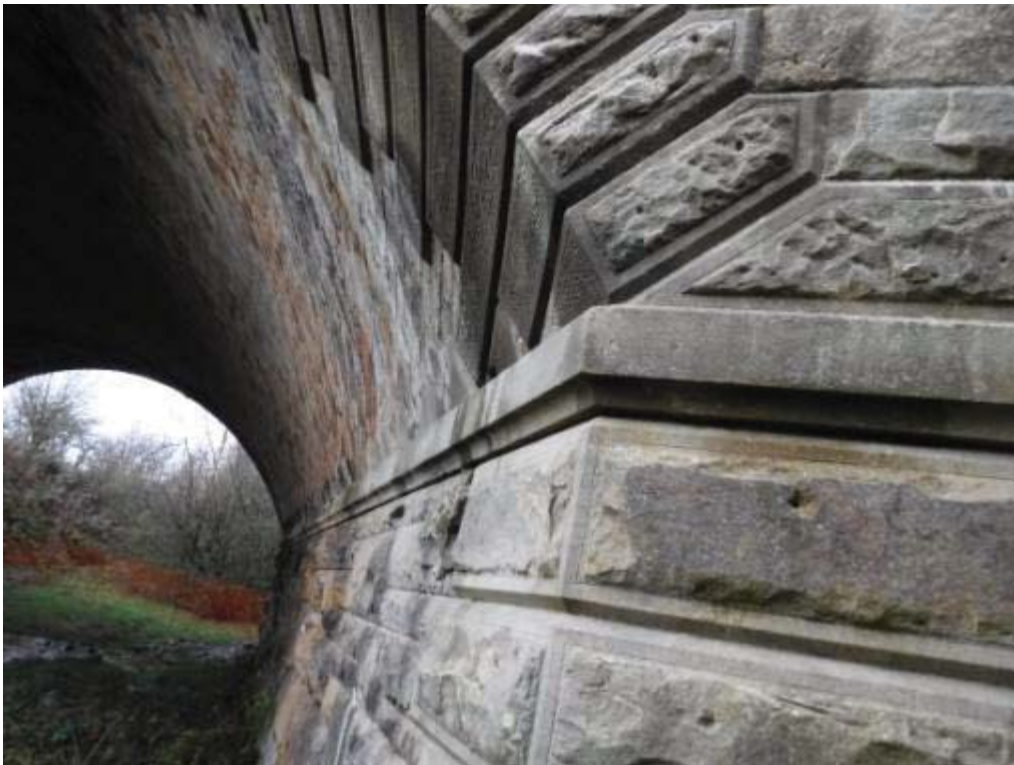
Photo No.146 - East springer course: View.

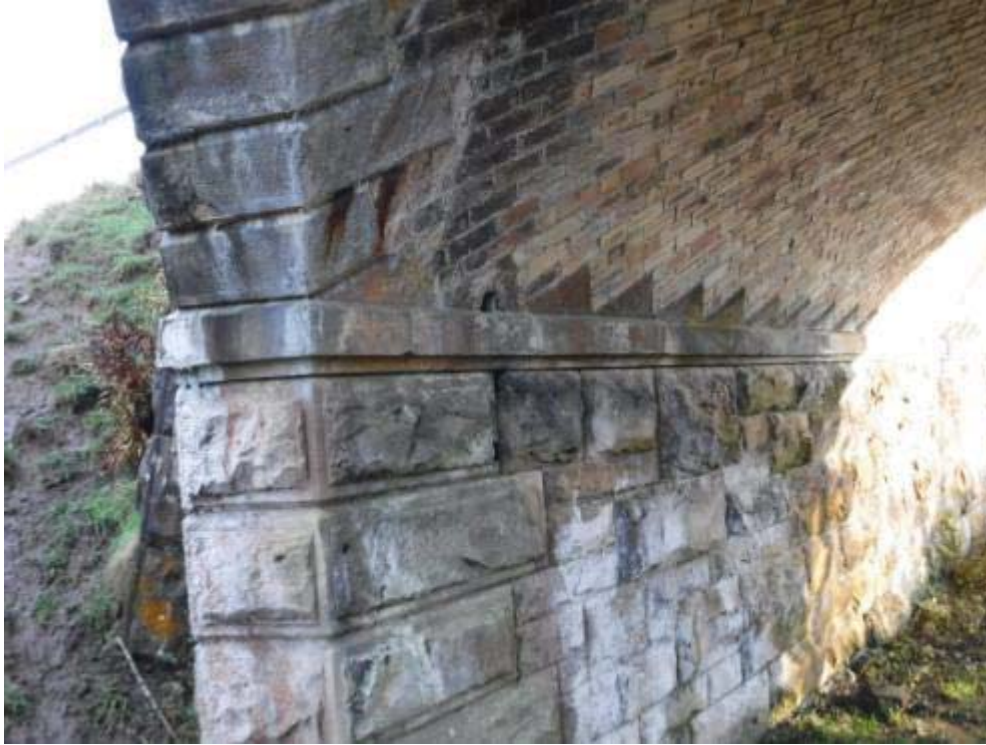
Photo No.149 - East springer course: Typical example of the condition.

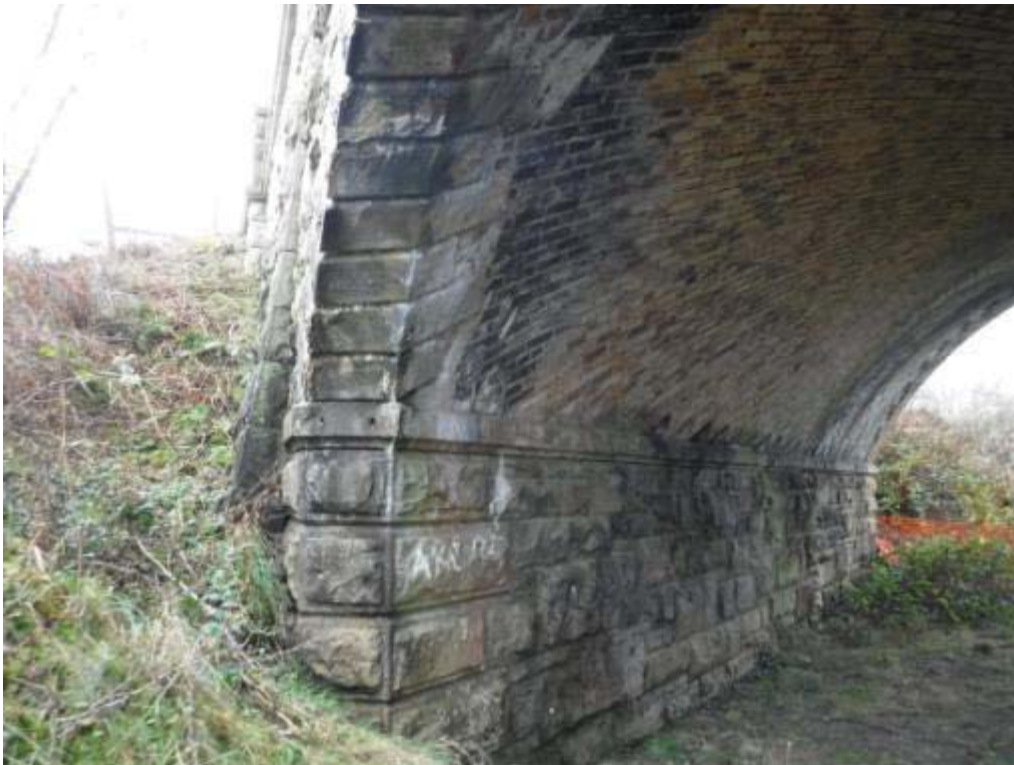
Photo No.150 - West springer course: View.

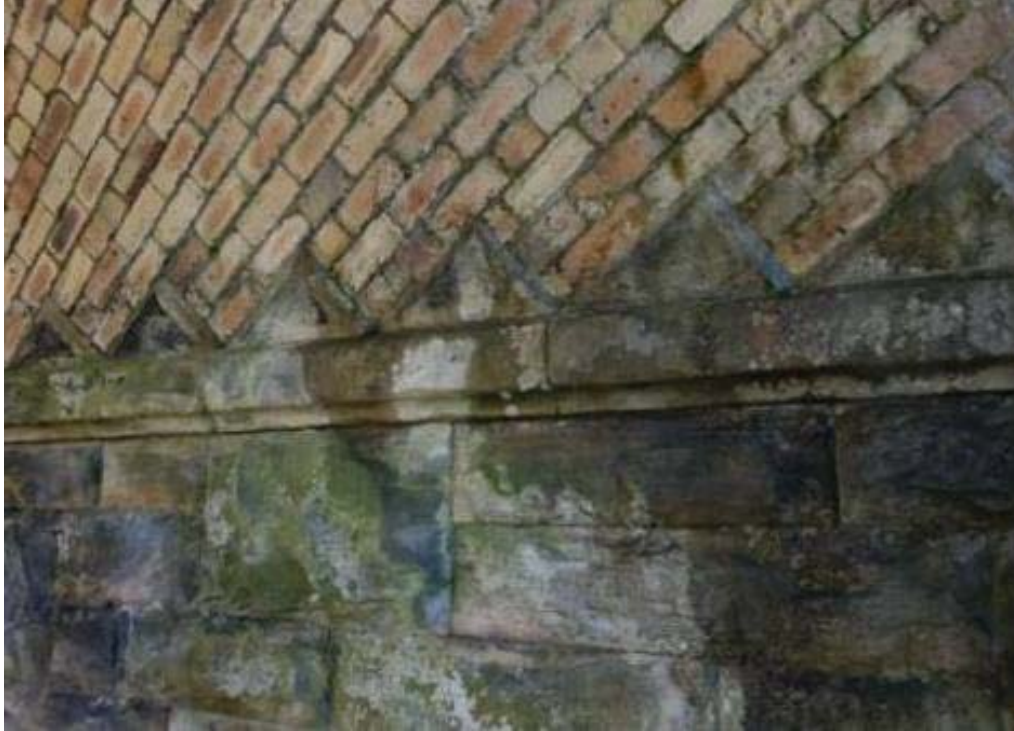
Photo No.151 - West springer course: Typical example of the condition.

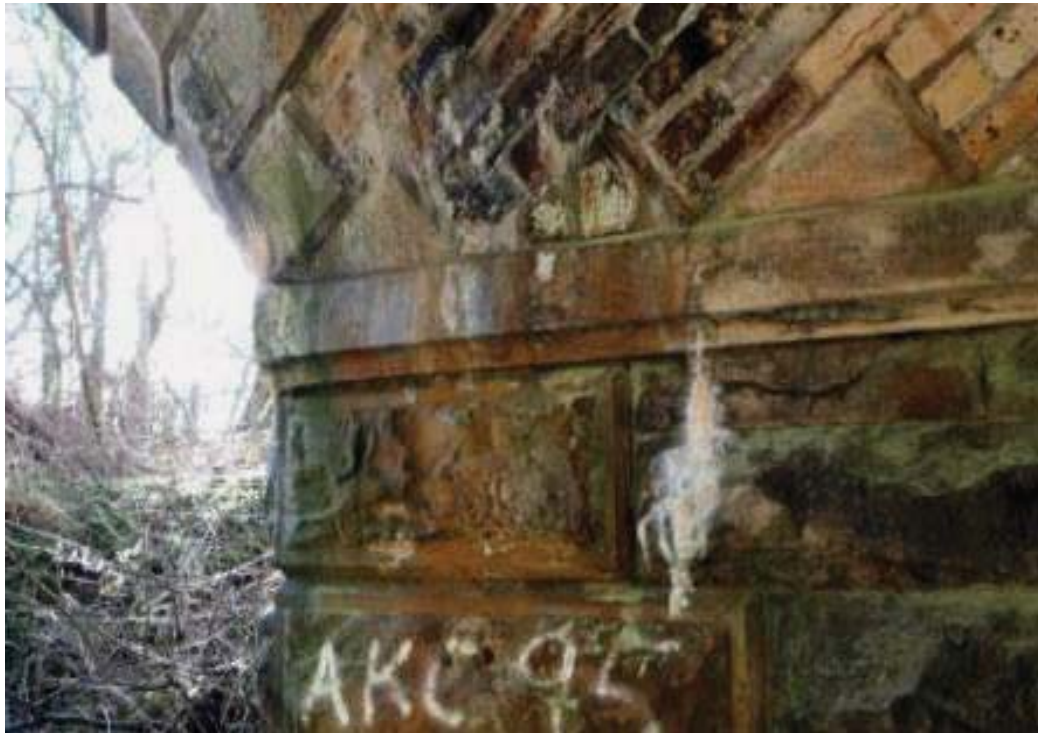
Photo No.152 - West springer course: Typical example of the condition at S/W return section.

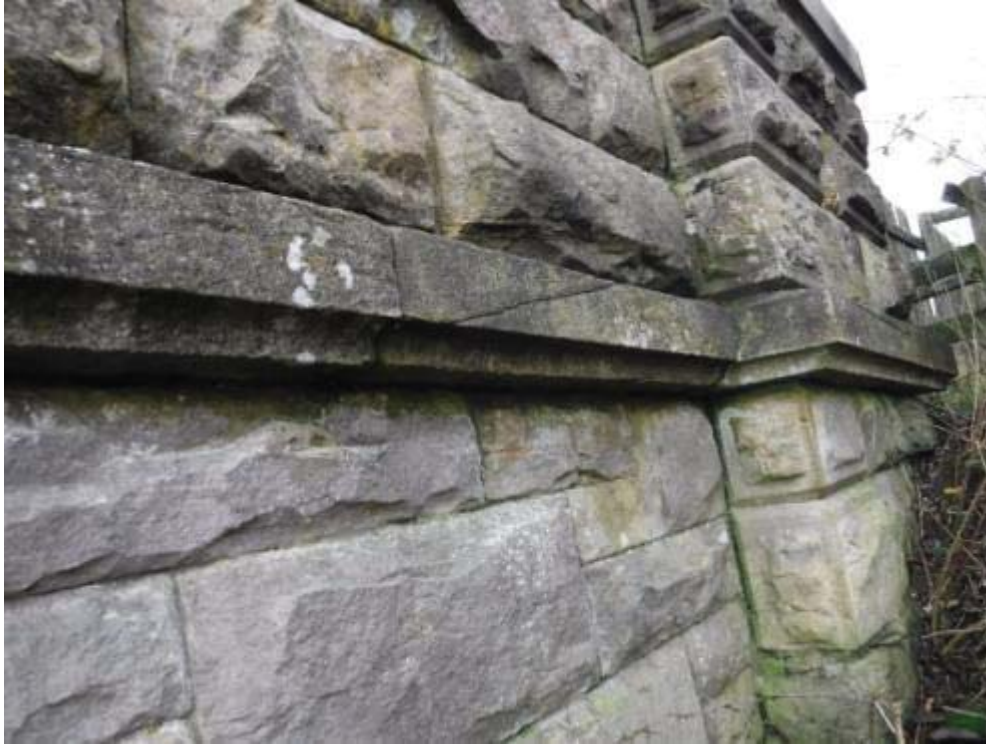
Photo No.155 - String course: Fissure type fractured stonework.

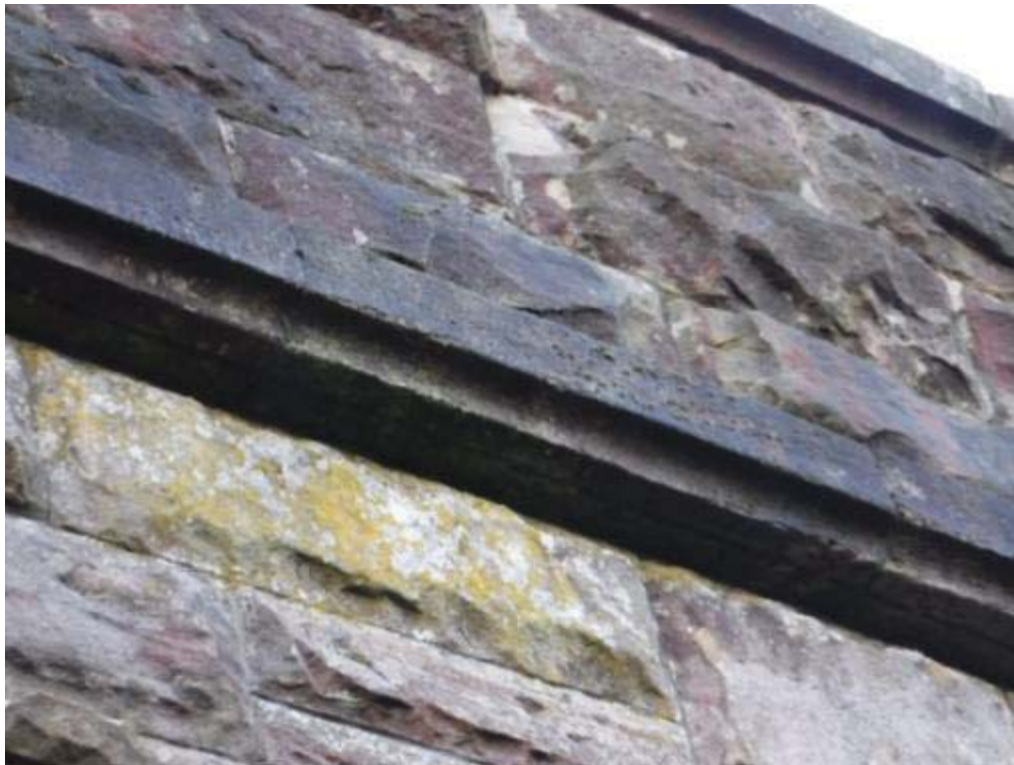
Photo No.156 - String course: Typical example of the condition.

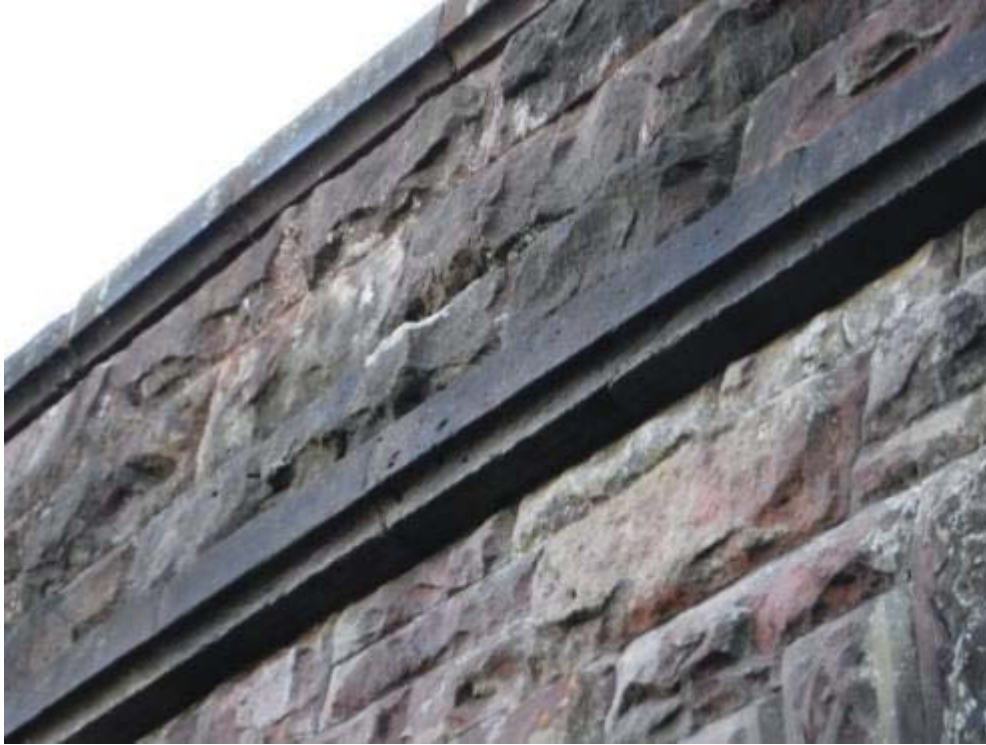
Photo No.157 - String course: Typical example of the condition.

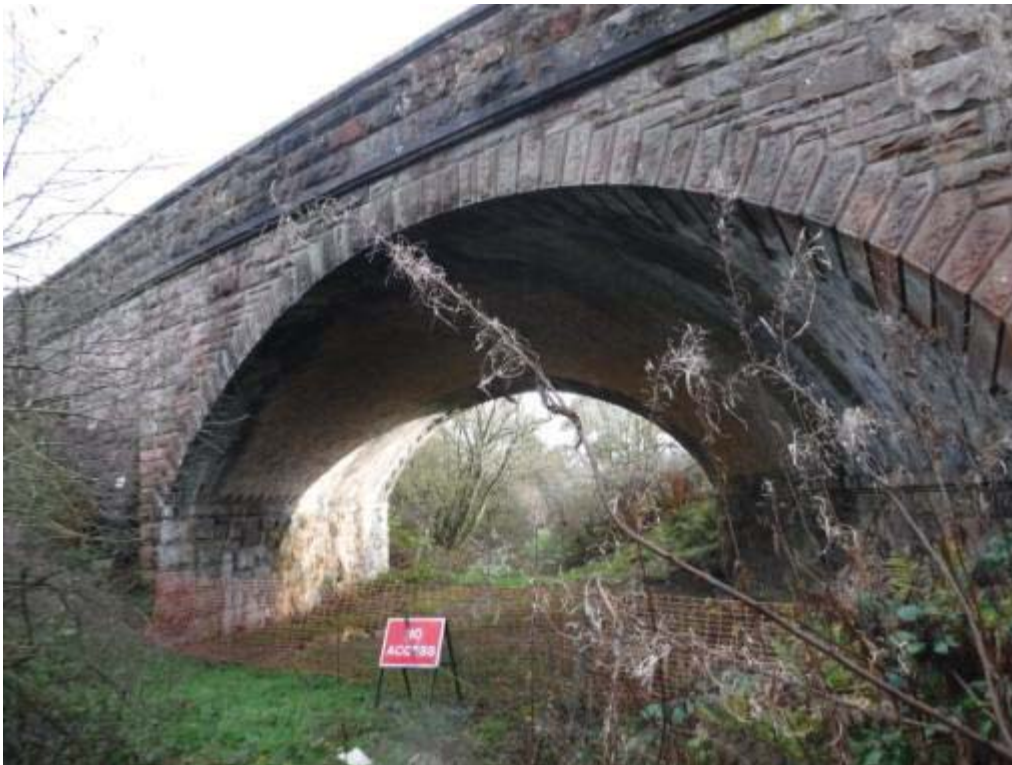
Photo No.158 - Area under the structure: Typical example.

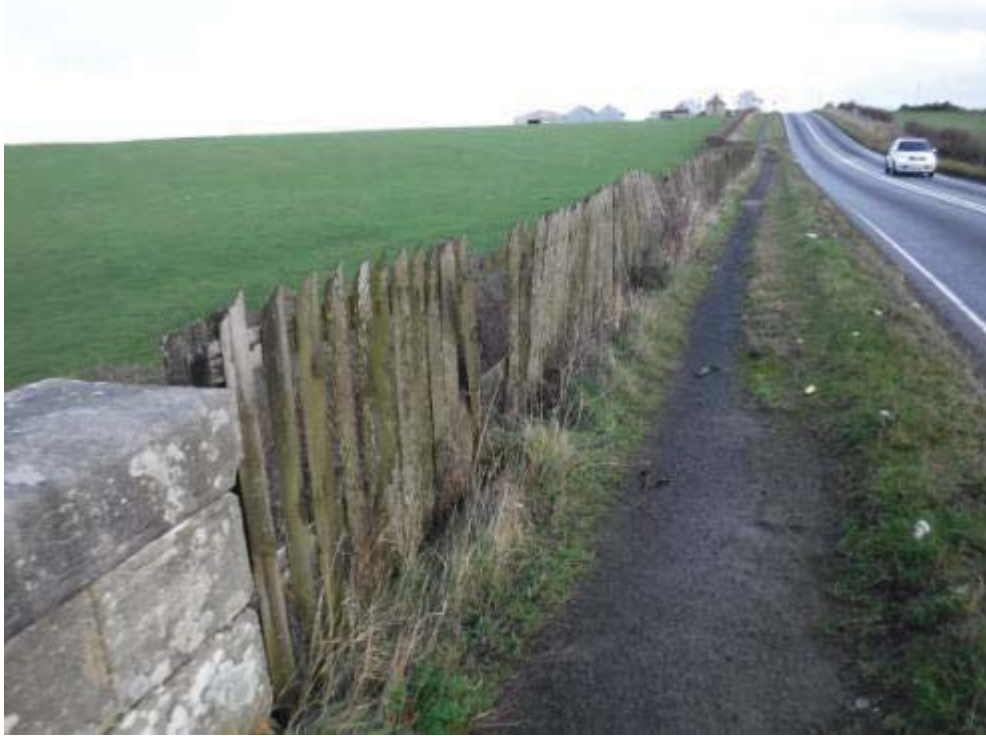
Photo No.159 - Approach road fencing: Typical example of the condition at N/E end.

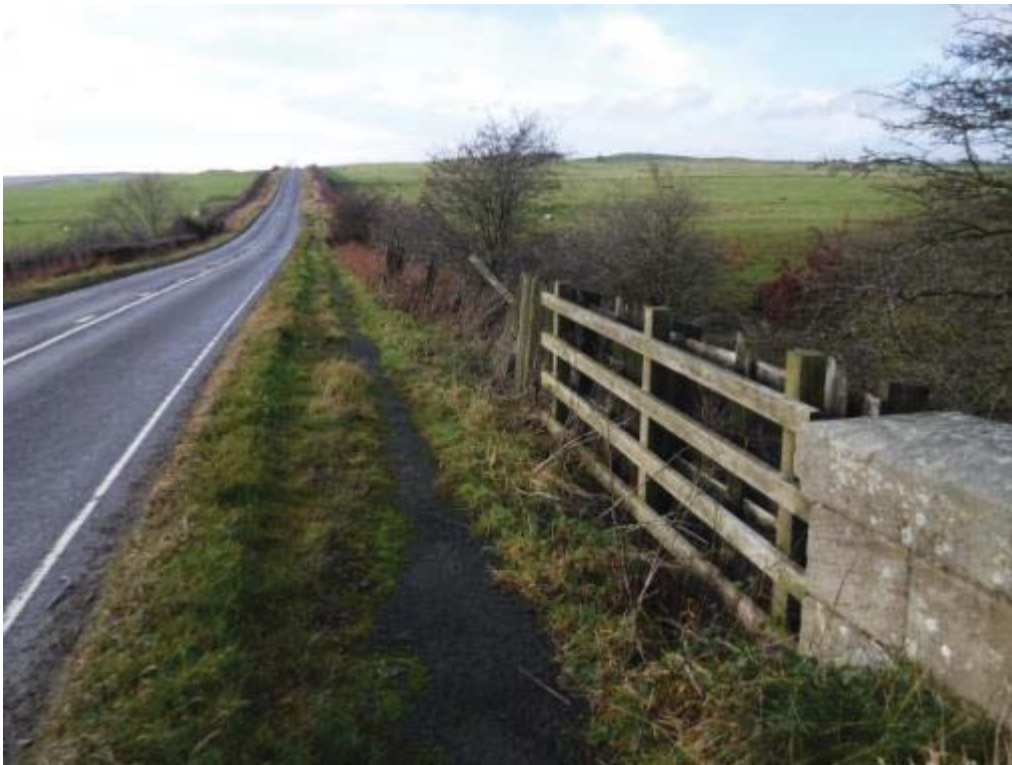
Photo No.160 - Approach road fencing: Typical example of the condition at N/W end.

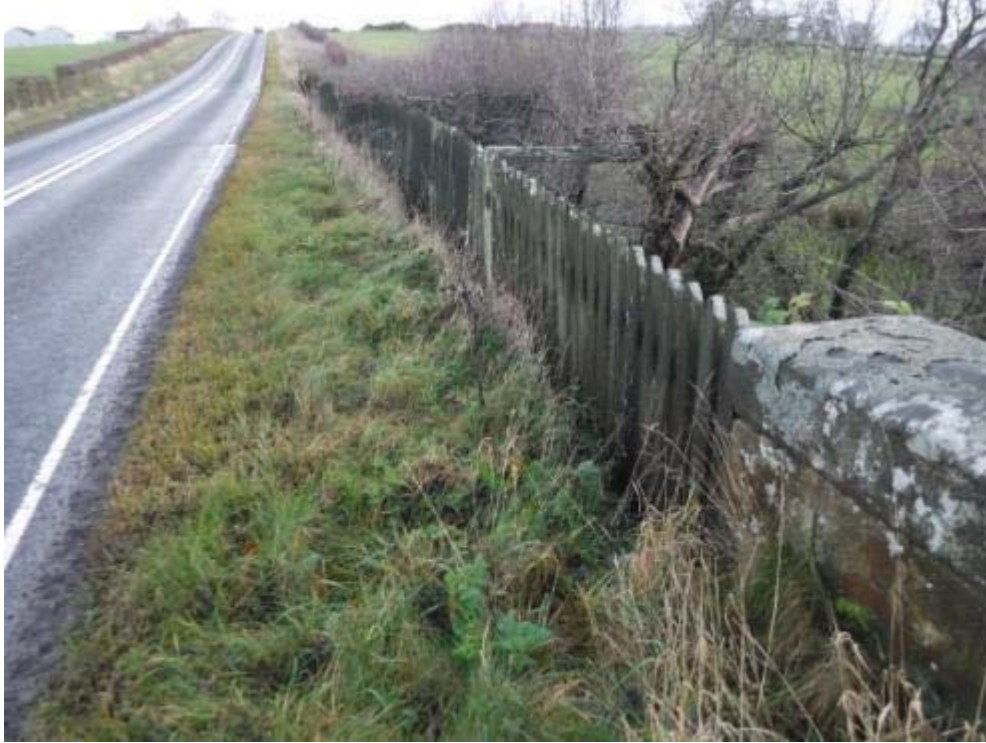
Photo No.161 - Approach road fencing: Typical example of the condition at S/E end.

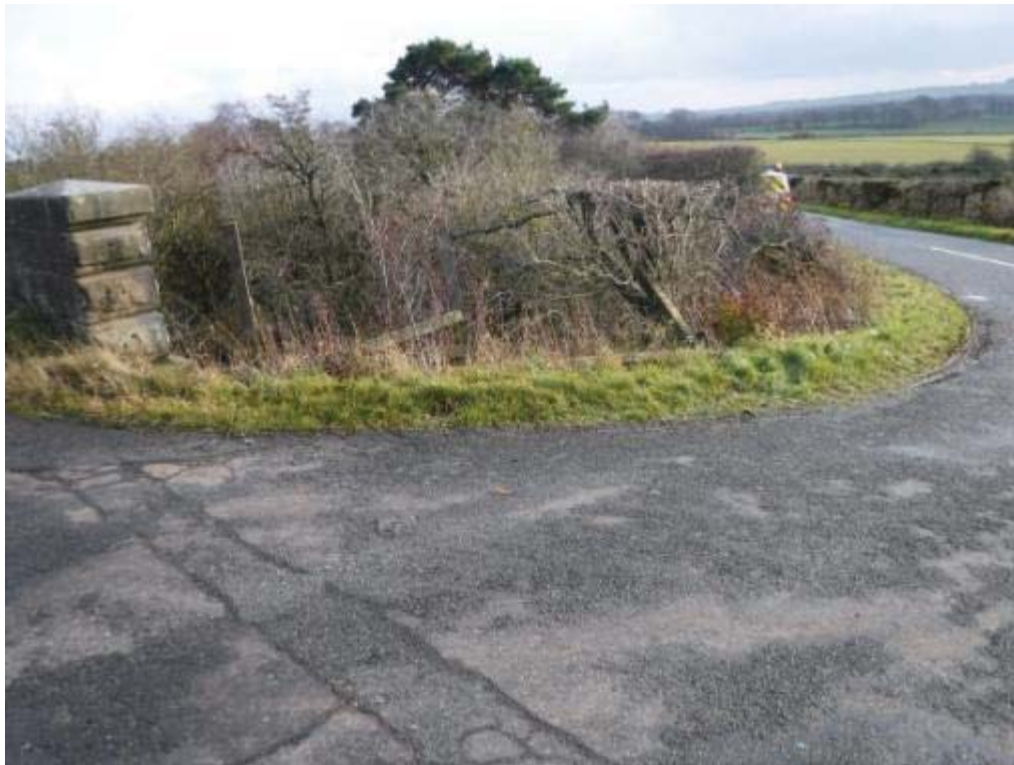
Photo No.162 - Approach road fencing: Typical example of the condition at S/W end.

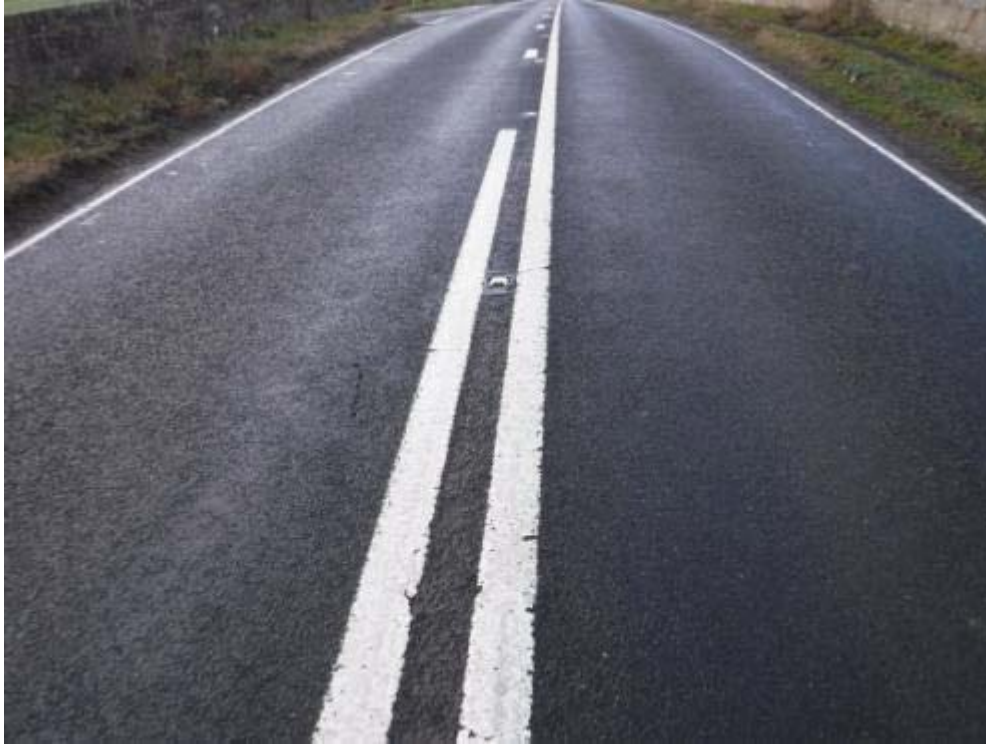
Photo No.163 - Road surface: Typical example of the condition.

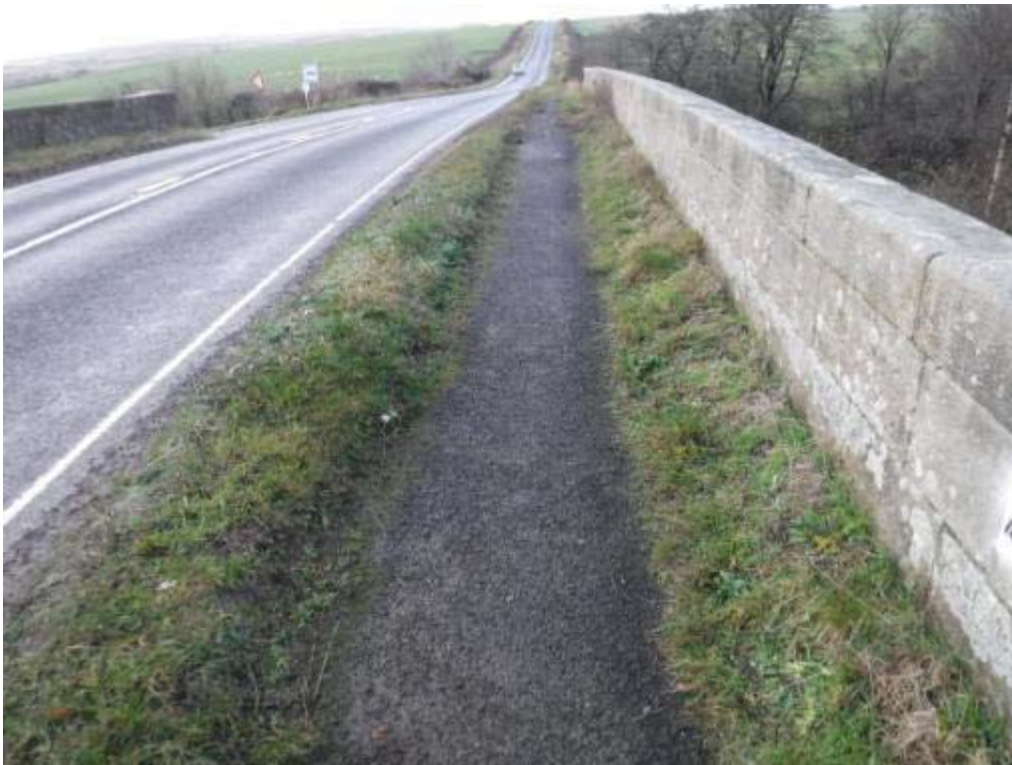
Photo No.164 - Footpath surface: Typical example of the condition.

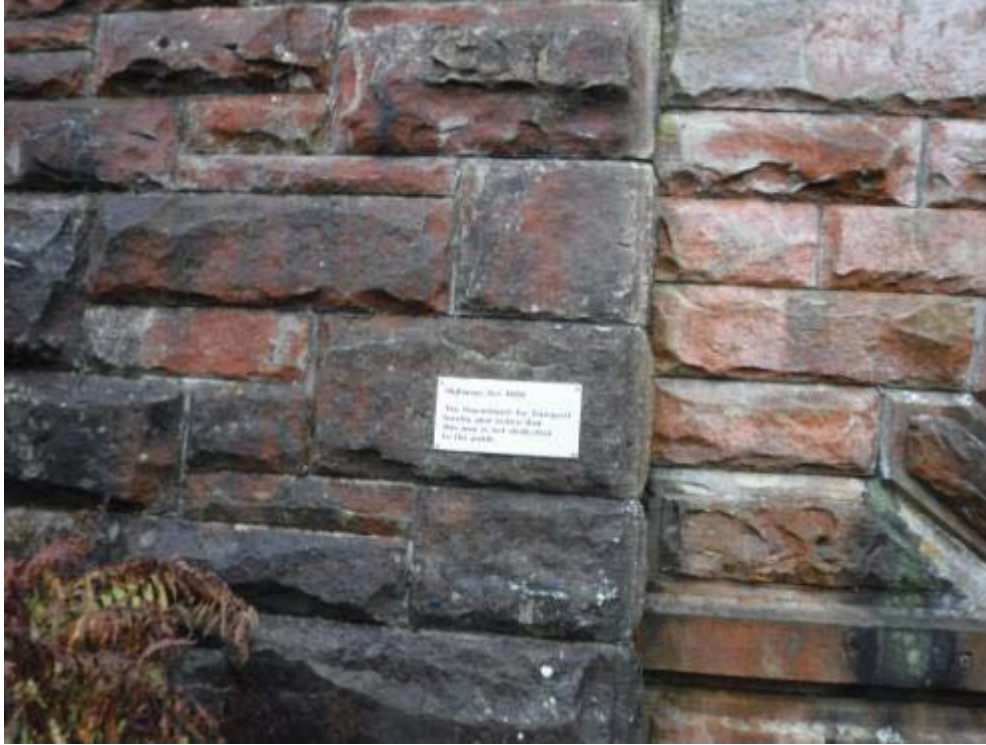
Photo No.165 - Non - Dedication plate: Typical example of the condition.

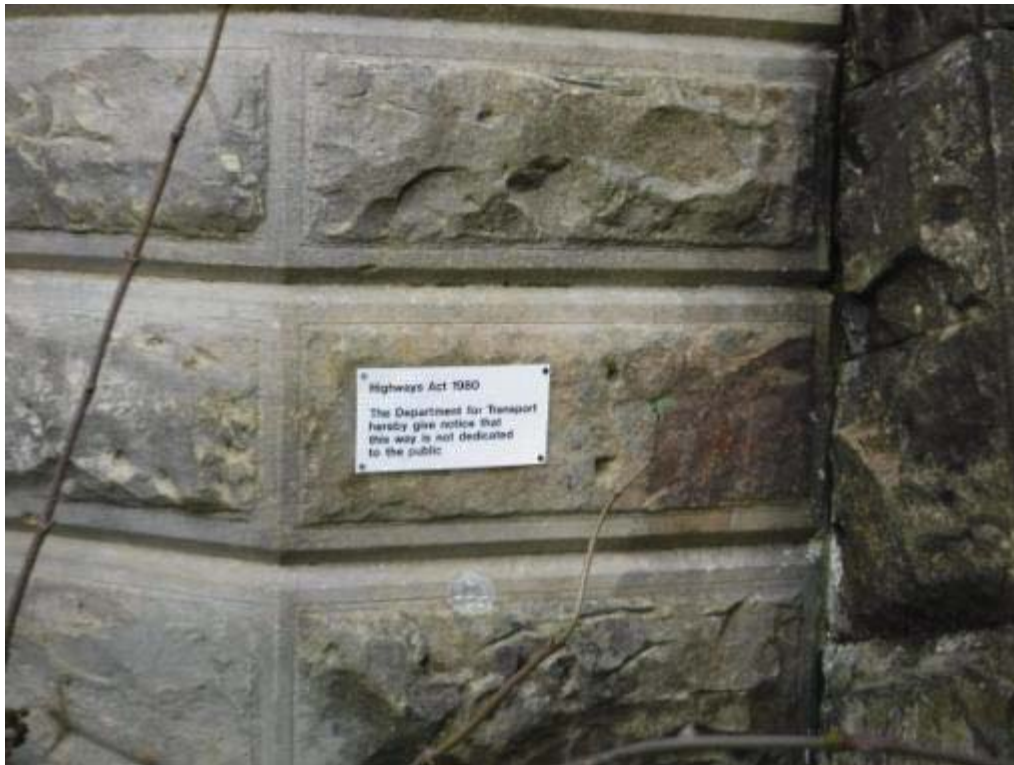
Photo No.166 - Non - Dedication plate: Typical example of the condition.

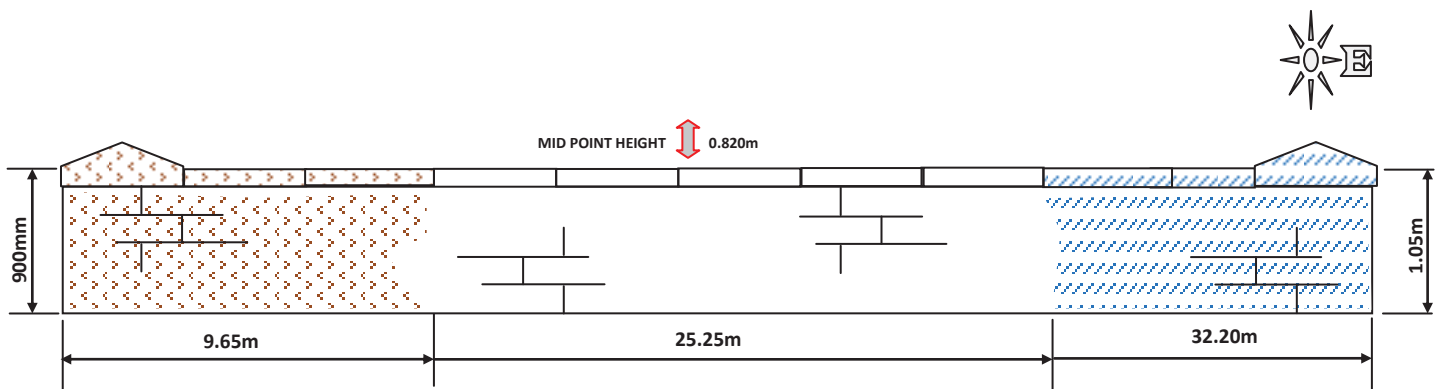
Highways Agency Historical Railways Estate
Structures Examinations Parapet Risk Assessment Report

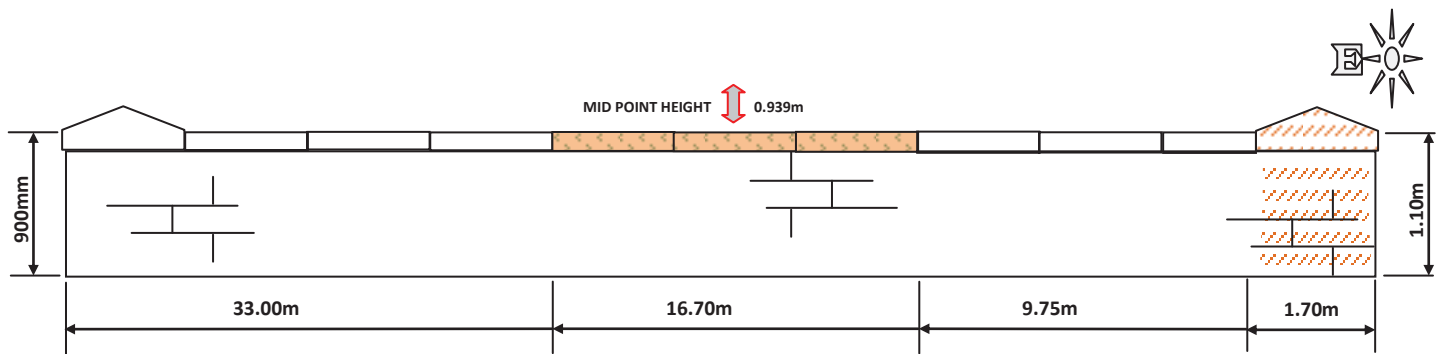
Examiner Input for Parapet Risk Assessment

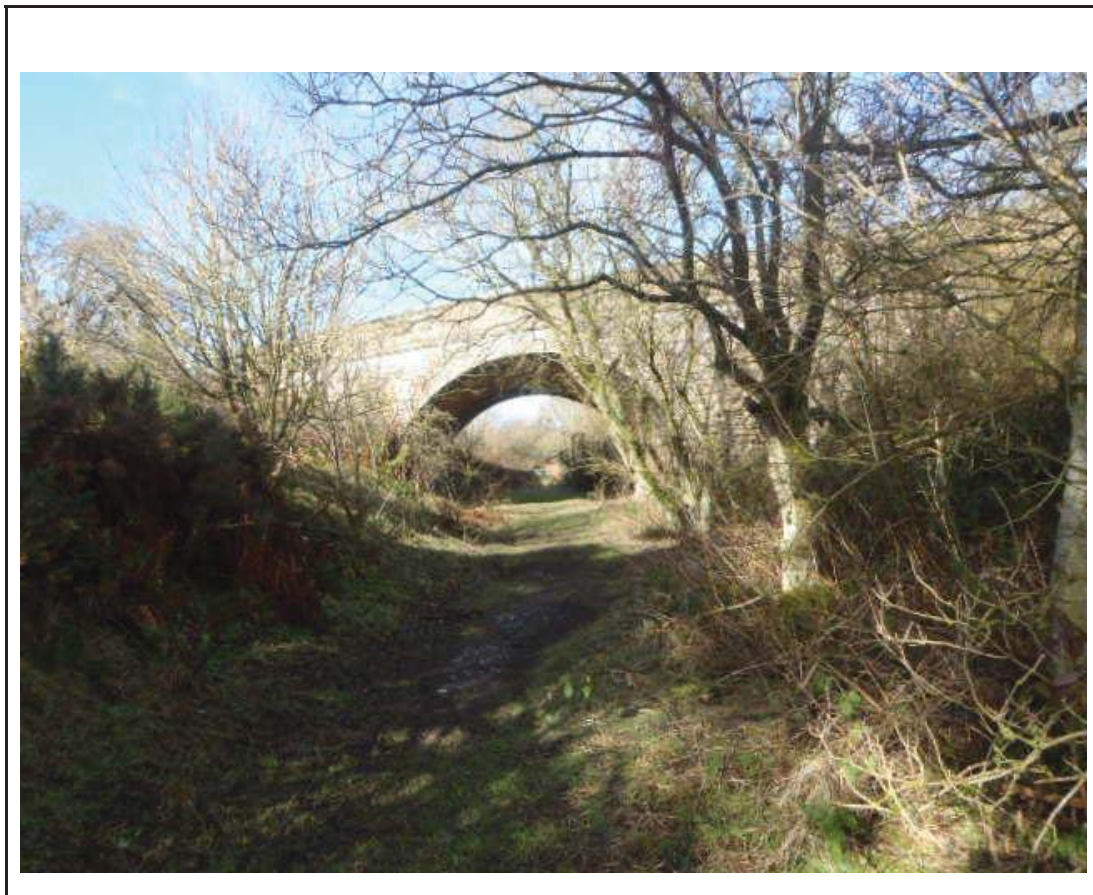
Visual Examination Report
(Continuation Sheet)

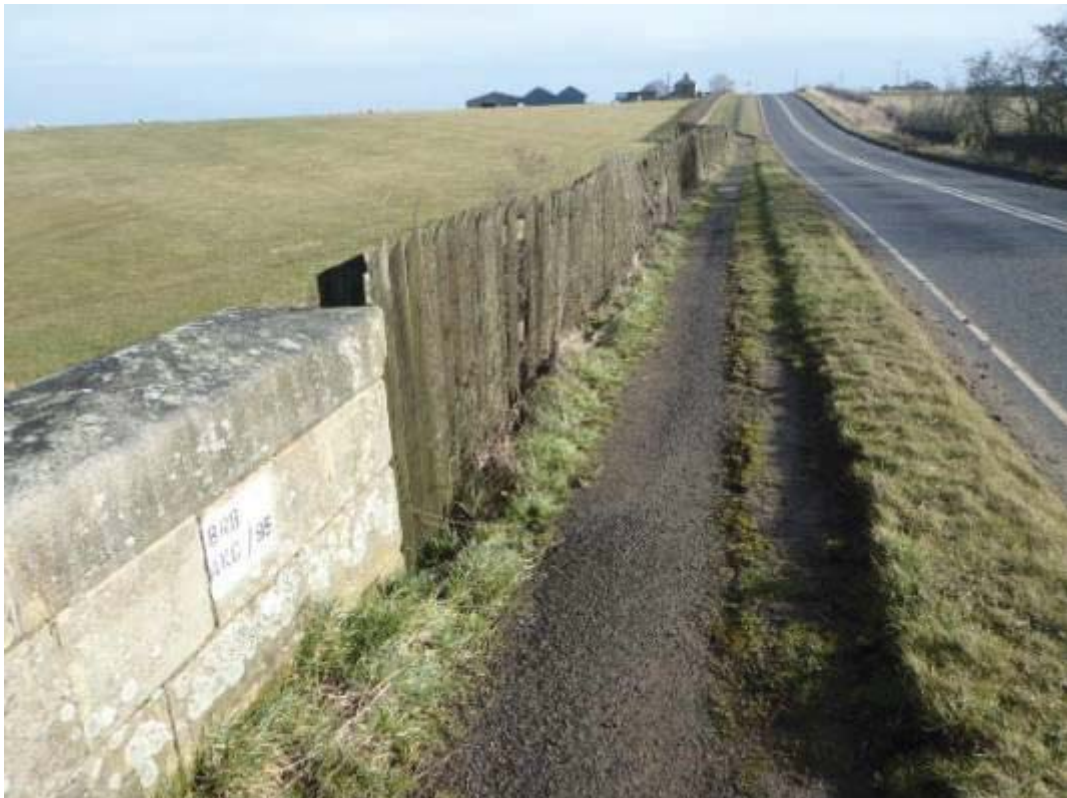
Photo No.1: Approach road fencing: Typical example of the condition at N/E end.

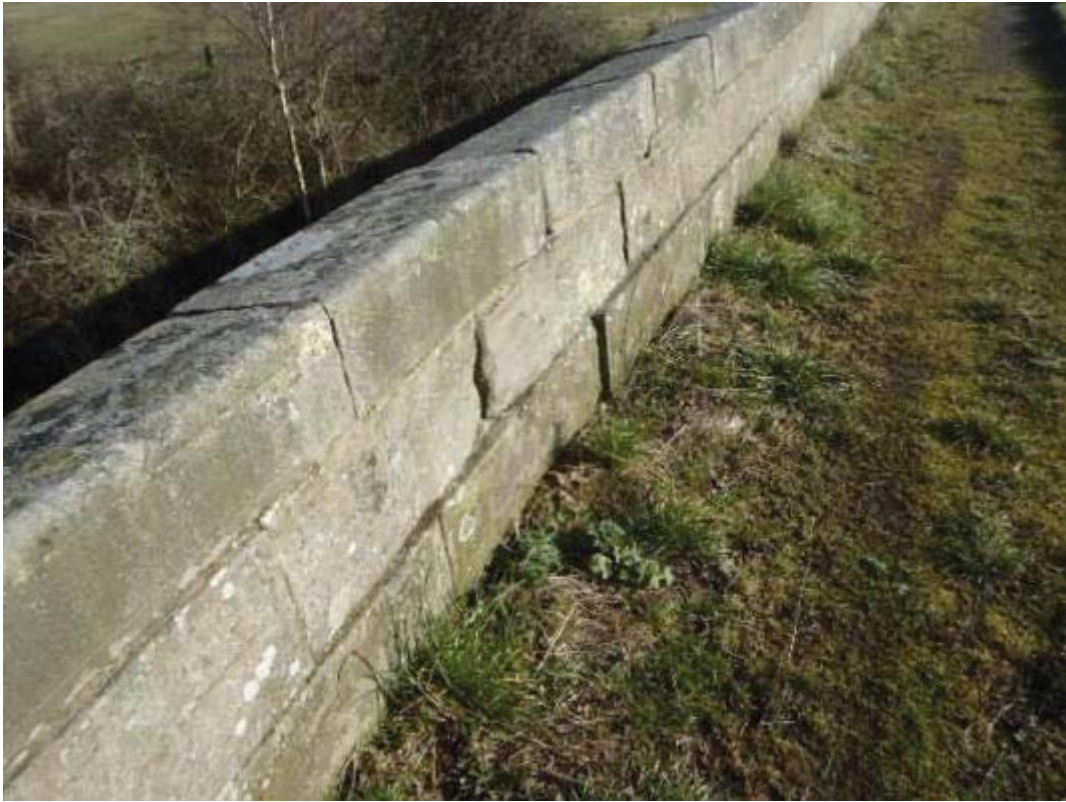
Photo No.2: North roadside parapet: Evidence of previous vehicular impact damage to the stonework.

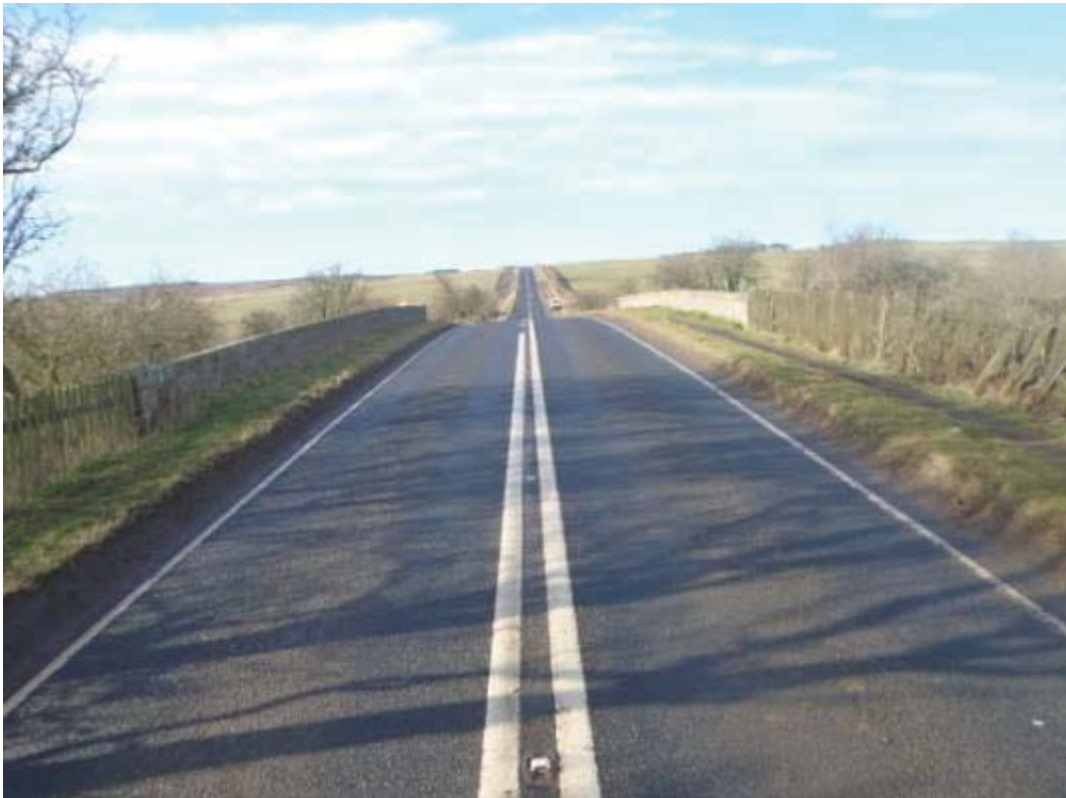
Photo No.3: View: Across Structure.

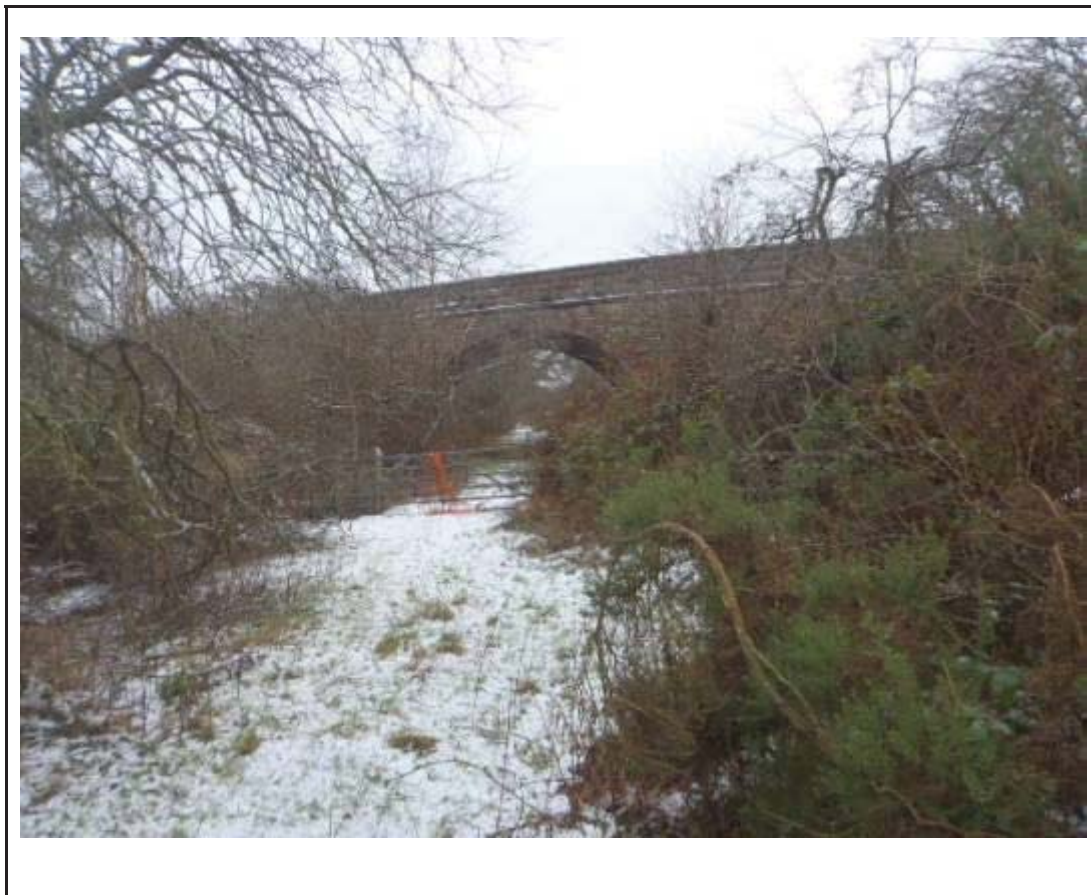
**Visual Examination Report
(Continuation Sheet)**

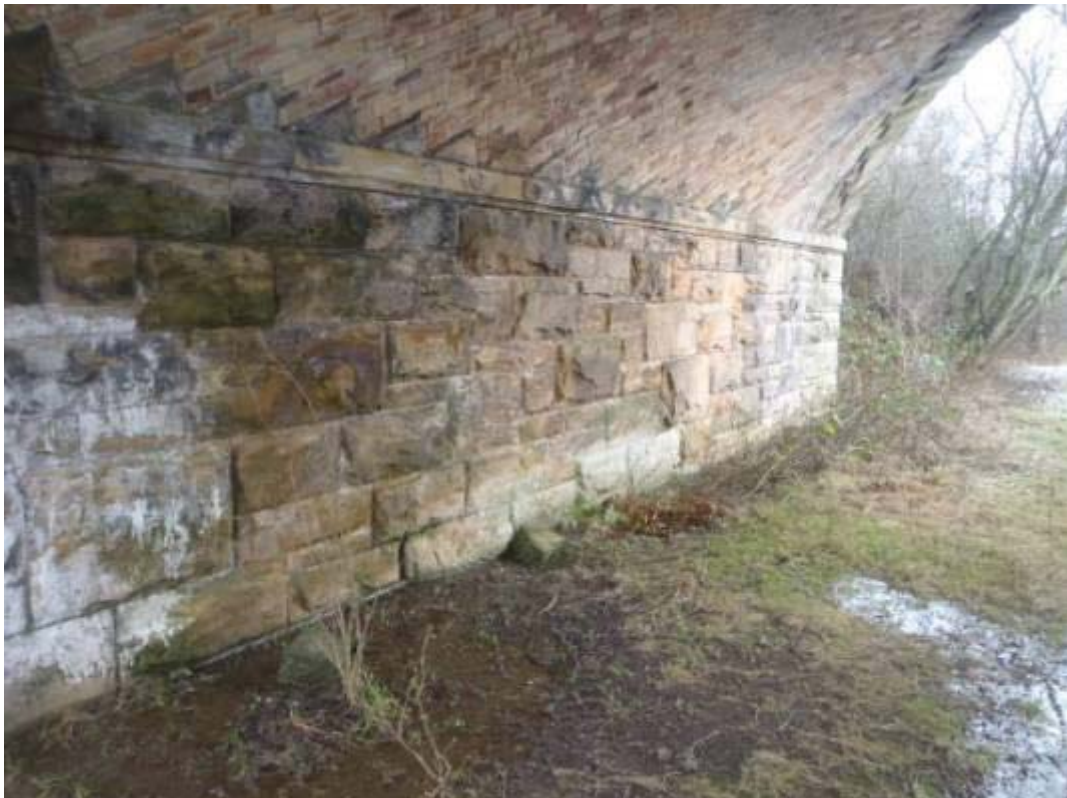
Photo No.1: Possible further deterioration: To the eroded stonework areas.

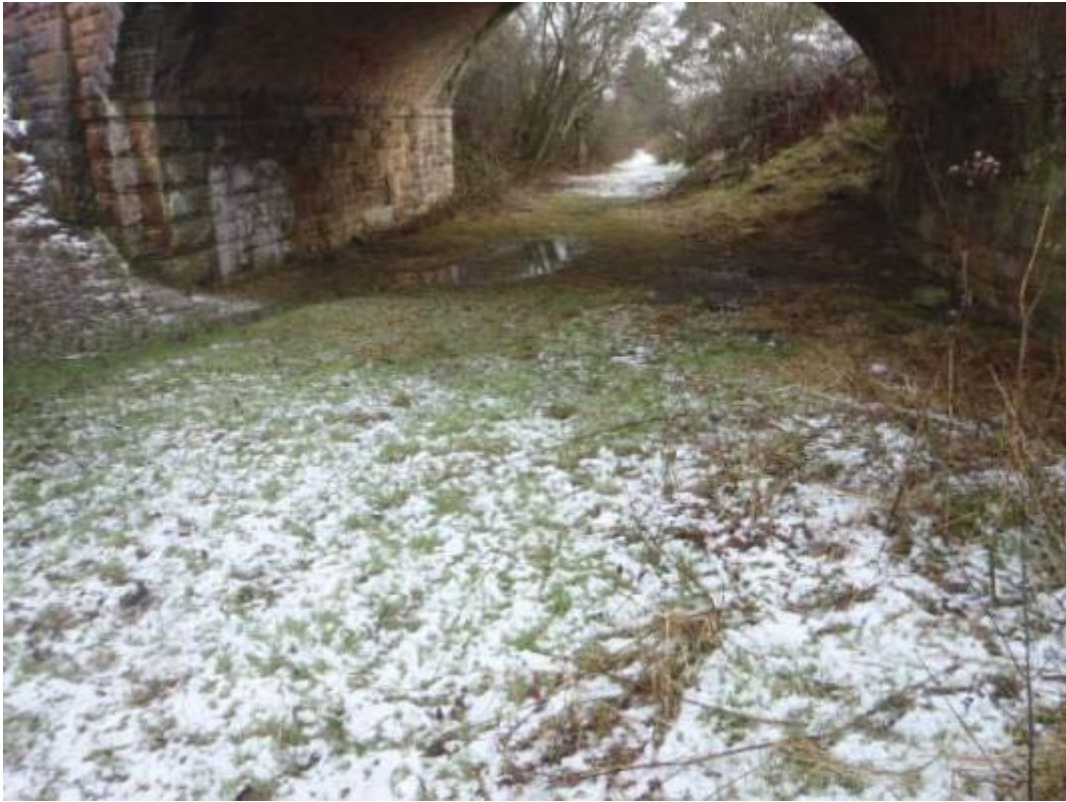
Photo No.2: Area under the structure: Typical example of the condition.

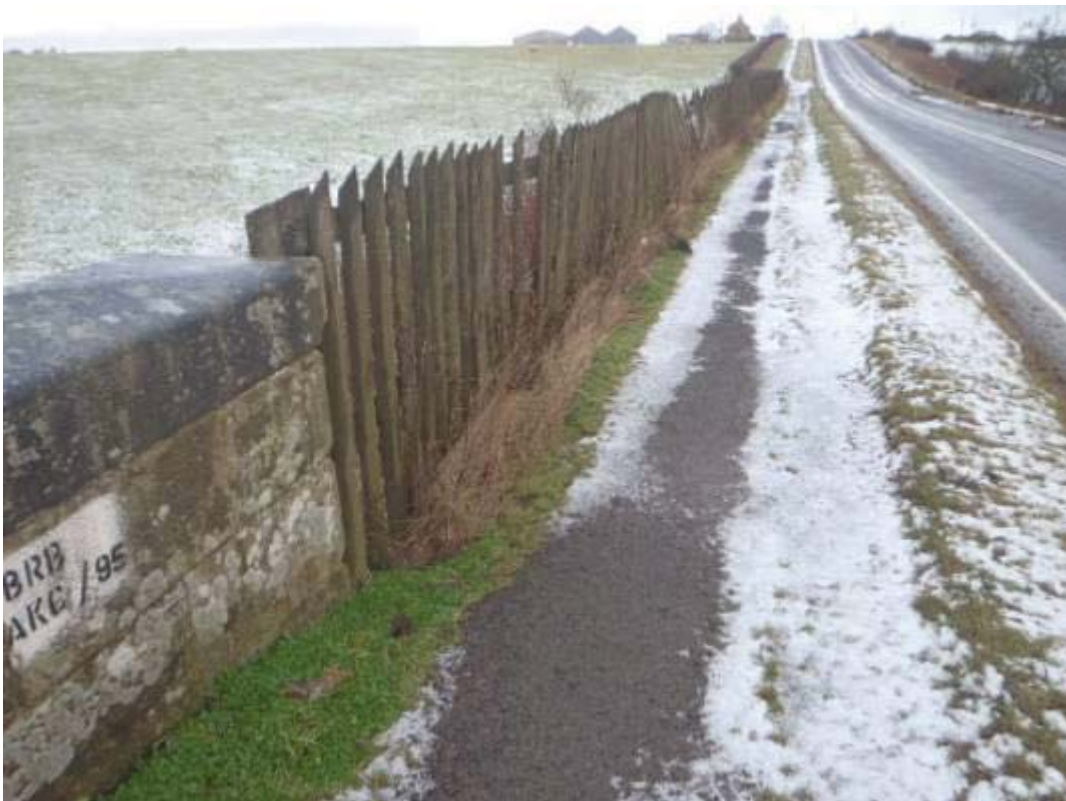
Photo No.3: Approach road fencing: Typical example of the condition at N/E end.
