Historical Railways Estate

Structure Reference

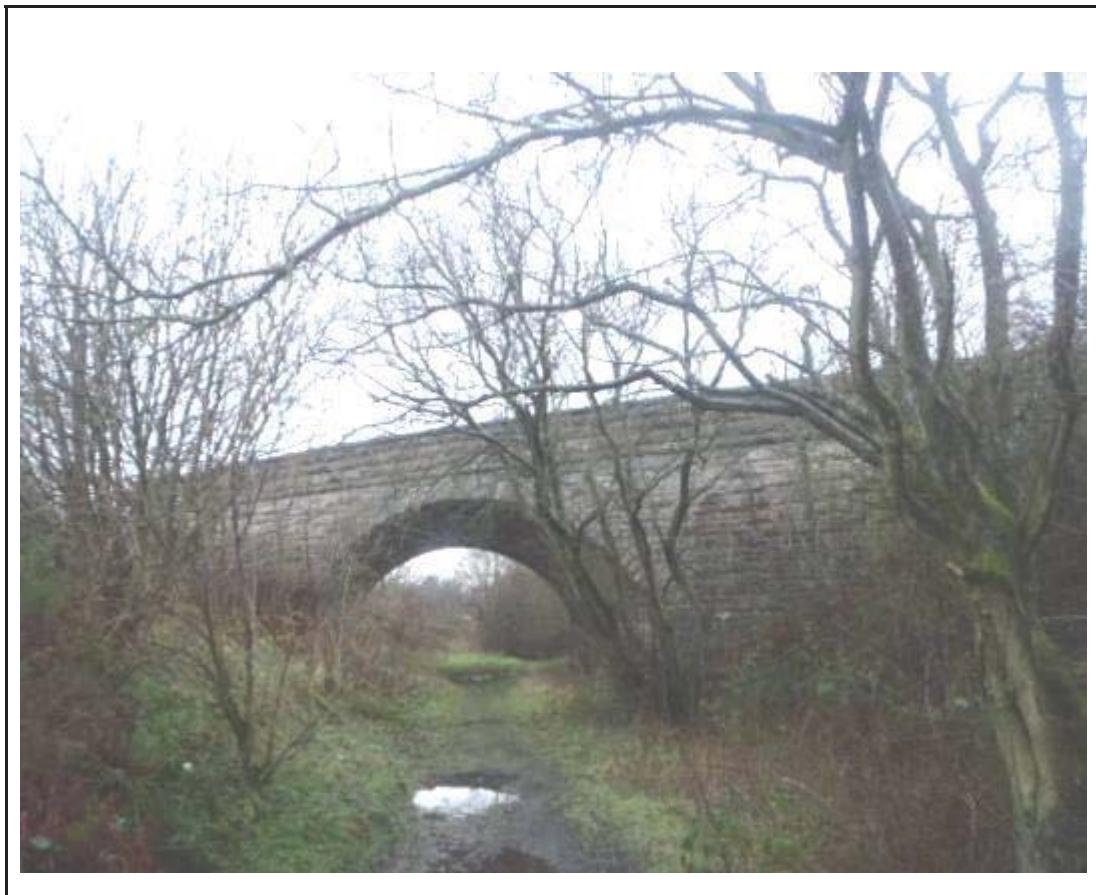
Visual Examination Report
(Continuation Sheet)

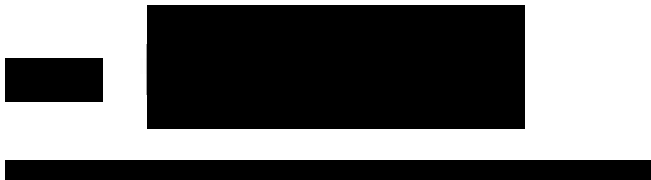
Visual Examination Report
(Continuation Sheet)

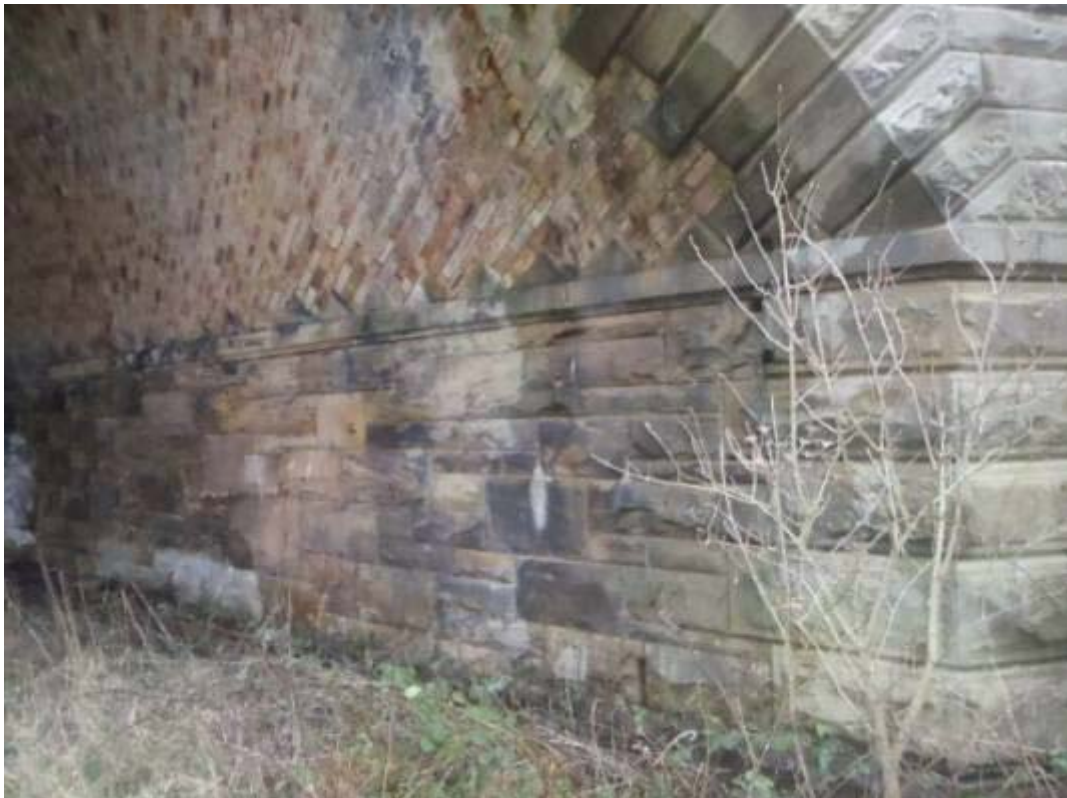
Photo No.1: Possible further deterioration: To the eroded stonework areas.

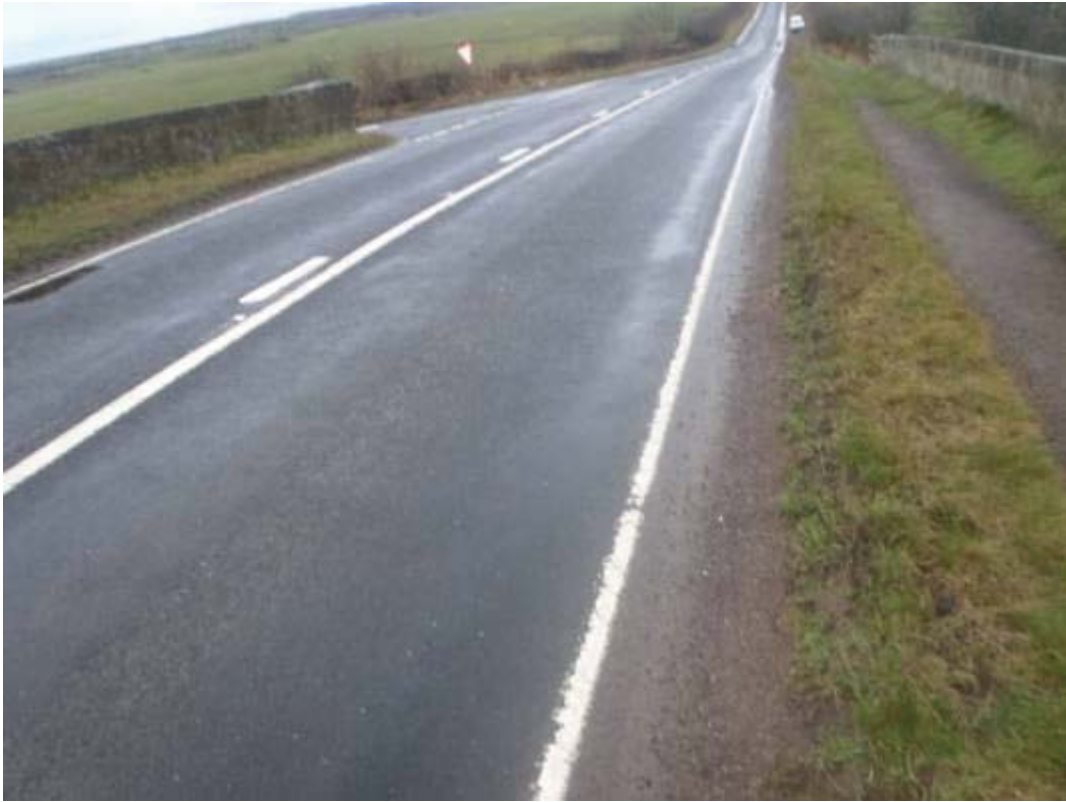
Photo No.2: Road surface: Typical example of the condition.

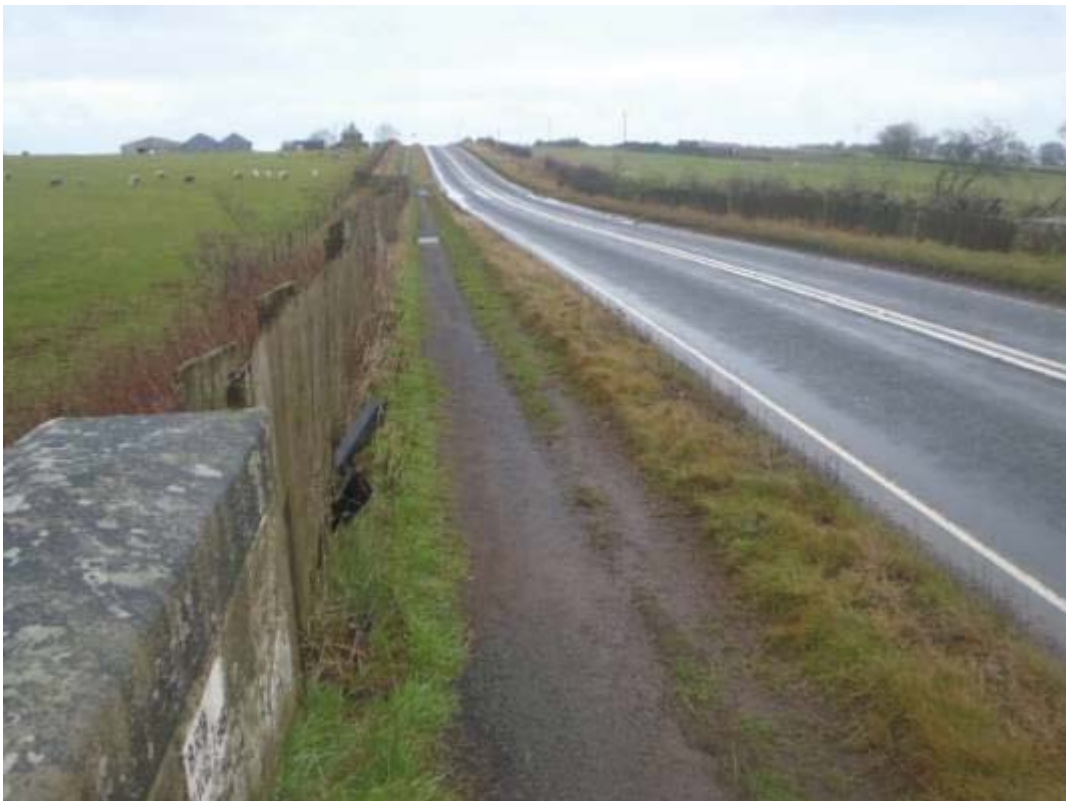
Photo No.3: Approach road fencing: Typical example of the condition at N/E end.

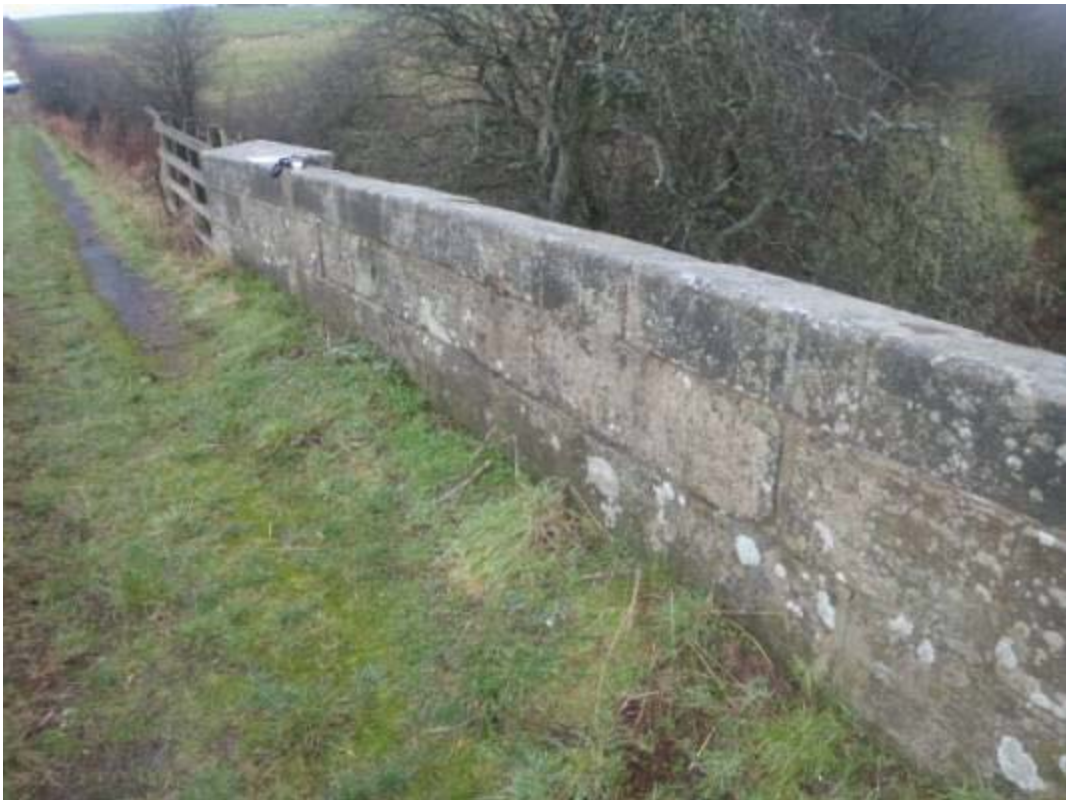
Photo No.7: Parapets: Evidence of previous vehicular impact damage to the stonework.

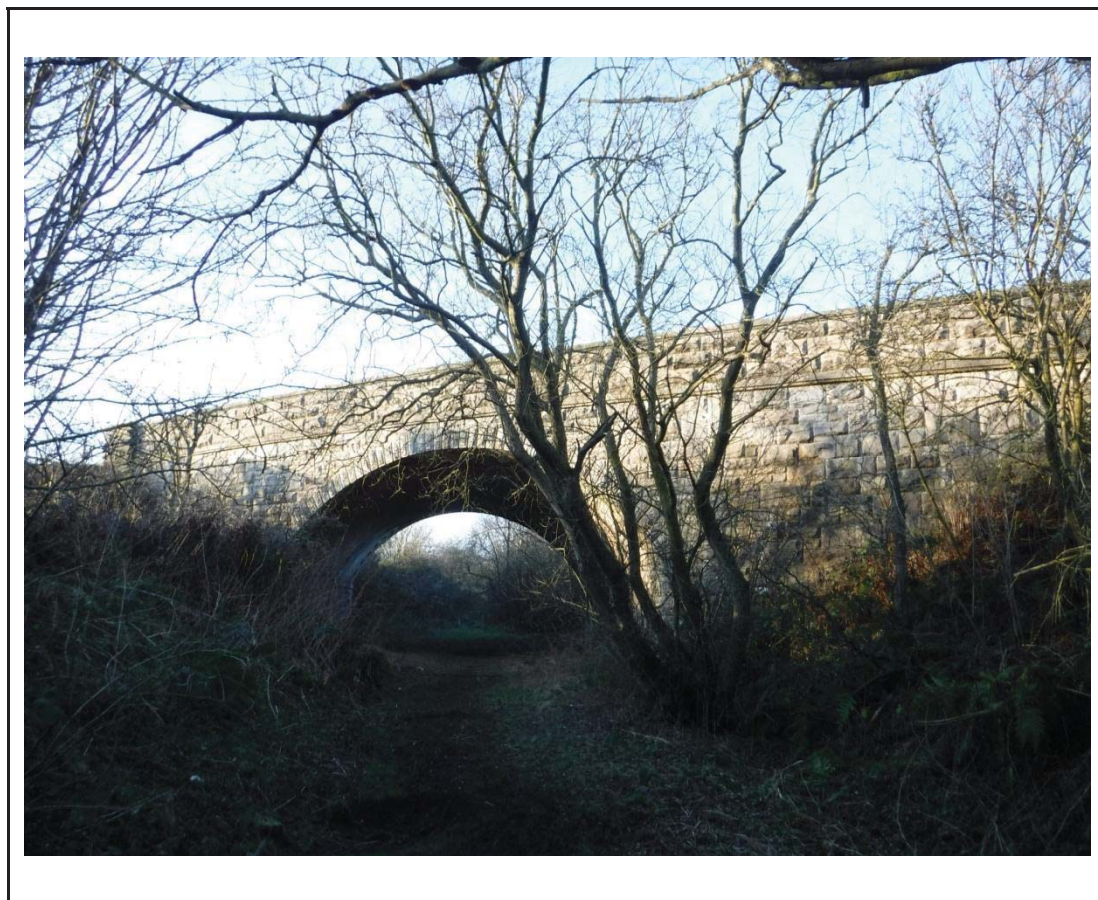
**Historical Railways Estate
Visual Examination Report
(Continuation Sheet)**

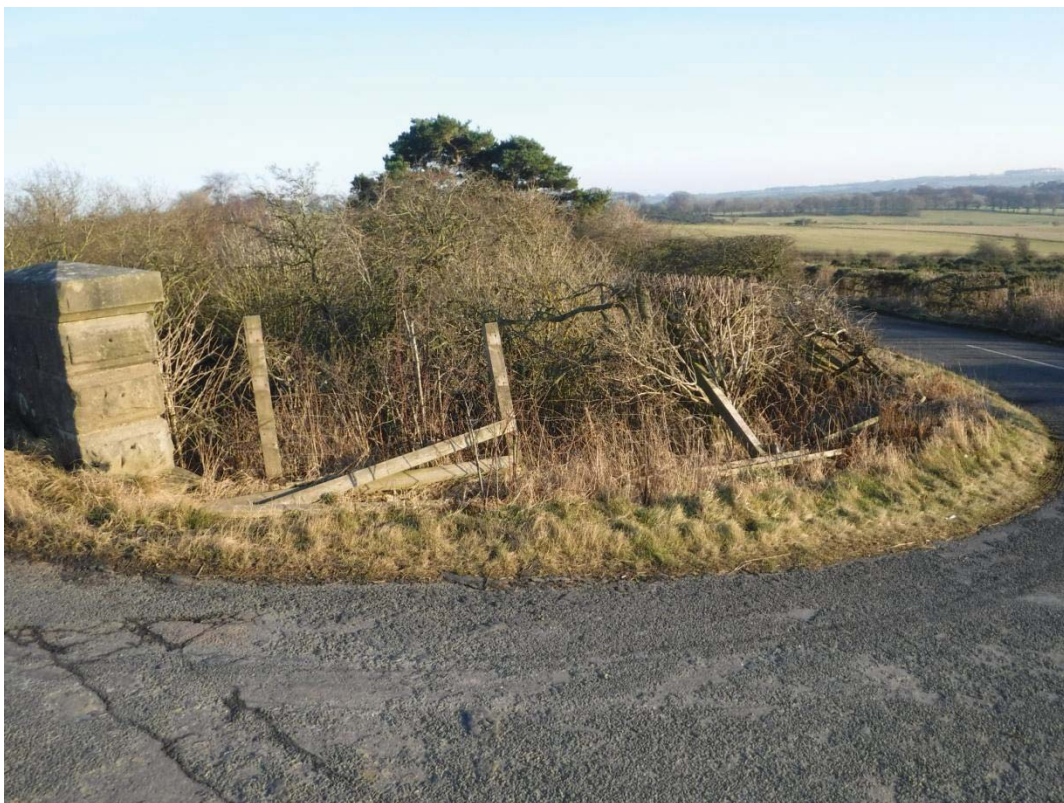
Photo No.1: S/W Approach road fencing: Possible vehicle impact damage.

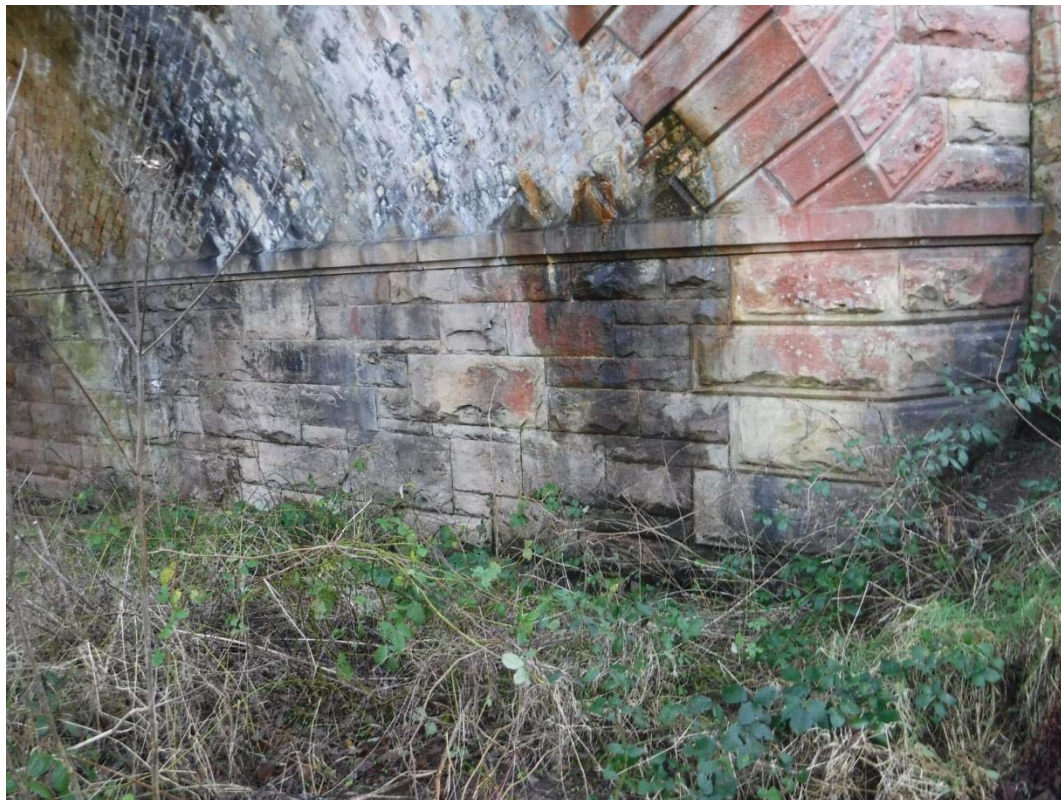
Photo No.2: Possible further deterioration: To the eroded stonework areas.

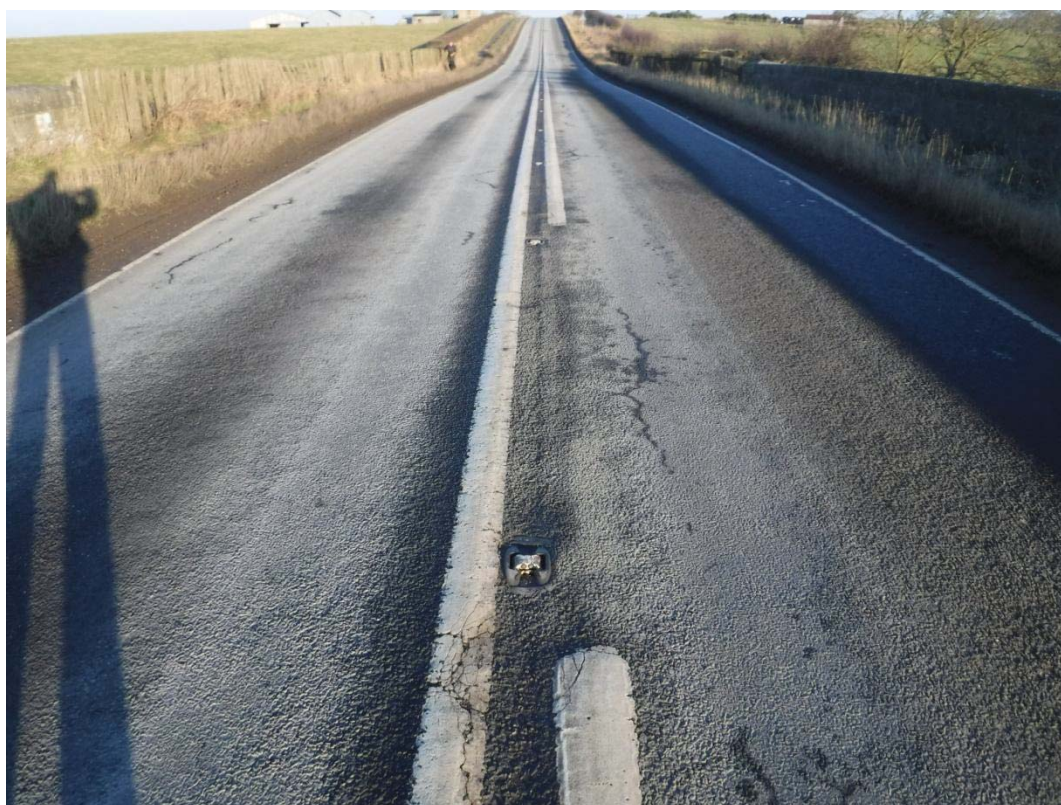
Photo No.3: Road surface: Typical example of the condition.

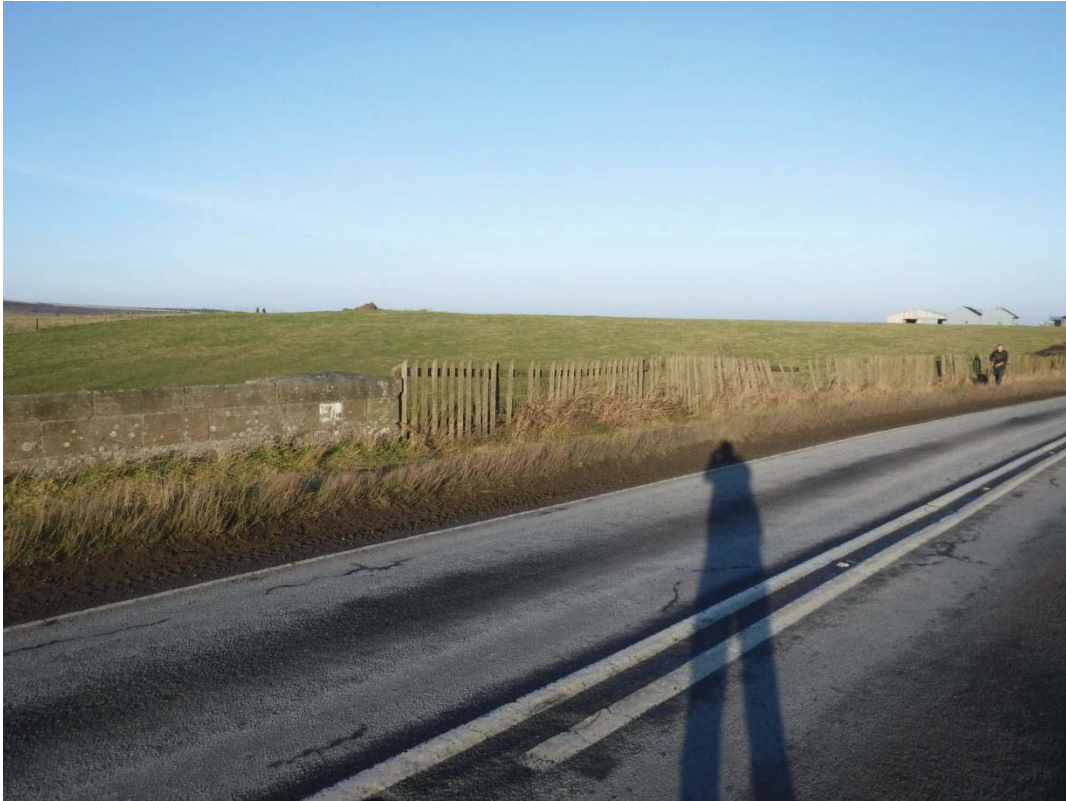
Photo No.6: Approach road fencing: Typical example of the condition at N/E end.

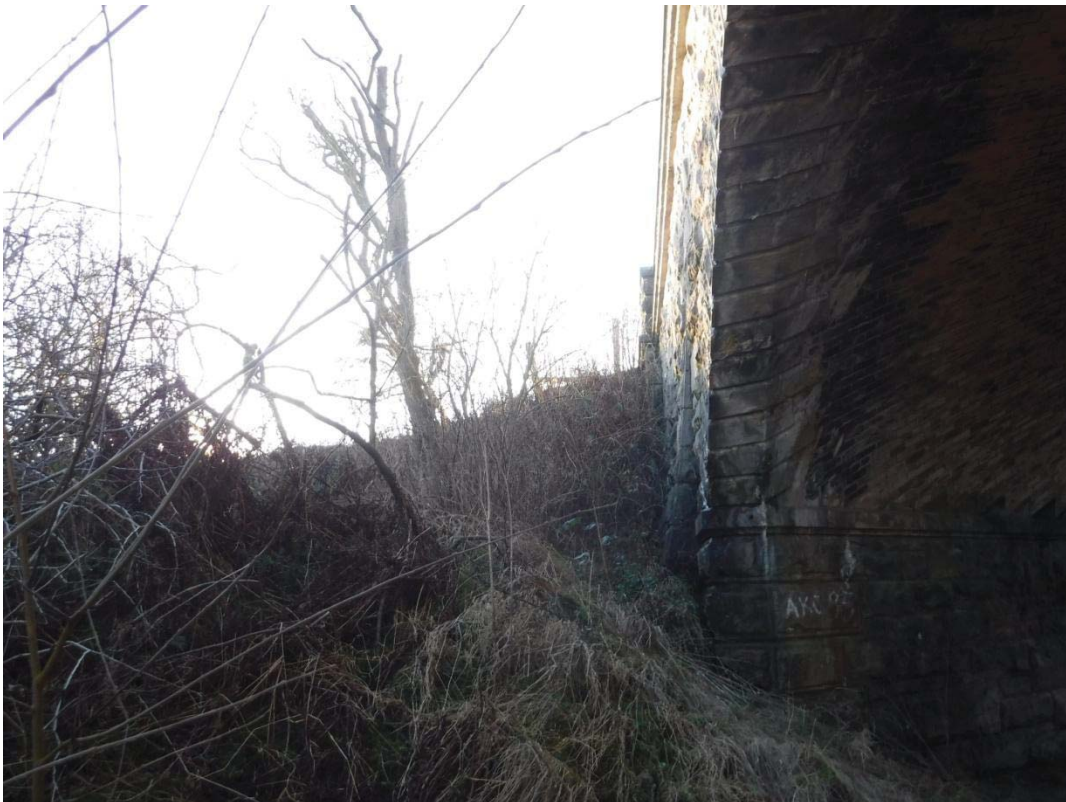
Photo No.7: Vegetation: Typical example.

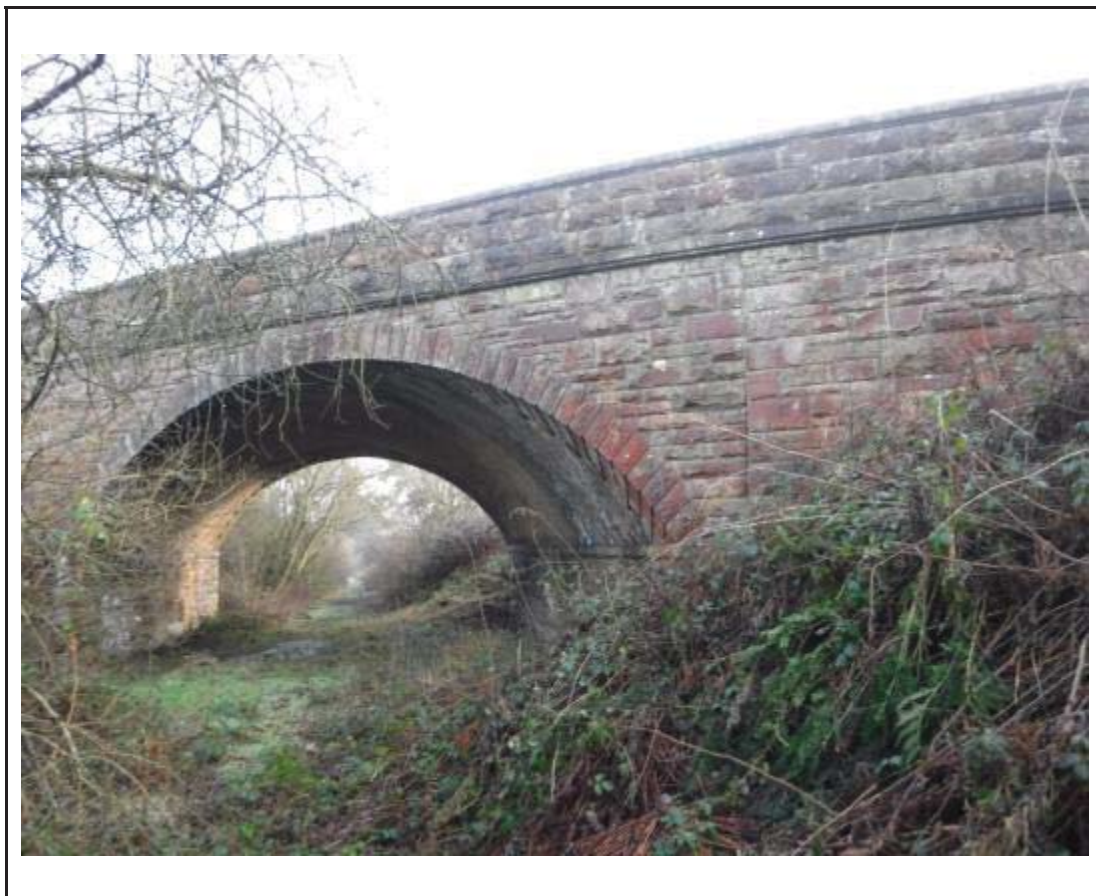
**Historical Railways Estate
Visual Examination Report
(Continuation Sheet)**

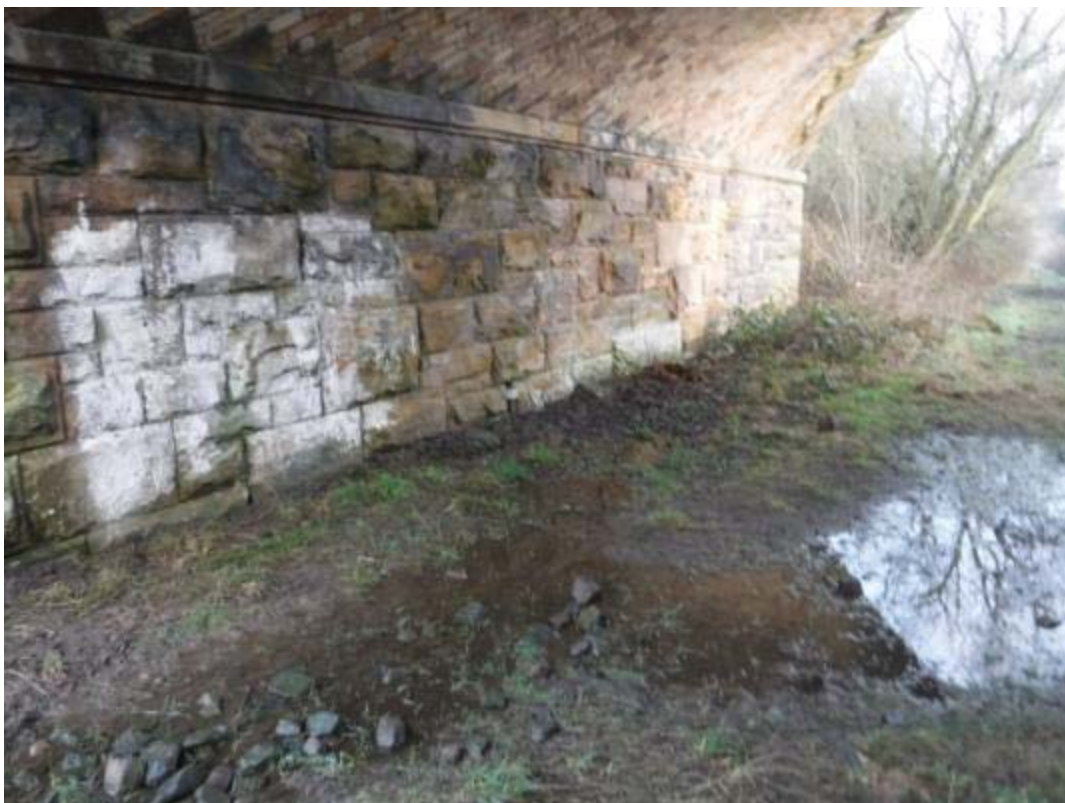
Photo No.1: Possible further deterioration: To the eroded stonework areas.

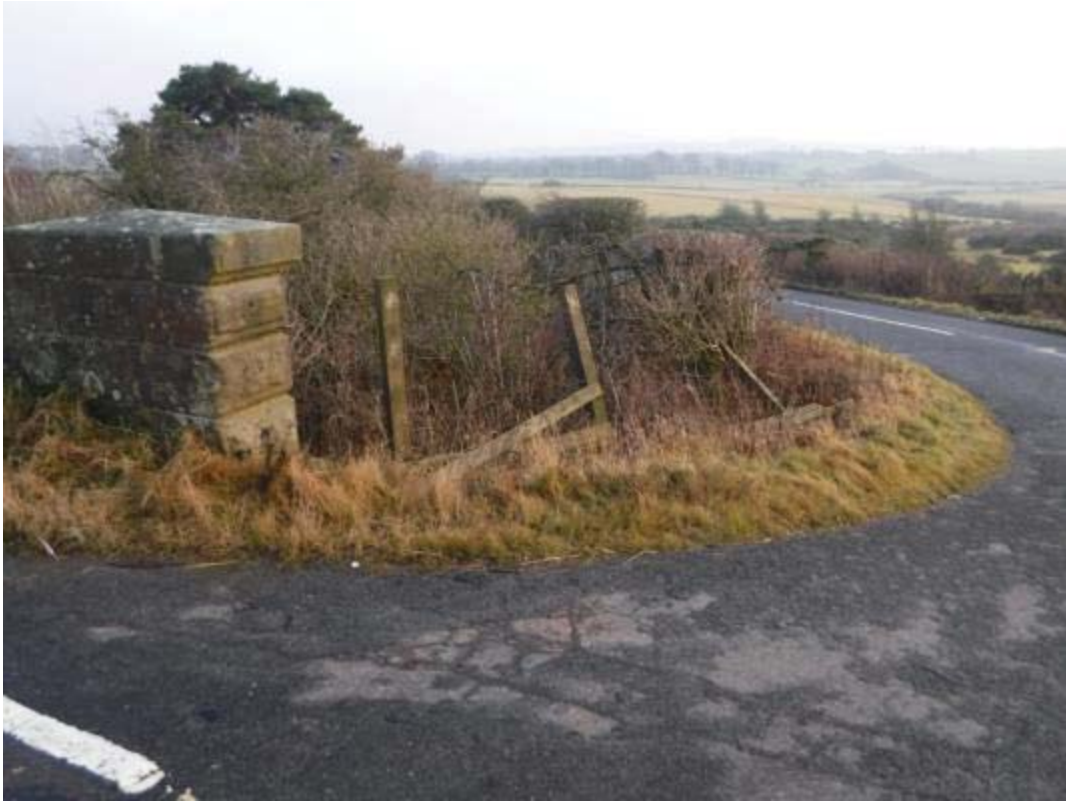
Photo No.2: Approach road fencing: Typical example of the condition at S/W end.

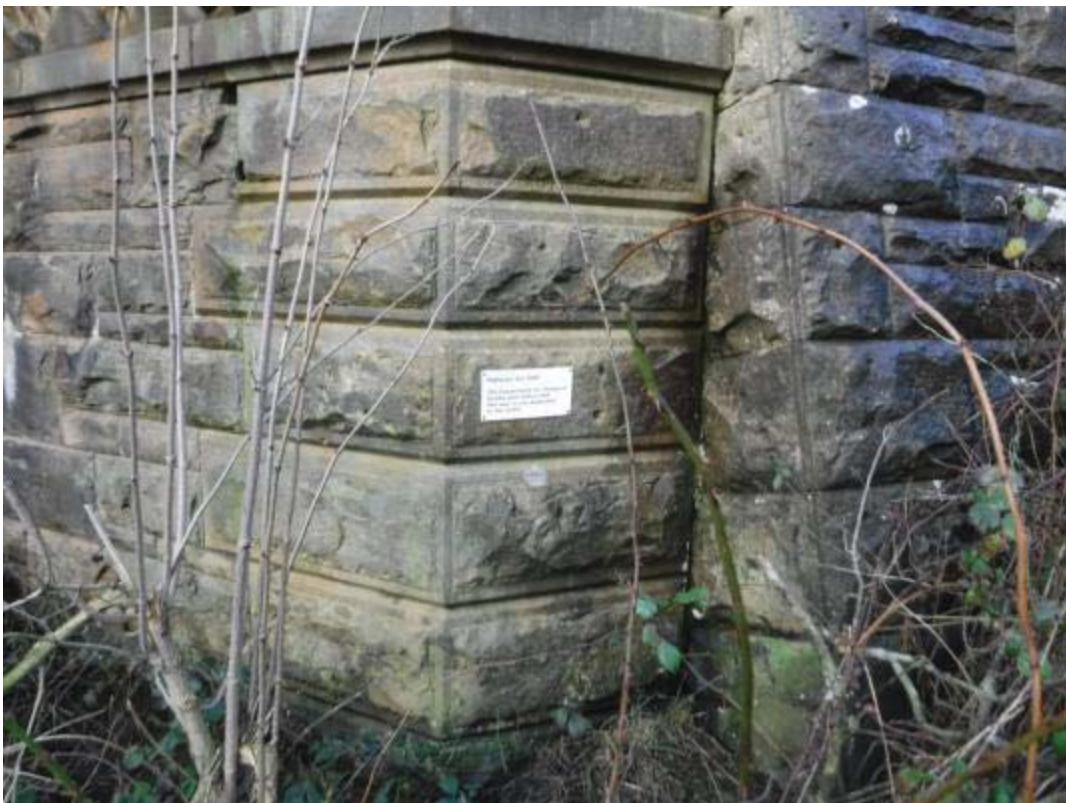
Photo No.3: Non - Dedication plate: Typical example of the condition.

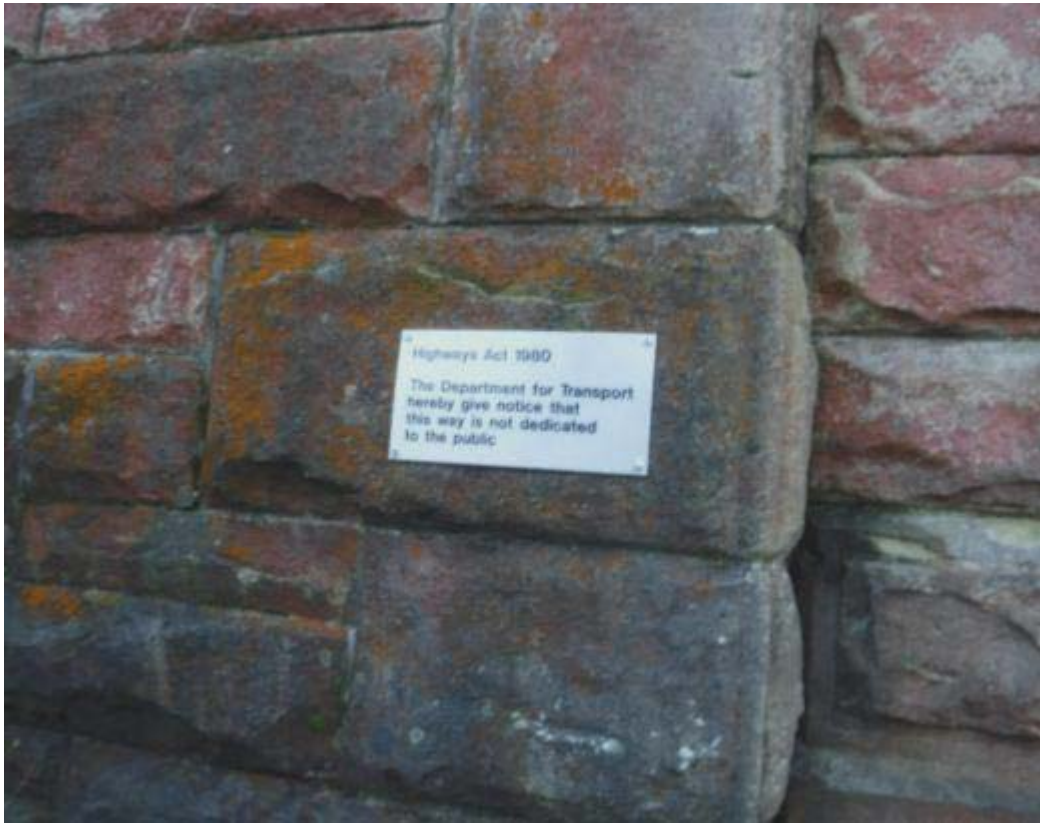
Photo No.4: Non - Dedication plate: Typical example of the condition.

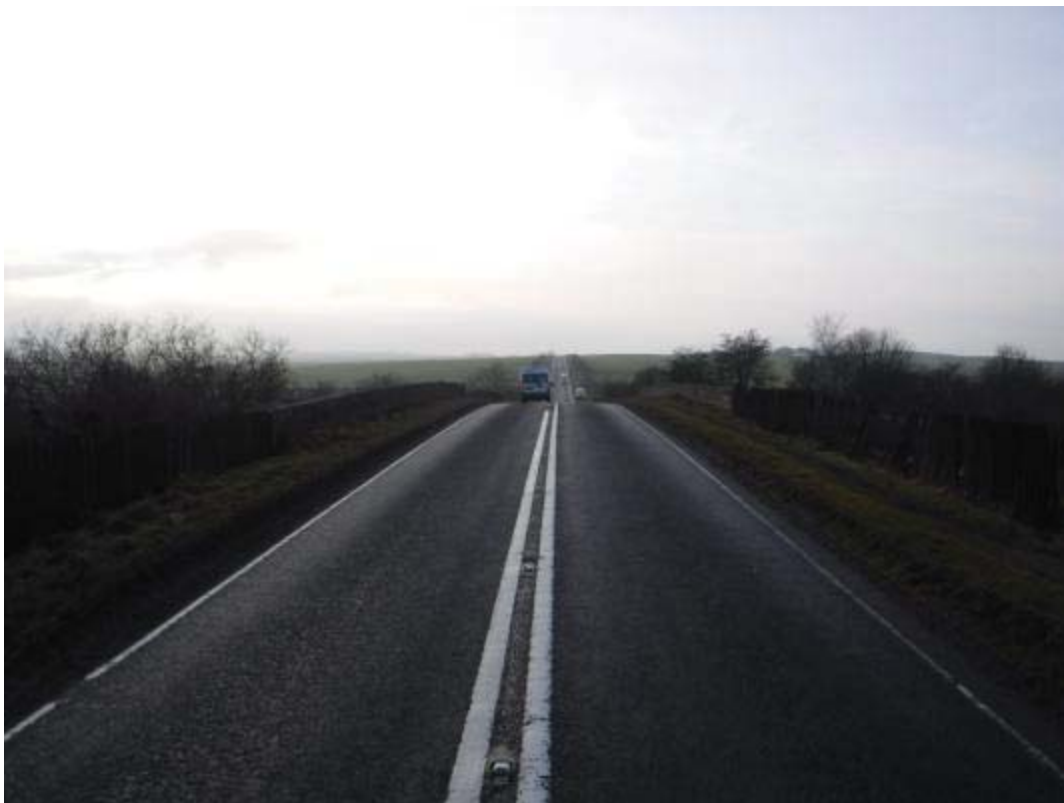
Photo No.5: View: Across Structure.

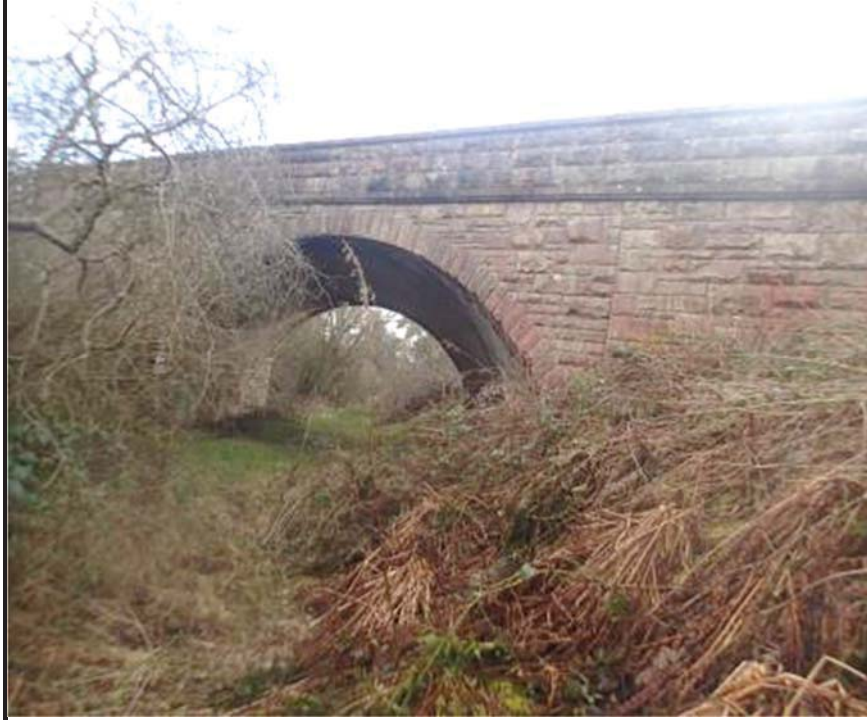
<p><u>NEW & LONG-STANDING DEFECTS</u></p> <p>The examiner had access to the previous detailed examination report dated 28/11/2018.</p> <p>Any changes identified within the structure have been highlighted in Red text.</p> <p>See page 2 for details.</p>

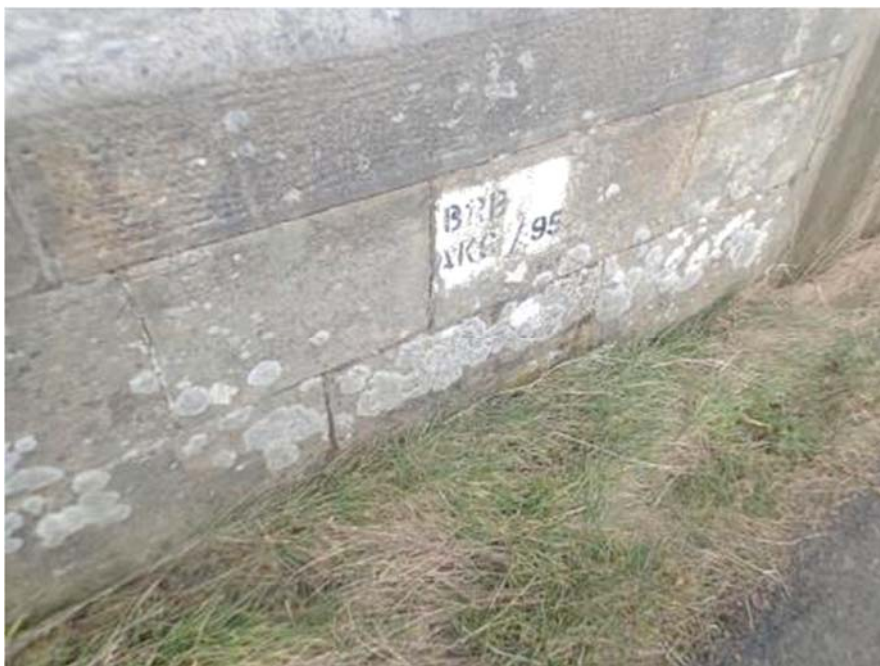
Photograph 11: example of long-standing displaced stonework noted along the north parapet

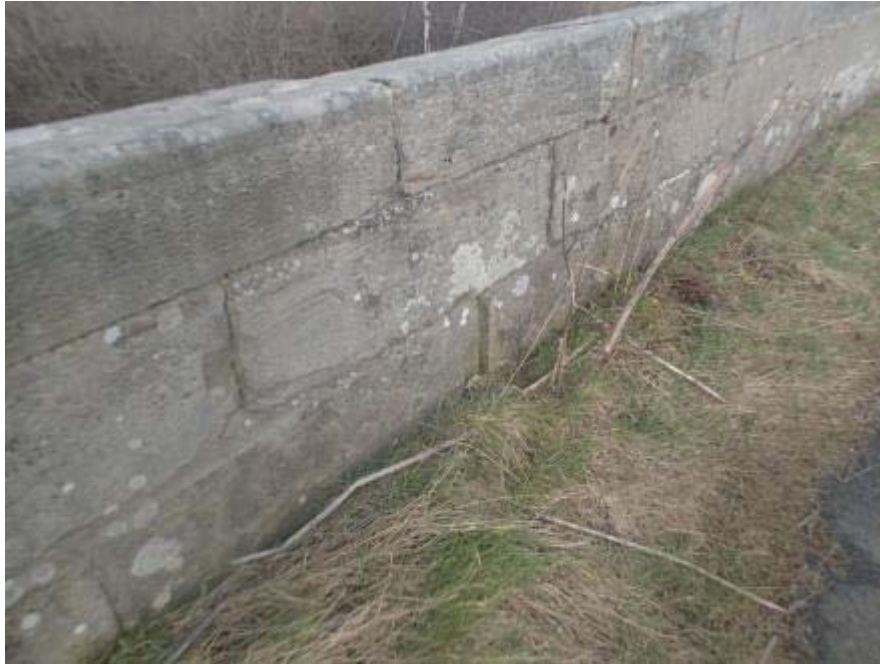
Photograph 12: example of long-standing displaced stonework noted along the north parapet

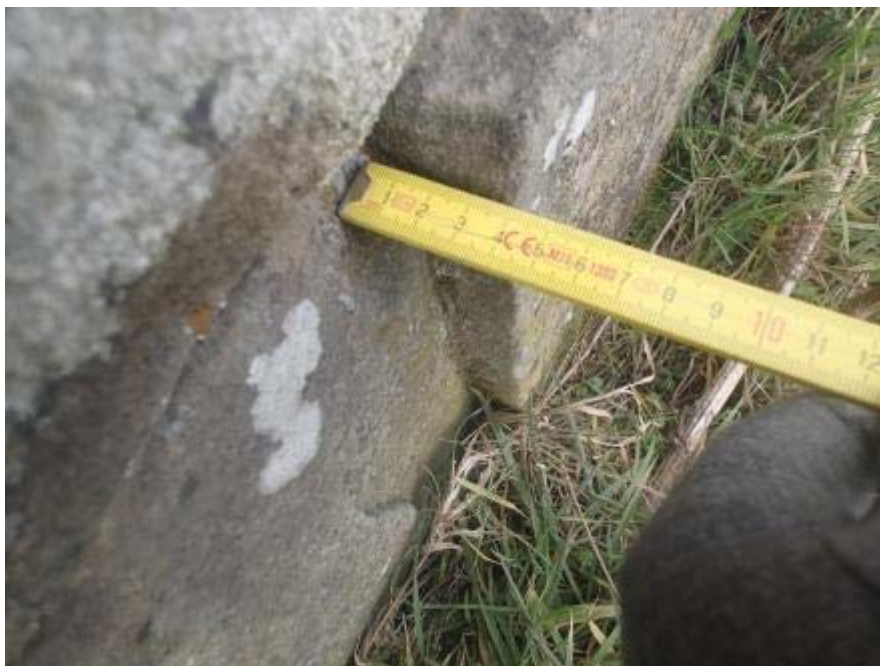
Photograph 13: the displacement was noted up to 40mm

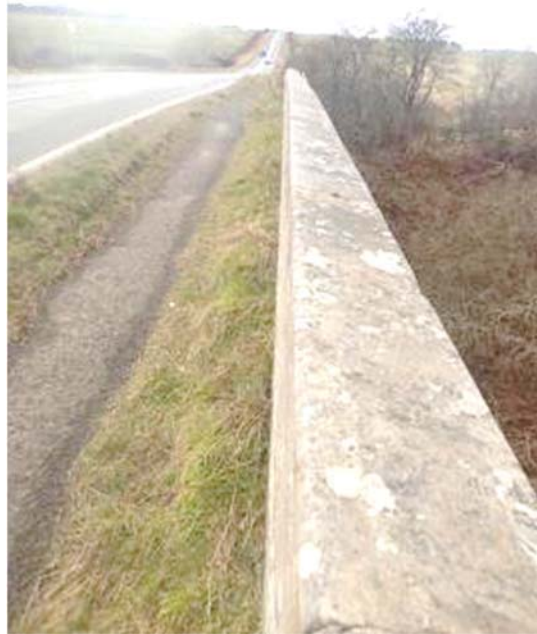
Photograph 14: long-standing leaning action is noted along the north parapet

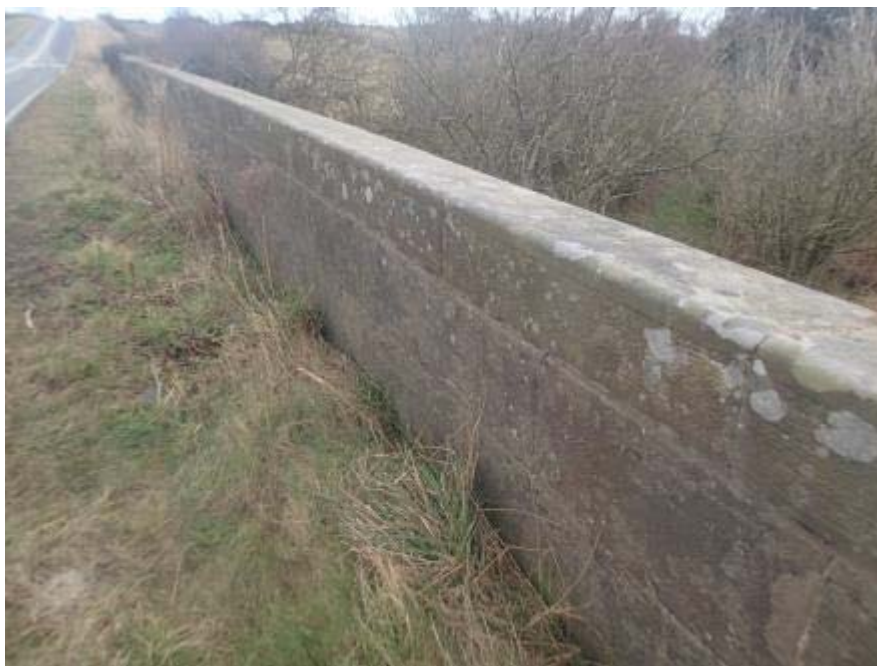
Photograph 15: example of long-standing displacement noted along the copings upon the south parapet

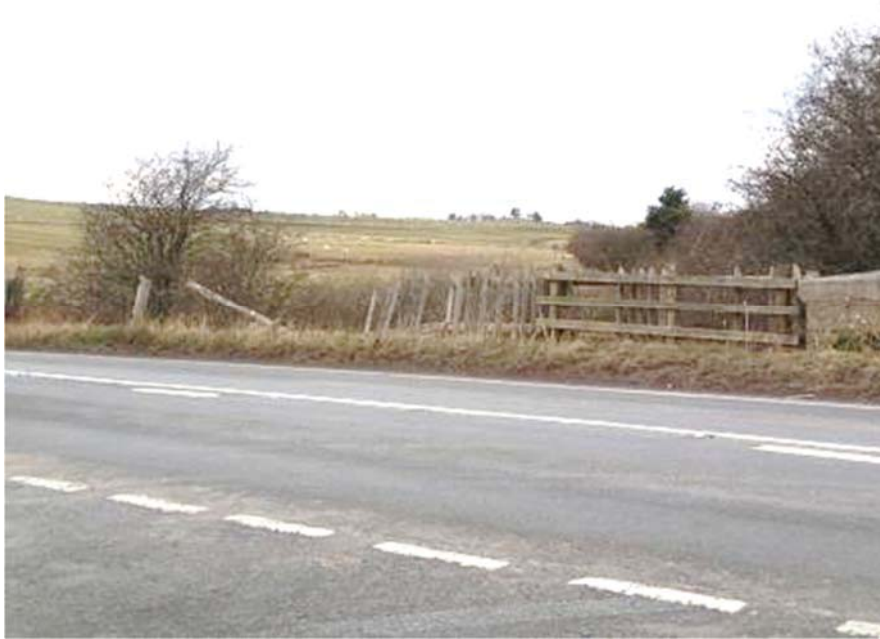
Photograph 16: general condition of the northwest fence line

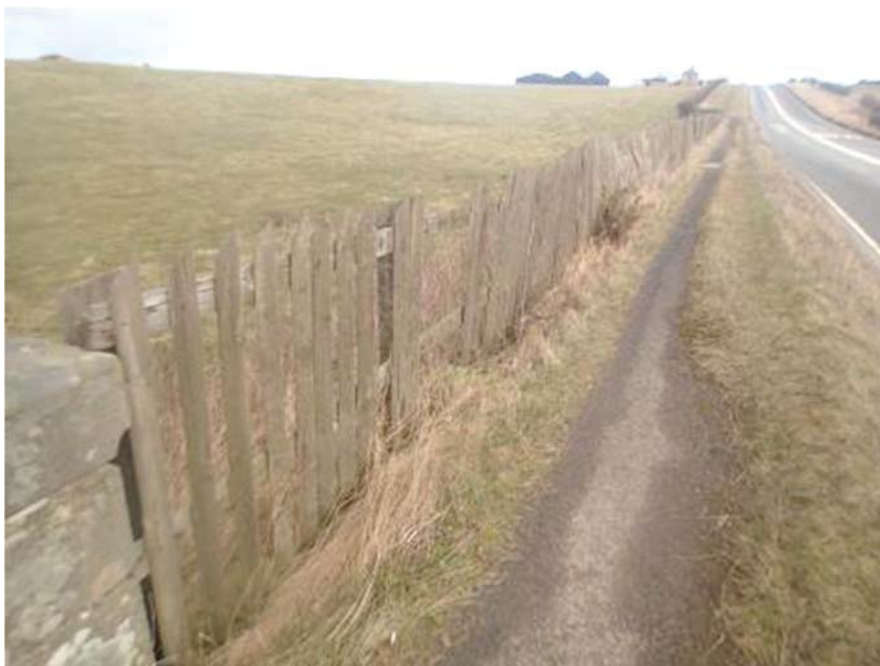
Photograph 17: general condition of the northeast fence line

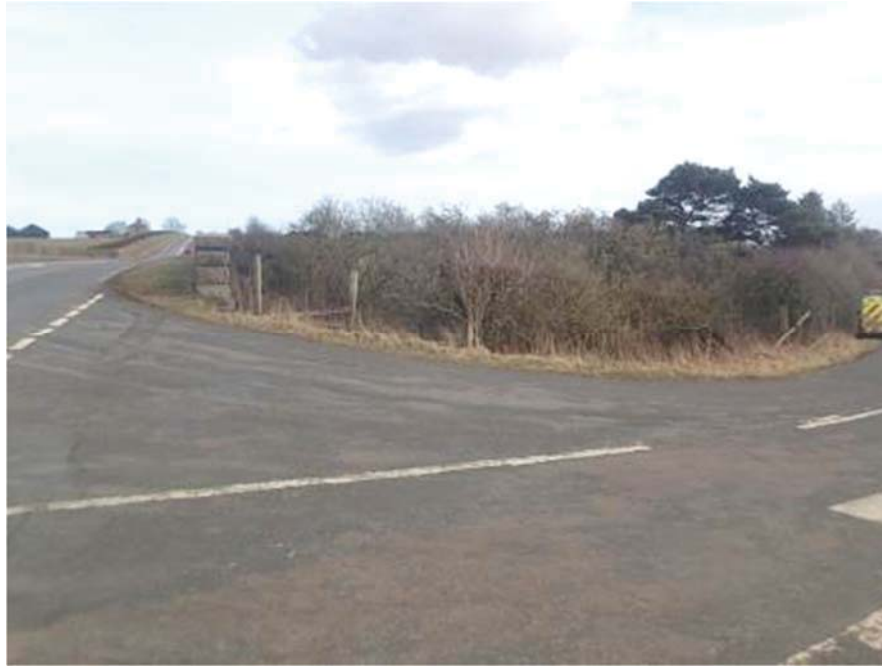
Photograph 18: long-standing failure of the southwest fence line

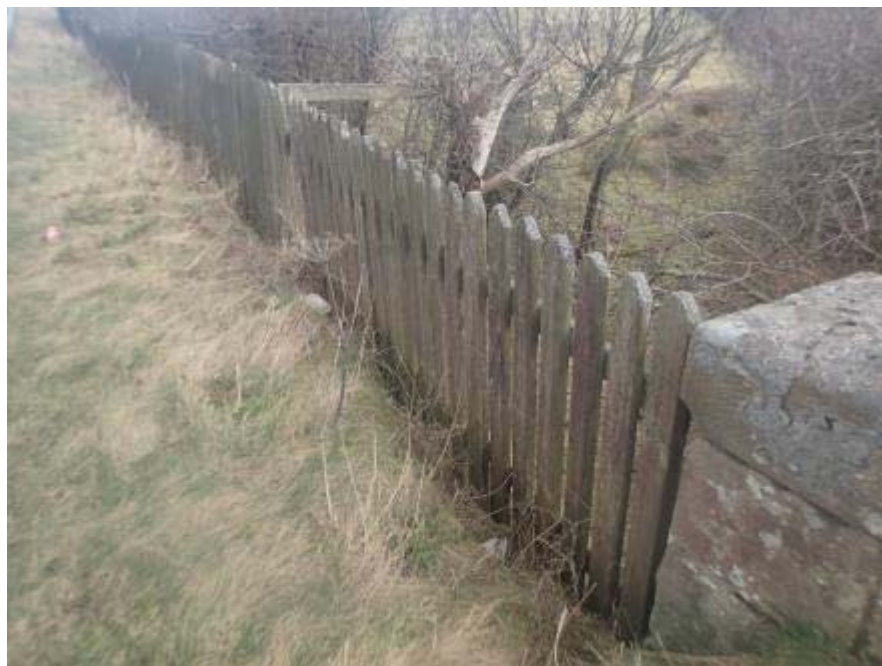
Photograph 19: general condition of the southeast fence line.
The fence line moves on touch.

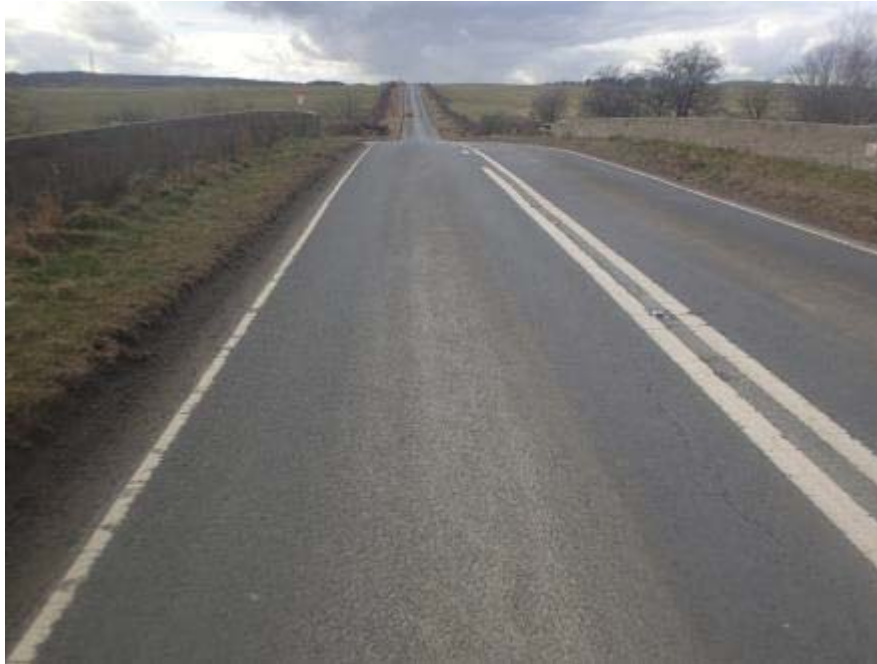
Photograph 20: general wear and tear of the asphalt over the line of the structure

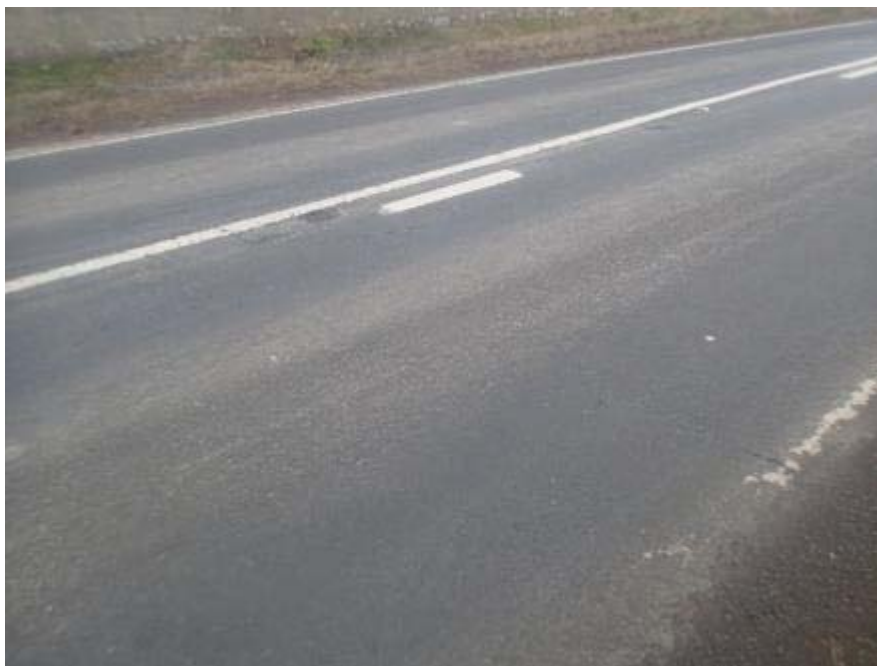
Photograph 21: odd surface fractures were noted within the asphalt
