# Highways Agency - Historical Railways Estate

AKC/99

# Highways Agency Historical Railways Estate Visual Examination Report

ROUTE: ALNWICK - CORNHILL

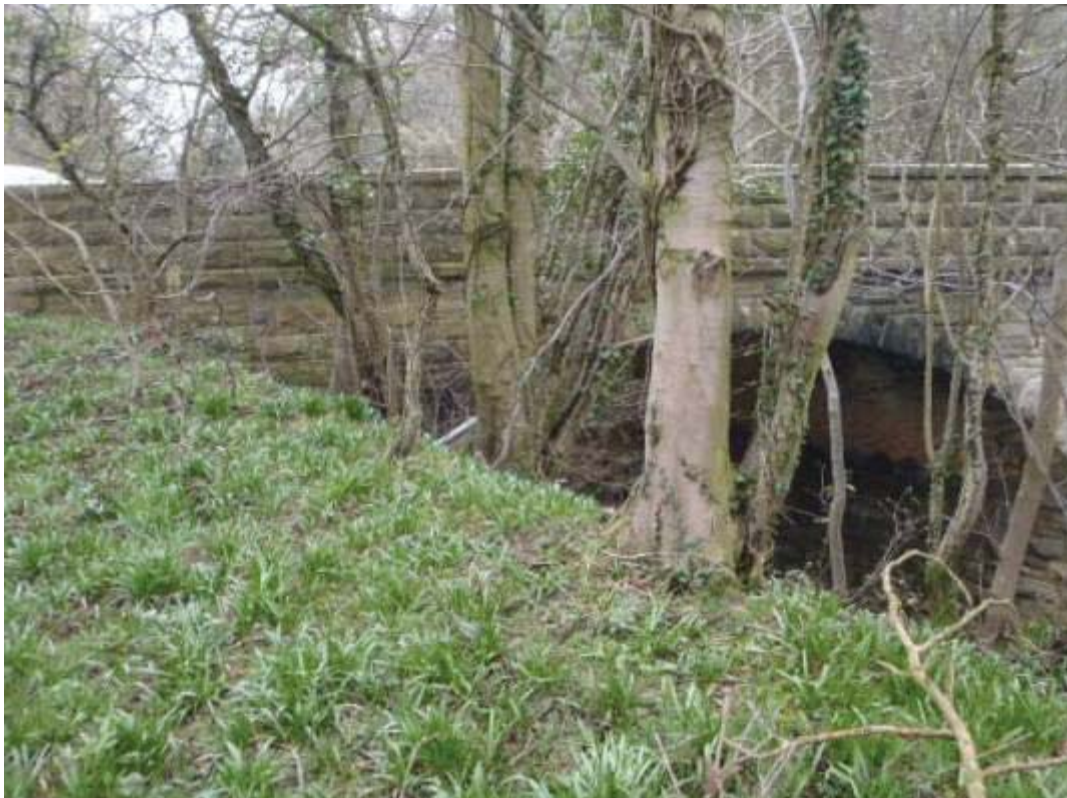
- ❖ **Severe defects** - Mature tree growth within the proximity of the structure. P1.
- ❖ **New defects** - N/A.
- ❖ **Changes to existing defects since last examination** - Possible further deterioration to the eroded stonework areas also further discarded household refuse to the west elevation. P2 to P3.

**Photo No.1: Mature tree growth: Within the proximity of the structure.**

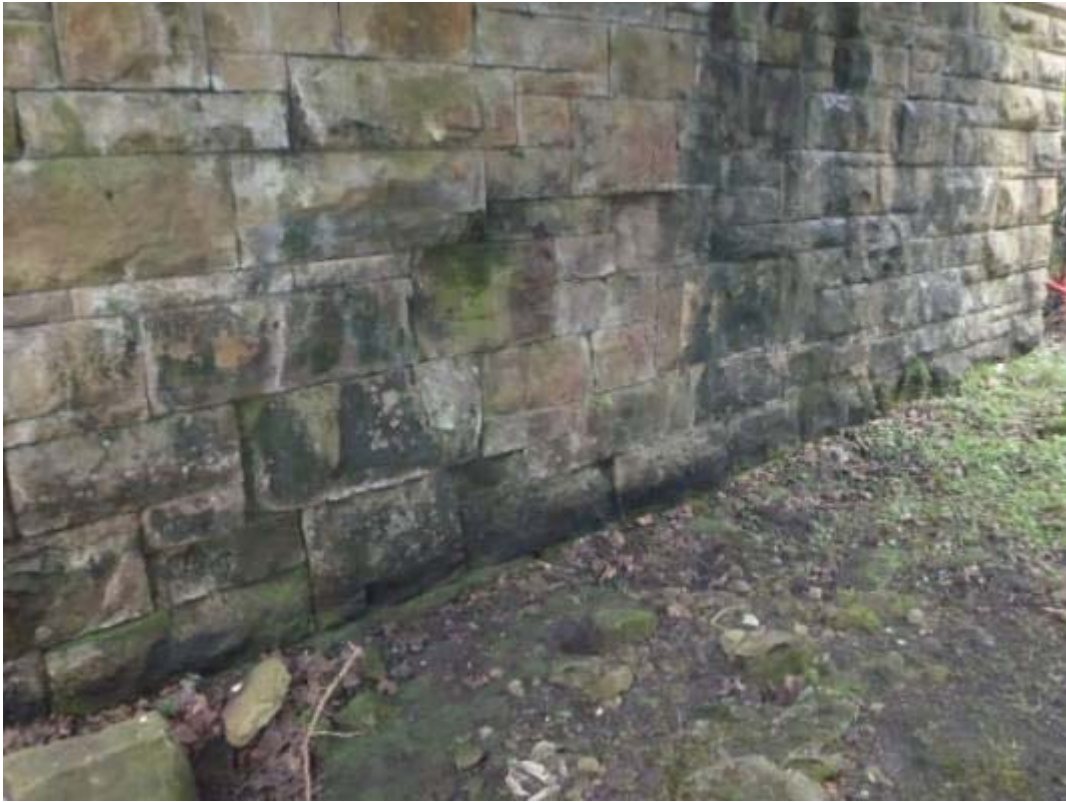
**Photo No.2: Possible further deterioration: To the eroded stonework areas.**

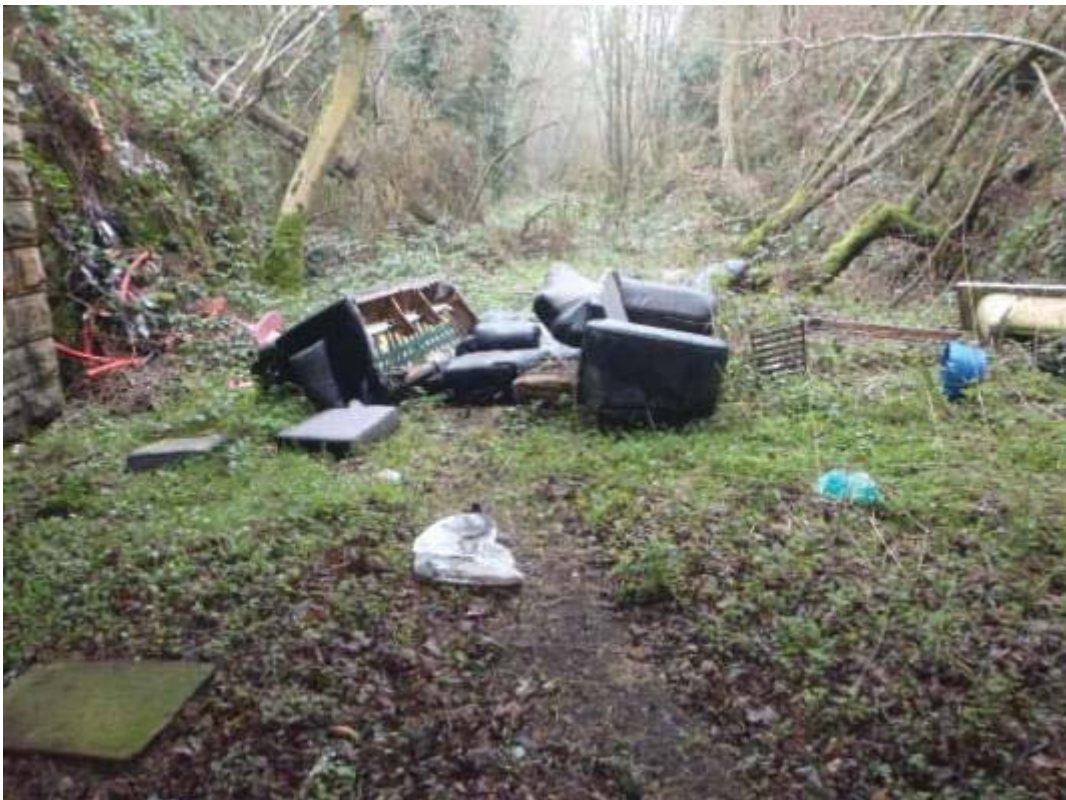
Fly tipping on land adjacent to bridge.

**Photo No.3: West elevation: Further discarded household refuse.**

Clear rubbish.

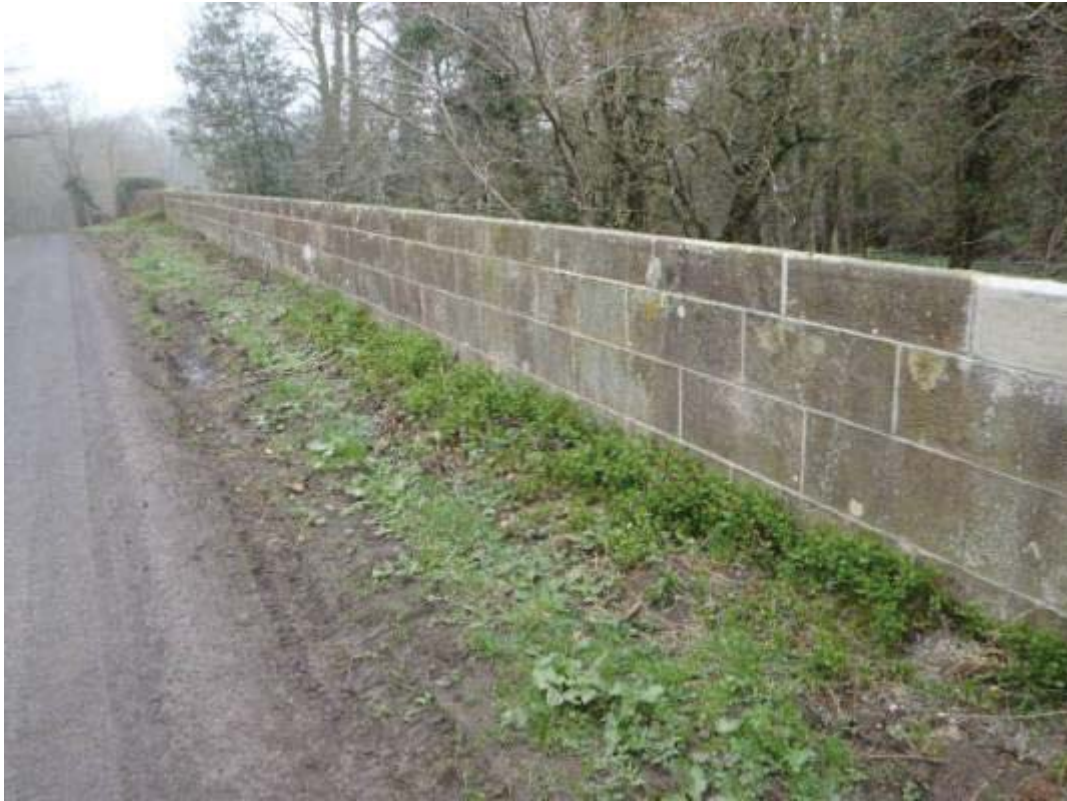
**Photo No.4: East roadside parapet: Pointing repairs.**

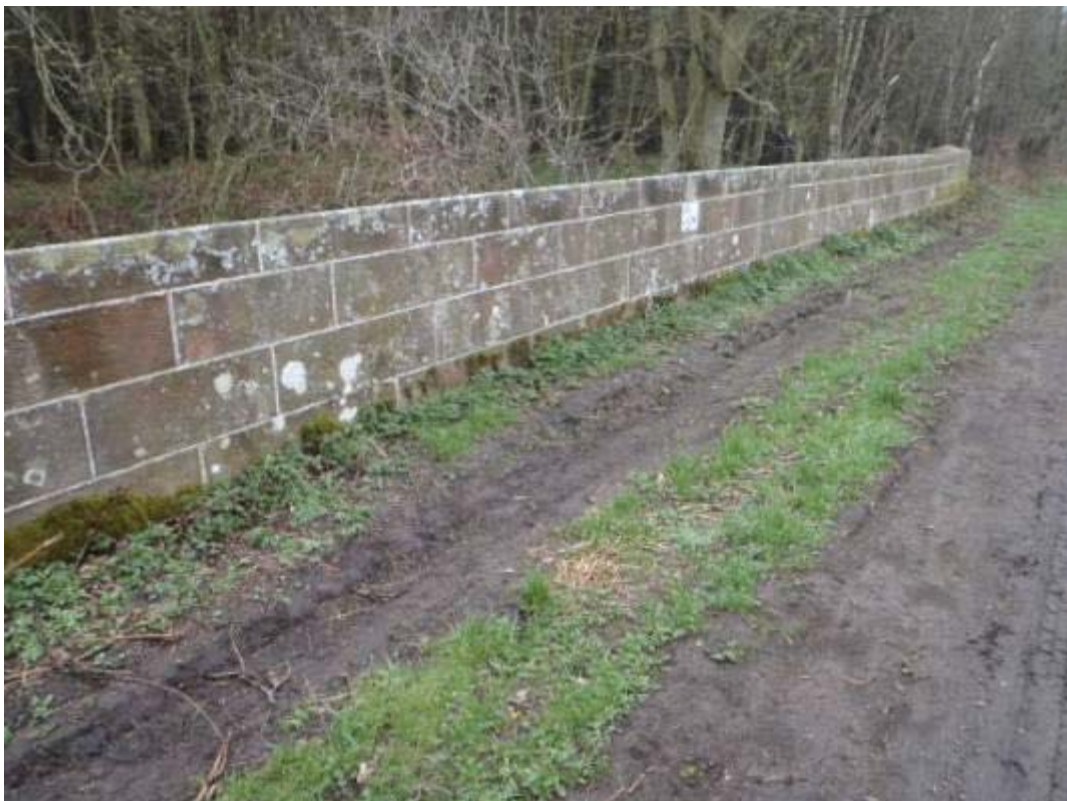
**Photo No.5: West roadside parapet: Pointing repairs.**

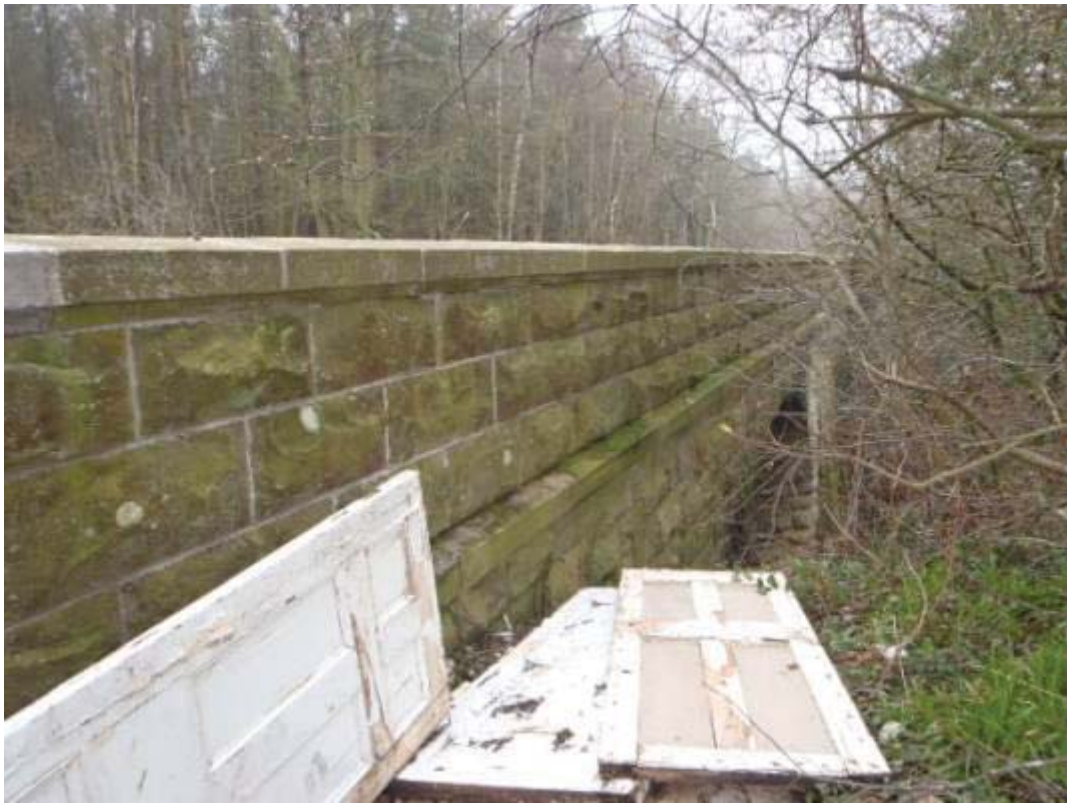
**Photo No.6: East outer parapet: Pointing repairs.**

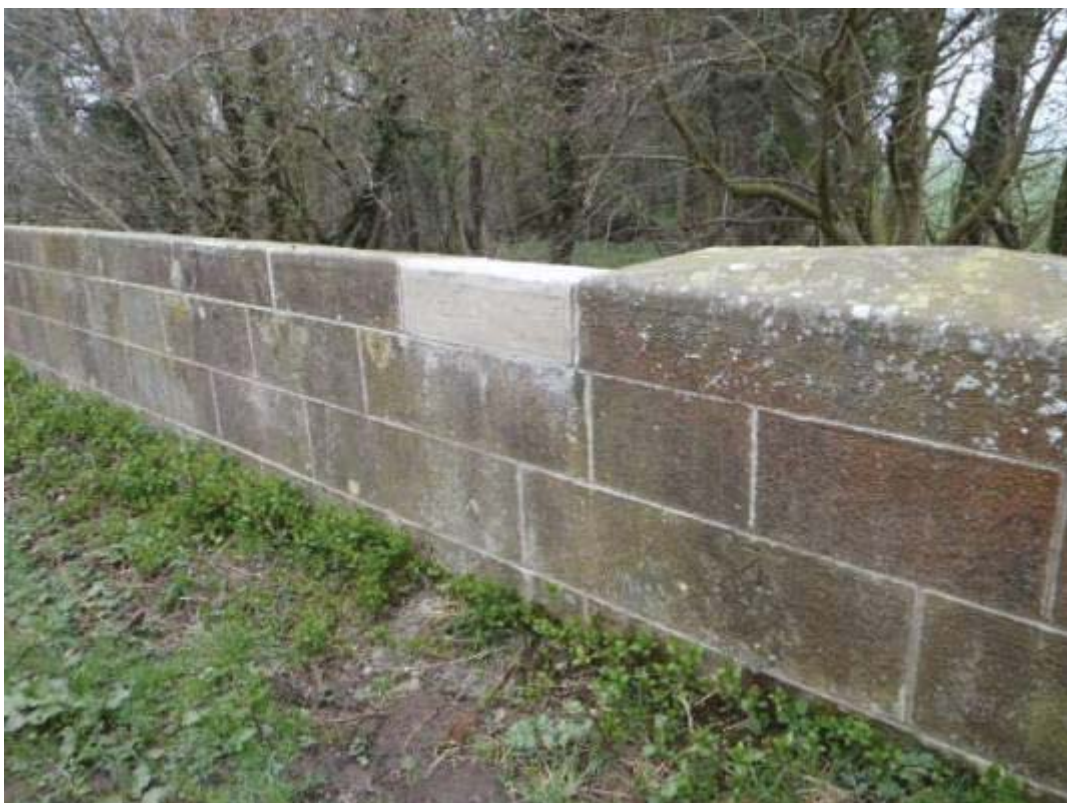
**Photo No.7: East roadside parapet: Coping stone replaced in concrete?**

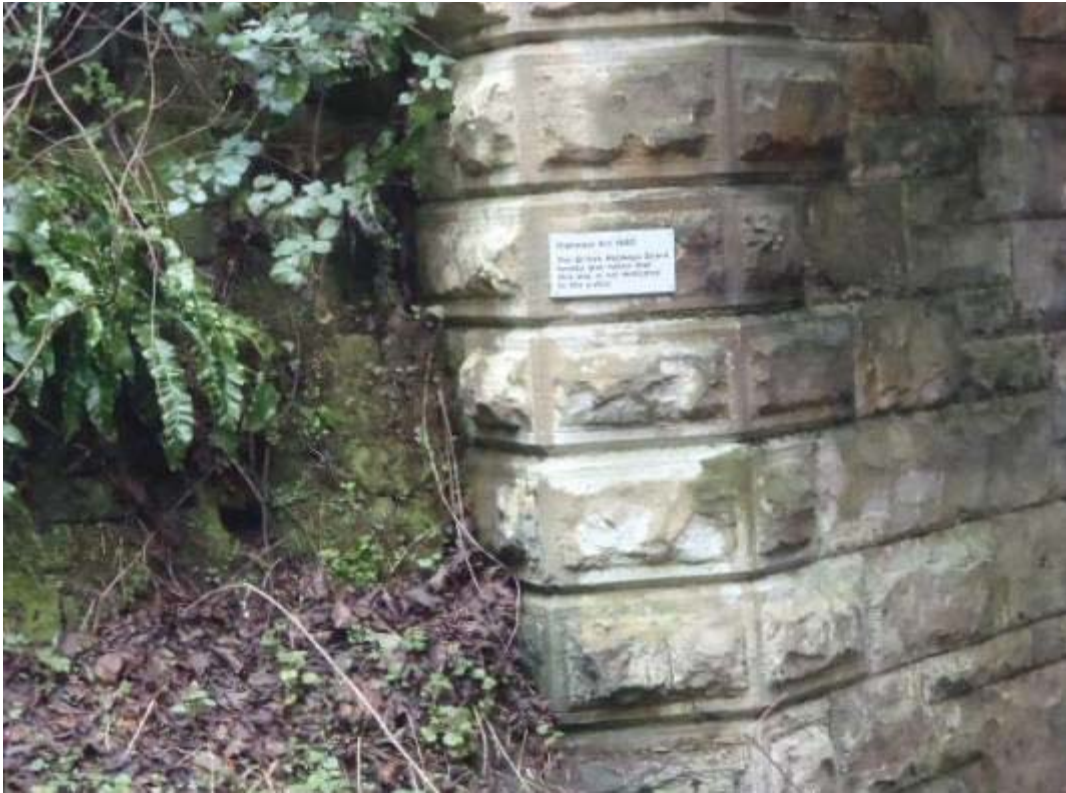
**Photo No.8: Non - Dedication plate: Provided to the abutment.**

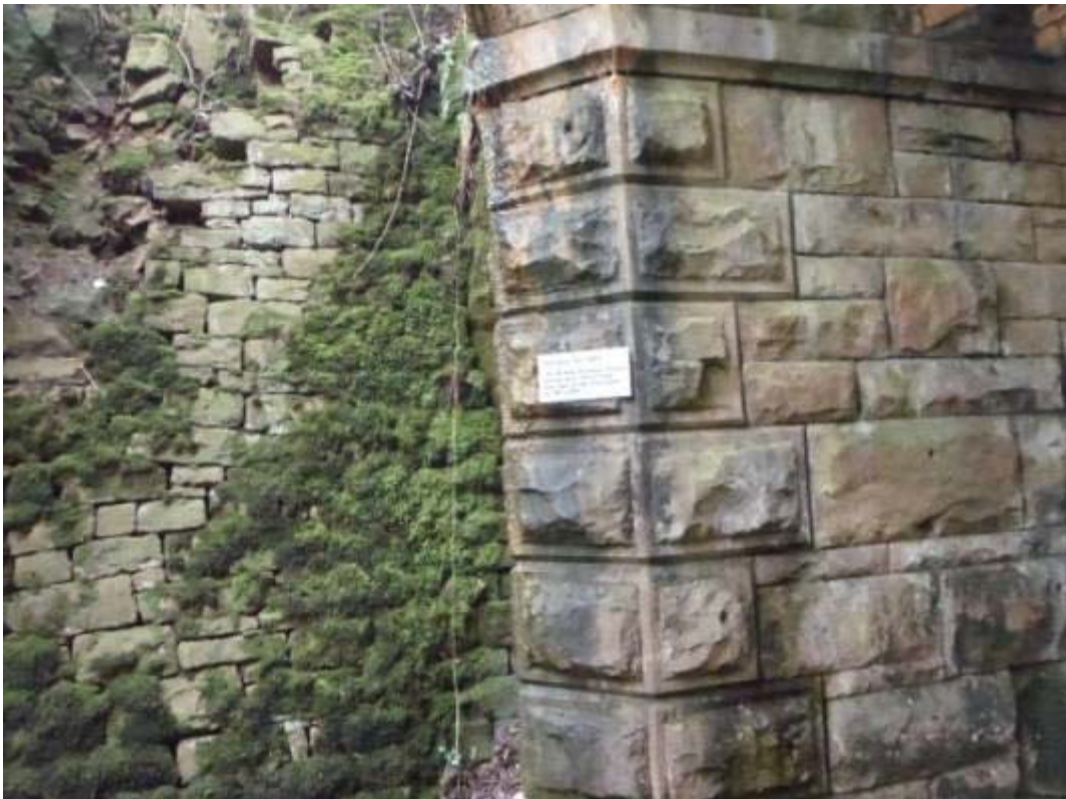
**Photo No.9: Non - Dedication plate: Provided to the abutment.**

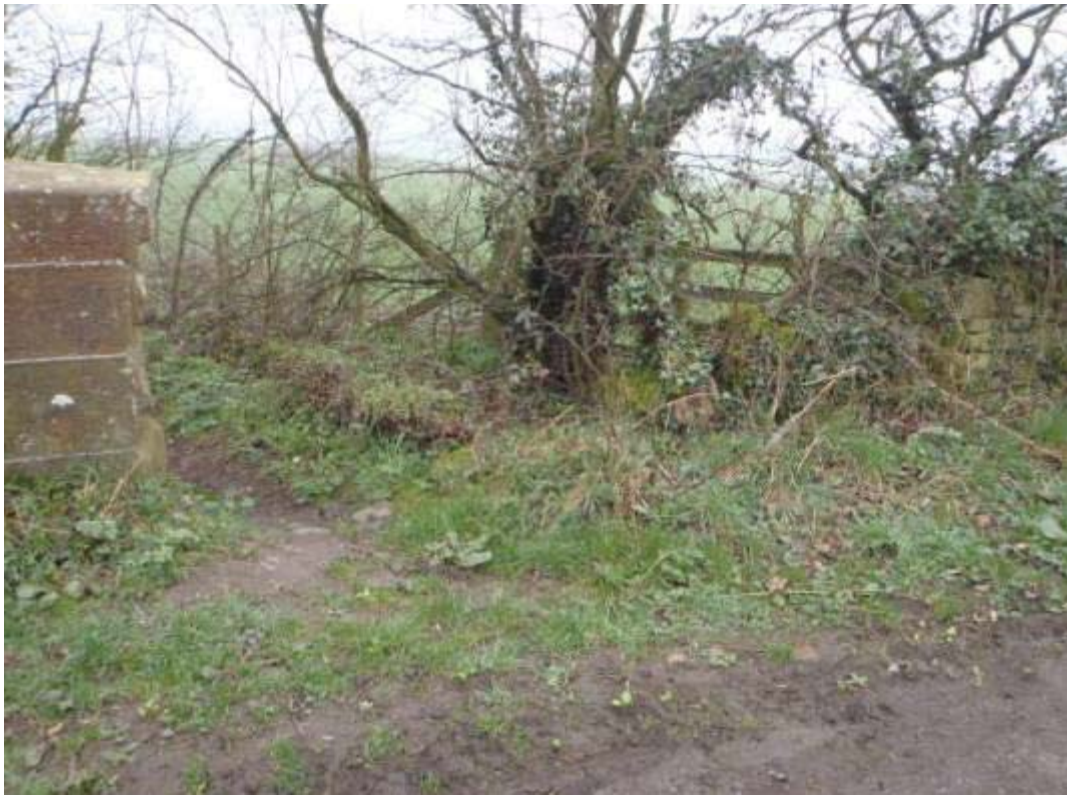
- ❖ **Use of structure** - Public access route to the top, open access to the underneath, located in a rural area, open access to the underneath.
- ❖ **Condition of approach fencing/walling and risk to the public** - Overall condition of the approach road fencing/walling is poor with sections collapsed/missing. {Uncertain of demarcation} P10.

**Photo No.10: Approach road fencing/walling: Typical example of the condition at S/E end.**

Repair/install approach fencing. £1.5K - P1

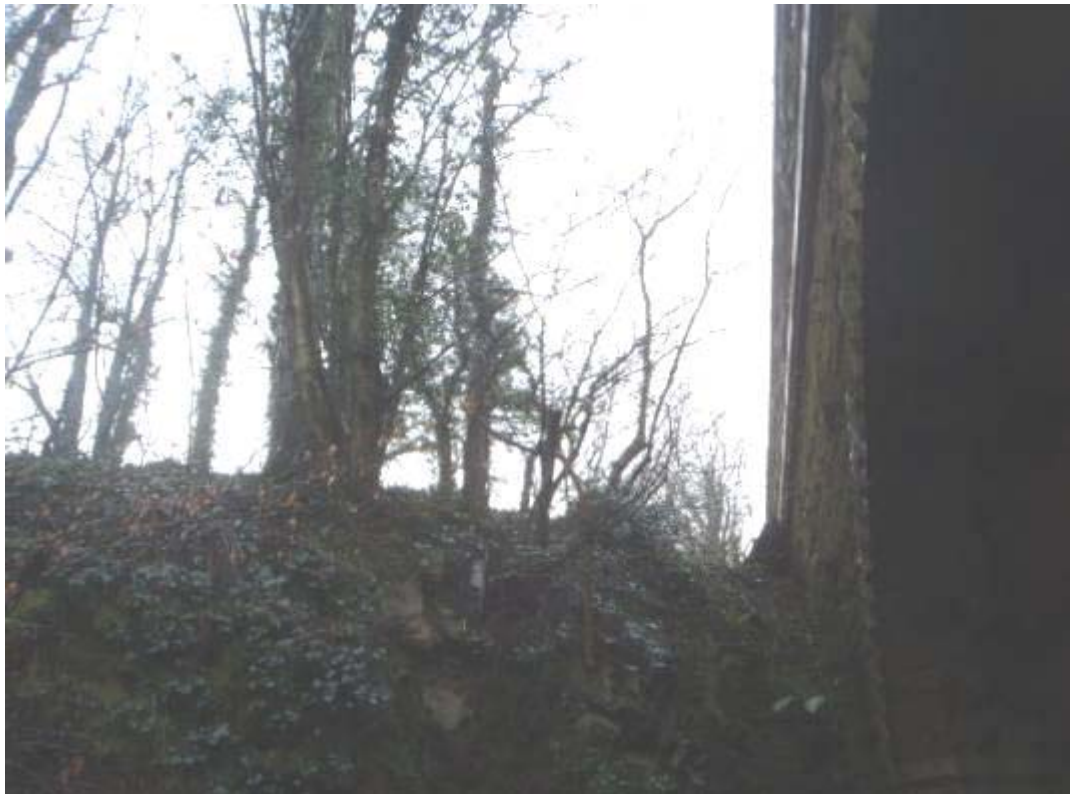
- ❖ **Severe defects** - Mature tree growth within the proximity of the structure. P1.
- ❖ **New defects** - 1No: Non - Dedication plate missing to the S/W abutment return.

**Photo No.1: Mature tree growth: Within the proximity of the structure.**

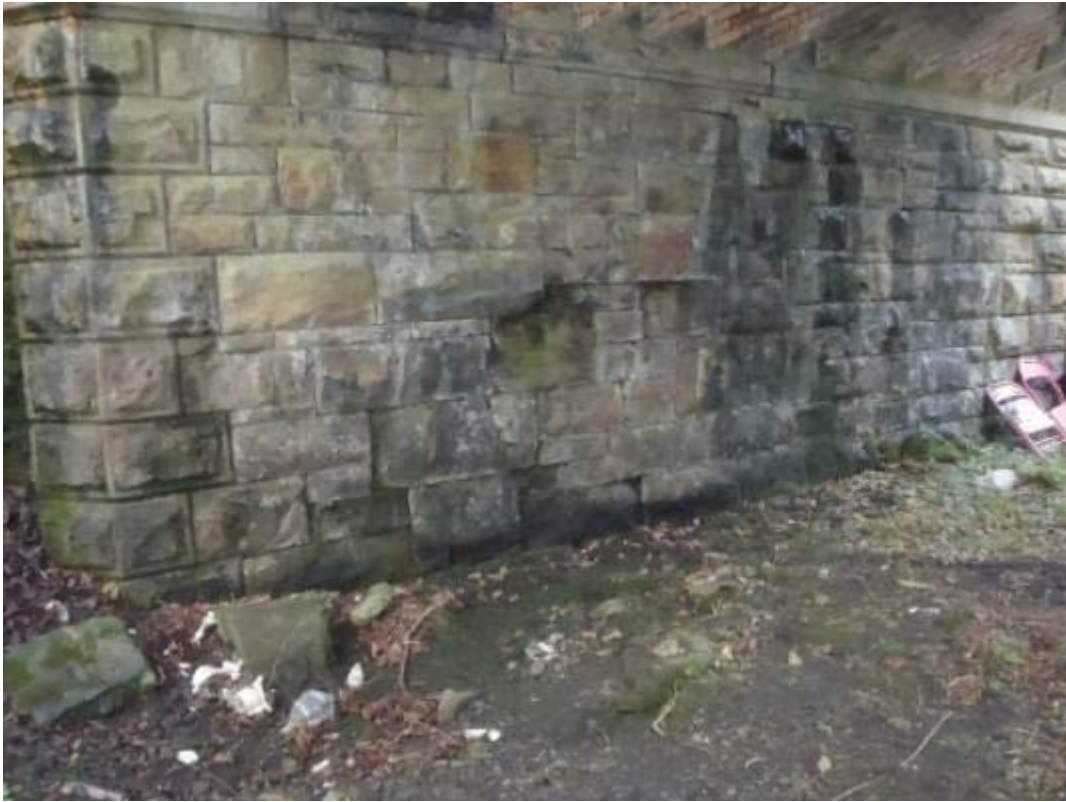
- ❖ **Changes to existing defects since last examination** - Possible further deterioration to the eroded stonework areas. P2.
- ❖ **Changes to the use of the structure since last examination** - N/A.

**Photo No.2: Possible further deterioration: To the eroded stonework areas.**

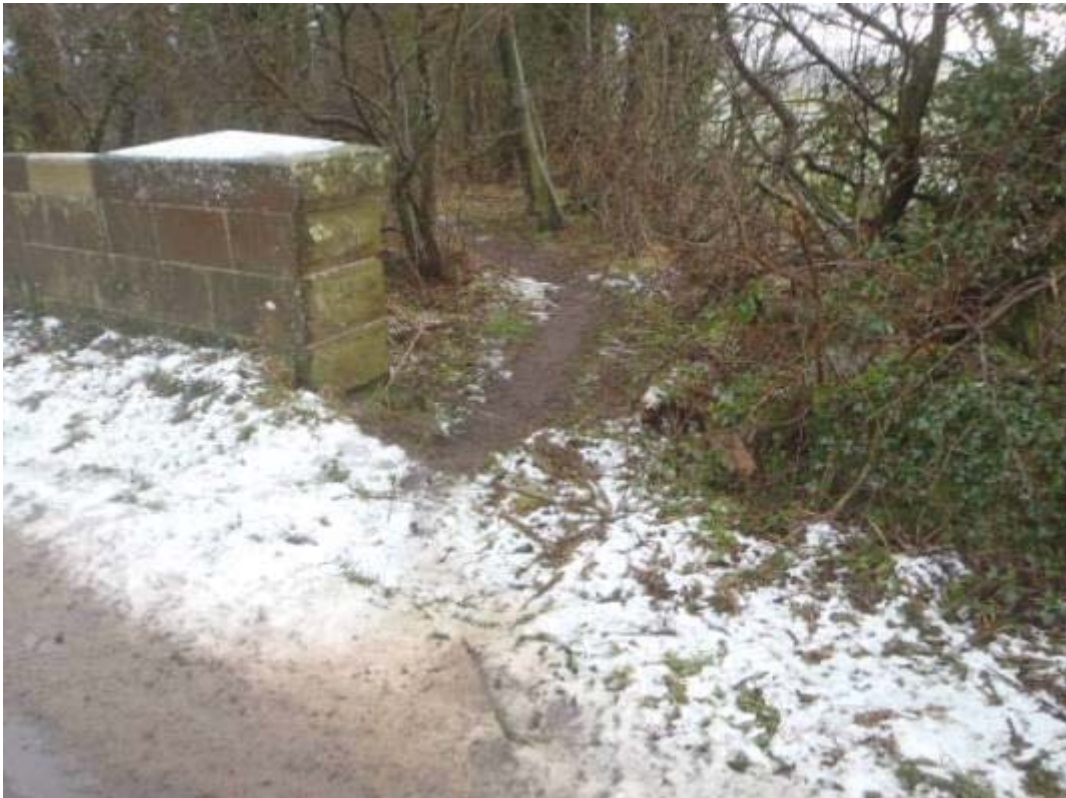
- ❖ **Condition of approach fencing/walling and risk to the public** - Overall condition of the approach road fencing/walling is poor with sections collapsed/missing. {Uncertain of demarcation} P3.

**Photo No.3: Approach road fencing/walling: Typical example of the condition at S/E end.**

Repair/install approach fencing. £1.5K - P1

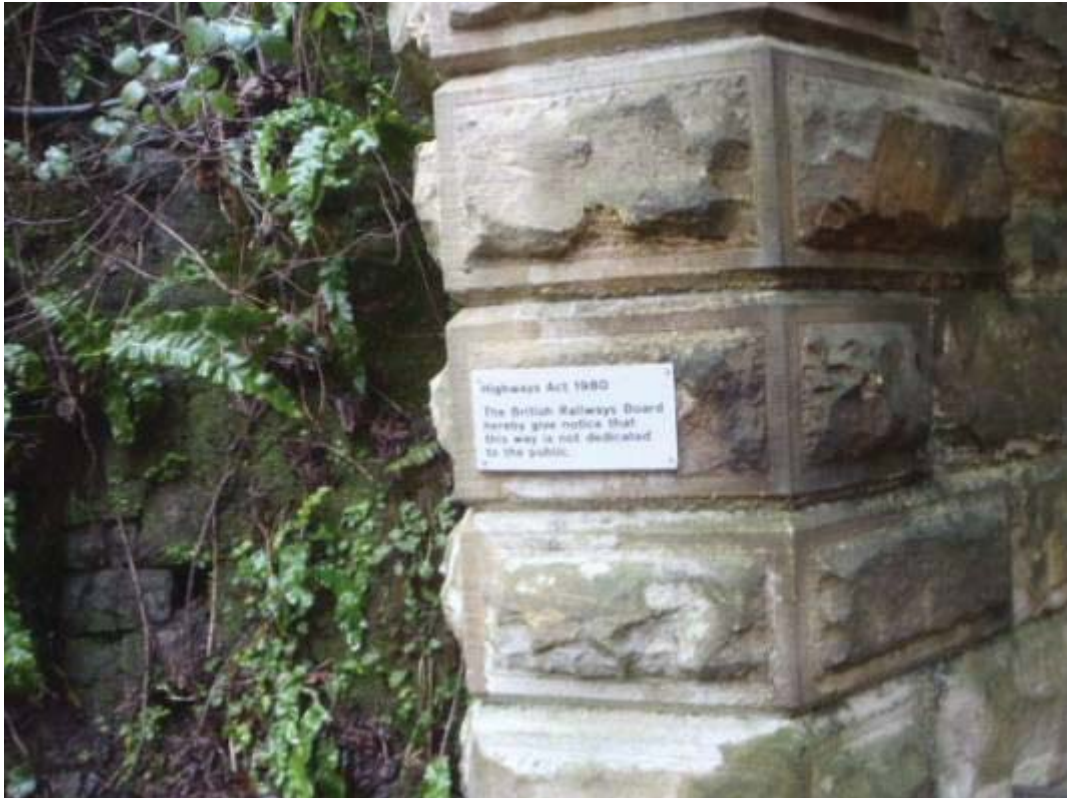
- ❖ **Condition of height restriction signs** - N/A.
- ❖ **Condition of Non - Dedication plates** - Overall condition of the Non - Dedication plates is fair one now missing to the S/W abutment return. P4.

**Photo No.4: Non - Dedication plate: Typical example of the condition.**

Replace Non-Dedication plate. £500 - P1

One of the non-dedication plates is missing. Replace it when other works are planned.

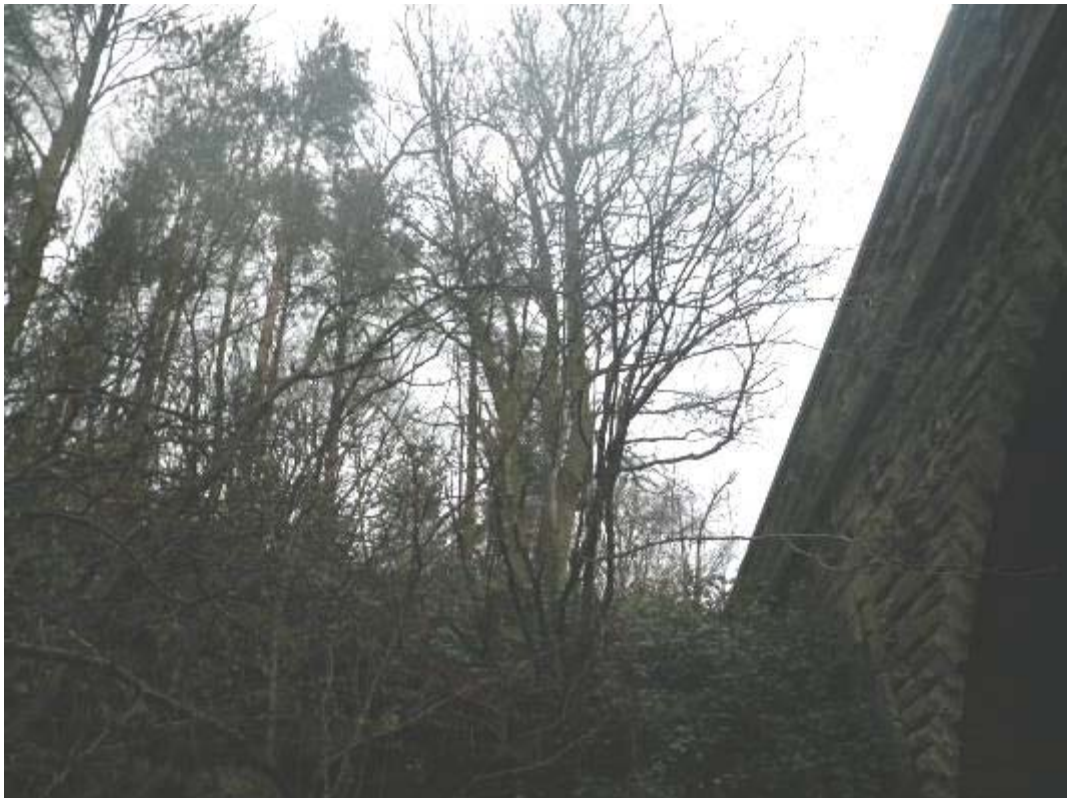
**Photo No.1: Mature tree growth: Within the proximity of the structure.**

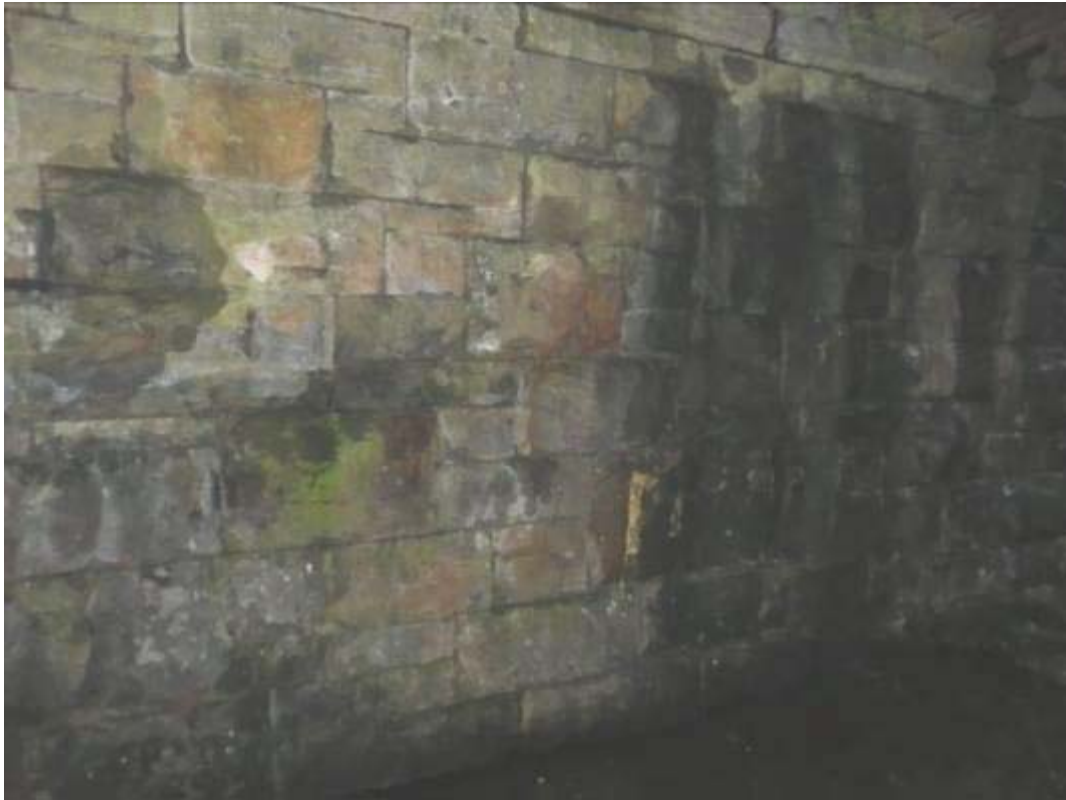
**Photo No.2: Possible further deterioration: To the eroded stonework areas.**

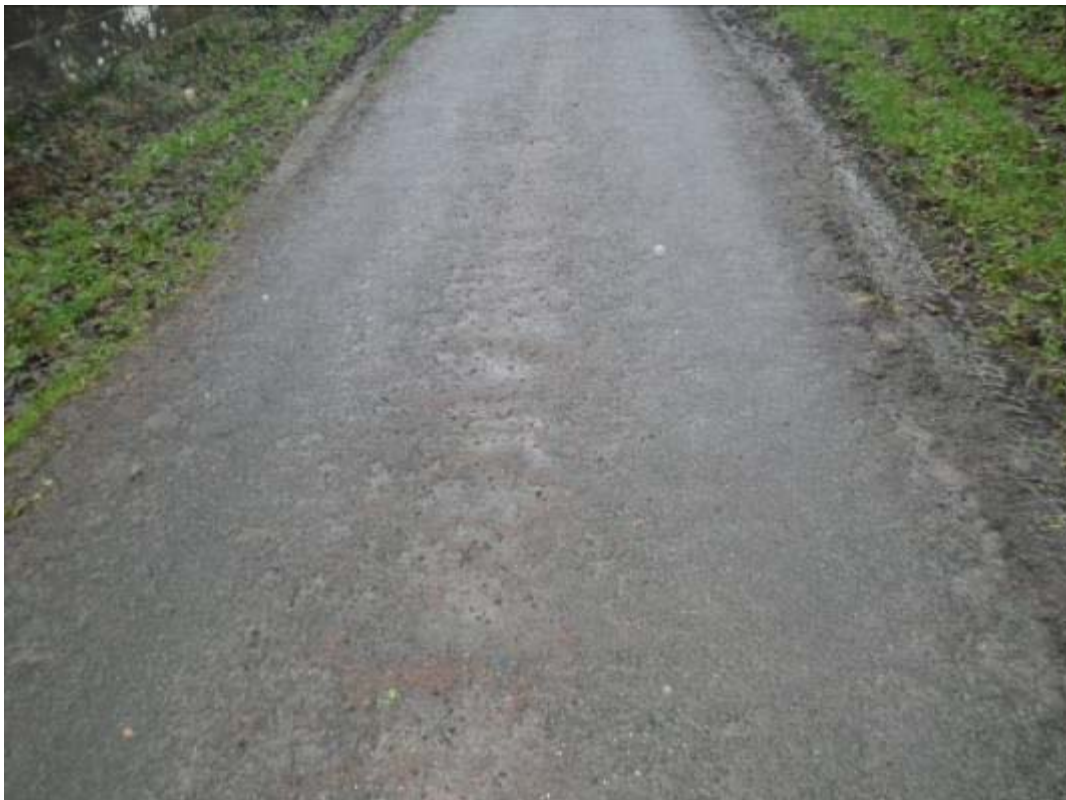
- ❖ **Severe defects** - Mature tree growth within the proximity of the structure. P1.
- ❖ **New defects** - N/A.
- ❖ **Changes to existing defects since last examination** - Possible further deterioration to the eroded stonework areas also the appearance of the road surface appears to be worse in places across the structure. P2 to P3.

**Photo No.3: Road surface: Typical example of the condition.**

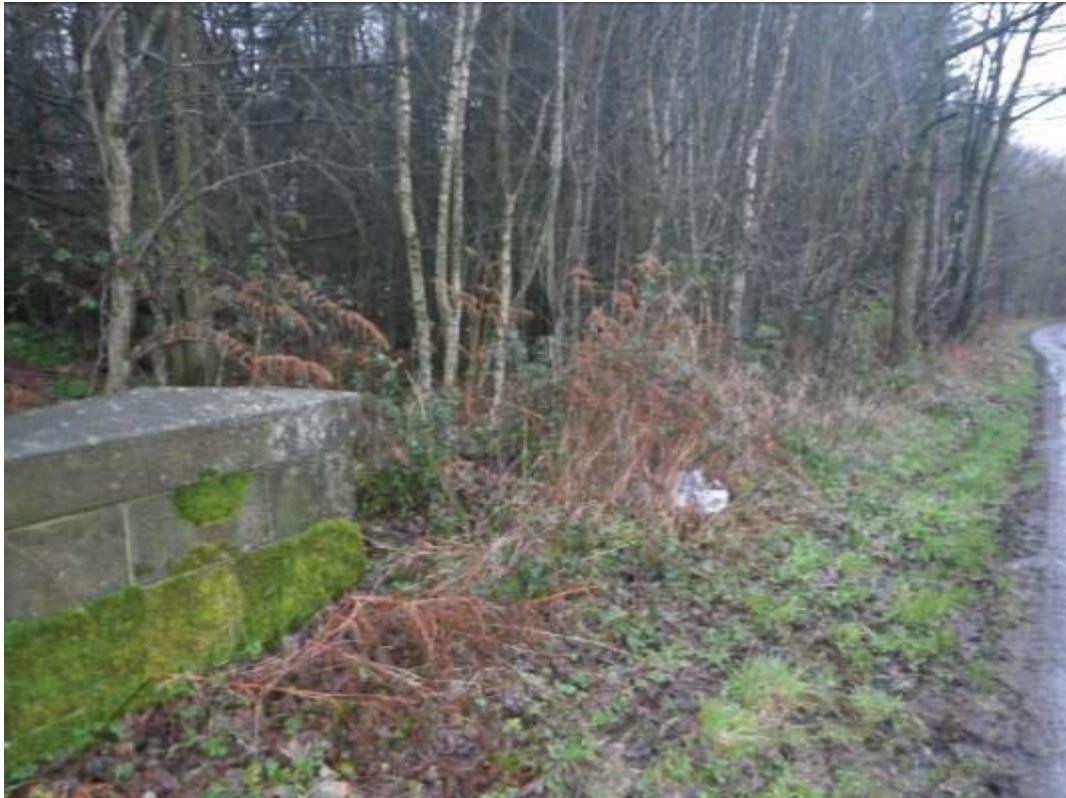
- ❖ **Use of structure** - Public access route to the top, open access to the underneath, located in a rural area in a rock cutting.
- ❖ **Condition of approach fencing/walling and risk to the public** - Overall condition of the approach road fencing/walling is poor with sections collapsed/missing. {Uncertain of demarcation} P4.

**Photo No.4: Approach road fencing/walling: Typical example of the condition at N/W end.**

Repair/install approach fencing. £1.5K - P1

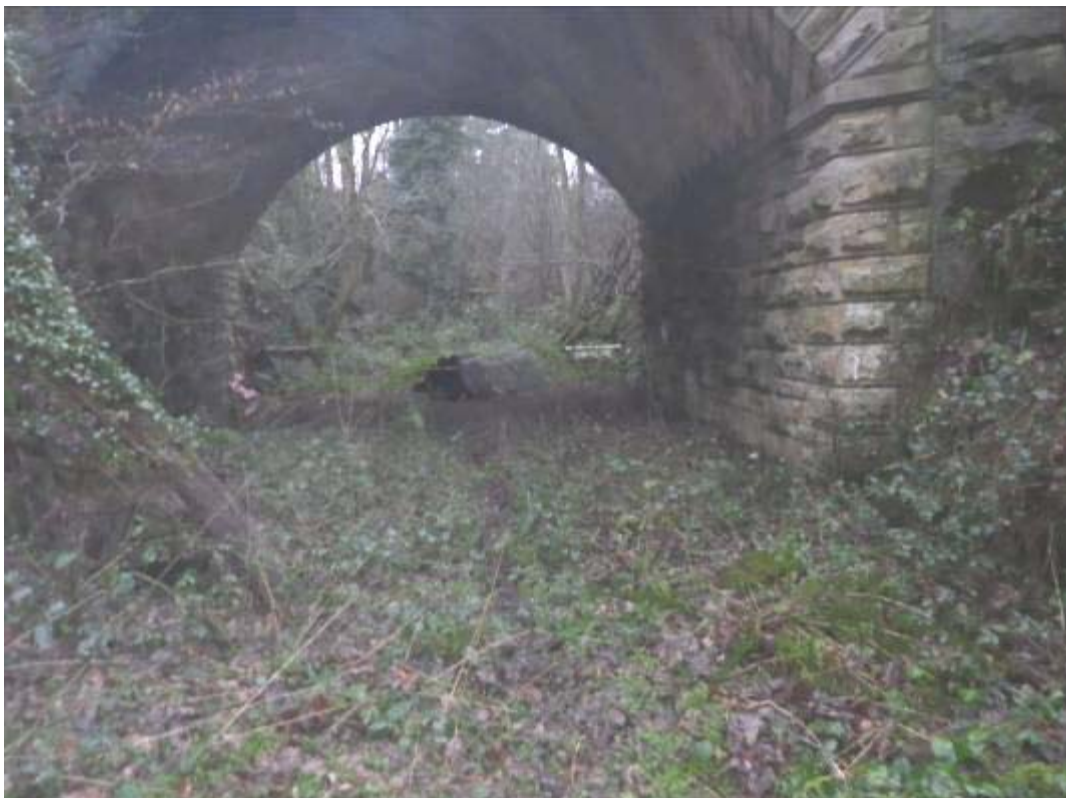
- ❖ **Security fencing** - Overall condition of the security fencing under the structure is poor, open access.P5.
- ❖ **Condition of weight restriction signs** - N/A.

**Photo No.5: Area under the structure: Typical example.**

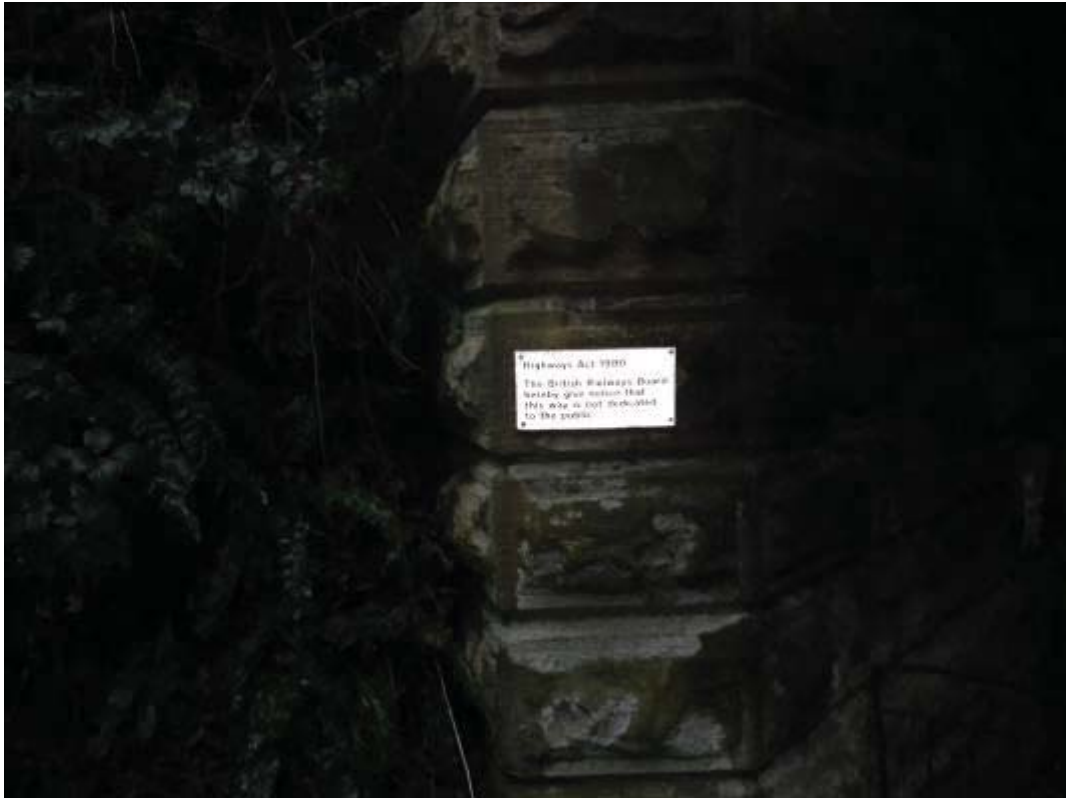
- ❖ **Condition of height restriction signs** - N/A.
- ❖ **Condition of Non - Dedication plates** - Overall condition of the Non - Dedication plates is only fair, one missing to the S/W abutment return. P6.

**Photo No.6: Non - Dedication plate: Typical example of the condition.**

Replace Non-Dedication plate. £500 - P1

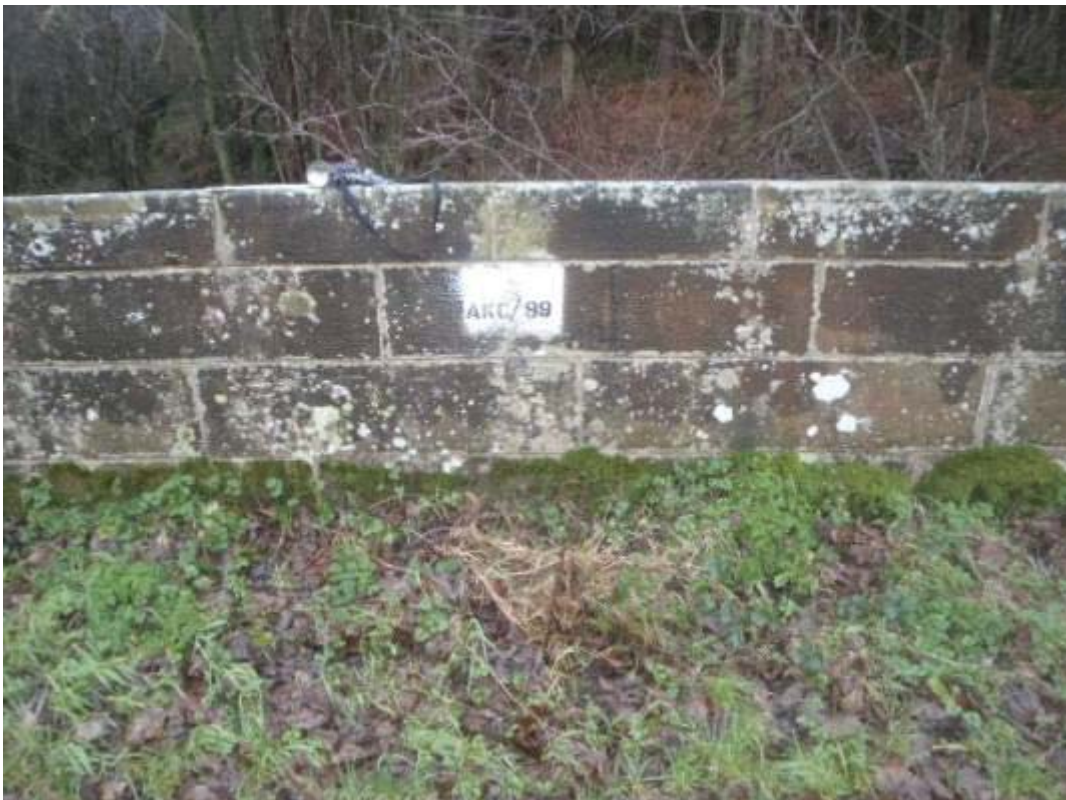
**Photo No.7: BRB lettering: Erased.**

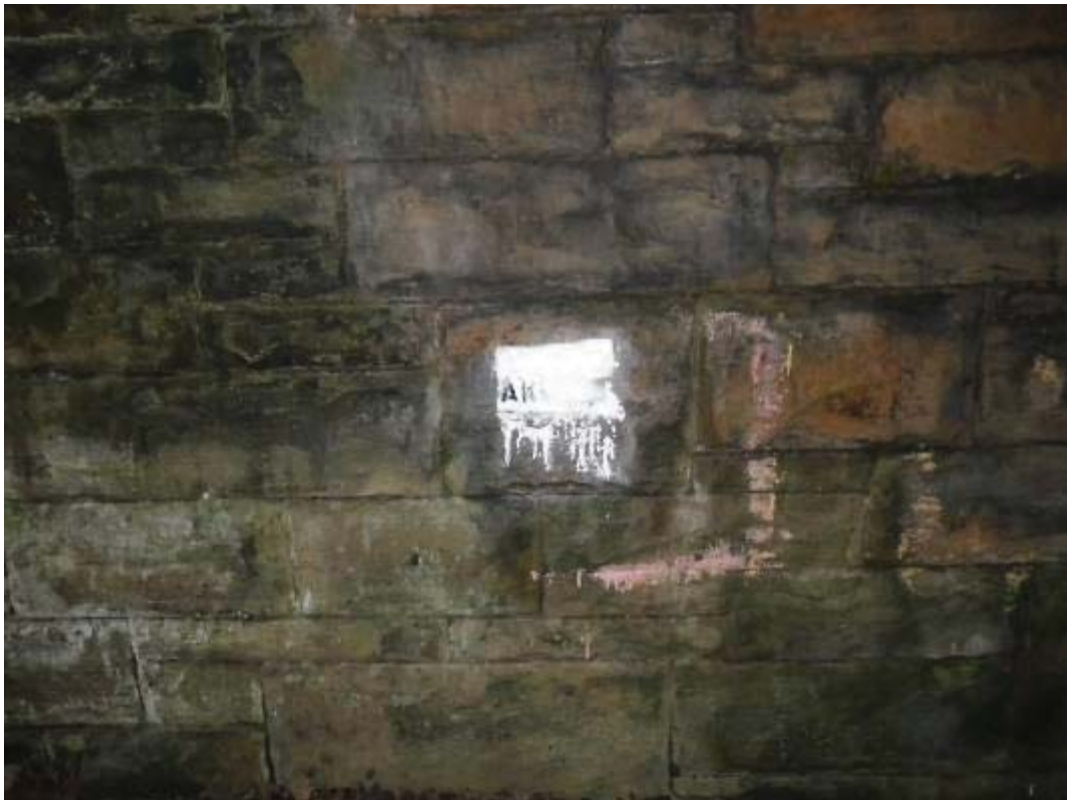
**Photo No.8: BRB lettering: Erased.**

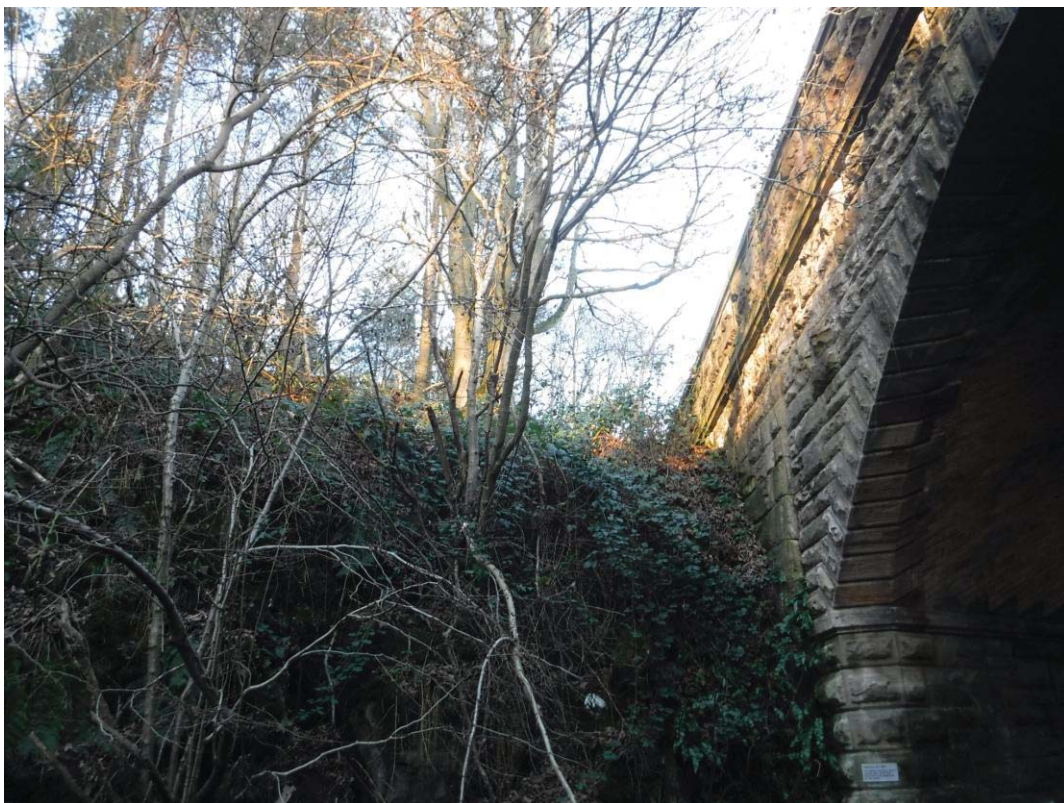
**Severe Defects** - Mature tree growth within the proximity of the structure. P1.

**Photo No.1: Mature tree growth: Within of the proximity of the structure.**

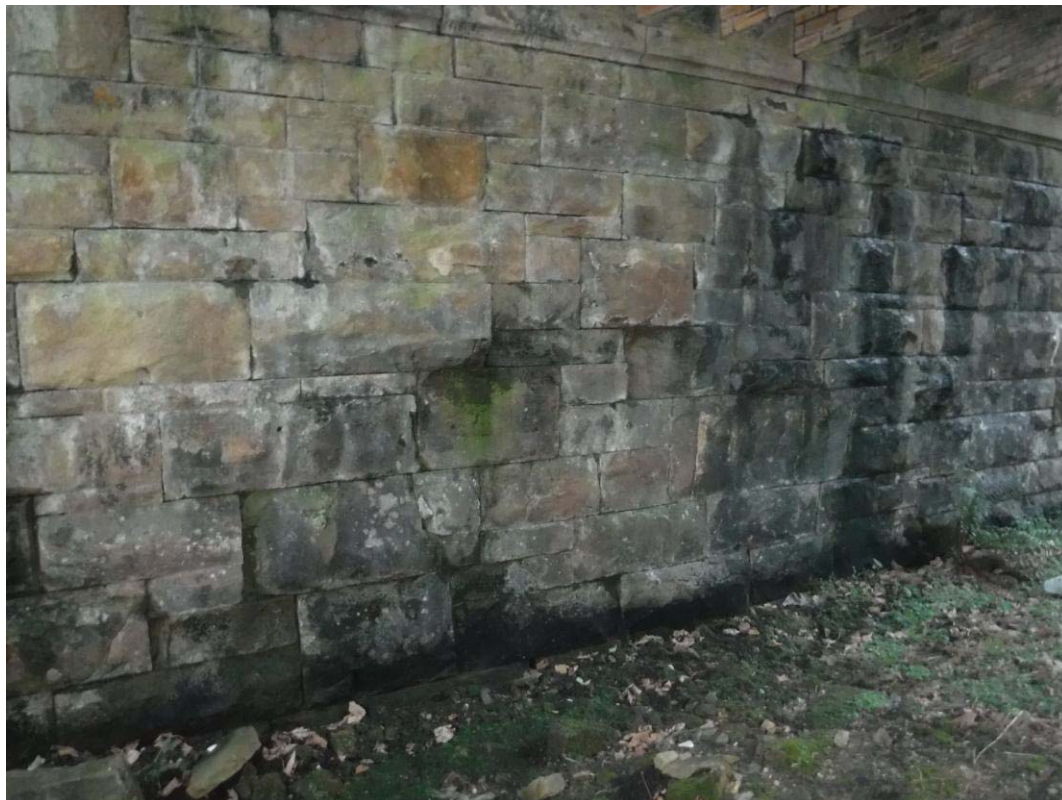
**Changes to Existing Defects since Last Examination** - Non - Dedication plate to the substructure is still missing, possible further deterioration to the eroded stonework areas also the appearance of the road surface appears to be worse in places across the structure at the verges. P2 to P3.

**Photo No.2: Possible further deterioration: To the eroded stonework areas.**

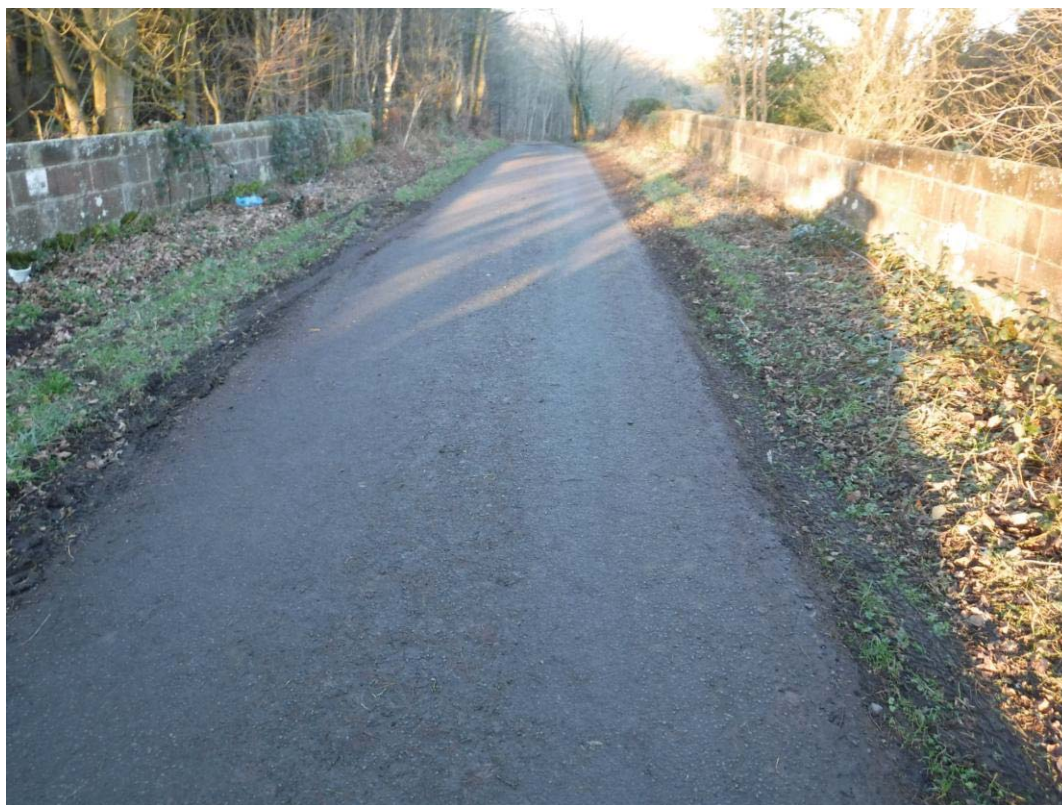
**Photo No.3: Road surface: Typical example of the condition.**
