# Highways Agency - Historical Railways Estate

AKC/99

# Highways Agency Historical Railways Estate Visual Examination Report

ROUTE: ALNWICK - CORNHILL

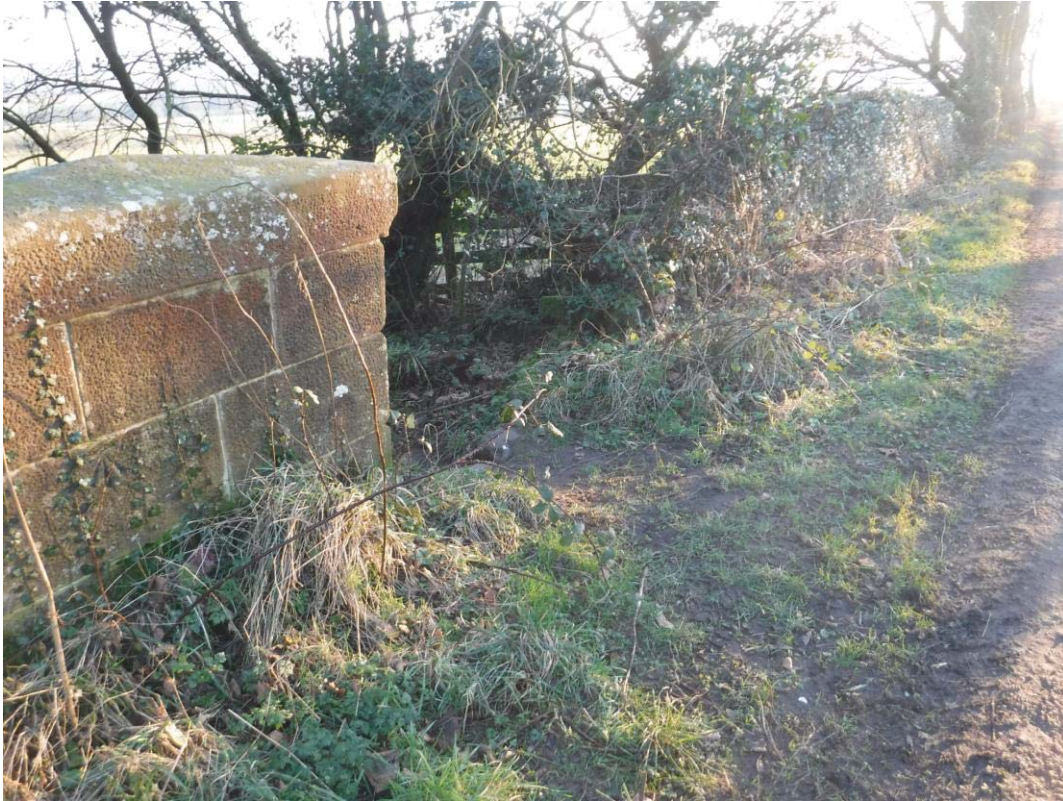
**Condition of Approach Fencing/Walling and Risk to the Public** - Overall condition of the approach road fencing/walling is poor with sections collapsed with sections missing. *{Uncertain of demarcation}* P4.

**Photo No.4: Approach road walling: Typical example of the condition at S/E end.**

Repair/install approach fencing. £1.5K - P1  
 Replace Non-Dedication plate. £500 - P1  
 Repair longitudinal fracture to the crown behind south voussoirs. £5K - P2  
 Clear rubbish.

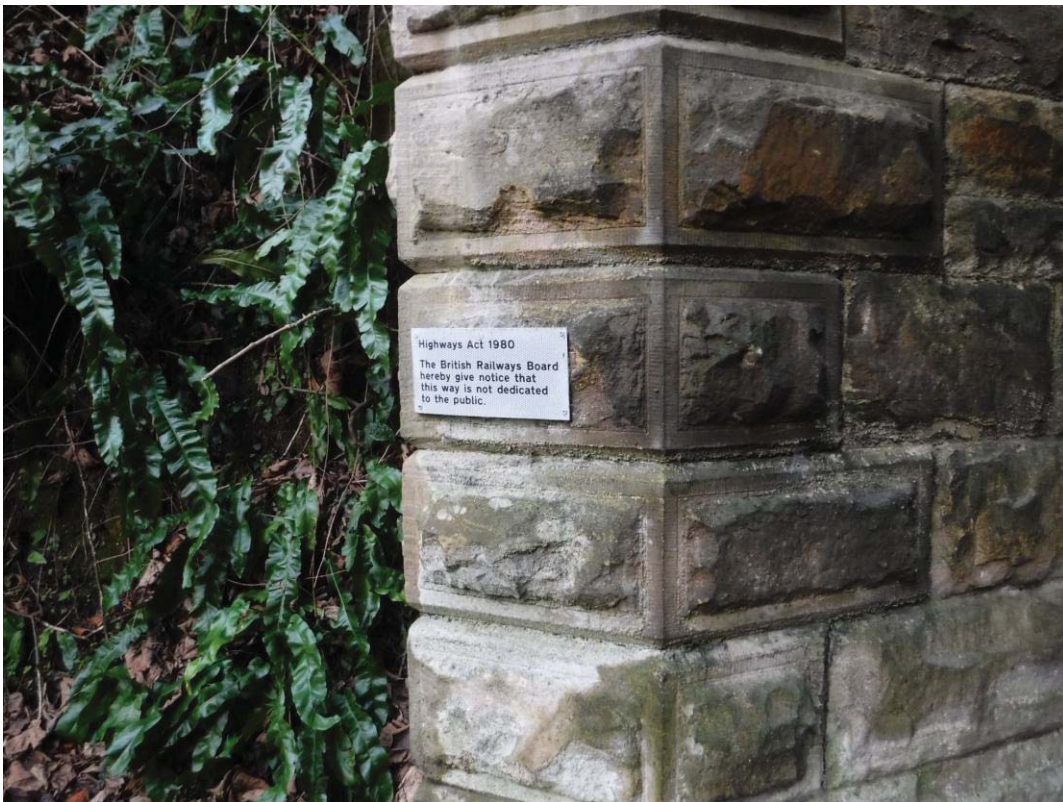
**Photo No.5: Non - Dedication plate: Typical example of the condition. {BRB}**

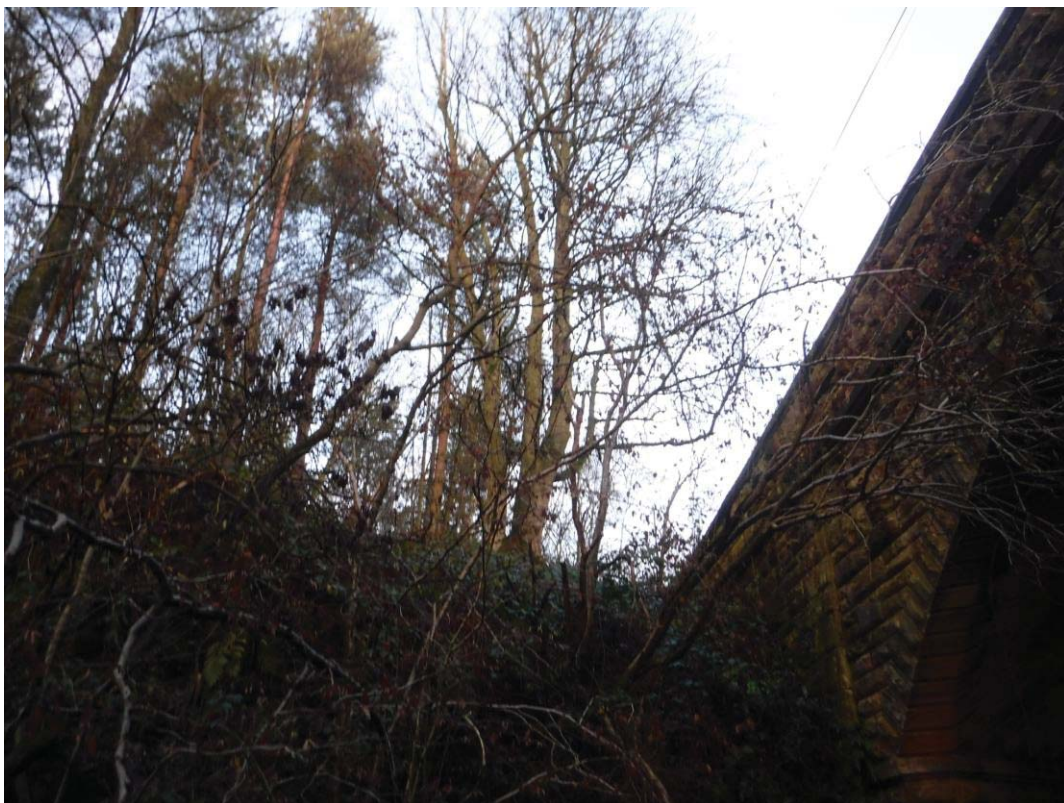
**Severe Defects** - Mature tree growth within the proximity of the structure. P1.

**Photo No.1: Mature tree growth: Within of the proximity of the structure.**

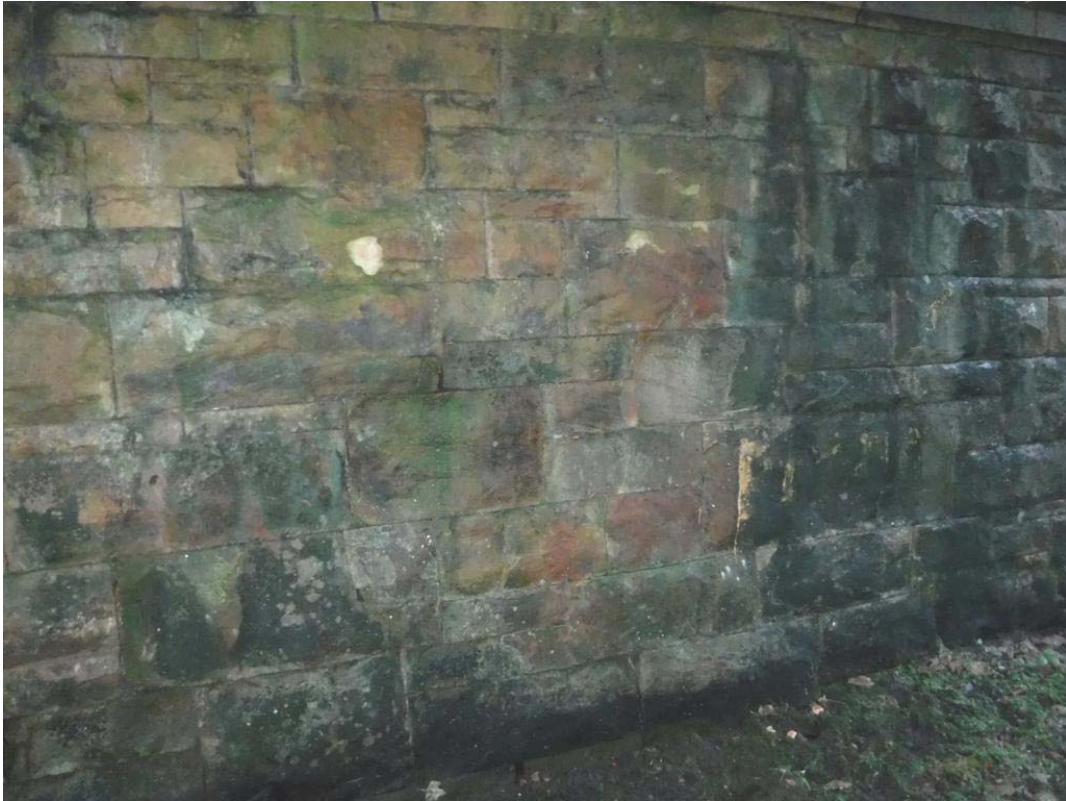
**Changes to Existing Defects since Last Examination** - Non - Dedication plate to the substructure is still missing, possible further deterioration to the eroded stonework areas. P2.

**Photo No.2: Possible further deterioration: To the eroded stonework areas.**

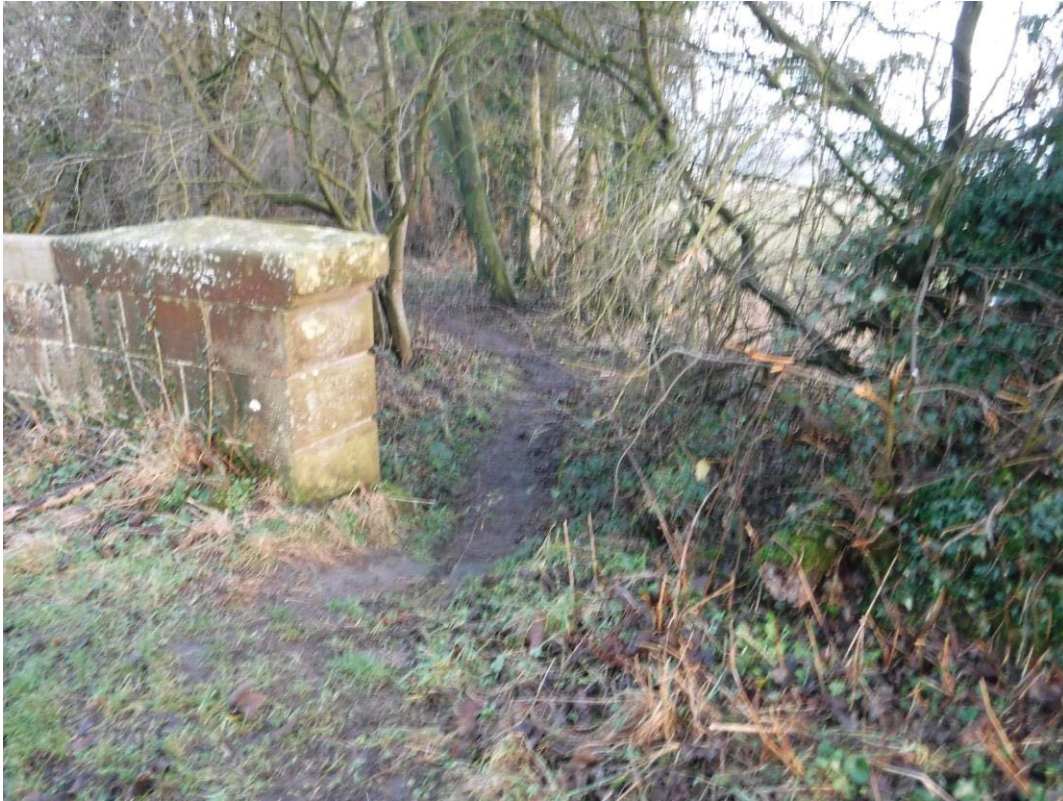
**Condition of Approach Fencing/Walling and Risk to the Public** - Overall condition of the approach road fencing/walling is poor with sections collapsed with sections missing. *{Uncertain of demarcation}* P4.

**Photo No.4: Approach road walling: Typical example of the condition at S/E end.**

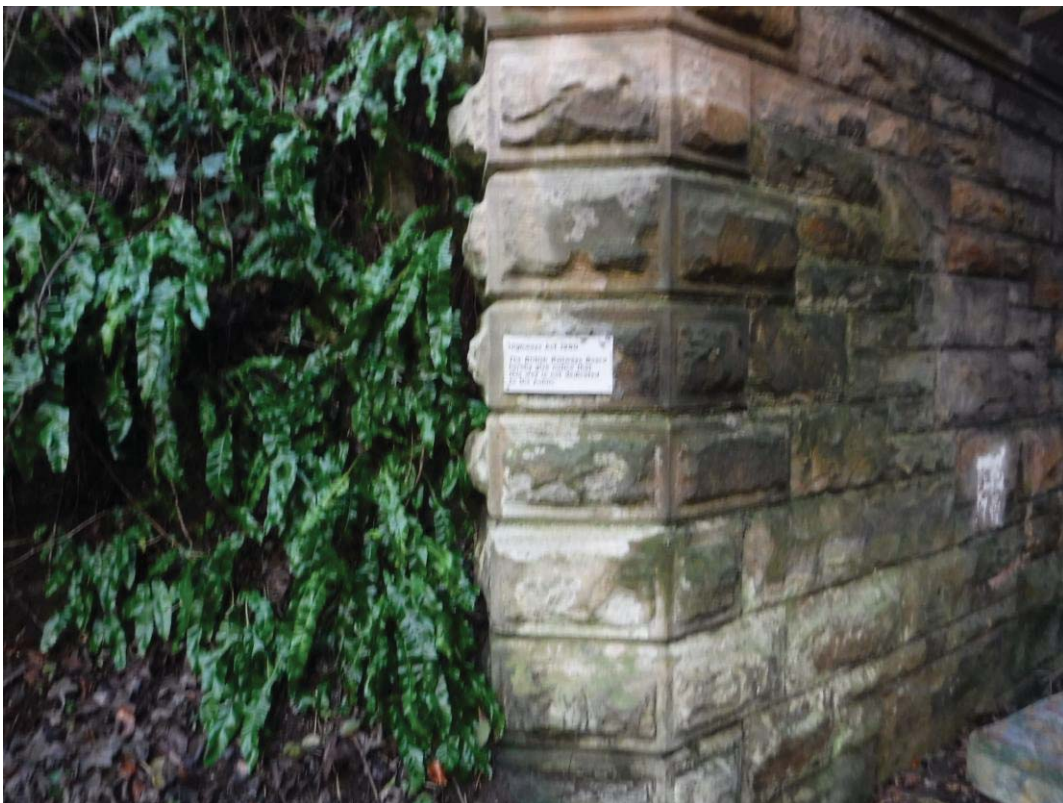
**Existence and Condition of Non - Dedication plates** - Overall condition of the Non - Dedication plates is fair. *{Only 1No: BRB plate displayed}* P5.

**Photo No.5: Non - Dedication plate: Typical example of the condition. {BRB}**

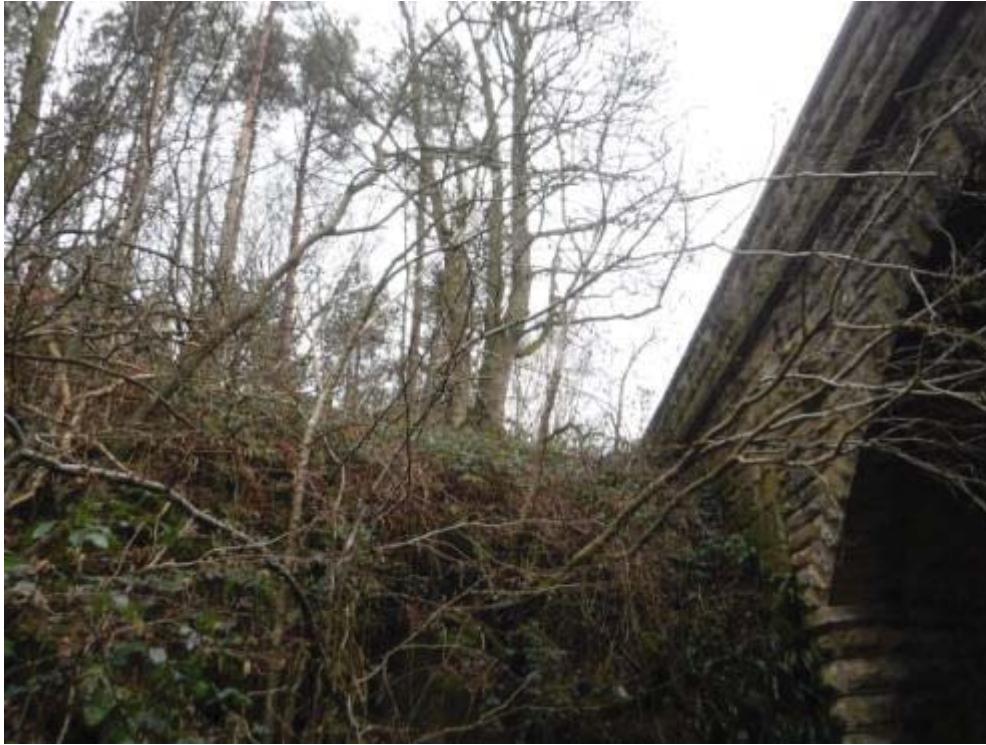
**Severe Defects** - Mature tree growth within of the proximity of the structure. P1.

**Photo No: 1 – Mature tree growth: Within of the proximity of the structure.**

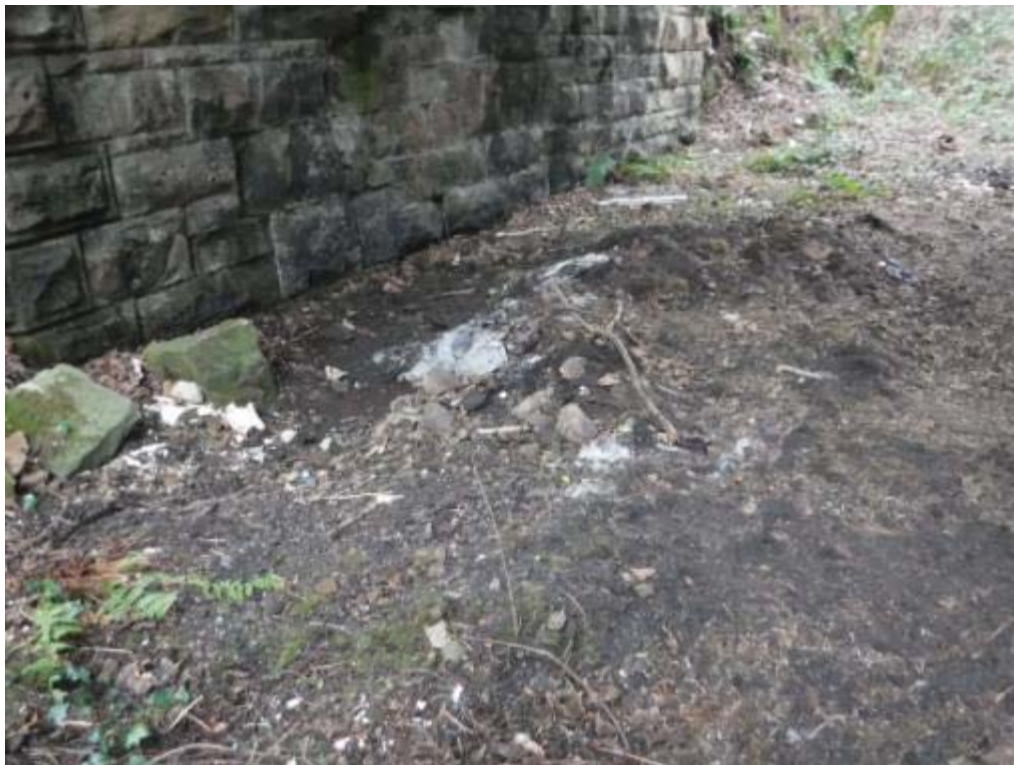
**New Defects** - Evidence of extinguished fires to the underneath of the structure with smoke discoloration to the arch ring soffit & south abutment. P2.

**Photo No: 2 – Area under the structure: Evidence of extinguished fire.**

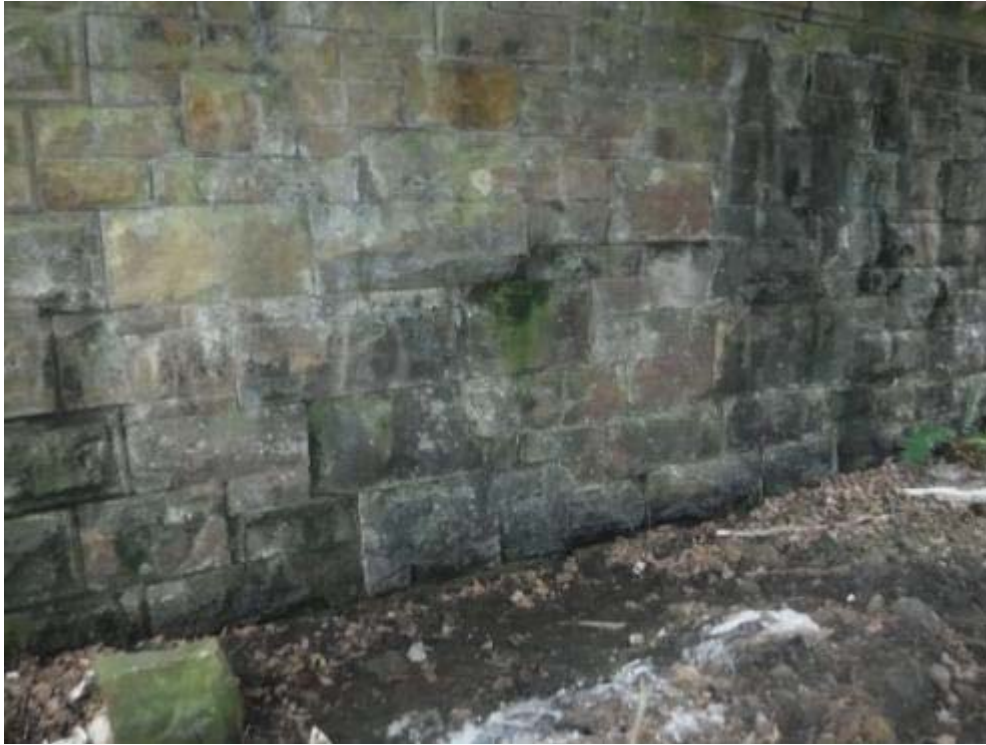
**Changes to Existing Defects since Last Examination** - Eroded stonework areas appear to be a prolonged defect showing no change; however the potential for further development remains high in extreme freezing weather also the condition of the road surface appears to be slightly worse in places across the structure. P3 to P4.

**Photo No: 3 – Erosion to the stonework: Typical example.**

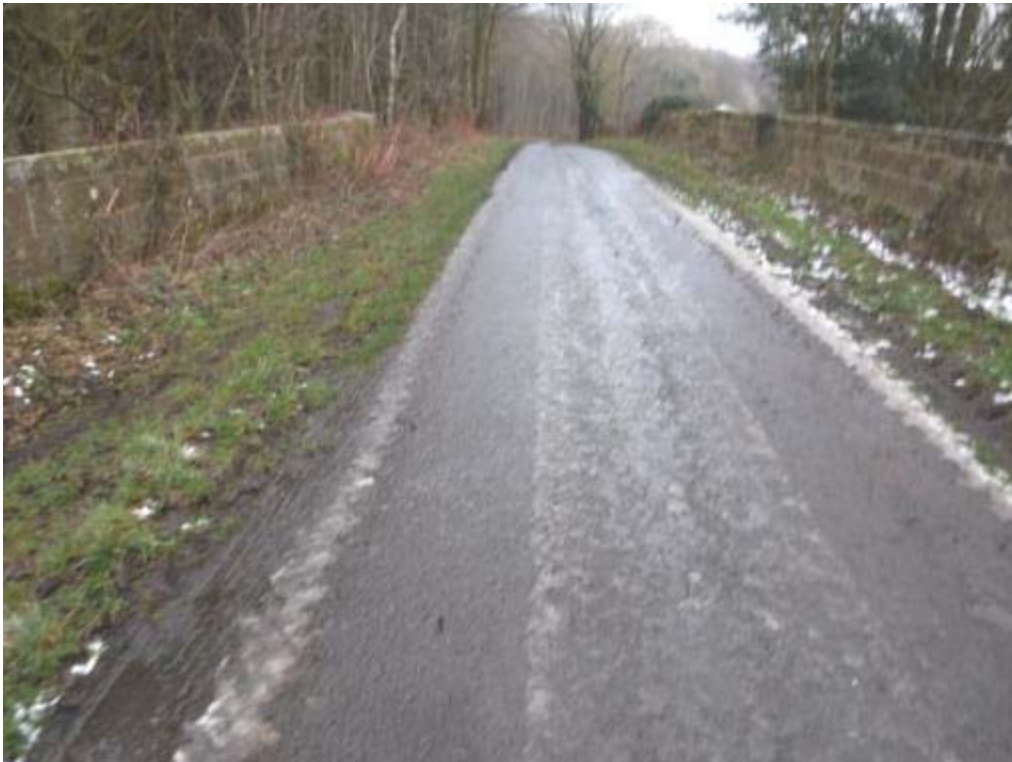
**Photo No: 4 - Road surface: Typical example of the condition.**

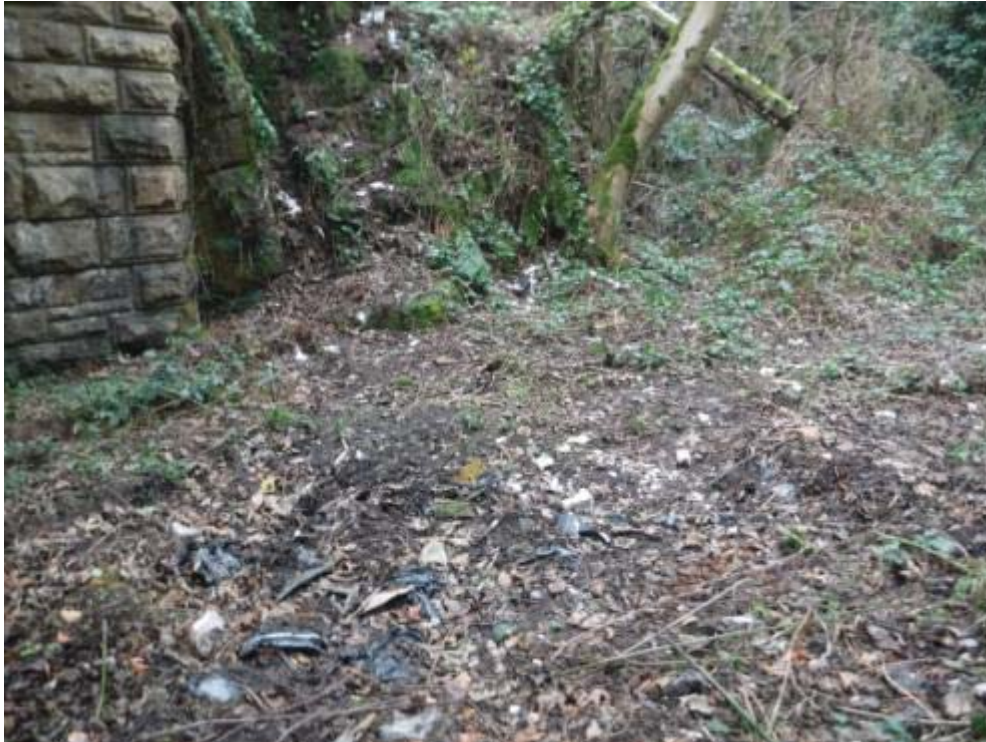
**Evidence of Repair/Maintenance/Investigation Work that appears to have been carried out since Last Examination** - Discarded materials have been removed some possibly burnt under & adjacent the structure. P5.

**Photo No: 5 - Area under & adjacent the structure: Cleared of discarded materials**

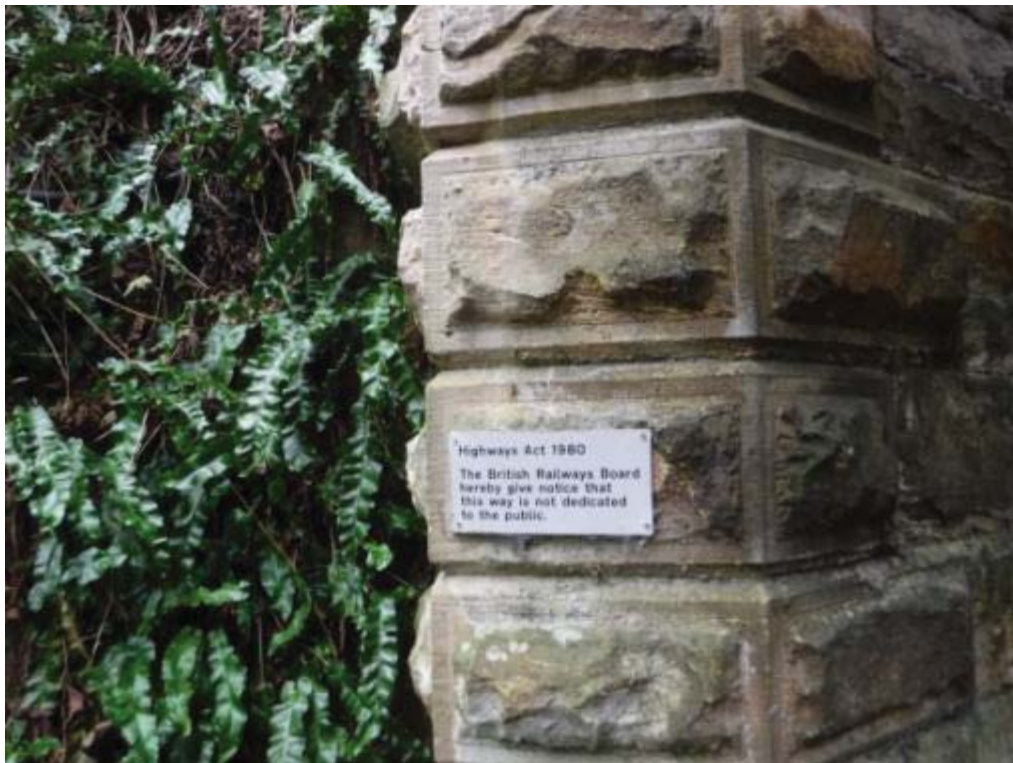
**Existence and Condition of Non - Dedication plates** - Overall condition of the Non - Dedication plates is fair. *{Only 1No: BRB plate displayed the other plate has been missing since 2015}* P6.

**Photo No: 6 - Non - Dedication plate: Typical example of the condition. {BRB}**

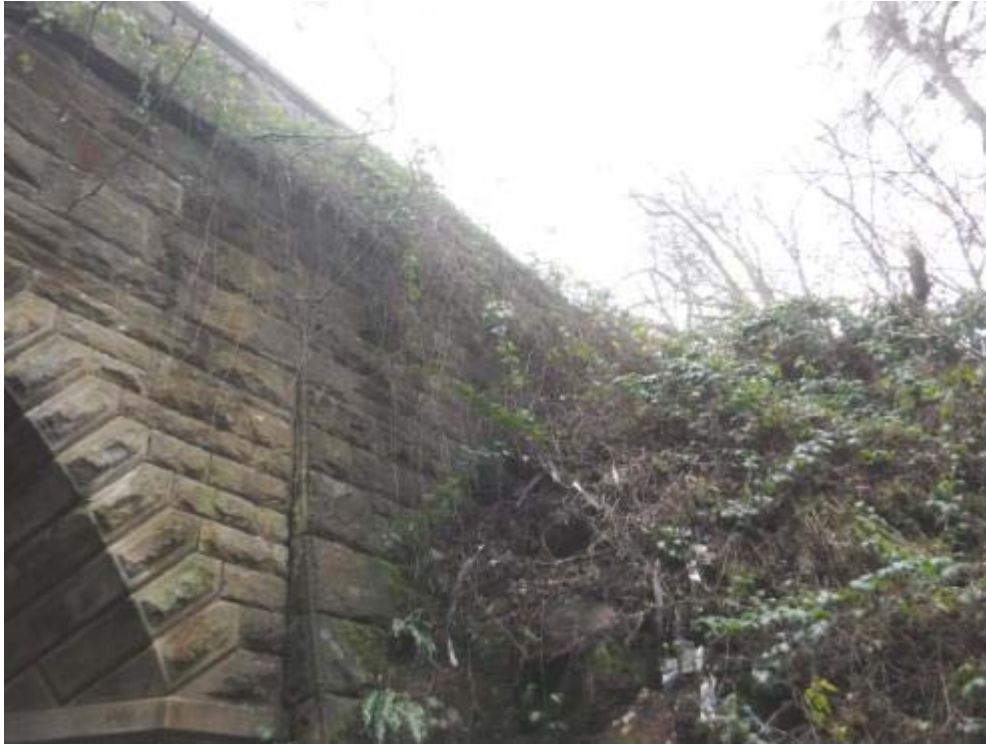
**Photo No: 7 – Vegetation: Typical example.**
