# ***AAIB Bulletin***

# ***1/2021***

Published 14 January 2021

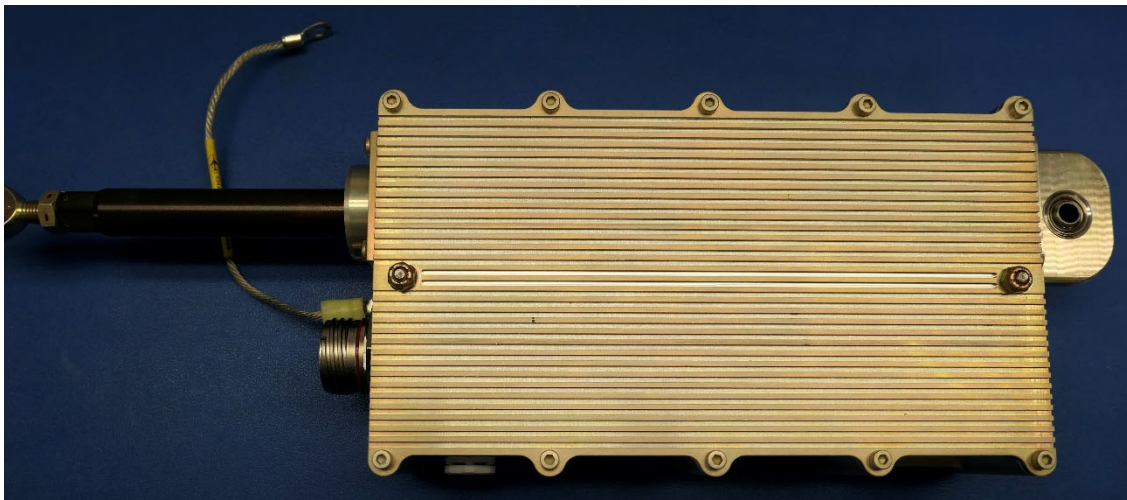
**Figure 10**

The right TCU (s/n 1014) passed all functional test and was therefore not subjected to any further assessment. Figure 10 shows an image of TCU s/n 1014.

TCU s/n 1014 after initial assessment

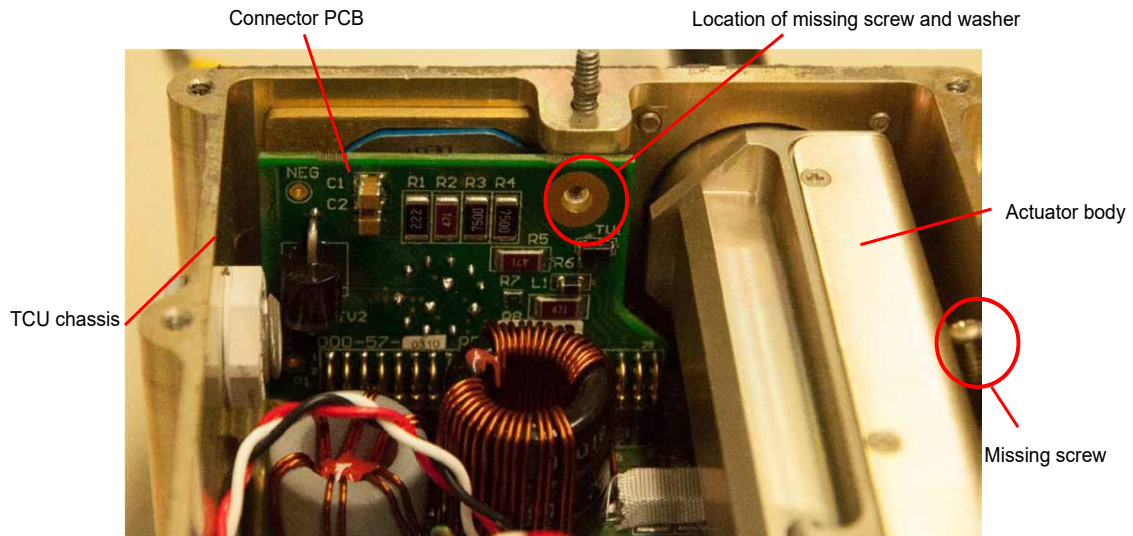
**Figure 11**

When the unit was shaken, before removing the cover, something rattled inside. Opening the unit revealed that the screw and washer which attached and earthed the electrical connector printed circuit board to the unit's chassis were missing. Both the screw and washer were found within the chassis<sup>16</sup> (Figures 11 and 12).

TCU s/n 1015 showing where the crew should have been, and where it was found.

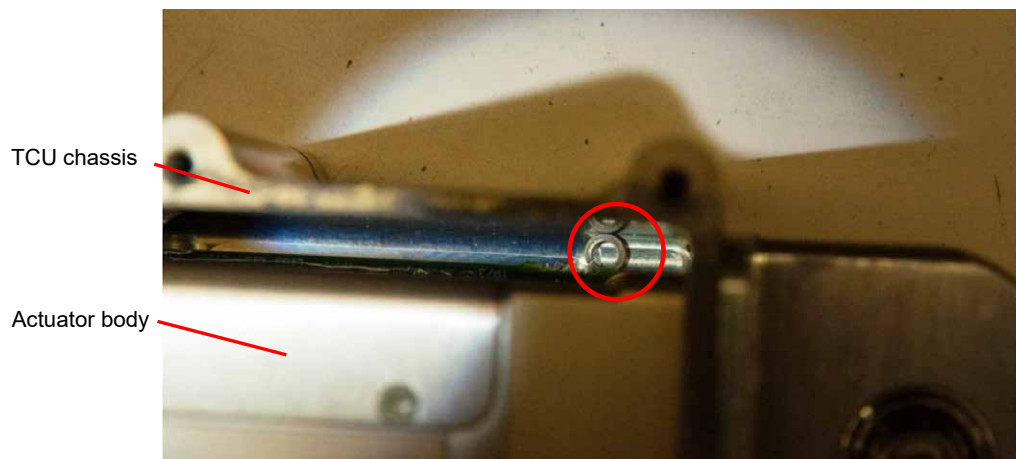
**Figure 12**

TCU s/n 1015 showing location missing washer was found

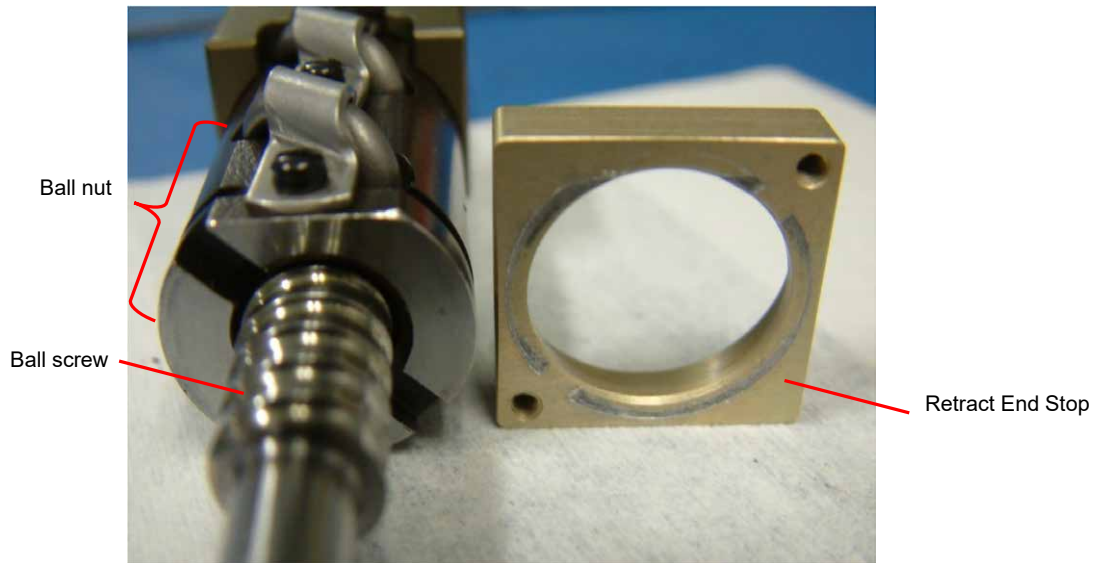
**Figure 13**

Damage in the actuator retract end stop (Figure 13) and thrust pack carrier was consistent with them being struck by the ball nut that travels with the actuator arm. There was some resistance when the ball nut was separated from the thrust pack carrier, which was determined to be the cause of the actuator being locked in the retract position. The impact marks on the retract end stop, and witness marks on the thrust pack carrier, indicated that the ball screw nut had struck the stop and thrust pack carrier with some force. The impact marks in the stop were 0.012 inch deep. This damage probably occurred during the trouble shooting activity when the aircraft was on the ground.

TCU s/n 1015 impact marking from actuator ball screw against retract end stop (retract end stop turned to show impact mark next to contact point on ball nut)

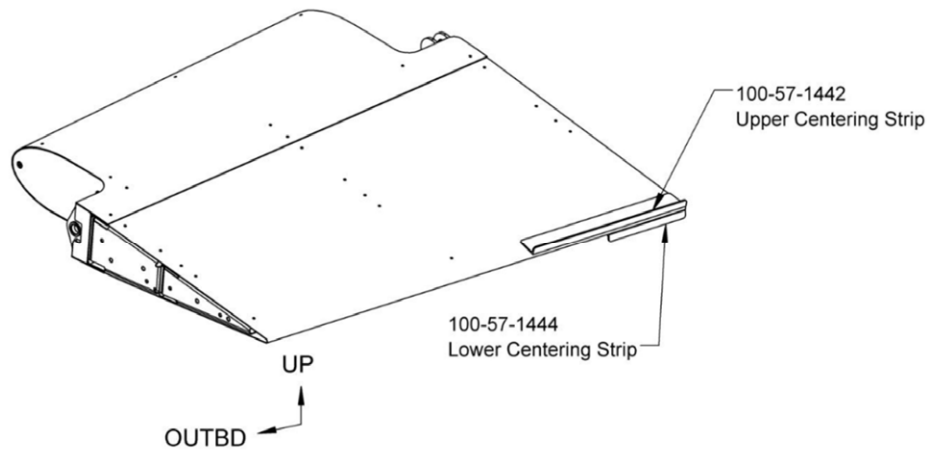
**Figure 17**

The modification documentation stated that there had been three uncommanded roll events relating to system failures. Due to the aerodynamic overbalance of the TACSs, it was possible for them to remain deployed if they were not faired when the TCUs were de-powered.

Centering strips introduced via Service Bulletin CAS/SB1475 issue A

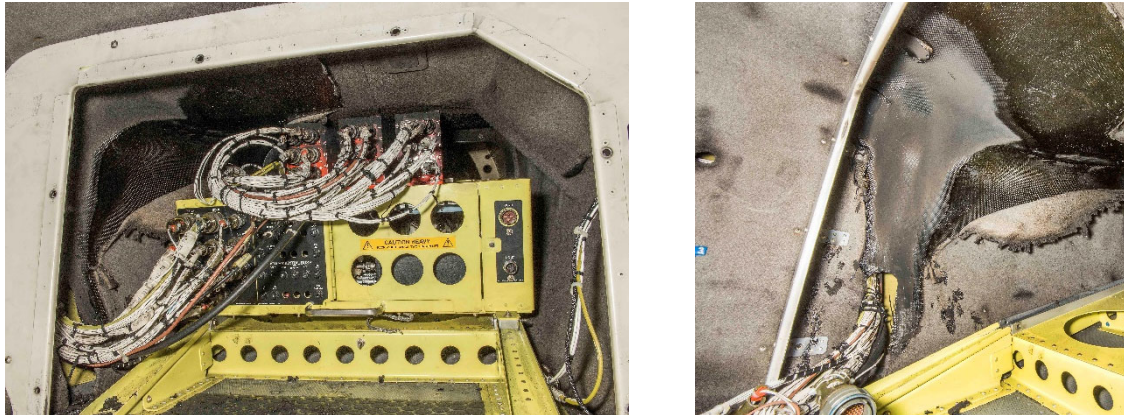
**Figures 1 and 2**

Upon opening the baggage bay the crew noticed a burning smell and, with the assistance of the engineer, they removed the panel to access the rear equipment bay. They found a 'smouldering fire', which self-extinguished before the arrival of the airfield fire service (Figures 1 and 2).

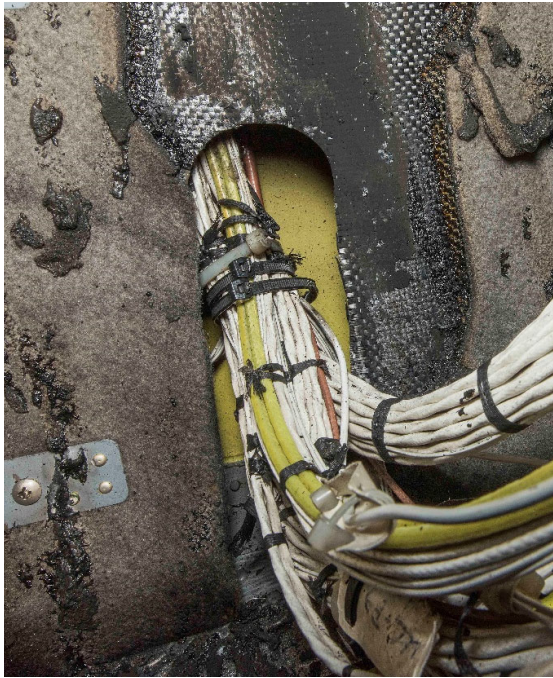
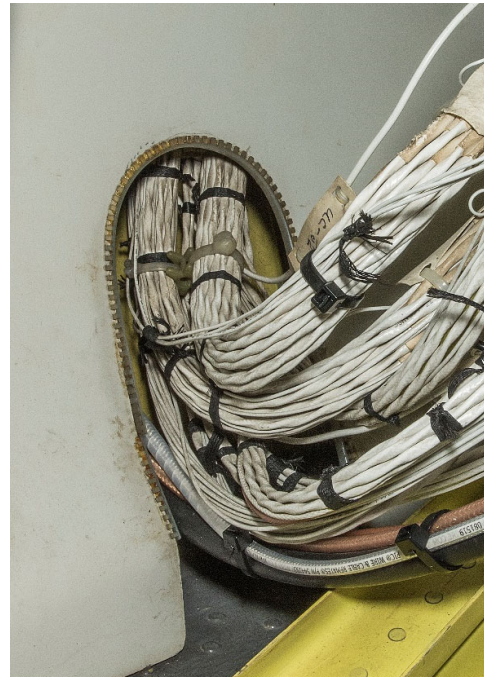
**Figures 3 and 4**

The operator owned another Agusta 109 (G-ETPI), which was equipped with a similar FTI installation. This helicopter was checked, and the protective strip was found correctly embodied (Figures 3 and 4).

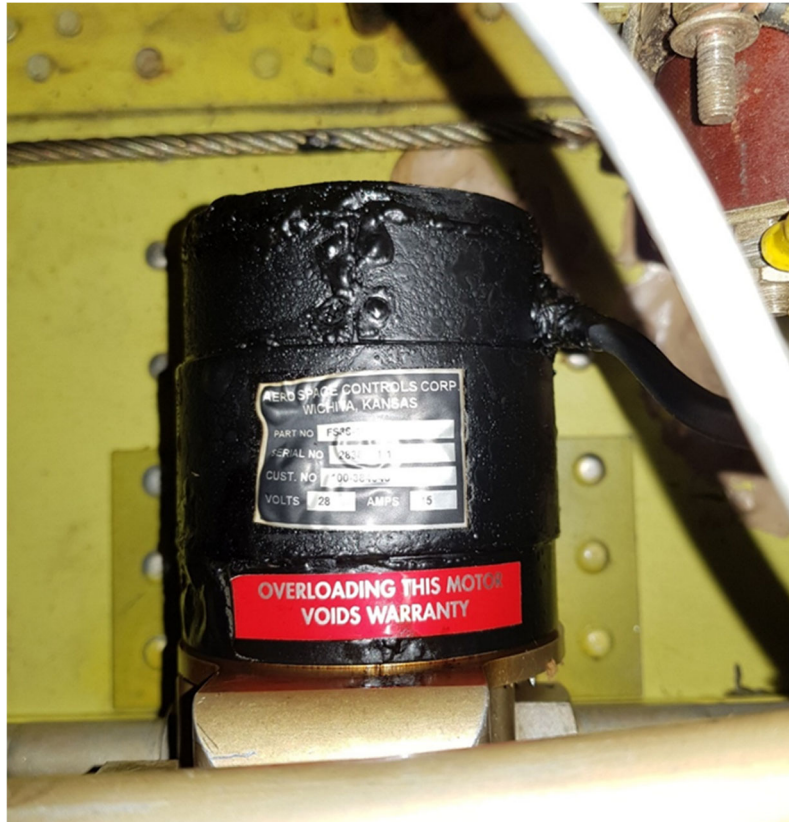
**Figure 1**

Examination of the aircraft, by the operator's engineers, discovered evidence of heat damage and a burnt smell from the flap motor (Figure 1). A check of the flap motor CB was carried out and was found to be intermittent in operation.

Flap motor showing evidence of damage due to overheating

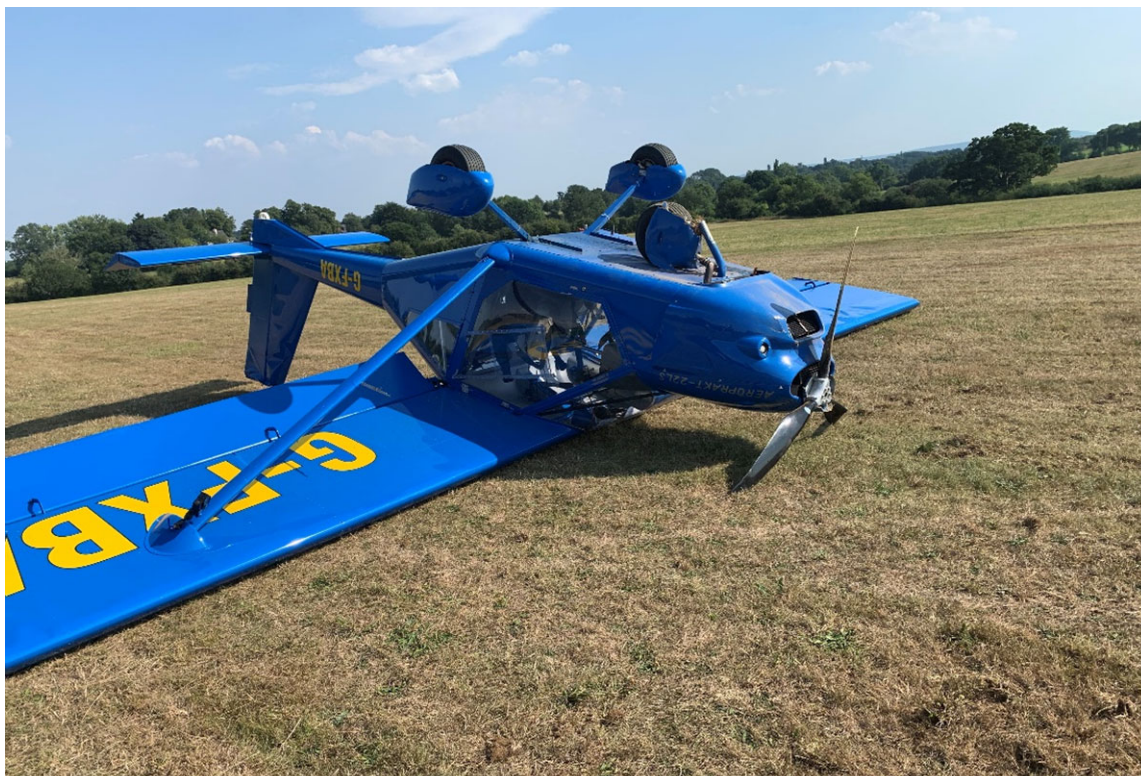
**Figure 1**

G-FXBA after the accident  
(Used with permission)

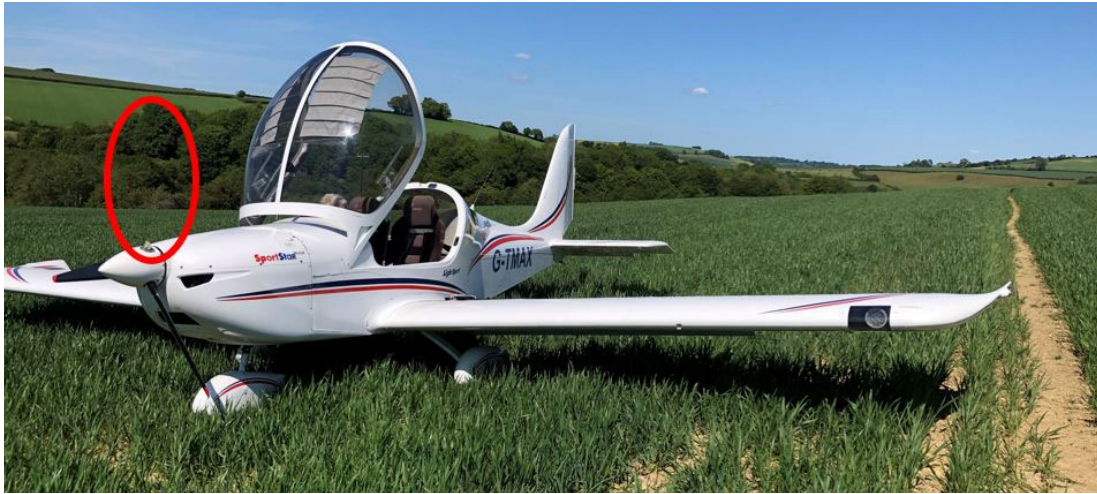
**Figure 1**

G-TMAX following the propeller blade detachment (missing blade position circled in red)

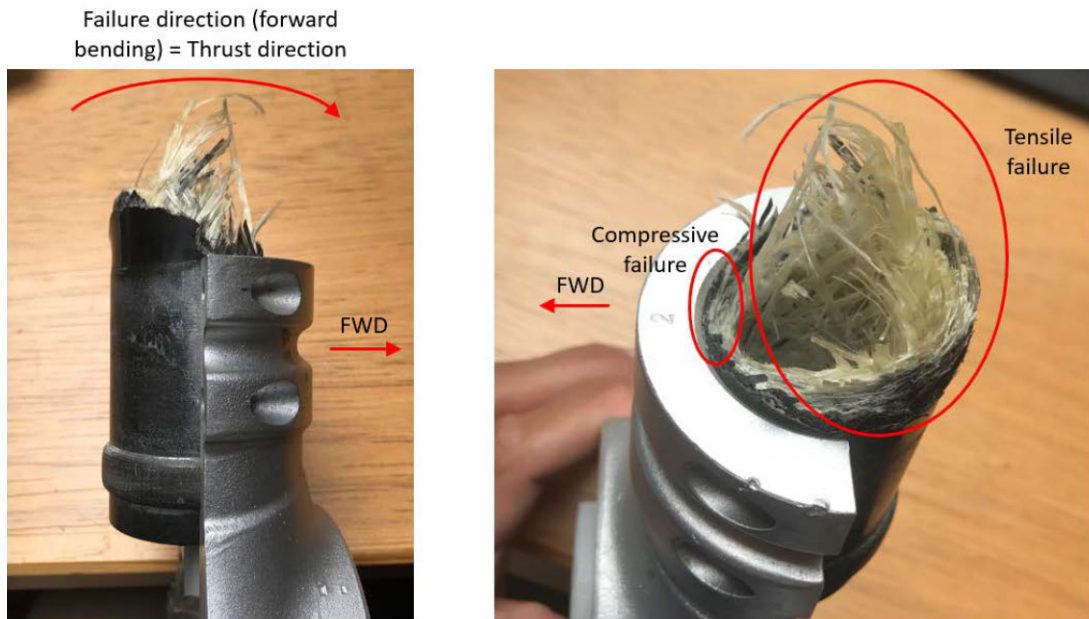
Visual examination of the retained root section of Blade 2 showed that it had failed by overload in forward bending, in the propeller thrust direction, in combination with the propeller centrifugal loading (Figure 3). There was no evidence of dirt or contamination on the fracture surfaces that might be present had progressive cracking occurred over a number of flights.

**Figure 3**  
Blade 2 fracture surfaces

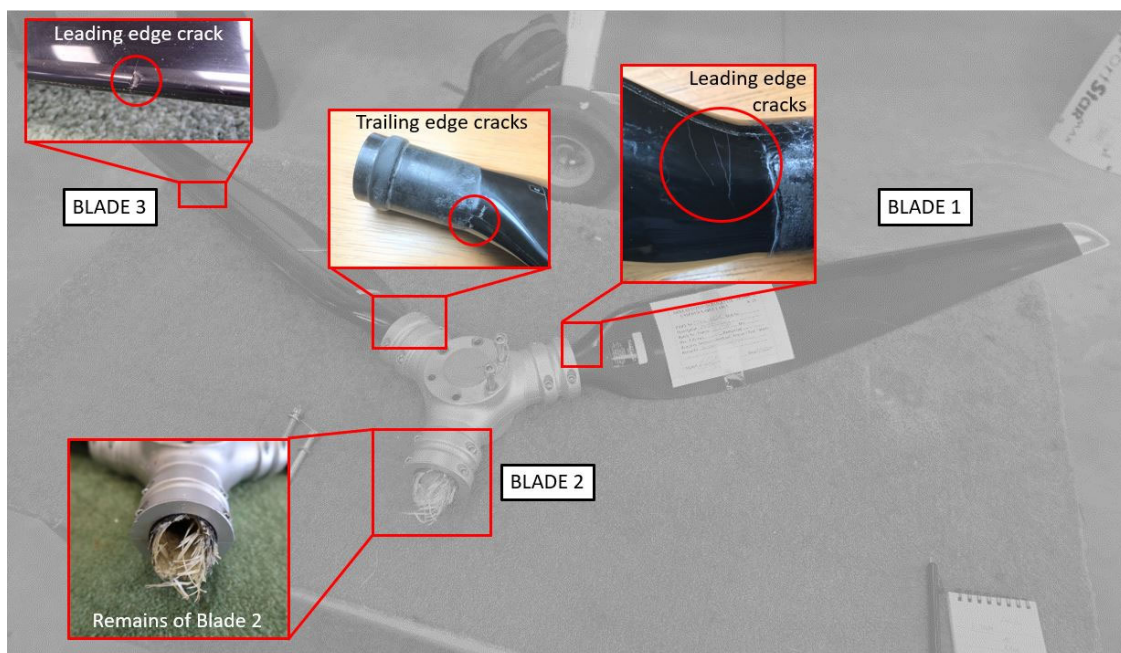
Cracks were evident in the trailing edge root section of Blade 3, and the leading edge root section of Blade 1 (Figure 4). It is likely that these cracks were the result of the high propeller vibration experienced following the release of Blade 2. A leading edge crack was also evident at approximately mid-span on Blade 3. This may have been caused by the excessive propeller vibration, or alternatively could have been caused by contact with Blade 2 following its release (Blade 3 follows Blade 2 in the rotation sequence).

**Figure 4**  
Propeller damage observations

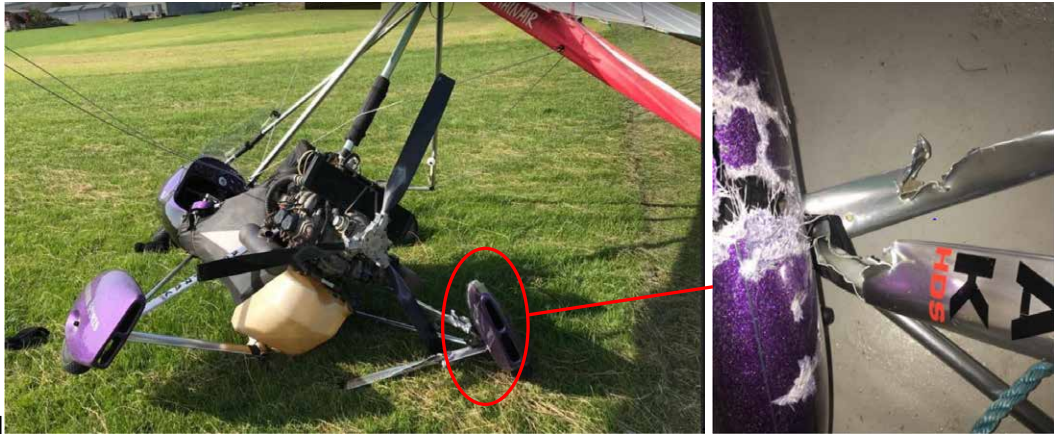
**Figure 1**

G-BZNS showing collapsed right landing gear and damage caused by propeller

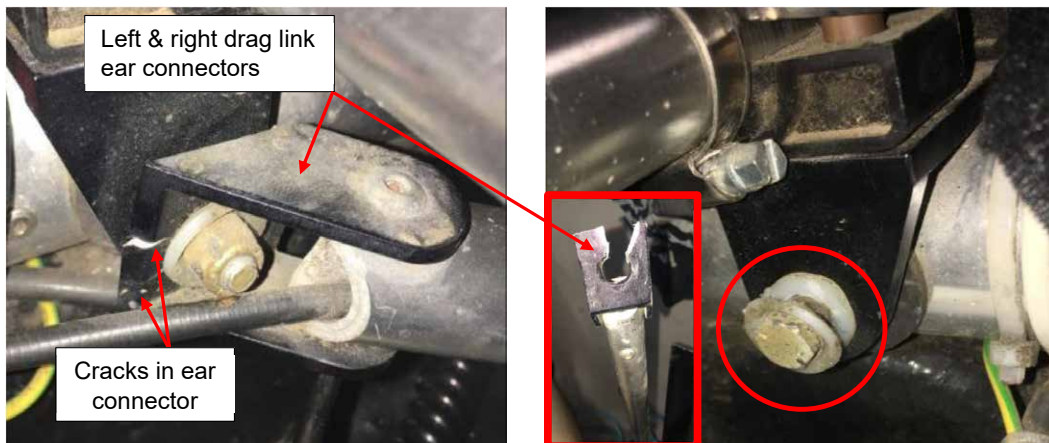
**Figure 2**

A BMAA article by Roger Patrick (2020) 'Now see ear', *Microlight Flying*, December 2020 briefly describes this incident and reminds owners to check the drag link connections carefully during their pre-flight checks.

Left drag link ear connection showing cracks and the failed right drag link ear connection

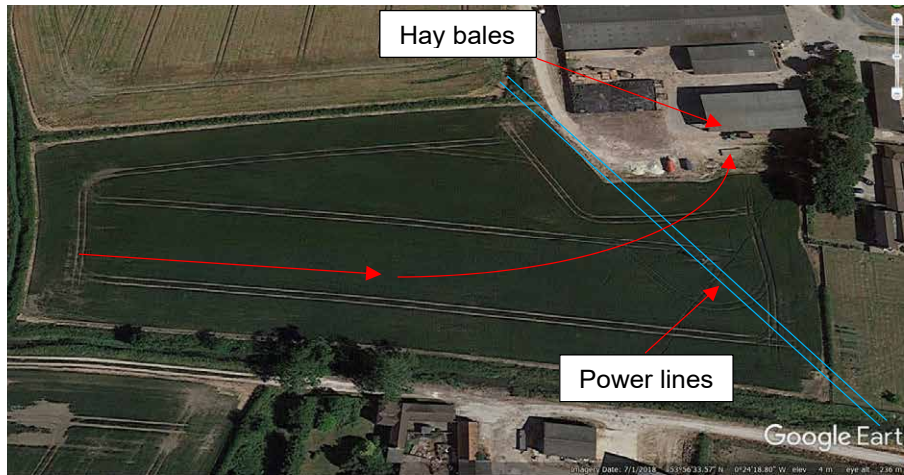
**Figure 1**  
Accident site

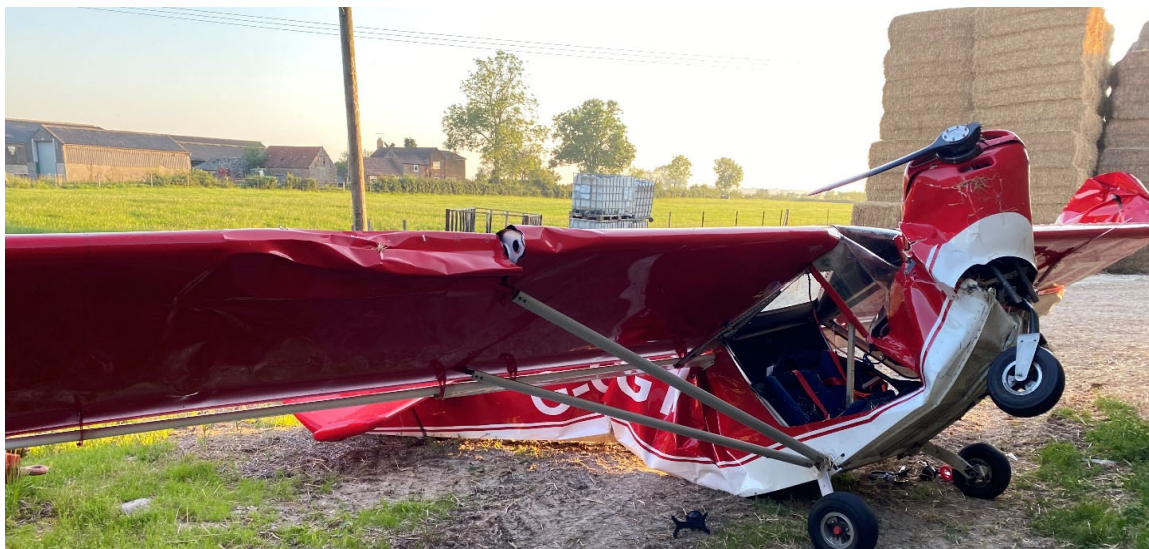
**Figure 3**

During the takeoff ground roll with the aircraft approaching flying speed, the pilot stated that the aircraft struck a bump and he inadvertently moved the flap lever. No defect was identified in the flap mechanism and due to the low aerodynamic loads, they deployed to flaps 40°. This would have created a sudden increase in lift and drag and reduced the stall speed. The manufacturer has highlighted in the POH that taking off with flaps 40° should be handled delicately and that the lift off and stall speeds are very similar. The pilot had practiced rejected takeoff manoeuvres to the right and straight ahead, but not to the left. The sensation of a left-wing stall resulted in the pilot turning to the left and he realised he would strike the hay bales or the farm buildings (Figure 3).

G-CGTV and accident site
