ACCIDENT

Aircraft Type and Registration:	Pelican PL, G-MPAC
No & Type of Engines:	1 Rotax 912-UL piston engine
Year of Manufacture:	2001 (Serial no: PFA 165-12944)
Date & Time (UTC):	30 August 2020 at 1205 hrs
Location:	Stoke Golding Airfield, Warwickshire
Type of Flight:	Private
Persons on Board:	Crew - 1 Passengers - 1
Injuries:	Crew - 1 (Serious) Passengers - None
Nature of Damage:	Damage to propeller, landing gear, wings and fuselage
Commander's Licence:	Private Pilot's Licence
Commander's Age:	63 years
Commander's Flying Experience:	630 hours (of which 114 were on type) Last 90 days - 13 hours Last 28 days - 3 hours
Information Source:	Aircraft Accident Report Form submitted by the pilot

Synopsis

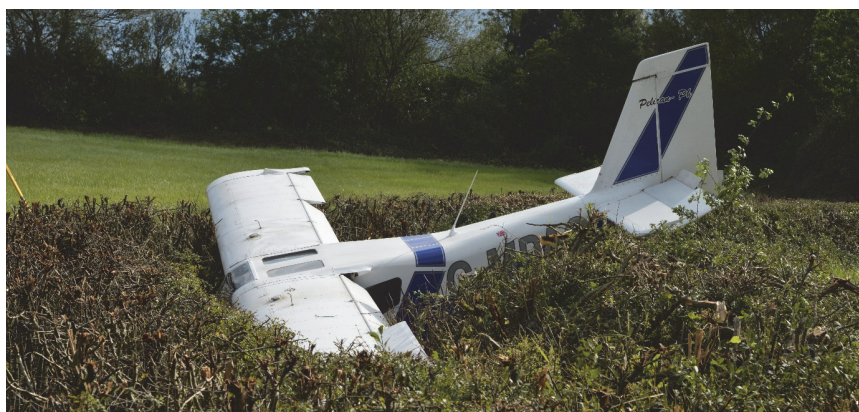
Figure 1

Approaching the end of the runway it became evident that the aircraft would overrun into the boundary hedge beyond. The pilot was not aware that the hedge line contained a ditch and assumed the safest course of action was to go through it. The pilot stated that if he had known of the ditch he would have tried to turn away before impact. G-MPAC left the runway at approximately 15 kt and penetrated the hedge before tipping forward and coming to an abrupt halt (Figure 1 and Figure 2).

G-MPAC in the airfield's boundary ditch
(image © Leicestershire Police)

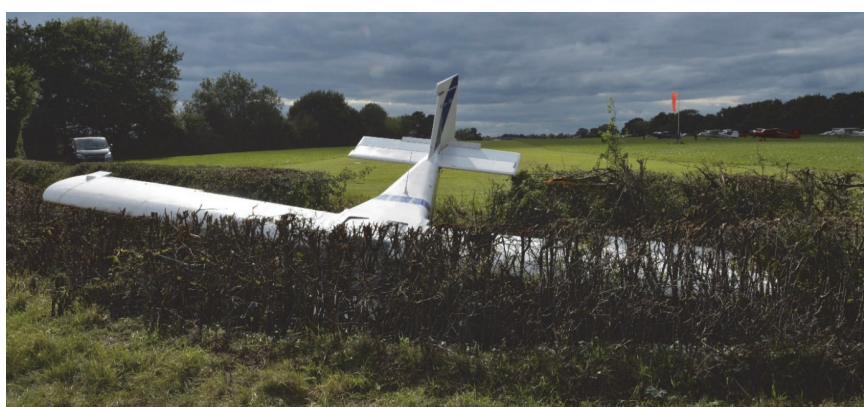
Figure 2

View looking down Runway 26
(image © Leicestershire Police)

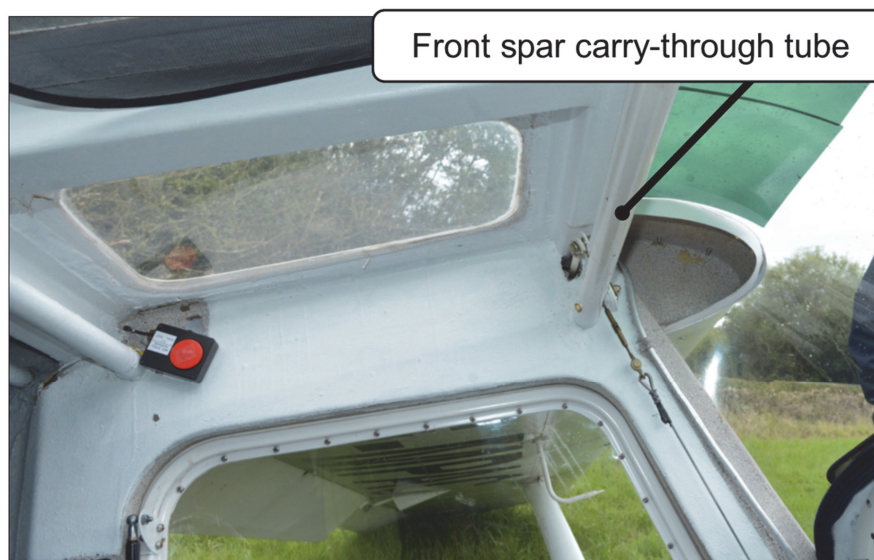
Figure 3

The sudden deceleration caused the pilot to be thrown forwards and he struck his head on the front spar carry-through tube just behind the windscreen (Figure 3). He suffered severe injuries as a result. The passenger's straps were tight and, having braced for impact, he was uninjured.

Front spar carry-through tube crossing behind G-MPAC's windscreen
(image © Leicestershire Police)

The pilot sustained severe head injuries resulting from impact with a metal bar running across the front of the cockpit. The aircraft was equipped with 3-point harnesses. The pilot reported that his lap strap had been tight and the diagonal shoulder strap was "comfortable". He surmised that tipping forwards into the ditch resulted in a greater upward vector within the cabin making contact with the bar more likely. The passenger attributed his lack of injuries to a tight shoulder strap and bracing for impact.

It is likely that the pilot's injuries resulted from his shoulder strap being "comfortable" rather than tight. The slackness in the shoulder strap was likely a result of the pilot adjusting it so that he could reach the instrument panel during the flight and not pulling it tight for landing. While the collision dynamics of this accident were due to a landing overrun, they could equally have resulted from a rejected takeoff.

- It alerted the only other owner of a G-registered Pelican aircraft to the potential for head injury in an accident if the harness shoulder strap is not tight.
- It used this accident as a case study to emphasise to its members the importance of the '*Hatches and Harnesses*' pre-landing check.

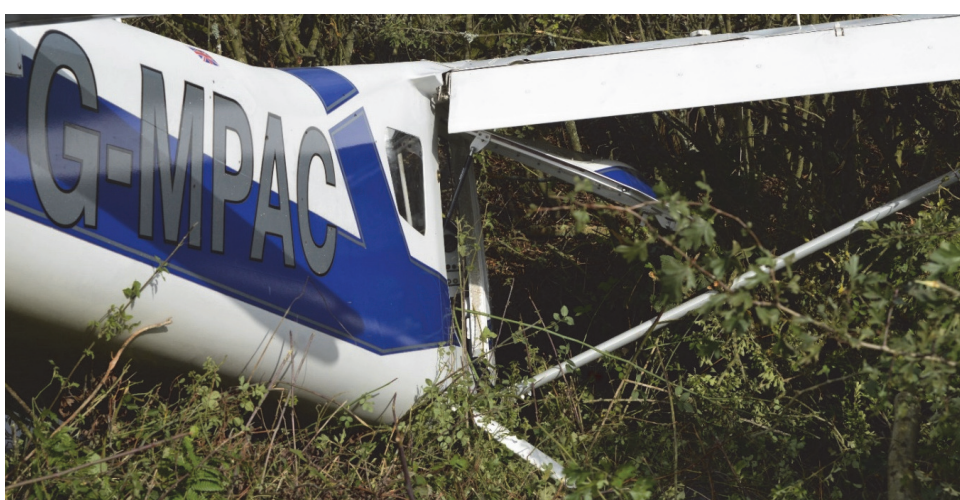
Figure 4

The occupants were able to exit the aircraft using the door on the right side of the aircraft, although progress was hindered by the hedge's thorny branches. Bystanders were quickly on scene to assist.

Photograph showing exit route through the right cockpit door
(image © Leicestershire Police)

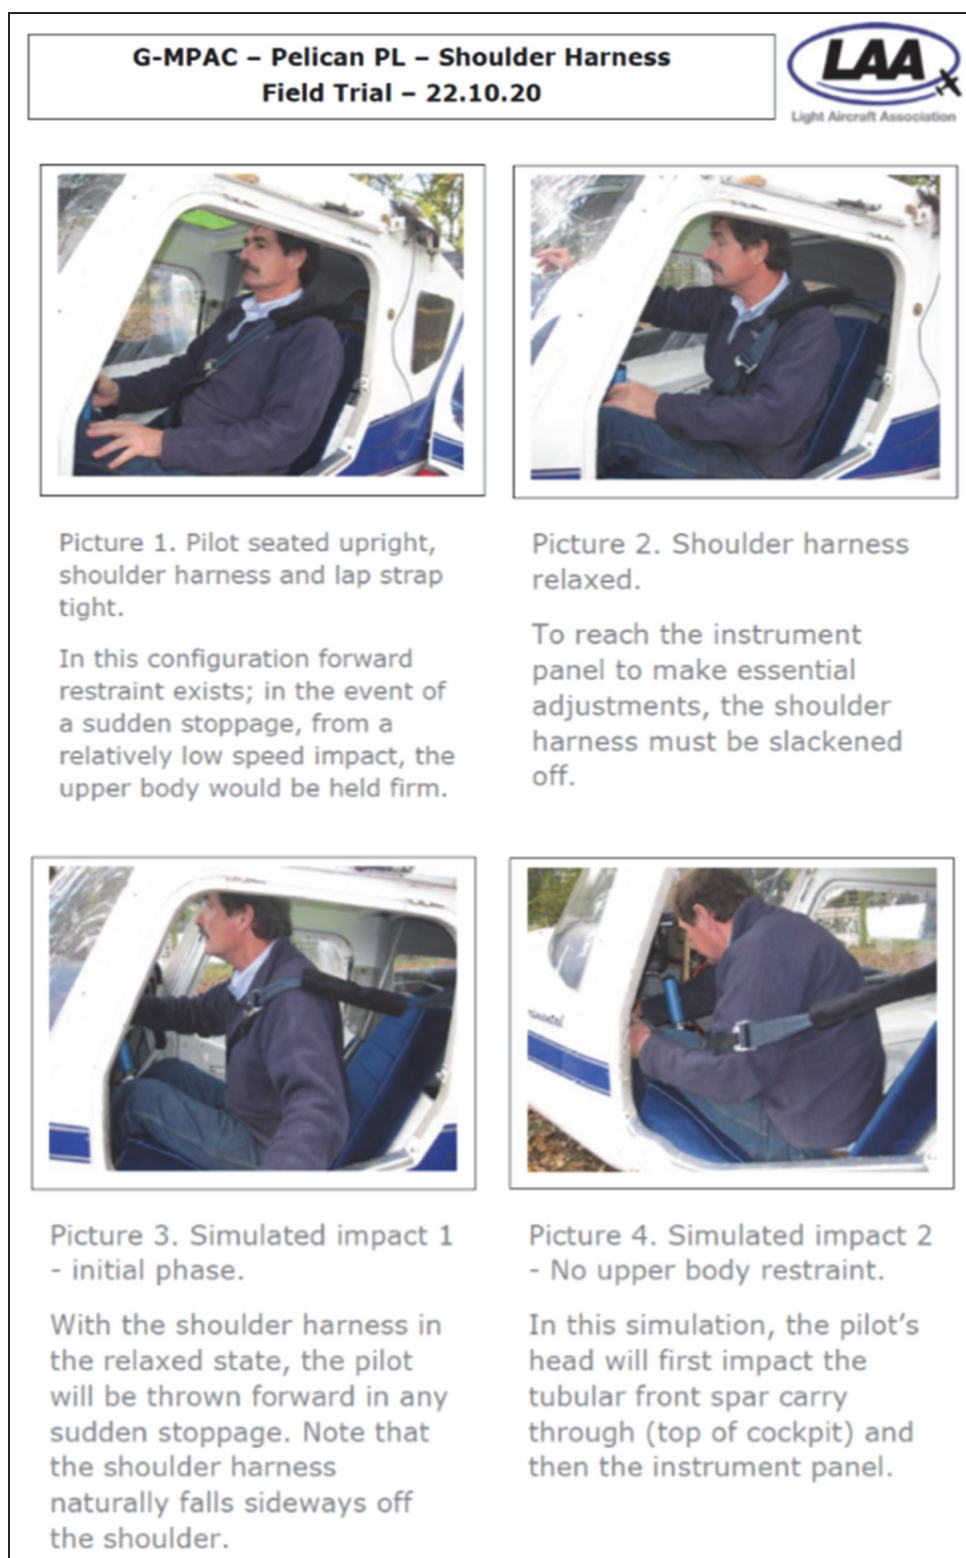
Figure 5

The Light Aircraft Association (LAA) conducted a field trial on the salvaged aircraft to assess the effectiveness of the harness in G-MPAC. They reported that the harness attachment points were secure and that the seat belt latch was in good working order. They considered it unlikely that the latch would have been inadvertently released during flight. The LAA also found that it was necessary to '*slacken off*' the single shoulder strap to reach forward and make '*essential adjustments*' on the instrument panel. It was apparent that unless the strap was tight it had a natural tendency to fall sideways off the shoulder. With a slack shoulder harness, the seat occupant's upper torso could pivot forward during a sudden deceleration allowing their head to strike the front spar carry-through tube crossing the top of the cockpit (Figure 5). The LAA used this accident as a case study highlighting to its members the importance of ensuring that all '*Hatches and Harnesses*' are secure and tight during pre-landing checks. The LAA also informed the only other owner of a G-registered

LAA field trials report
(courtesy of the LAA)
