SERIOUS INCIDENT

Aircraft Type and Registration:	DJI Matrice 210 (UAS, registration n/a)	
No & Type of Engines:	4 electric motors	
Year of Manufacture:	2019 (Serial no: 17TDG350020016)	
Date & Time (UTC):	6 October 2019 at 1150 hrs	
Location:	Danbury, Essex	
Type of Flight:	Emergency services operations	
Persons on Board:	Crew - N/A	Passengers - N/A
Injuries	Crew - N/A	Passengers - N/A
Nature of Damage:	None	
Commander's Licence:	Other	
Commander's Age:	38 years	
Commander's Flying Experience:	262 hours (of which 5 were on type) Last 90 days - 28 hours Last 28 days - 16 hours	
Information Source:	Aircraft Accident Report Form submitted by the pilot and additional AAIB enquiries

Synopsis

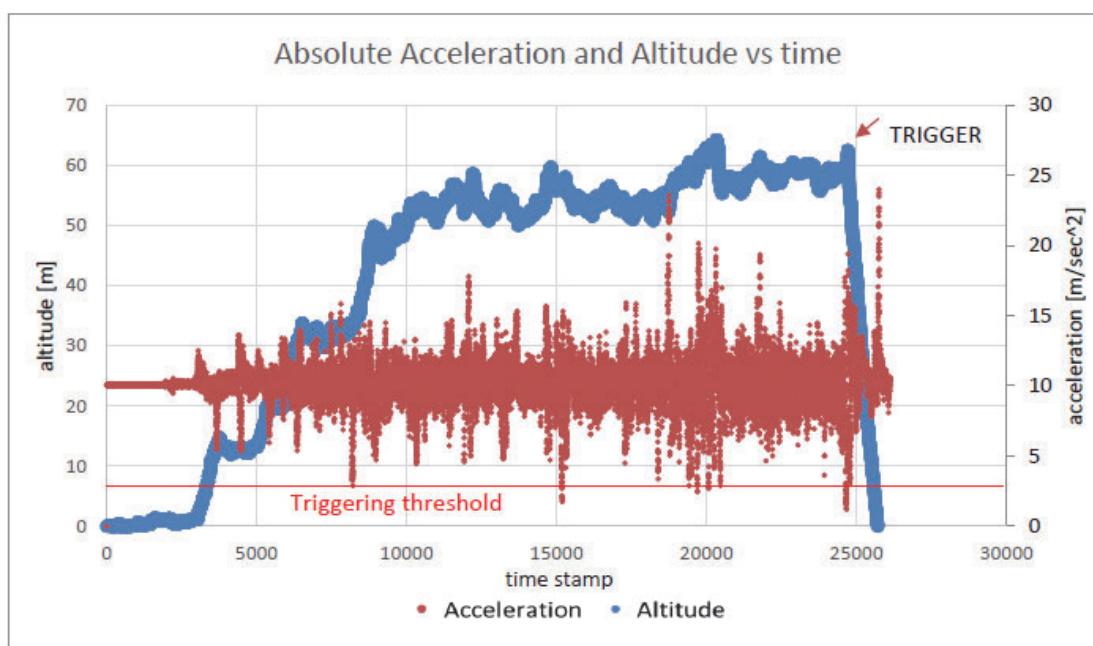
Figure 2

The parachute manufacturer analysed the log files from both the aircraft and the parachute system and stated that they were '*similar until the moment of deployment*'. Thereafter the aircraft's flight log ended at cruise altitude, while the parachute system log continued to record the parachute deployment, characterised by erratic acceleration readings, and a descent at a constant rate (Figure 2 - note that the altitude data recorded by the SafeAir is barometric).

SafeAir recorded data for the accident flight
(Source ParaZero)

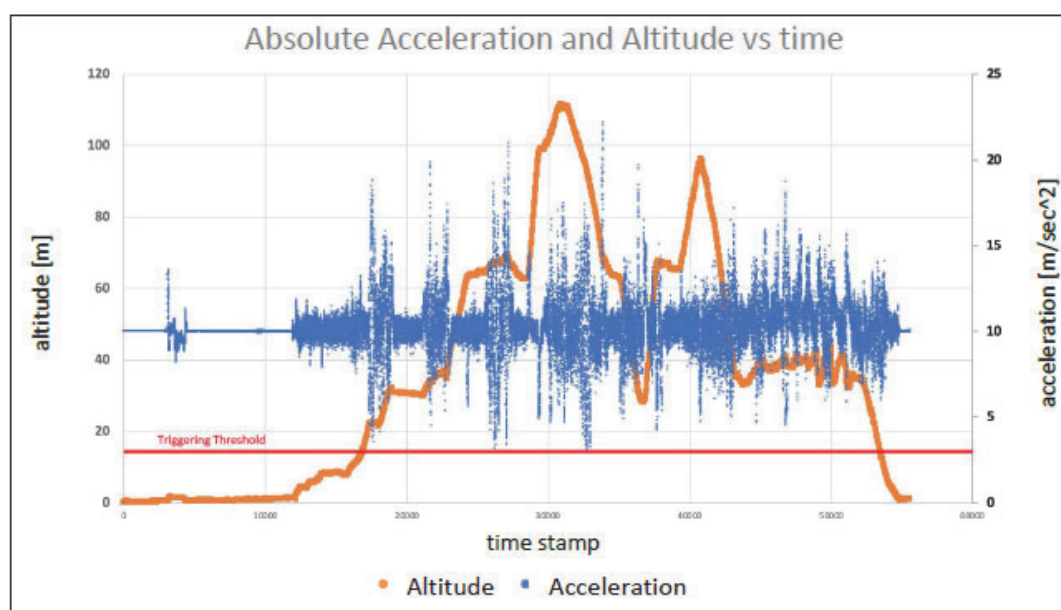
Figure 3

The Matrice 200 with the SafeAir unit fitted was then flight tested to assess the behaviour of the parachute system during flight. A flight profile similar to that of the accident flight was used and additional, more extreme, manoeuvres were flown. No abnormal events were recorded during the flight test. The parachute system did not trigger, nor did the acceleration cross the triggering threshold (Figure 3).

SafeAir recorded data for the test flight
(Source ParaZero)

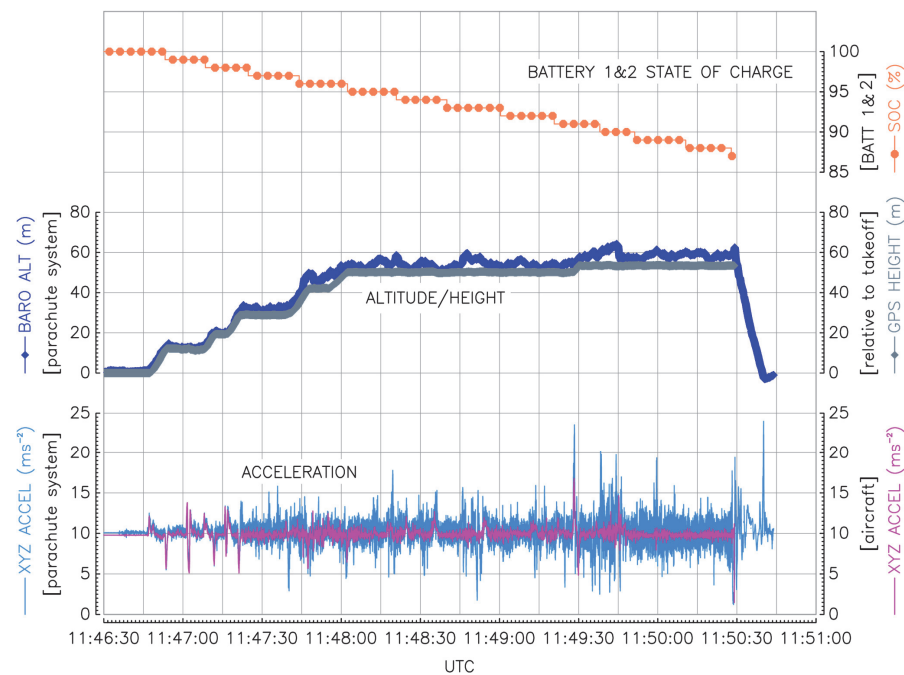
Figure 4

A review of the aircraft's on-board recorded data by the AAIB confirmed that the recording ended abruptly after 220 seconds, when the aircraft was hovering at a height of 53.5 m (recorded resolution is 0.5 m), having travelled 390 m from the takeoff point. The energy level (state of charge) of the aircraft's two batteries was 87% (Figure 4). The figure also compares the aircraft's altitude and acceleration data with the equivalent data from the SafeAir log file and shows that as the flight progressed, the acceleration recorded by the SafeAir system grew in amplitude compared to that recorded by the aircraft.

Flight log data from the aircraft and SafeAir system for the accident flight

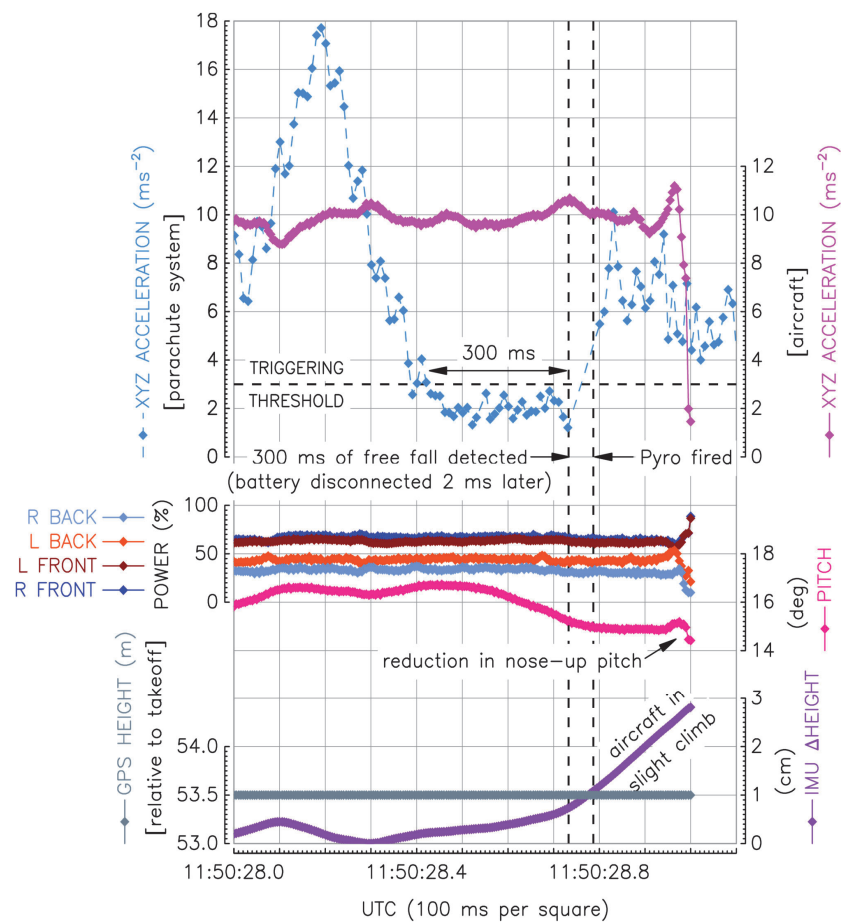
Figure 5 is a close-up of the last one second of the flight before power was lost to the aircraft. During this second the aircraft's inertial measurement unit (IMU) sensed slight changes in vertical speed that equated to about 2.6 cm height gain, with the aircraft's acceleration decreasing from just over 1g to below the SafeAir's trigger threshold over the last 25 ms. During these last 25 ms, the aircraft's nose-up pitch reduced by 0.77° (so about 30°/sec) and the thrust (probably in response) increased the power of the front motors and decreased the power of the rear motors. There were 23 more points in the aircraft's log file, covering a 109 ms period, that were corrupted (the last 12 of which appeared to be from an earlier flight two months earlier). The aircraft's log did not contain any warnings or provide an insight into the reason for the parachute activation, or if the batteries had been disconnected.

Figure 5 also shows the acceleration recorded by the SafeAir system, when it detected 300 ms of freefall. This triggered the TerminateAir within 2 ms and the parachute deployed 50 ms later. However, the drop in acceleration to below the SafeAir trigger threshold occurred about 700 ms before a drop in acceleration was measured by the aircraft.

Comparison of acceleration prior to parachute deployment

The two acceleration data sets in Figure 5 appear misaligned; however, given that the aircraft logged data at about 200 Hz and timestamped each line of data in the log file with a UTC time, these should be accurate to within 5 ms. Similarly, the parachute system logged data at about 100 Hz so should be accurate to within 10 ms. It is also time stamped data but relative to the start of logging. The alignment of these data sets, therefore, relies on matching accelerations during a couple of portions of the flight, ideally at the start and then as near to the end as possible where a match in acceleration can be found to confirm the alignment. Figure 6 does this by comparing accelerations shortly after takeoff and then 150 seconds later (about 60 seconds before parachute deployment). Note that each square on the x-axis is 500 ms so any misalignment more than say 50 ms would be noticeable.

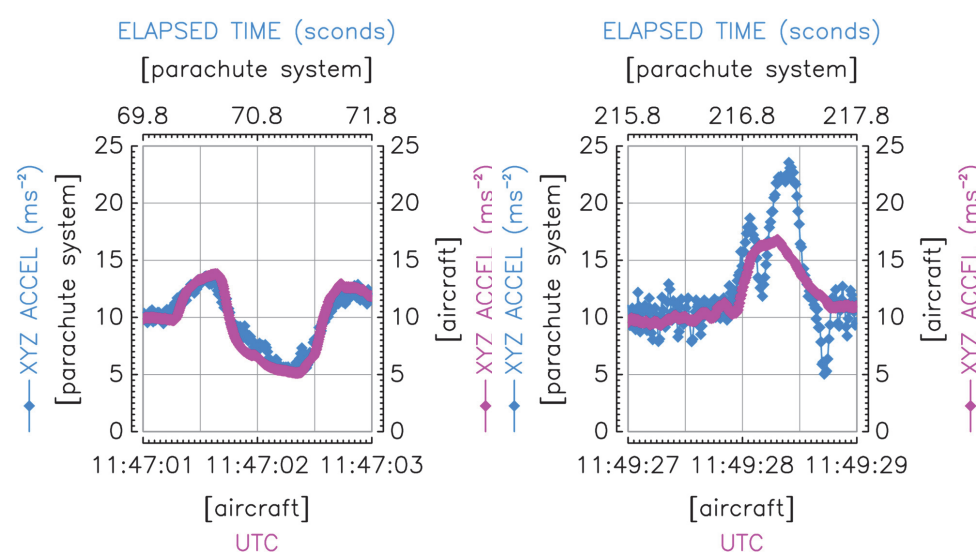
Figure 6

Comparison of accelerations to time align aircraft and parachute system datasets
