# ***AAIB Bulletin***

# ***2/2021***

Pitts S-2A Pitts Special	G-ODDS	24-Aug-19	3
--------------------------	--------	-----------	---

<b>Aircraft Type and Registration:</b>	Pitts S-2A Pitts Special, G-ODDS	
<b>No &amp; Type of Engines:</b>	1 Lycoming AEIO-360-A1E piston engine	
<b>Year of Manufacture:</b>	1980 (Serial no: 2225)	
<b>Date &amp; Time (UTC):</b>	24 August 2019 at 1304 hrs	
<b>Location:</b>	Stonor, Oxfordshire	
<b>Type of Flight:</b>	Training	
<b>Persons on Board:</b>	Crew - 2	Passengers - None
<b>Injuries:</b>	Crew - 2 (Fatal)	Passengers - N/A
<b>Nature of Damage:</b>	Aircraft destroyed	
<b>Commander's Licence:</b>	Private Pilot's Licence (Class Rating Instructor)	
<b>Commander's Age:</b>	35 years	
<b>Commander's Flying Experience:</b>	Approximately 710 hours (of which about 172 hours were on type) Last 90 days - 35 hours Last 28 days - 12 hours	
<b>Student's Flying Experience:</b>	197 hours (of which 1 hour 25 minutes were on type) Last 90 days - 34 hours Last 28 days - 8 hours	
<b>Information Source:</b>	AAIB Field Investigation

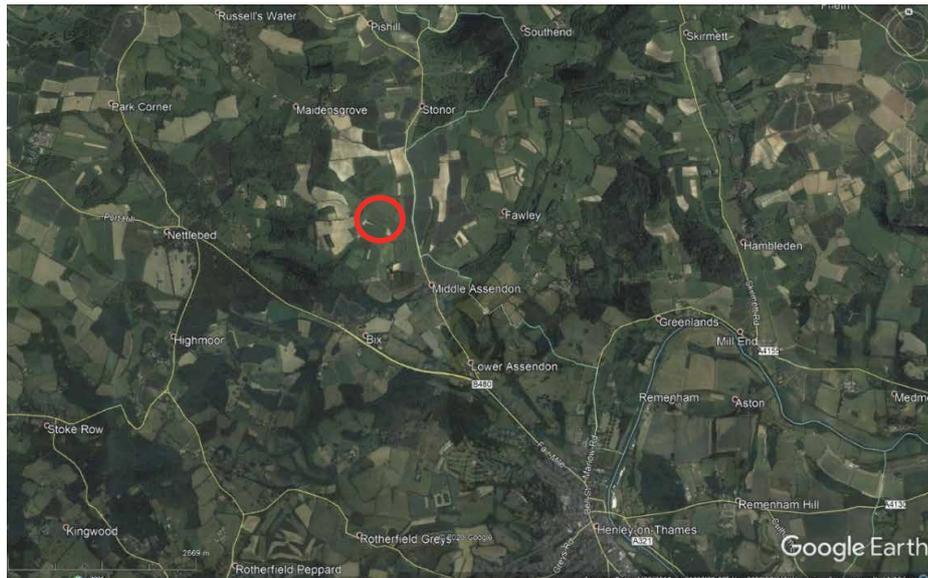
**Figure 1**  
Accident site

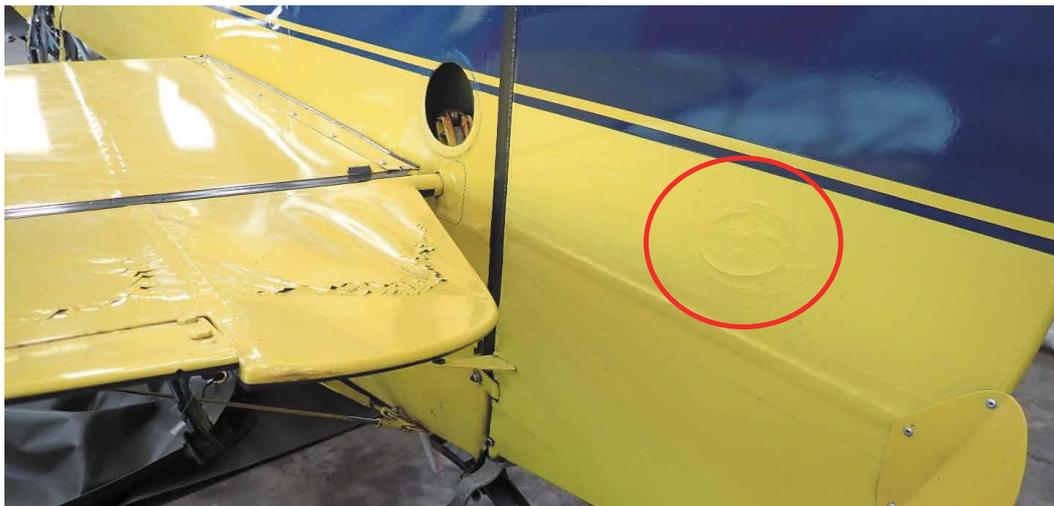
All the control cables were inspected and found intact. However, the control column in the rear cockpit had become detached near the hinge point. It was observed that there was impact damage to the left rudder surface (Figure 6) with corresponding damage to the left elevator. The rudder stops were present and undamaged, and the trim tab was set to neutral.

Elevator and rudder damage (circled)

It is considered that, at the time of impact, the rudder was in the neutral position or towards the right. The contact damage on the left side of the rudder and the deformation to the left elevator would require a significant impact force. The left rudder stop was intact, and, after the accident, it was not possible to move the rudder far enough to touch the elevator, therefore the rudder must have deformed. The lightweight rudder is stiff, and it would need a lot of momentum to deform significantly which could not be achieved if the rudder was against the left stop. If the pedals were holding the rudder neutrally or to the right, it is still possible for the rudder to move. As the fuselage deformed during the impact, the bending would have released the tension in the rudder cables, thereby allowing free movement of the rudder.

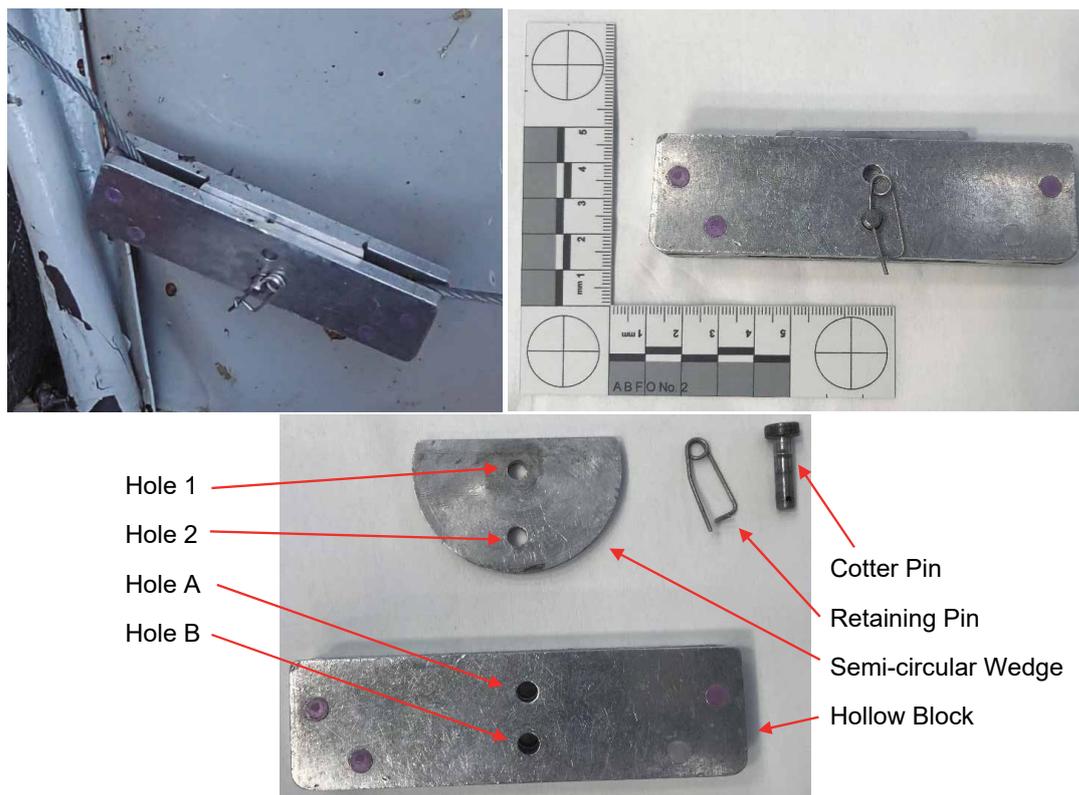
During the initial examination of the aircraft at the accident site it was noted that there were four unidentified devices fitted onto the rudder cables. They were left in place for further examination at the AAIB facilities. A device was fitted on each of the cables between the forward and rear rudder pedals and on the cables aft of the rear rudder pedals. After removal, it could be seen that each device constituted an aluminium block, aluminium semi-circular wedge, steel cotter pin and steel retaining pin (Figure 7) with the forward devices a matching pair and the aft pair matching. Each pair was similar in construction and design however there were some minor dimensional differences.

Rudder cable device shown in situ,  
removed for examination and constituent parts

A change of more than 30 mm in the front pedal neutral position when using the devices, caused the retreating pedal to come into contact with the end of the heel tray cut-out, thus preventing full pedal and rudder deflection. In the accident flight configuration (B2+B2), this interference restricted rudder movement by 3° (ie reduced the rudder movement from +/- 30° to +/-27°) and the maximum device setting restricted the rudder by 10° (from +/- 30° to +/-20°). In April 2019, the aircraft had a 50-hour maintenance check and, during the check, the devices were found already fitted to the rudder cables. While inspecting the rudder travel, the engineer noticed that there was a 6 mm gap between the rudder lever and the fuselage stop when the pedals were at the limit of their travel. This 6 mm gap at the rudder stop equated to approximately 3° of rudder travel. The devices were removed, and it was noted in the maintenance documentation that '*Non-approved rudder cable devices found fitted. Once removed rudder travel then is satisfactory*'. There was no discussion about this note between the operator and the maintenance organisation.

The fitting of such devices should be an EASA approved modification so that their operation and effects can be tested and documented. The investigation was unable to locate any approval for a modification to fit these devices. It was noted during a maintenance check that the devices, which were fitted at the time, restricted the rudder travel by 3° (10% of travel).

Unapproved devices, which adjusted the rudder pedal positions, were found on the rudder cables but were unlikely to have impeded the recovery from the spin.

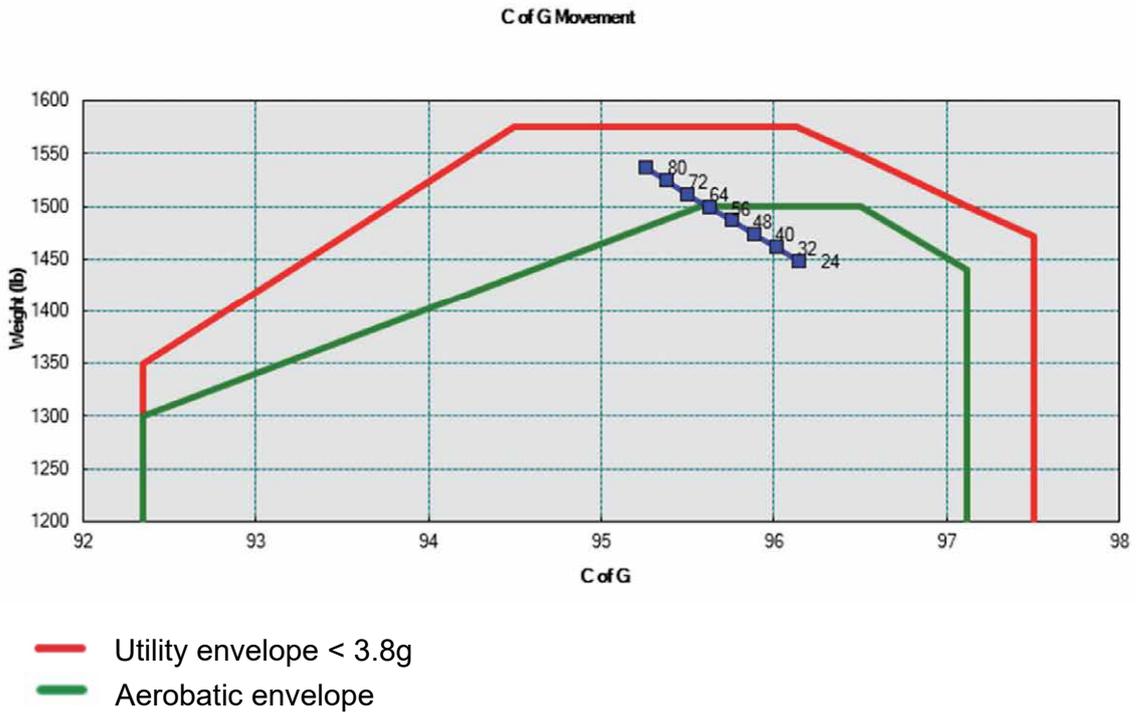
Following the fitting of a new propeller, the aircraft was reweighed in 2007 and its mass had increased to 1,124 lb and the C of G position had moved further aft to 89.79 inches aft of datum. The operator stated they were unaware of the most recent weight report at the time of the accident and only found the most recent weight and balance report after the event. In addition, the pilots' weights used in the calculations were significantly less than their actual weights; the commander's weight was underestimated by 6.35 kg (14 lb) and the student's weight by 9.98 kg (22 lb). The source of these figures is unknown. A copy of the Weight and Balance calculation believed to have been used by the commander prior to the accident flight is shown in Figure 9. The numerals on the blue line corresponds to a range of possible fuel quantities in litres.

The use of incorrect figures could have misled the commander into thinking that the aircraft was within its flight envelope for the planned sortie. Figure 10 shows a more accurate result with figures from the most recent weight and balance report. The actual pilot weights, the weights of the additional seat cushions and the miscellaneous equipment found in the aft cockpit locker have also been included.

**Figure 9**  
Commander's Weight and Balance spreadsheet

- The use of spreadsheets has been discontinued and Aircraft Flight Manual (AFM) weight and balance charts are used instead. A current weight and balance report is now included in the aircraft technical log.
- The operator has circulated the AFM weight and balance charts together with current weight and balance reports to all instructors.
- Scales are now provided so pilots can weigh themselves. The operator has found large discrepancies between given and actual weights among its pilots and no longer accepts assumed or estimated weights.

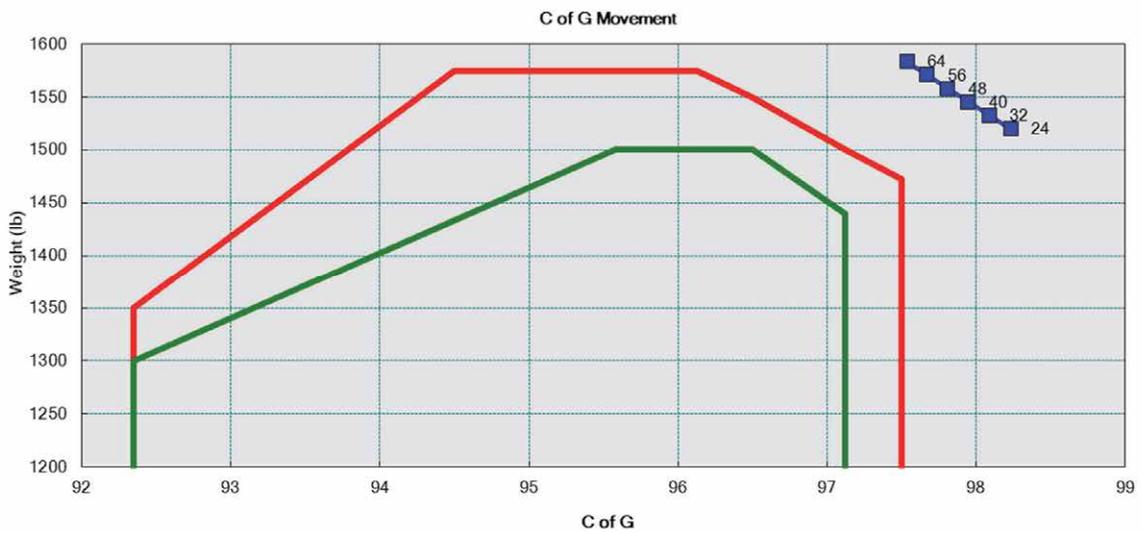
**Figure 10**  
Revised Weight and Balance spreadsheet

With these figures the aircraft was overloaded for both the aerobatic and utility flight envelopes. The most rearward C of G limit for aerobatics is 96.5 inches at a gross weight of 1,500 lb increasing to 97.12 inches at 1,440 lb. For the utility category the limits are 96.13 inches at 1,575 lb increasing to 97.5 inches at 1,472 lb. The aircraft manufacturer stated that the overload condition would not have affected the aircraft's capacity to recover from a spin. Having been advised that, at the time of the accident, G-ODDS's C of G position was further aft than the limit, the manufacturer stated that:

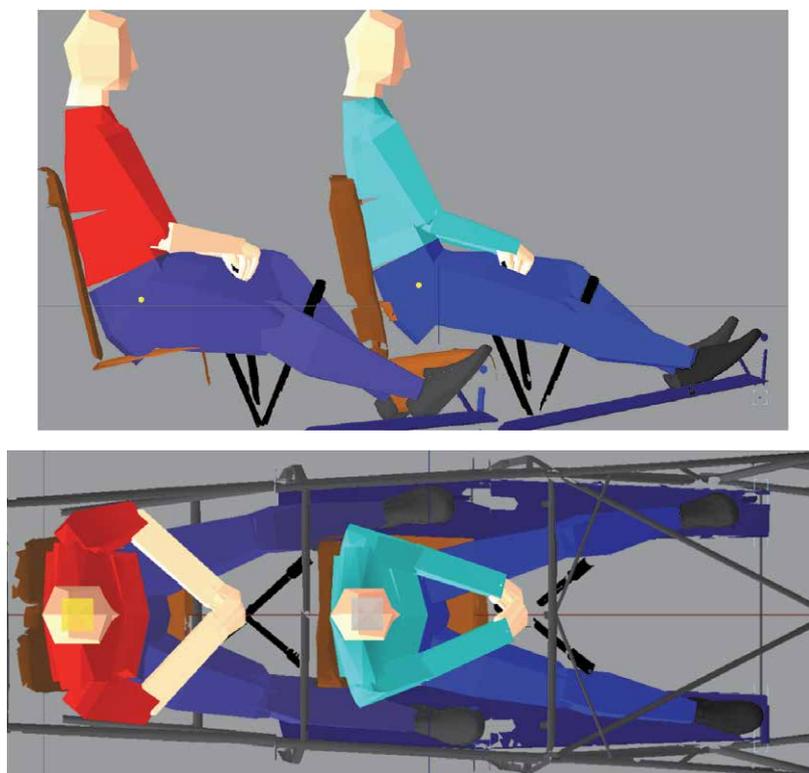
Right rudder pedals full forward without the devices fitted  
(brake pedals omitted for clarity)

The assessment showed that the commander was unlikely to have been able to move the pedal to this position because the leg is fully extended with only the tip of the toes in contact with the pedal. The student was likely to have had better foot contact on the pedal and the leg is only slightly bent, but this position may have been uncomfortable due to the additional seat cushions digging into the thigh and the front seat back on the inside of the calves. The assessment showed that the receding pedal position was unlikely to pose a problem for either pilot to exert the force necessary to return the rudder to the neutral position.

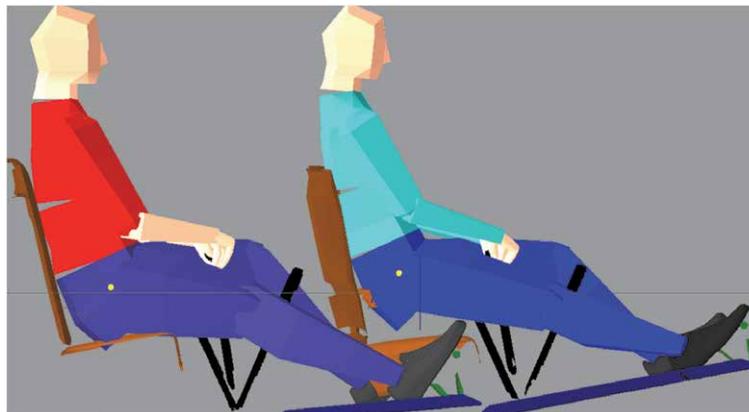
With the devices fitted as they were on the accident flight (Figure 15), the assessment showed that the commander would be able to reach the extreme of pedal travel more easily. Full extension of their leg was still required but instead of the toe, the ball of their foot would likely have been on the pedal affording more control.

Right rudder pedals fully forward with the devices fitted  
(brake pedals omitted for clarity)

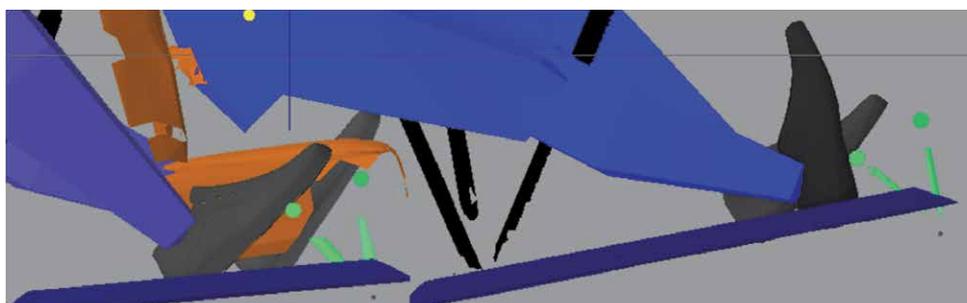
Digital modelling and practical assessment of this scenario was made using the SAMMIE tool and an exemplar aircraft and it was found that it was possible to apply the required rudder input even against a 'locked' straight leg. The commander's joint mobility was explored via digital modelling (Figure 16) and although the ankle is nearing the limits of extreme movement, it is possible for full opposite rudder to be applied. Typically, an external force would be required to extend the ankle to this position but a further 6° of extension is possible in the extreme range.

Commander ankle movement with full opposite rudder  
(brake pedals omitted for clarity)

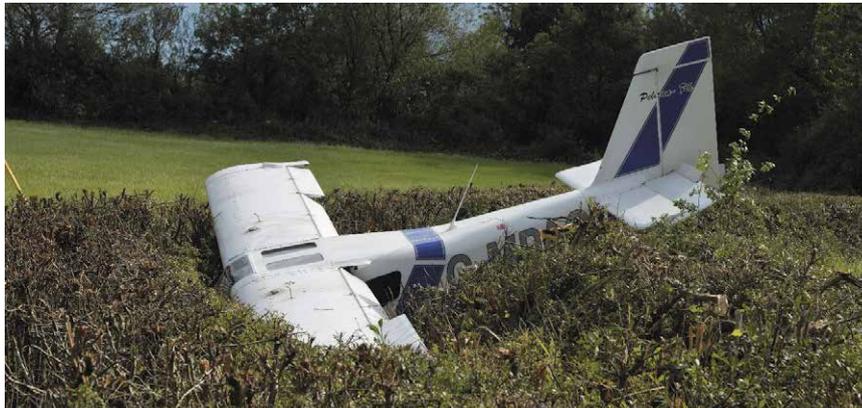
Approaching the end of the runway it became evident that the aircraft would overrun into the boundary hedge beyond. The pilot was not aware that the hedge line contained a ditch and assumed the safest course of action was to go through it. The pilot stated that if he had known of the ditch he would have tried to turn away before impact. G-MPAC left the runway at approximately 15 kt and penetrated the hedge before tipping forward and coming to an abrupt halt (Figure 1 and Figure 2).

G-MPAC in the airfield's boundary ditch  
(image © Leicestershire Police)

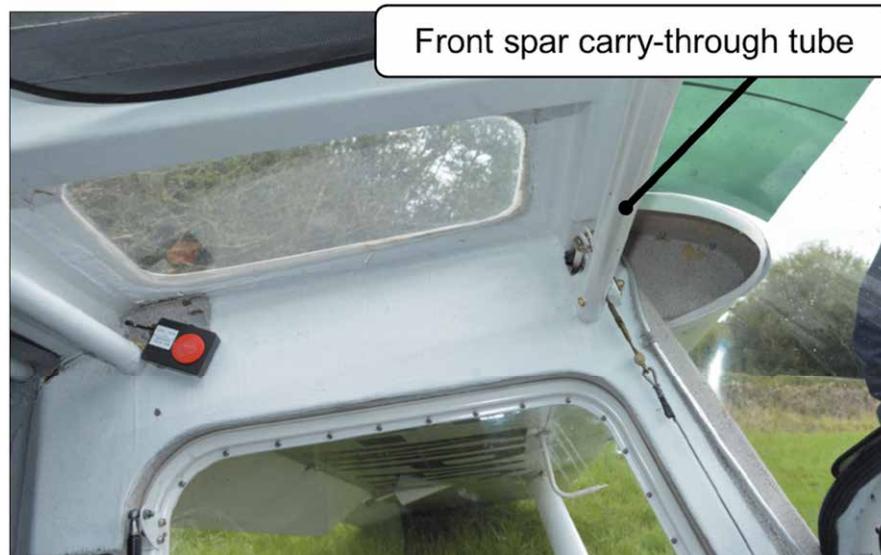
The sudden deceleration caused the pilot to be thrown forwards and he struck his head on the front spar carry-through tube just behind the windscreen (Figure 3). He suffered severe injuries as a result. The passenger's straps were tight and, having braced for impact, he was uninjured.

Front spar carry-through tube crossing behind G-MPAC's windscreen  
(image © Leicestershire Police)

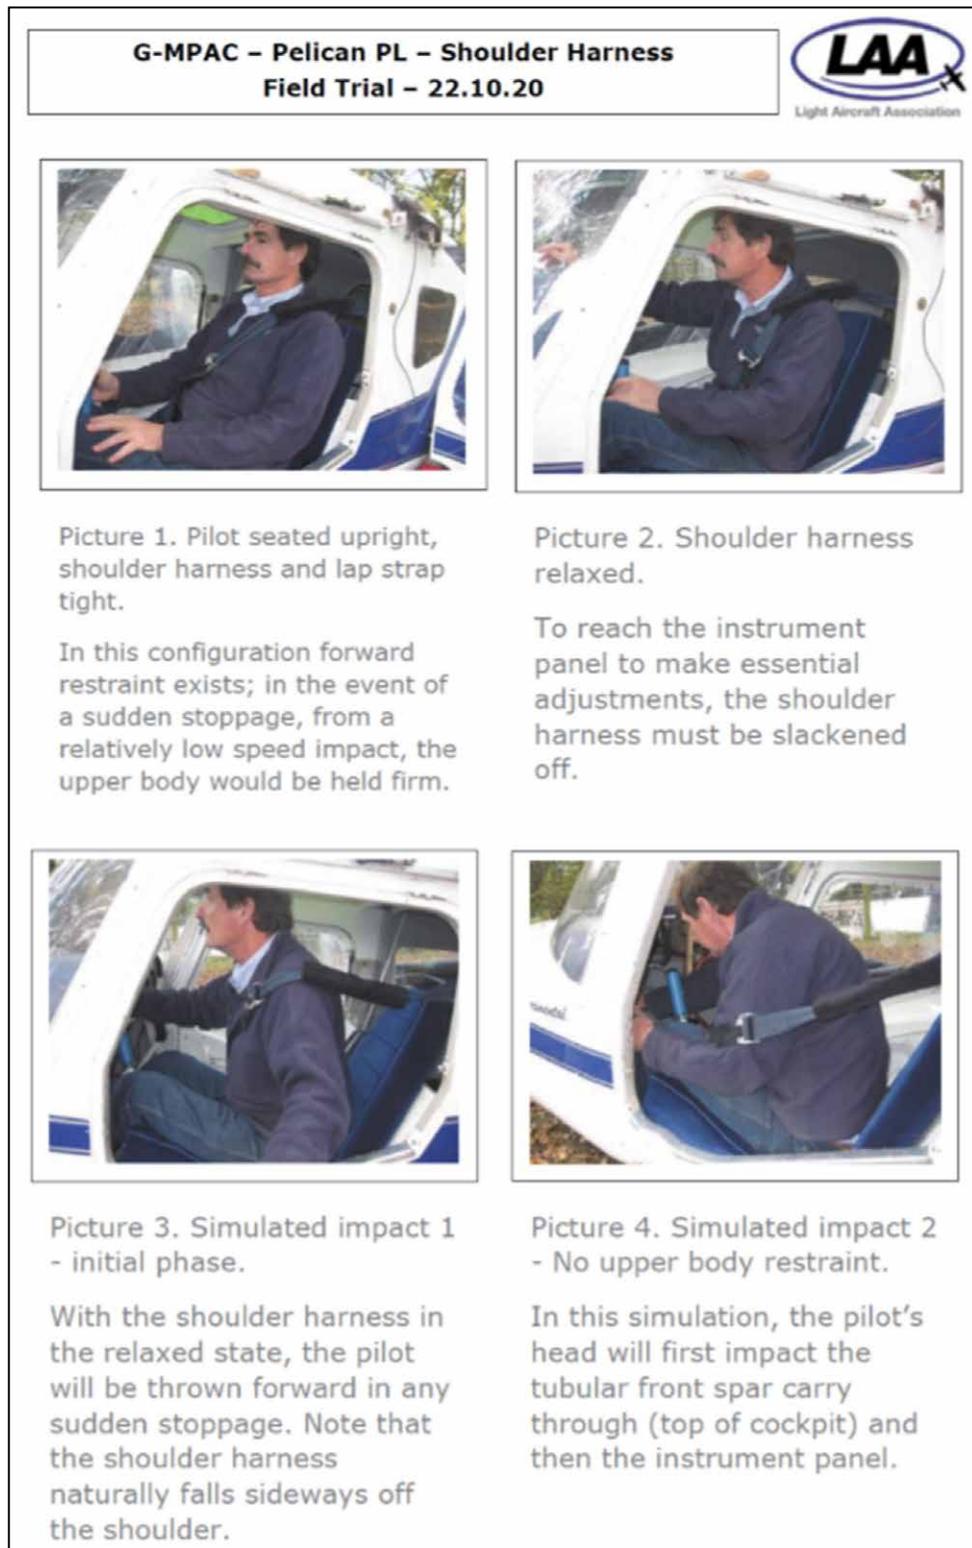
The Light Aircraft Association (LAA) conducted a field trial on the salvaged aircraft to assess the effectiveness of the harness in G-MPAC. They reported that the harness attachment points were secure and that the seat belt latch was in good working order. They considered it unlikely that the latch would have been inadvertently released during flight. The LAA also found that it was necessary to '*slacken off*' the single shoulder strap to reach forward and make '*essential adjustments*' on the instrument panel. It was apparent that unless the strap was tight it had a natural tendency to fall sideways off the shoulder. With a slack shoulder harness, the seat occupant's upper torso could pivot forward during a sudden deceleration allowing their head to strike the front spar carry-through tube crossing the top of the cockpit (Figure 5). The LAA used this accident as a case study highlighting to its members the importance of ensuring that all '*Hatches and Harnesses*' are secure and tight during pre-landing checks. The LAA also informed the only other owner of a G-registered

LAA field trials report  
(courtesy of the LAA)

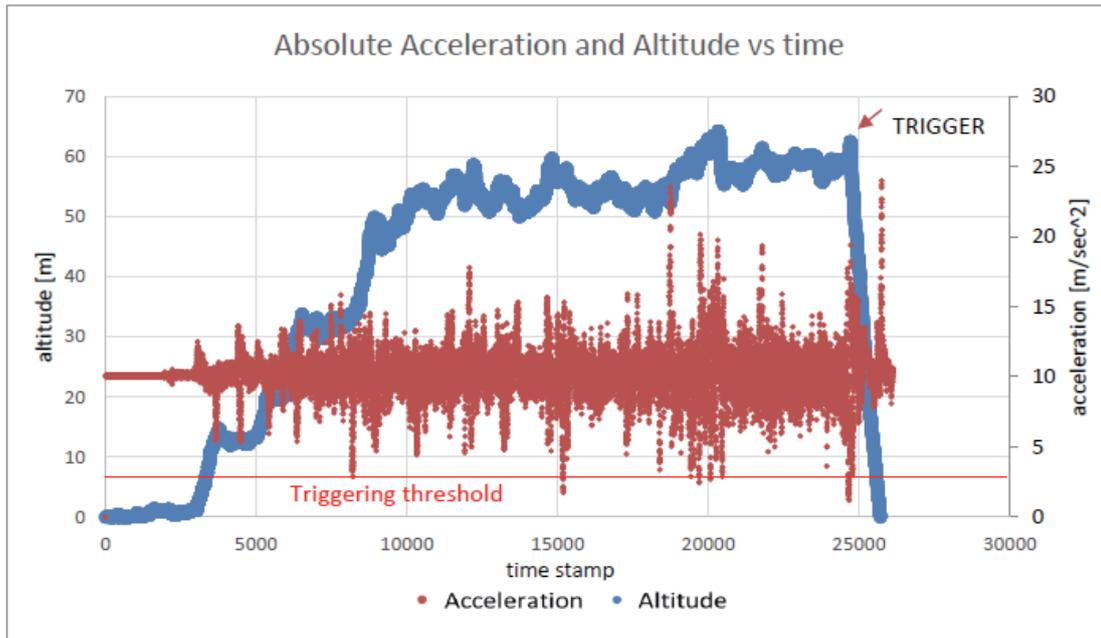
The parachute manufacturer analysed the log files from both the aircraft and the parachute system and stated that they were '*similar until the moment of deployment*'. Thereafter the aircraft's flight log ended at cruise altitude, while the parachute system log continued to record the parachute deployment, characterised by erratic acceleration readings, and a descent at a constant rate (Figure 2 - note that the altitude data recorded by the SafeAir is barometric).

SafeAir recorded data for the accident flight  
(Source ParaZero)

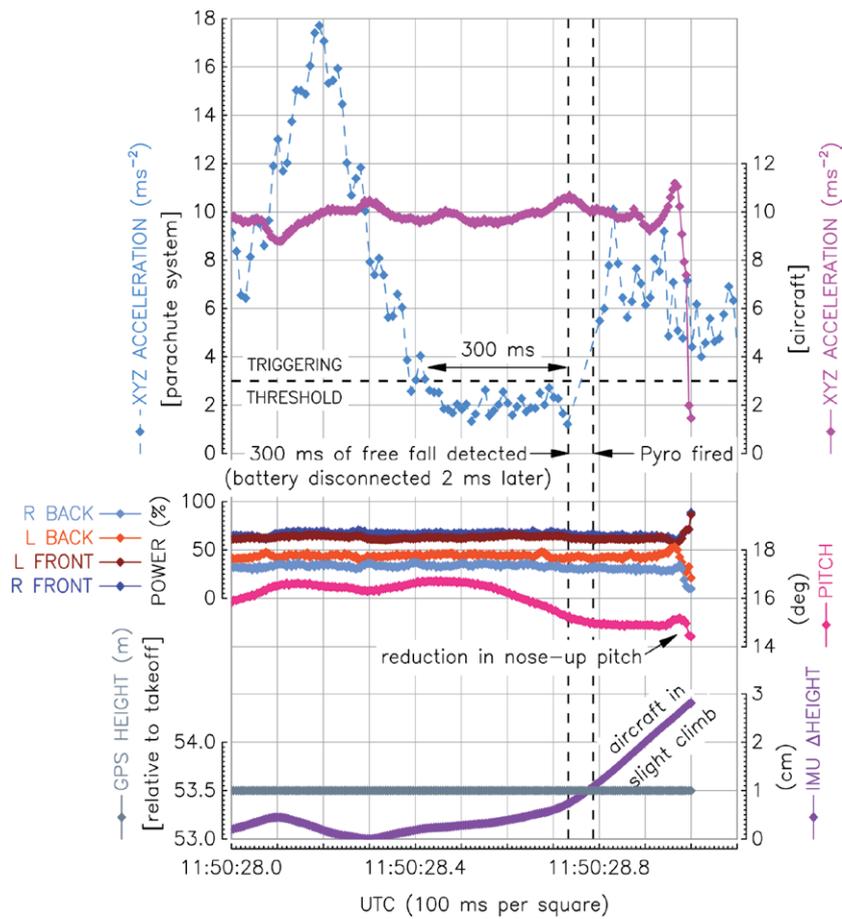
Figure 5 is a close-up of the last one second of the flight before power was lost to the aircraft. During this second the aircraft's inertial measurement unit (IMU) sensed slight changes in vertical speed that equated to about 2.6 cm height gain, with the aircraft's acceleration decreasing from just over 1g to below the SafeAir's trigger threshold over the last 25 ms. During these last 25 ms, the aircraft's nose-up pitch reduced by  $0.77^\circ$  (so about  $30^\circ/\text{sec}$ ) and the thrust (probably in response) increased the power of the front motors and decreased the power of the rear motors. There were 23 more points in the aircraft's log file, covering a 109 ms period, that were corrupted (the last 12 of which appeared to be from an earlier flight two months earlier). The aircraft's log did not contain any warnings or provide an insight into the reason for the parachute activation, or if the batteries had been disconnected.

Figure 5 also shows the acceleration recorded by the SafeAir system, when it detected 300 ms of freefall. This triggered the TerminateAir within 2 ms and the parachute deployed 50 ms later. However, the drop in acceleration to below the SafeAir trigger threshold occurred about 700 ms before a drop in acceleration was measured by the aircraft.

Comparison of acceleration prior to parachute deployment
