# DESIGN AND OPERATION OF TRASH SCREENS CASE STUDY

## CARR DYKE

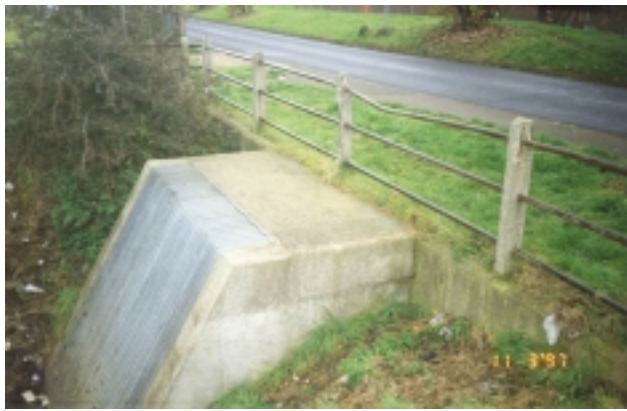
**Figure 1.1 General view of the present**

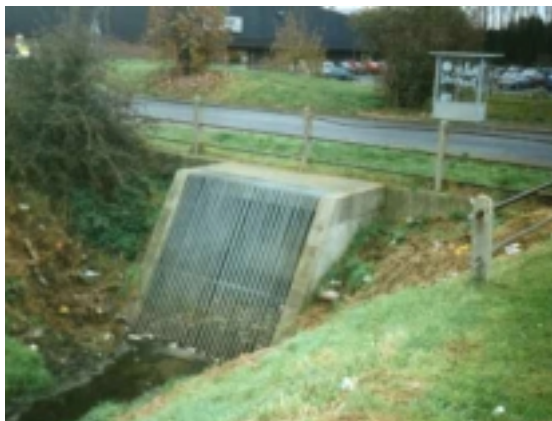
**Figure 3.1.1 View of the screen under normal flow conditions.**

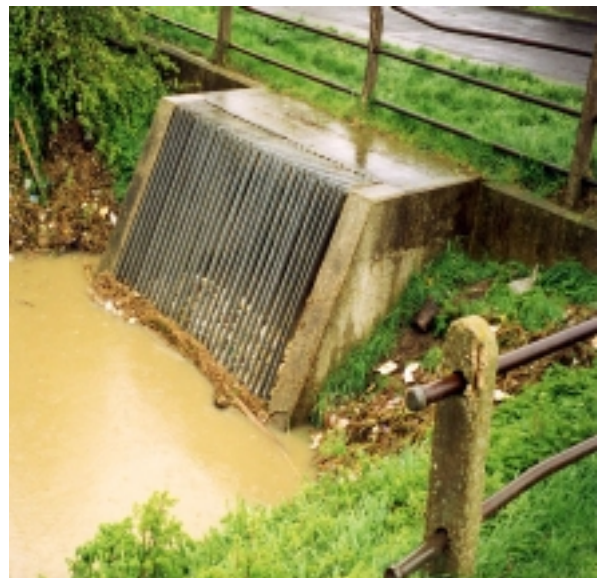
The screen was designed and installed in 1979 and as such does not comply with the latest guidelines. There are no over flow measures and when the screen becomes fully blinded flooding occurs which can spill over the road into the supermarket. A number of flooding incidences have been recorded.

**Figure 3.1.2 View of the screen at 1 in 20 year event. The water level is below peak at this point. Notice that there is debris behind the screen.**

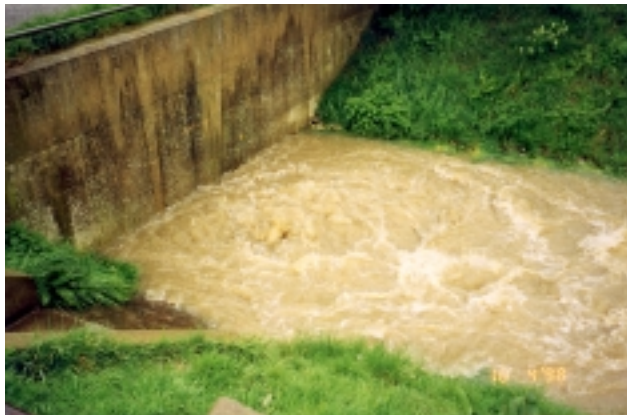
**View of the syphon outlet downstream of the screen during high flows. The syphon creates significant turbulence downstream**
