# DESIGN AND OPERATION OF TRASH SCREENS CASE STUDY

## LEEN SYPHON

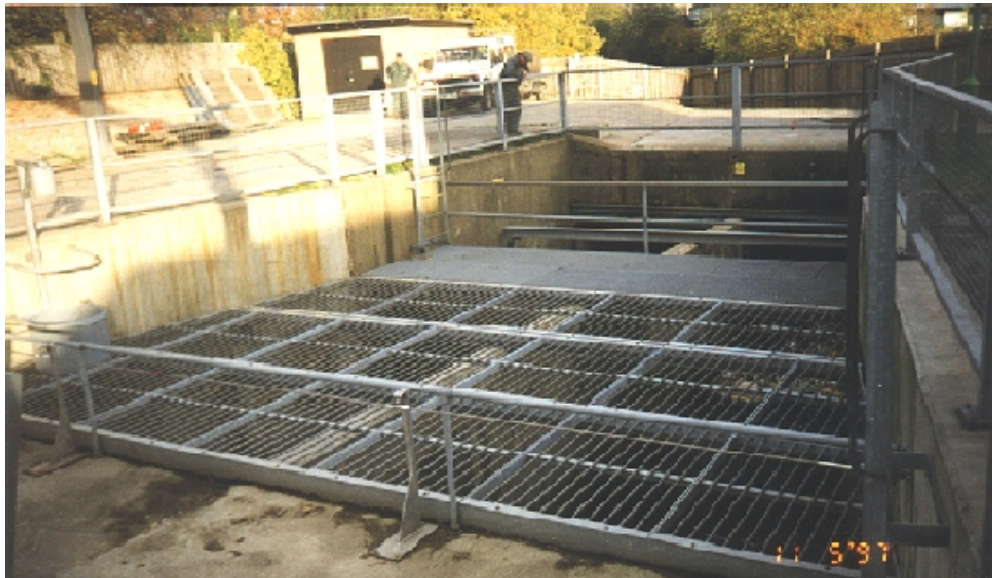
To the rear of the screen and across the flume channel there exists a horizontal screened overflow grill and a removable open mesh walkway. The flume channel has been left uncovered to the rear, between the walkway and the entrance to the syphon culverts. This is to ensure the flow of water and small debris during extreme flood conditions which could otherwise lead to complete blockage of the screen and screened overflow, resulting in flooding upstream of the site.

**Figure 2.4 View on the horizontal screen area looking downstream.  
Note that the area at the rear is now open.**

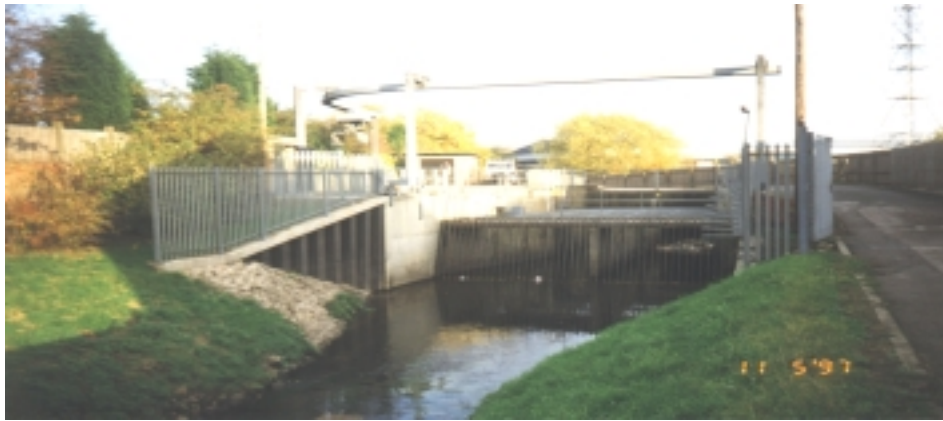
**Figure 2.5 View on the screen from the access road, up-stream, note the gantry arrangement. Also note the security fencing to prevent access to the screen compound and moving plant.**

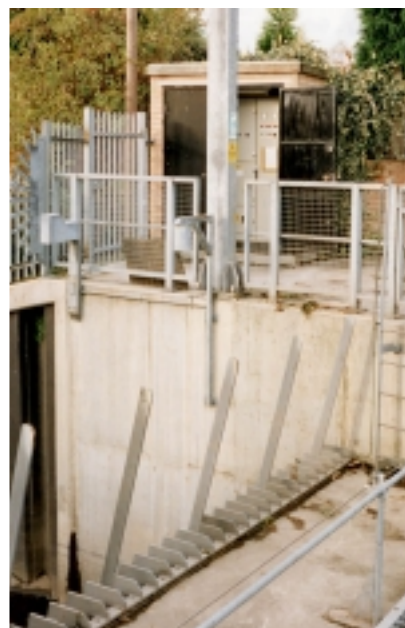
**Figure 3.1 The extended guide bars are clearly visible here as is the ultrasonic level gauge near the bottom of the gantry pots.**

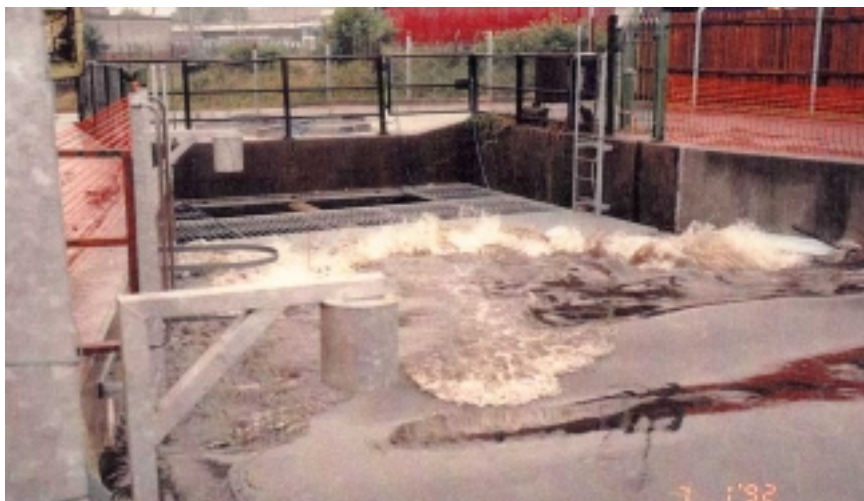
During flood events in July and August 1992 serious failings in the original design were brought to light and subsequently a number of modifications had to be made.

**Figure 5.1 Flooding drowned out the installation. Panels in the horizontal platform had to be removed.**

- 2) Following complete blockage of the front of the weed screen, water and debris began to flow over the screen and onto the overflow grills behind. Initially water was successfully able to flow through these grills, however as more debris built up on the surface of these grills the passage of water was increasingly impeded resulting in a further increase in water levels upstream.

Operating staff realised this to be a significant problem during the July 1992 event and removed the rear two overflow panels, close to the culvert, to prevent further build up of debris and hence total blockage of the screen. It was therefore considered that to alleviate this problem in the future these panels should not be replaced.

- A new screen with wider bar spacing
- The removal of two horizontal screened overflow panels to the rear of the screen between the open mesh walkway and the entrance to the syphon culverts.
- Installation of a new heavier grab.
- The extension of a number of the weed screen bars above the top of the screen, over half of the screen closest to the dumping ground.

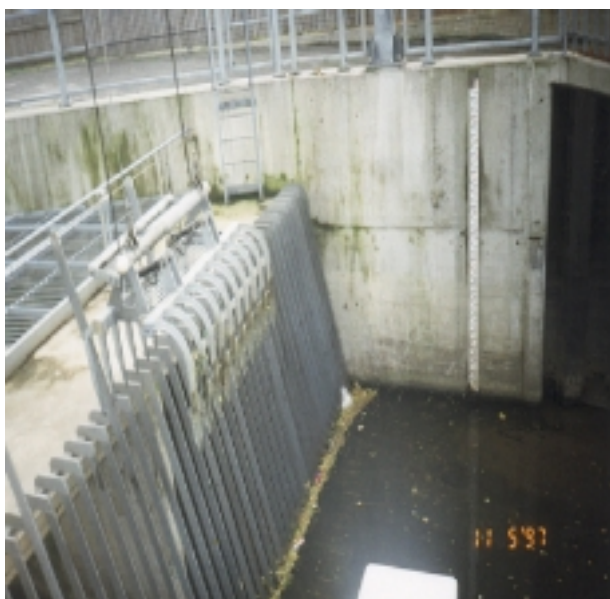
- 3) The original grab was noted to be incapable of coping with the flood and debris conditions. The grab was not capable of penetrating the dense weed build up on the screen but instead would hit the weed and fall away from the screen resulting in little to no removal of debris. It is considered that this problem was an additional factor in the rapid build up of weed on the trash screen. In addition to this as the debris and water levels built up to the top of the screen the grab was noted to be washed over the screen by the high water velocities, further impeding the removal of debris.

**Figure 5.2.1 The mechanical grab has to run on guides that come above the screen area. Originally, these were not in place.**

Despite this modification problems still occur with the grab becoming caught on the concrete plinth to which the screen is fixed. High water levels and strong currents cause the grab to tilt as it enters the water, which pushes the back teeth over the plinth. As a consequence the grab cannot be lowered successfully to remove trapped weed. Operations staff have on occasions physically guided the grab to prevent this from happening. This in itself gives rise to a number of health and safety issues.

This problem was addressed by two modifications. Firstly the existing grab was replaced by a larger heavier grab, to assist in penetration of the weed and give greater resistance to river flow. Secondly a number of the raked bars on the new weed screen were extended above the top level of the screen over half of the screen close to the dumping ground. These extended bars were spaced along the screen such that two are located behind the grab at each of its drop positions for the cleaning cycle No. 1. It was considered that these bars would prevent the grab from being washed over the screen during times of high flow and in effect guide the grab to its required cleaning position.

As stated earlier, one modification was undertaken in 1992. This was the extension of raked bars on the screen to guide the grab into position during high flows.

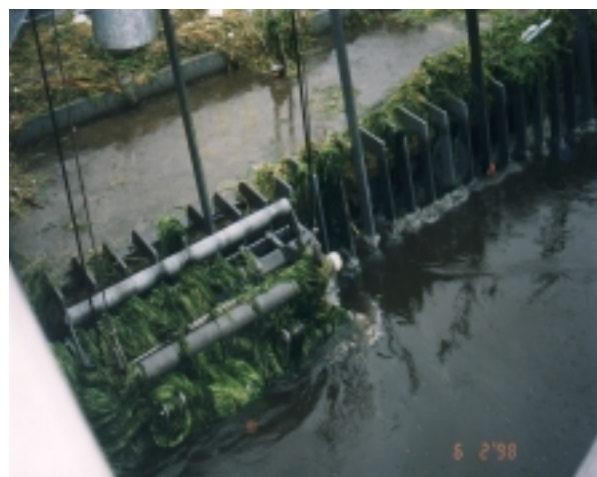
**Figure 5.2.2 Grab in operation during high flow.**
