# DESIGN AND OPERATION OF TRASH SCREENS CASE STUDY

## LUSTRUM BECK

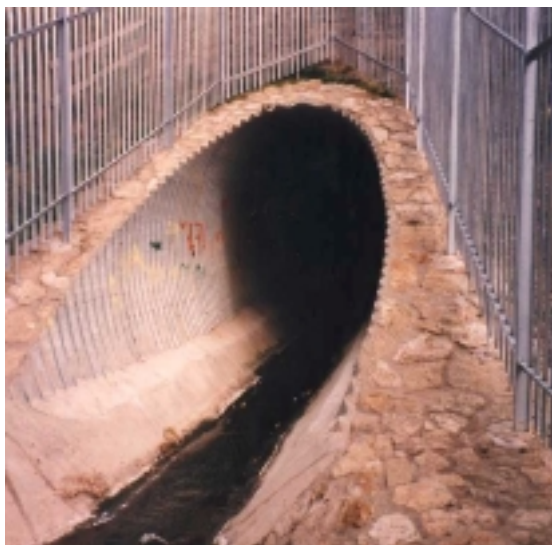
After this incident, the Cleveland County Council installed a high security fence around the culvert entrance. However, these measures were not sufficient to prevent a further incident in the culvert where a child became trapped in a side culvert on a rising flow. It took the emergency services some time to afford the rescue.

**Figure 1.2 View on the new armco culvert, note the concrete haunching allowing access into the culvert. The fence was installed after the fatal accident. However, it did not deter children from entering the culvert.**

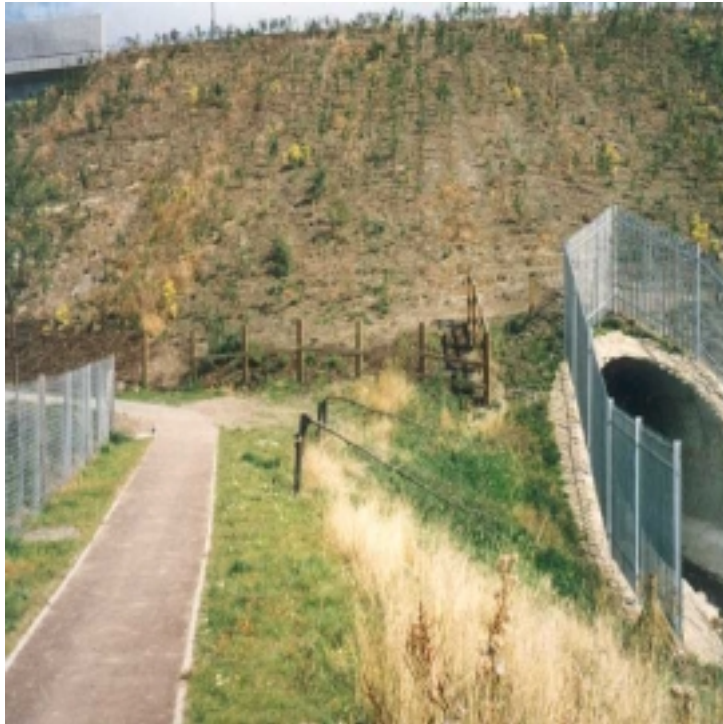
**Figure 1.4 View showing the public footpath running adjacent to the new culvert and the inadequacy of the fencing.**

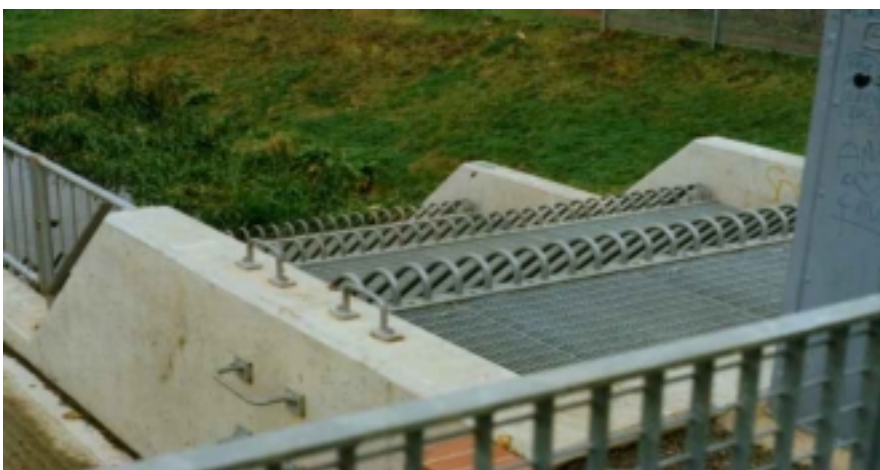
The screen area is 69.5 m<sup>2</sup>, this being from three stages of raking screen each with a rake length of 1.8m and three working platform areas, each 1.8m wide. (*Manual, Section 3.3.4 details methods of determining screen area*).

**Figure 2.3 General view of the screen clearly showing the three stages and the heavy duty construction materials.**

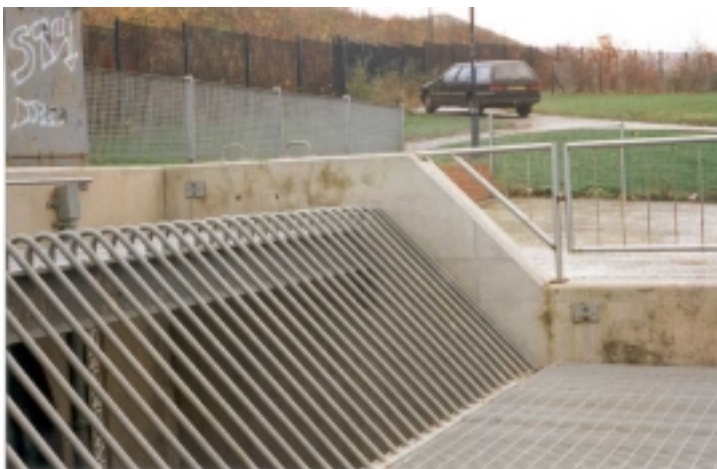
Part of the compound area surfacing is reinforced concrete, this allows for the debris storage and transfer to disposal vehicles. This surface is graded to provide a fall to the watercourse area, allowing drainage of collected debris prior to final removal.

**Figure 2.5 The screen site includes a concrete hard standing and areas for turning vehicles. The access road is dedicated to the screen.**

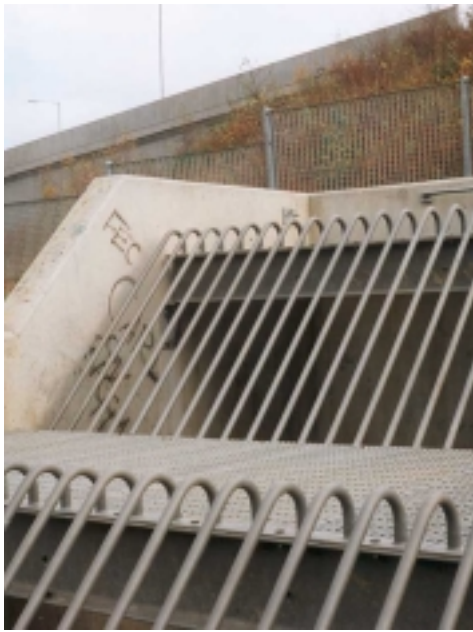
**Figure 3.3 View on top screen, the angle of rake and construction details are clearly visible.**

There are three levels of working platform, from which each level of screen can be cleared. Each platform is of non-slip, open mesh steel-decking construction, secured with specialist counter sunk locking bolts to the steel frame of the super structure. This secure locking was a modification to the original system after it was found that children had started to dismantle the decking.
