DESIGN AND OPERATION OF TRASH SCREENS CASE STUDY

MONK'S PARK LABYRINTH

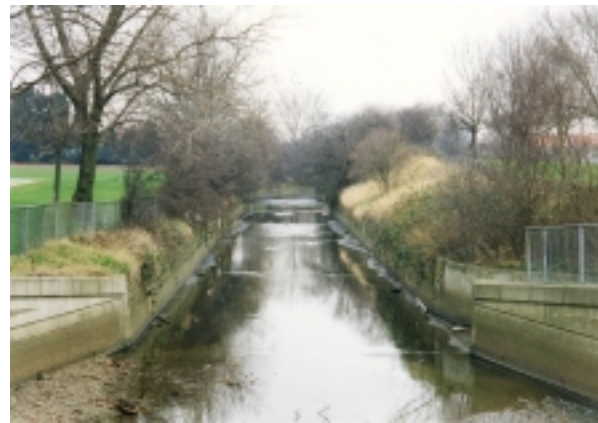
Figure 2.4.2 View upstream, under normal flow conditions. There can be a significant build up of transported river bed material collected in the silt trap.

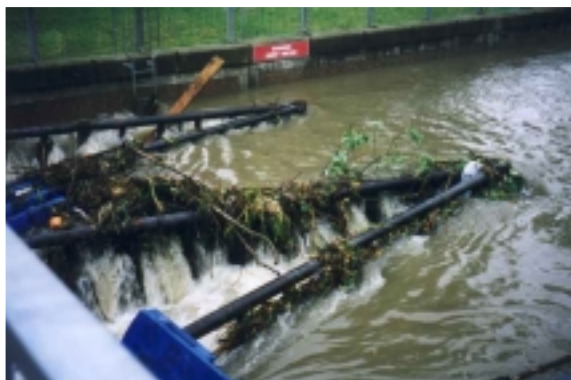
Figure 3.1.1 Debris collecting on the screen prior to the event reaching its peak. The weir effect of the structure is clearly visible.

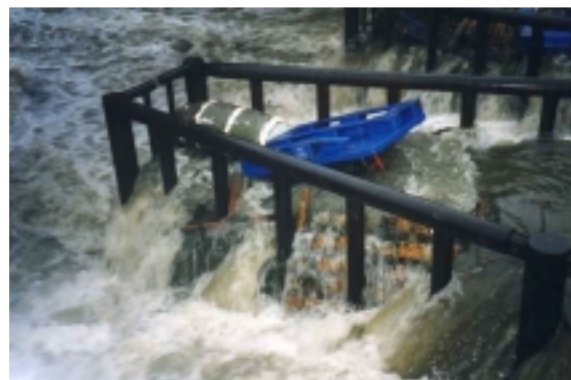
Figure 3.1.2 Debris collected on the screen during a significant event. The type of debris oil drums and pallets have the potential to damage the

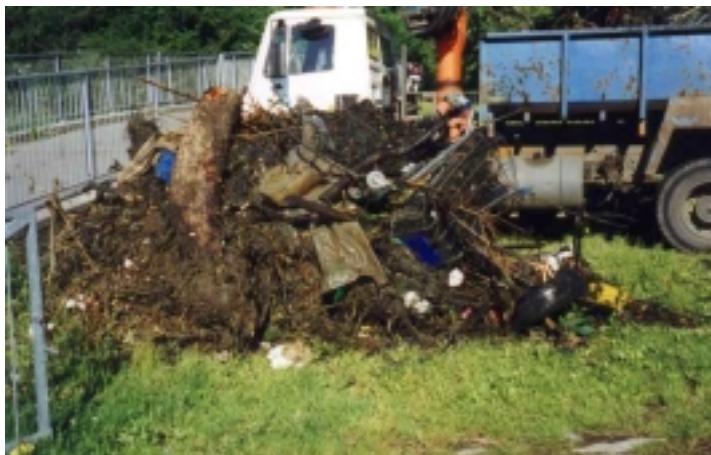
Figure 3.1.4 A significant event can bring a large amount of debris downstream.

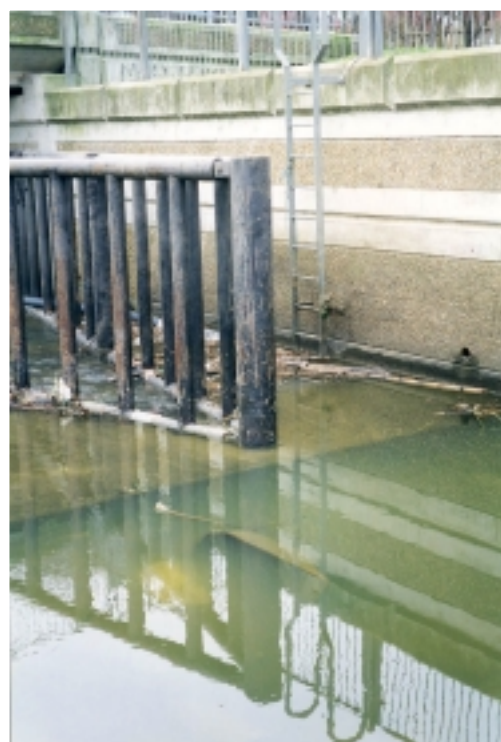
Entry to the channel bed for operatives can be from a vertical ladder adjacent to the bridge or via the channel access ramp. Access is safe when there is dry weather flow, although care must be taken not to step into the silt trap (about 0.6m deeper) immediately upstream of the screen.

Figure 3.3 Entry to the channel can be from the ladder as shown in the photograph or by vehicle ramp. However the silt trap poses an additional safety risk as it is between the ramp and the structure. The step down is clearly visible in the photograph.
