Soil piping tests on Thorngumbald flood embankment

Keywords: Flood embankments, soil piping, mode of failure,
internal erosion

Science Report FD2411/TR3. This short investigation was
part-funded by EA Science as part of Defra project FD2411.

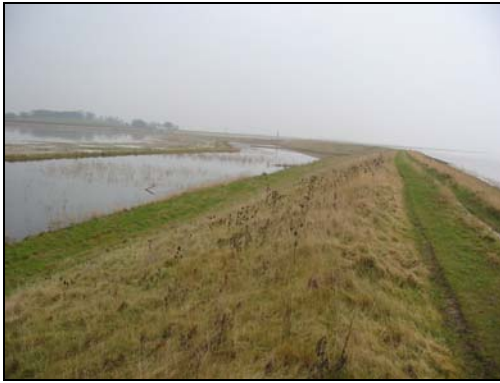
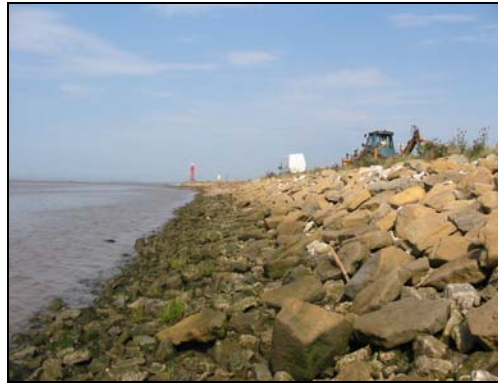
Figure 2: Views of the Embankment

At the test site, the crest of the embankment was about 3m above the adjacent shore level and about 3.5m above land level on the landward side. It had side slopes of about 1:3 (vertical to horizontal) and a crest width of about 3m. Pictorial views of the embankment are shown in Figure 2 and a typical section of the embankment is shown in Figure 3.

Landward embankment face

Seaward embankment face

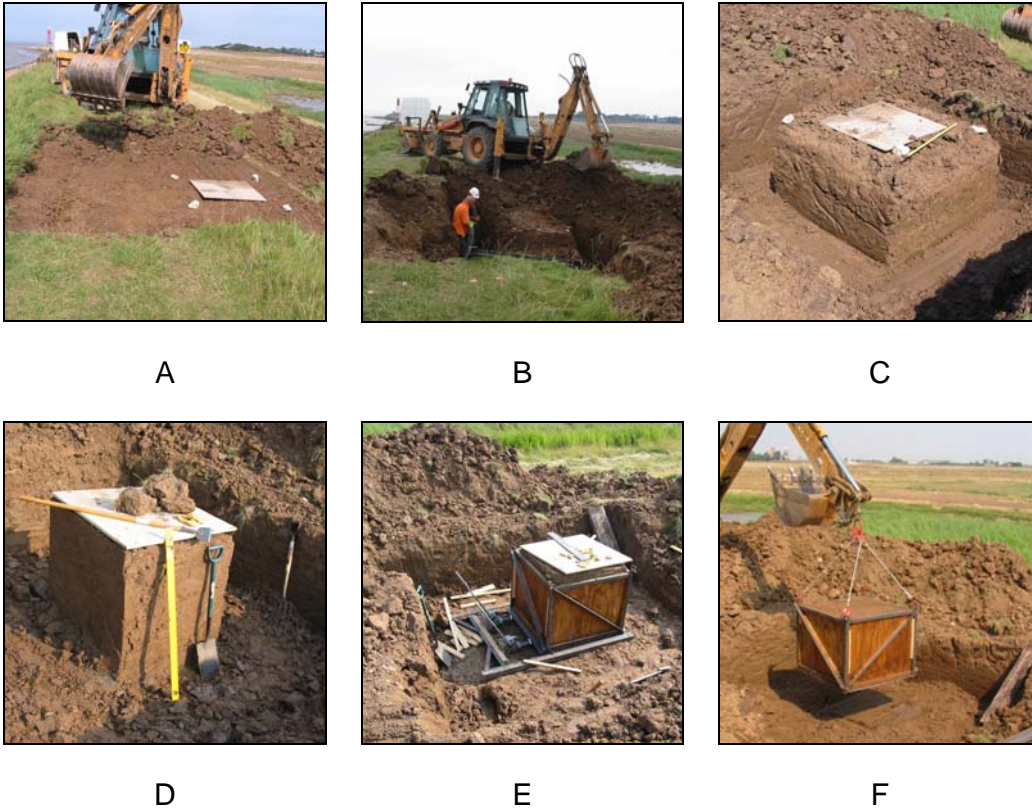
Figure 4: Recovery Method for Embankment Samples

The sampling sequence is shown pictorially in Figure 4. The location of the sample was identified and marked on the embankment surface (A). Excavator was then used to remove the surface soil to a level platform slightly above the required depth of the top of the box (B). A 1m deep trench was dug at a minimum distance of 30cm (C) from the edge of the sample. This then allowed the sample to be trimmed to fit the inside size of the box (D). The box was then lowered over the sample and allowed to sit on the base of the trench with approximately 20cm of sample proud of the top of the box. A specially designed jacking system was then attached to the base which enabled insertion of metal cutting plates into the base of the box and thus cut the sample at the base (E). The top was then trimmed and the excavator was then used to hoist the boxed sample from the excavation pit (F). Dry sand was poured into any cavities that remained between the sampling box and sides of the specimen before attaching the lid. The lid was sealed to prevent loss of moisture. The recovered specimens were placed on a 20mm thick rubber layer during transportation to Wallingford.

During specimen recovery, it was found that up to a depth of about 1.3m, upper layer of the embankment comprised blocky, firm to stiff, brown silty clay with some voids and sometimes approximately orthogonal fissures resulting in small blocks of soil. The degree of fissuring was variable both on plan and with depth. The largest voids were about 20mm wide and were discontinuous. In general, fissuring and the degree of voids decreased with depth. As such deeper specimen comprised of more homogeneous material, with a fewer voids and fissures. It is possible that the embankment was formed without adequate compaction and it is most likely that the lower parts were compacted due to overburden pressure.

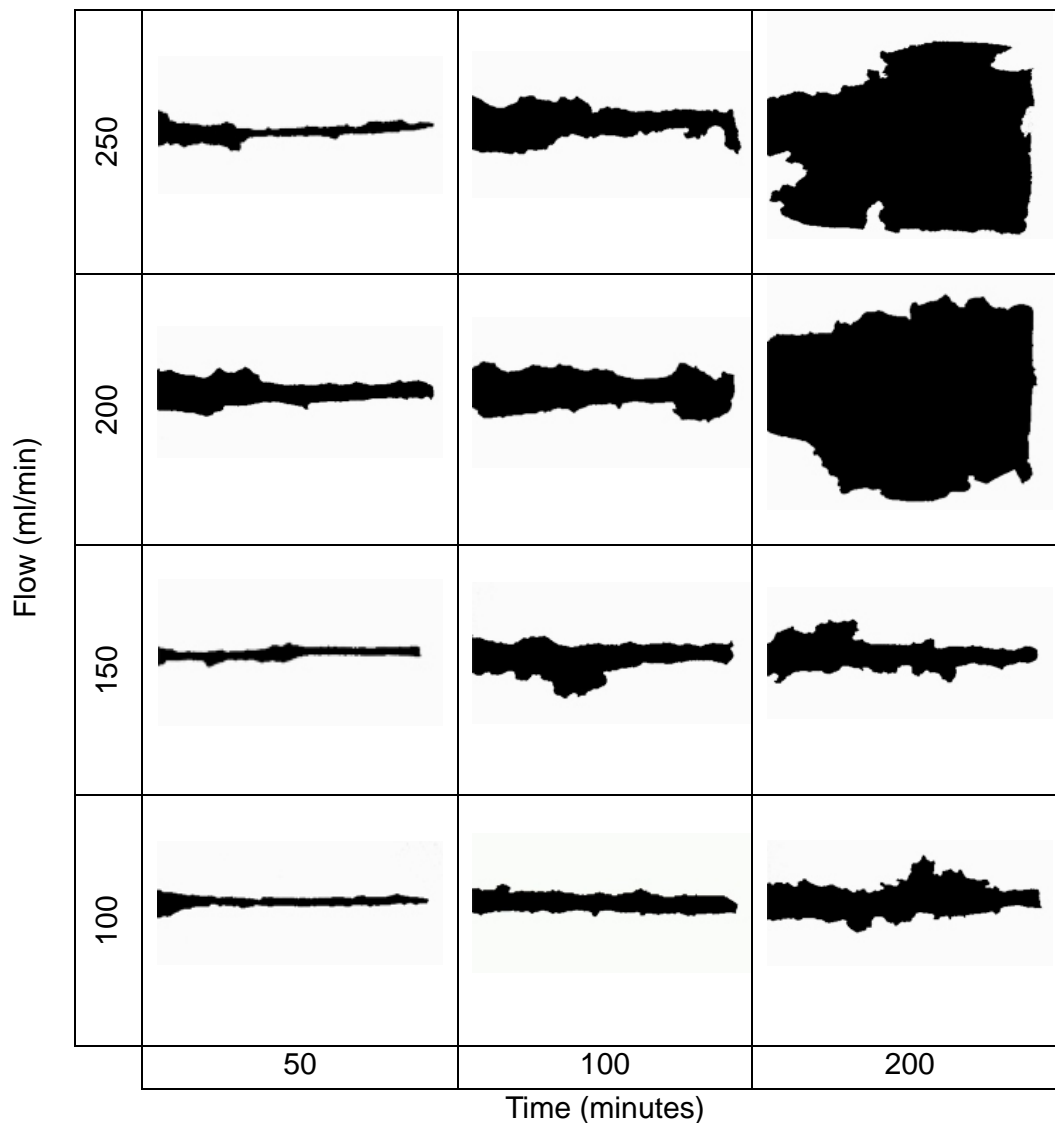
Figure 10. Cross-sections of Eroded Shapes from Internal Erosion Test Arising at a Range of Times for a Range of Flow Rates for Tests on Specimens Compacted at the Field Density.

A resin cast of the eroded void was obtained for each test. The resin cast was then digitised in three dimensions and the volume of the eroded material was calculated. Eroded shapes of the pipes formed for different flow rates and for 50, 100 and 200 minute duration are shown in Figure 10 (black colour shows a typical cross-section of the shape of eroded volume).

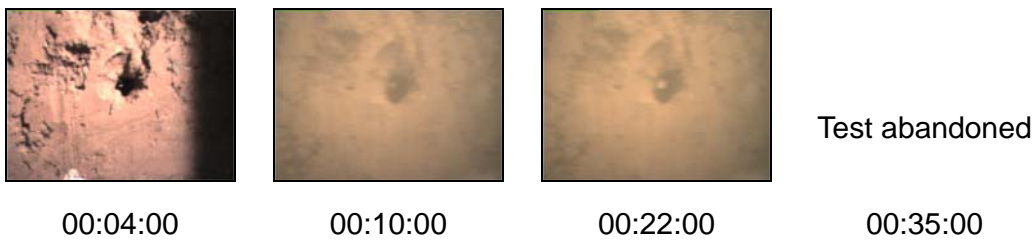
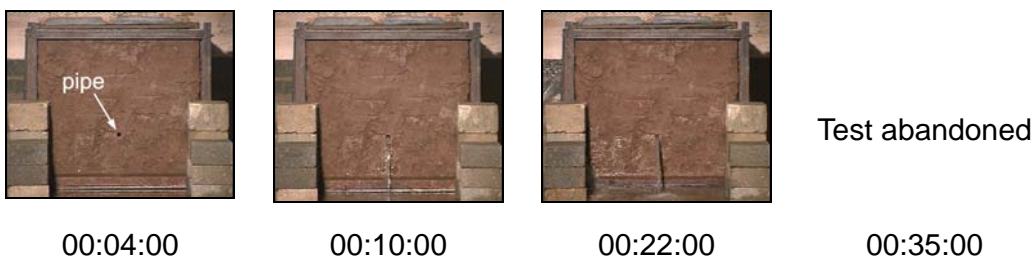
The first sample to be tested was Box 1, which was taken near to the top of the embankment with its base being at 1.33m for the embankment crest. Test 1 was run twice due to complications. The upstream water level and discharge through the pipe against pipe are shown Figure 15. The results show that the upstream head of water was not constant. This was because during the first run a major leak appeared in the side of the flume, just as peak water level was achieved. The test therefore had to be abandoned so that repairs could be carried out. The second run also ran into difficulties shortly after peak water level was reached. This time large leakage was observed between the upstream face and the weir. It was not possible to control this leakage and the force to the water caused the soil block to be moved out from within the box. The test was abandoned, as the specimen was unusable. The upstream and downstream faces of the sample block are shown in Figures 16 and 17 respectively. Over the 22 minutes of variable head, both the upstream and downstream faces of the pipe did not show signs of erosion.

Figure 16: Upstream Face for Test No. 1

Figure 17: Downstream Face for Test No. 1

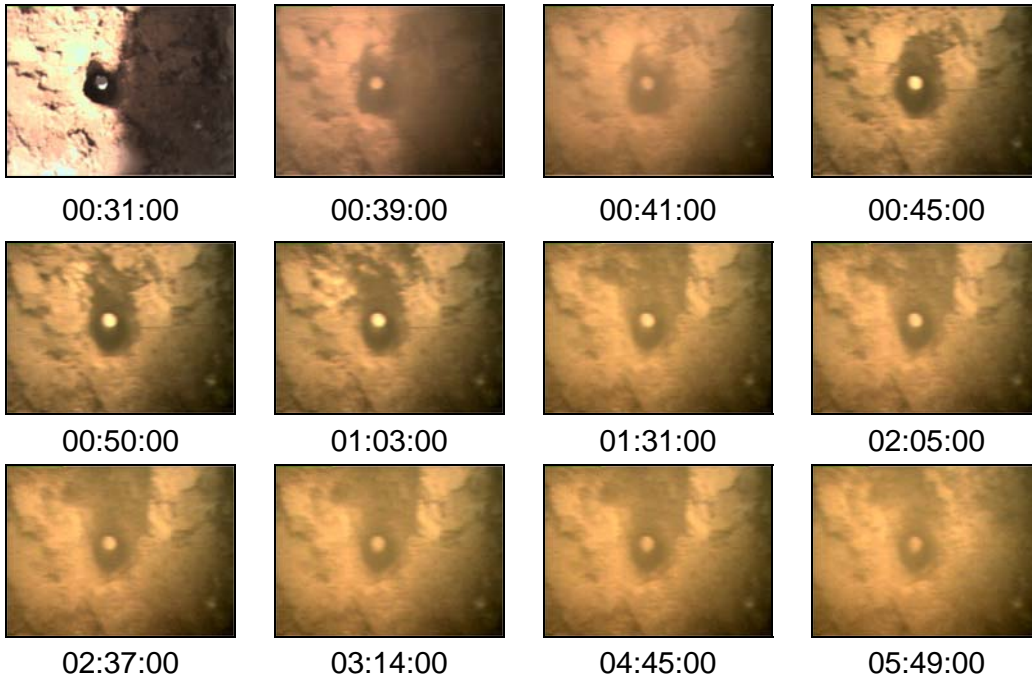
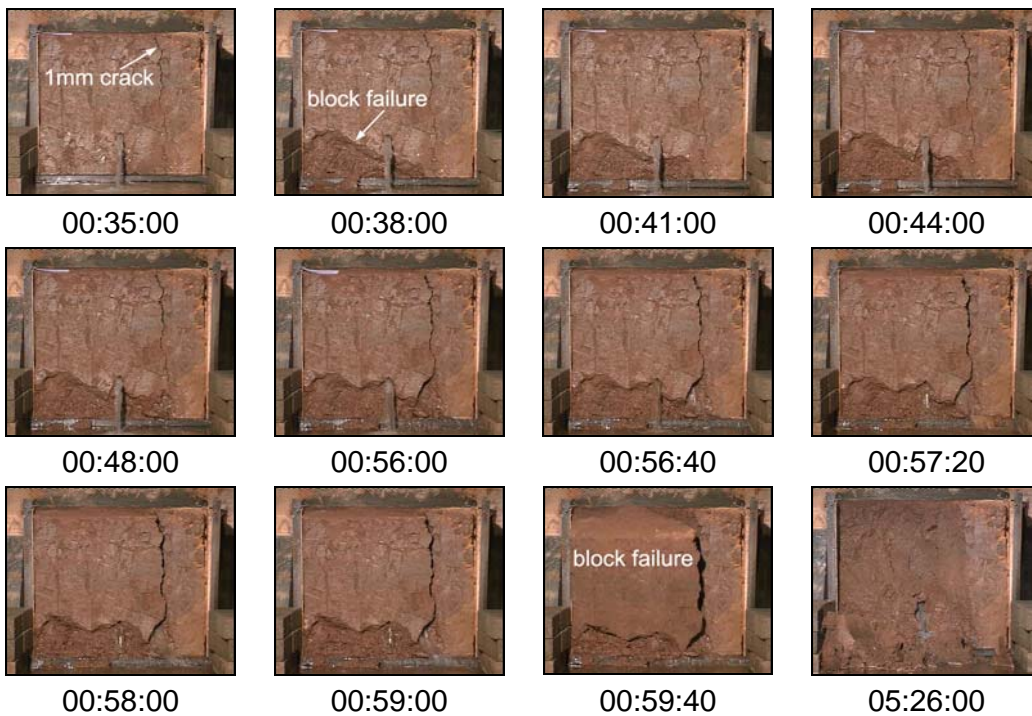
Test 2 used the sample from Box 2. The sample was inspected before the start of the test and a crack was noticed along the top and continuing down the downstream face. The degree to which this crack developed during transport or simply reflected a wider existing network of fissures within the sample was unclear. Given the care taken to transport undisturbed samples, it is thought more likely to reflect an existing fault or fissure line within the sample. At the beginning of the test the crack was estimated to be approximately 1mm in width, but it was not possible to ascertain its depth. During the test this crack was monitored. Under cutting of the downstream face was also observed and approximately 38 minutes after start of the test a small block failure occurred essentially below the level of the pipe (see second photograph in Figure 20) This was considered to have occurred due to ingress of water into fissures in the sample. Subsequent to this failure, the vertical crack started to widen and large block failure of the downstream face occurred about 58 minutes after the start of the test. The presence of voids and fissures are considered to have been the main cause of block failures.

Figure 19: Upstream Face for Test No. 2

Figure 20: Downstream Face for Test No. 2

are shown Figure 18. The upstream and downstream faces of the test specimen are shown in Figures 19 and 20.

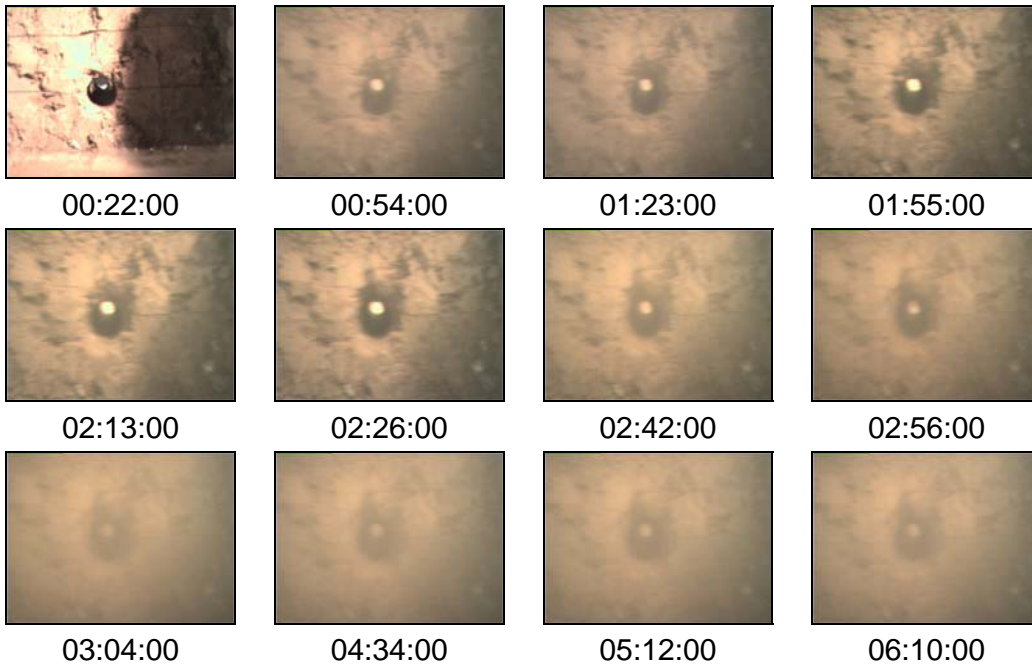
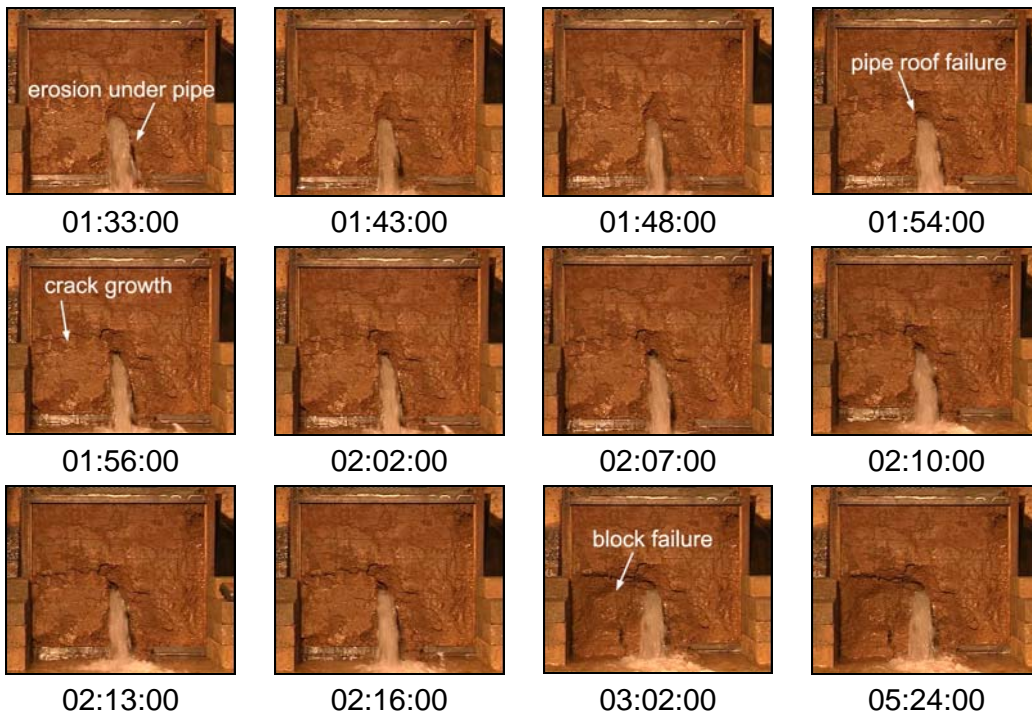
Box 3 was used for this test. The sample was the deepest of the three with its base at 2.01m below the crest. Erosion was again seen below the level of the pipe outlet. In this case erosion was directly under the outlet and then spread to either side. There was also some erosion above the outlet and into the specimen along the roof of the pipe to a distance of approximately 180mm into the specimen. Approximately 2 hours after the start of the test a large block failure occurred on the downstream face. Increased seepage was noted in the area of the crack. After approximately 5 hours, another large block failure occurred on the opposite side of the previous failure. This caused material on the roof of the pipe to fail. The upstream water level and discharge through the pipe are shown Figure 21. The upstream and downstream faces of the test specimen are shown in Figures 22 and 23 respectively. It was clear in this instance that voids and fissures were the main contributing factors.

Figure 22: Upstream Face for Test No. 3

Figure 23: Downstream Face for Test No. 3
