SERIOUS INCIDENT

Aircraft Type and Registration:	1) Boeing 737-8AS, EI-DPC 2) Boeing 737-8Z9, G-GDFR 3) Boeing 757-28A, G-OOBA
No & Type of Engines:	1) 2 CFM56-7B27 turbofan engines 2) 2 CFM56-7B26 turbofan engines 3) 2 Rolls-Royce RB211-535E4-37 turbofan engines
Year of Manufacture:	1) 2006 (Serial no: 33604) 2) 2003 (Serial no: 30421) 3) 2000 (Serial no: 32446)
Date & Time (UTC):	8 September 2020 at 2227 hrs
Location:	Birmingham Airport
Type of Flight:	1) Commercial Air Transport (Passenger) 2) Commercial Air Transport (Passenger) 3) Commercial Air Transport (Passenger)
Persons on Board:	1) Crew - 6 Passengers - 35 2) Crew - 6 Passengers - 181 3) Crew - 8 Passengers - 190
Injuries:	1) Crew - None Passengers - None 2) Crew - None Passengers - None 3) Crew - None Passengers - None
Nature of Damage:	1) None reported 2) None reported 3) None reported
Commander's Licence:	1) Airline Transport Pilot's Licence 2) Airline Transport Pilot's Licence 3) Airline Transport Pilot's Licence

Synopsis

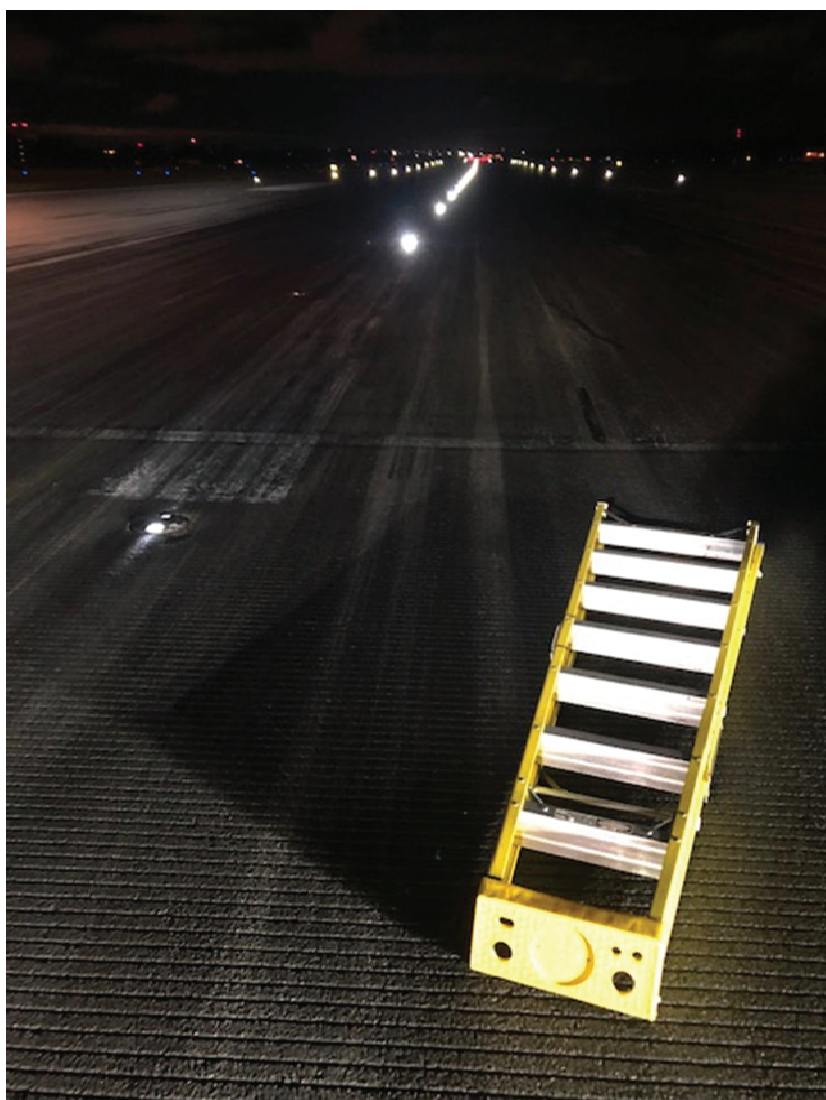
View up Runway 33 with the ladder in the approximate position it was found

Figure 1 shows the position of the ladder as found on the runway. The ladder was removed from the runway by the ASU personnel before being collected by the technicians. The ladder was positioned to the right of the centreline of the runway in use (Runway 33) laying almost parallel with the centreline. It was lying beside touch down zone markings which are 550 m from the runway threshold and 150 m beyond the aiming point markings.

With landing speeds in excess of 120 kt, an aircraft hitting an object such as the ladder may have resulted in substantial damage. In this case, taking the position of the ladder on the runway into account, and the main and nose landing gear track width, all three aircraft narrowly missed the ladder.

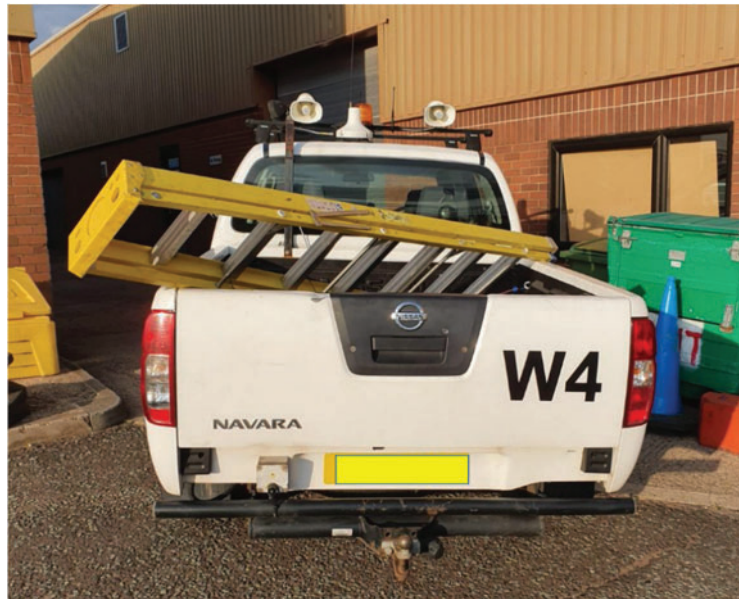
Figure 4
Ladder loaded onto WV4

In preparation for the work on the approach light the stepladder was put into the load bay of WV4 and the elastic bungee strap used to secure it in place. Figures 4 and 5 show how the ladder was positioned and held in the load bay.

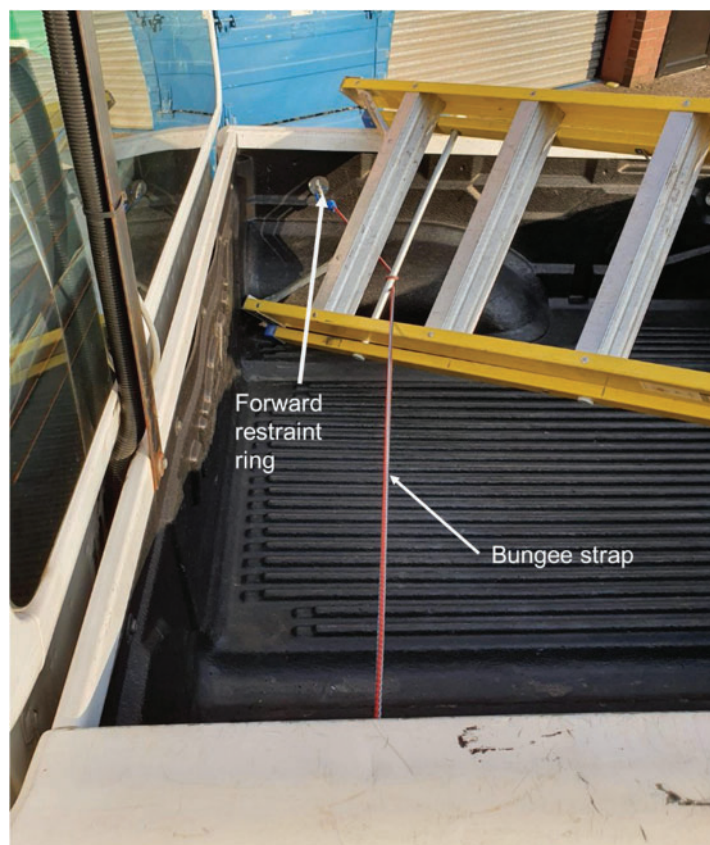
Figure 5
Ladder restraint method in WV4
(Picture taken after the event and reconstructed by one of the technicians)

At first sight the bungee may have seemed suitable to secure the ladder in WV4. However, when the actual method used was demonstrated, it could be seen why the bungee was unsuitable. The bungee had been stretched almost to its limits around a strut on the ladder and hooked to the right and left forward fixed rings in the load bay side panels (Figure 5). When the vehicle is stationary or moving slowly the method used would keep the ladder in place. Any gentle acceleration or moderate cornering would cause the ladder to move, and the remaining elasticity in the bungee would have provided sufficient restraint.

It is likely that as WV4 accelerated, having passed the aiming point markings, the ladder was caused to move more rapidly, and its inertia resulted in a 'snatch' load on the bungee when it reached the limit of elasticity. At this point, the snatch load would have been transferred into the wire hooks fitted to the ends of the bungee. In this case one of the hooks opened out (Figure 7) making it less effective in the restraint ring. As a result it most likely unhooked, rapidly sprang back, and unravelled itself from the ladder strut. This left the now unrestrained ladder to topple rearwards from WV4. As it fell out and contacted the runway it slid a short distance before coming to a stop causing the abrasion to the edges of the plastic at the top of the ladder (Figure 6).

During examination of WV4 and the ladder, a safer method of carrying the ladder was demonstrated. The ladder was placed upright in the load area angled forward, leaning against a vertical frame attached to the roof bars with its feet against the base of the tailgate. The frame was ideally placed to fix the ladder in place with a ratchet strap.

- Working Instruction WI-EE-ES-AE-104 issued. Use of WV4. The load area must be kept sterile and clear of materials and tooling to avoid any FOD. Any exceptions to this must be pre-authorised by the Airfield Engineering Supervisor or Senior Airfield Technicians via email. Confirmation should be gained before proceeding with any use.
- Implement an airport vehicle management procedure for all users to include a vehicle FOD inspection procedure.
- Undertake a suitability assessment of all engineering services vehicles used to undertake tasks on the runway and manoeuvring area.

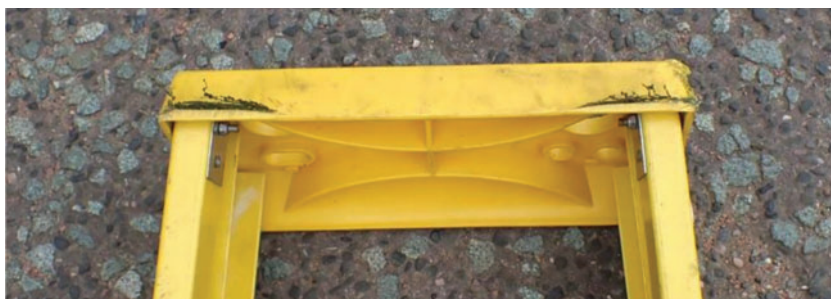
Figure 6

The ladder was recovered from the runway by the airport operations staff. Later examination of the ladder found minor scuff damage on the corner edges of the combined step and hinge plate. A small amount of material towards the edge of the scuff marks had been frayed and discoloured with a grey-black appearance (Figure 6). The bungee was examined, and this was in good condition except for the opening out of one of its hooks (Figure 7).

Scuff damage to the top of the ladder

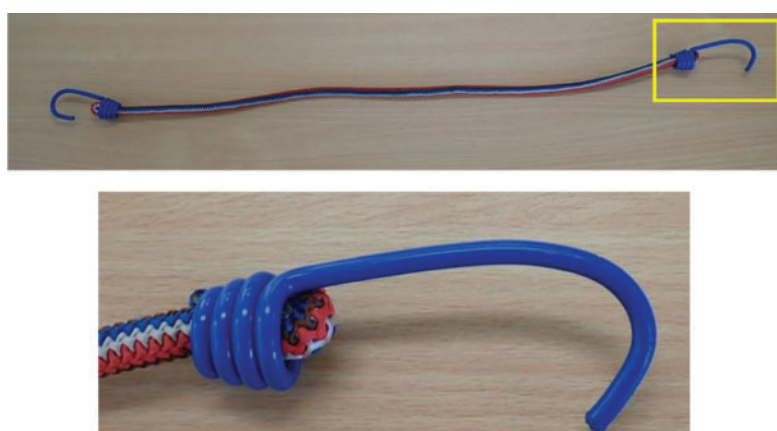
Figure 7

Bungee strap and damage to hook

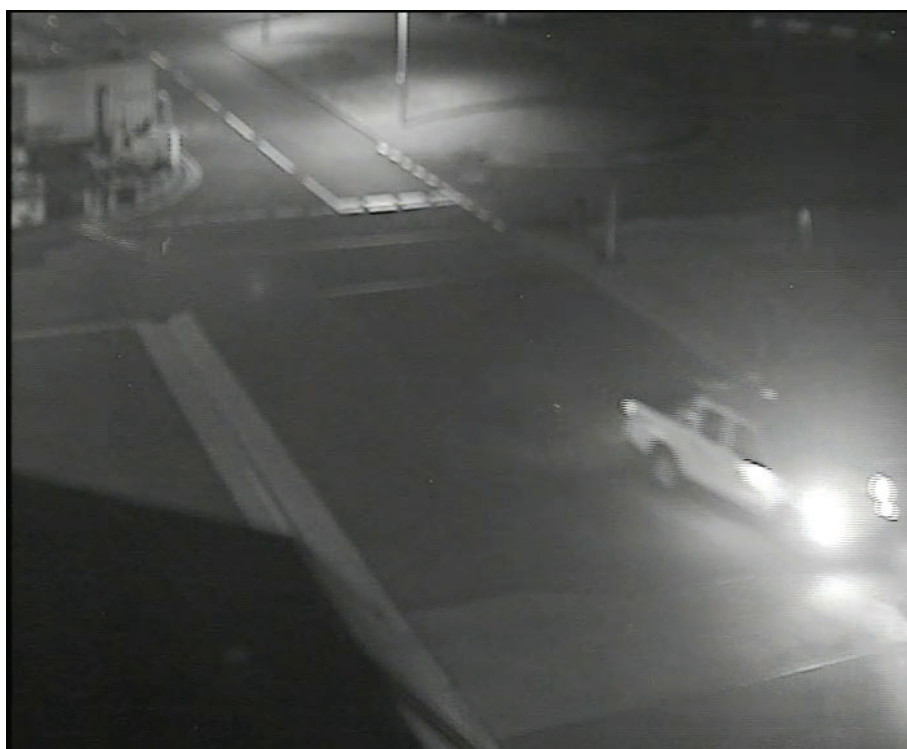
**Figure 8**

WV4 passing the fire station at 2133 hrs

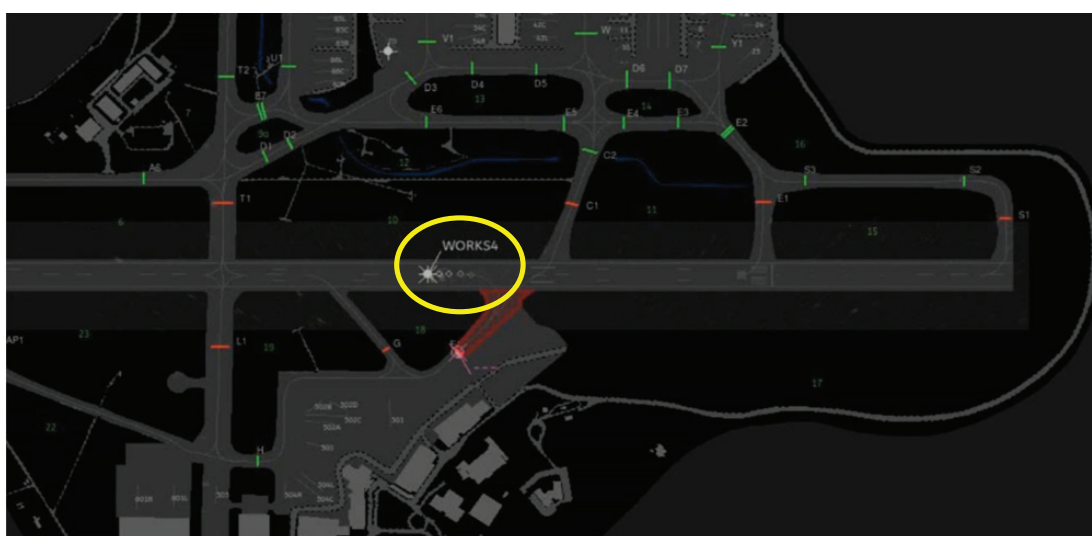
Figure 10

WV4 at the location where the ladder was found

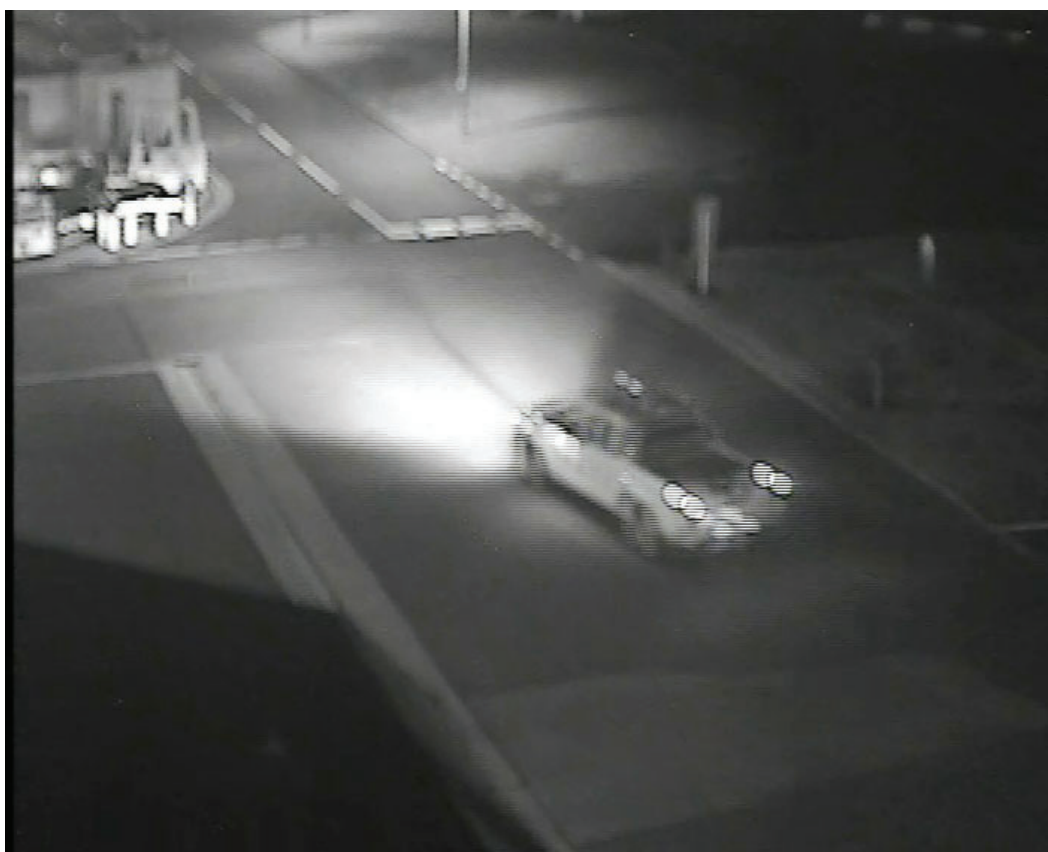
Having driven to the end of Runway 33, WV4 was then turned around and headed for the first centreline light they were to attend to, which was number 104 (see Figure 3). The scheduled maintenance requirements for the centreline lights was to check the torque on the bolts holding the lights in position. To do this the technicians had a wireless Bluetooth-equipped electronic torque wrench. This indicated to the technician doing the work when the correct torque was applied, and also transmitted the data to a mobile device which recorded the date and time of the work. When they reached centreline light 104, Technician 2 again got out the vehicle to complete the work. When he attempted to wirelessly connect the torque wrench with the mobile device, he found it would not do so and they therefore had to return to the engineering base in order to get it to work as required. WV4 vacated the runway at 2159 hrs. To drive to the engineering base, WV4 passed the front of the fire station and was captured on CCTV. Figure 11 is a CCTV image of WV4 with the tailgate of the truck up, but the ladder not present.

CCTV of WV4 returning to the engineering base at 2159 hrs

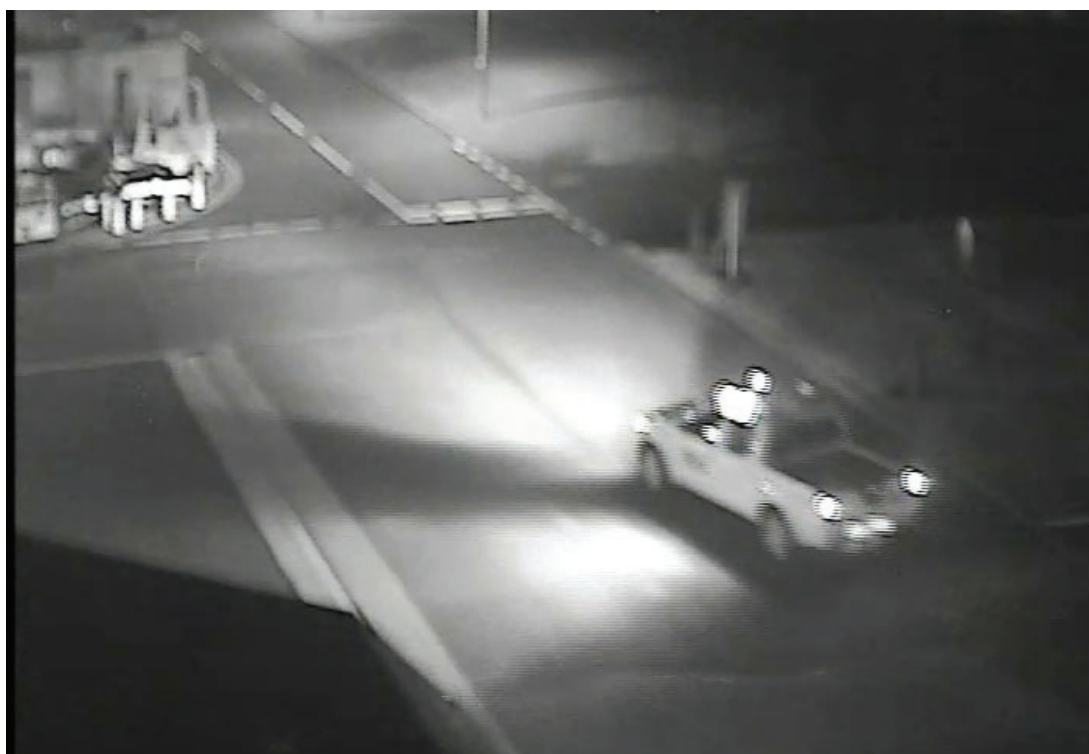
Figure 12

At 2218 hrs Technician 1 was informed by ATC that the first inbound aircraft was 20 nm from touchdown. This was acknowledged by Technician 1, and Technician 2 got back into the vehicle before they vacated the runway via Taxiway B. The vehicle again passed the fire station at 2220 hrs as shown at Figure 12. Note, the tailgate of the truck is up, and the ladder is not present.

WV4 passing the fire station at 2220 hrs

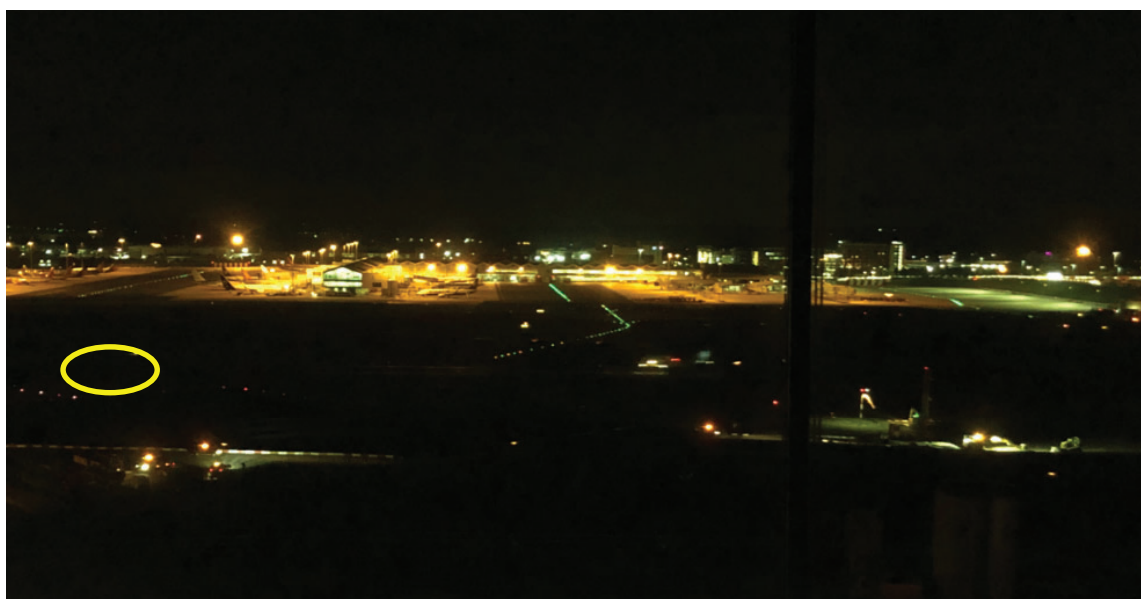
The visual control tower has a view of the whole manoeuvring area of the airport. At night this view is restricted simply because large parts of the airport, including the runway, are not illuminated by overhead lighting. Figure 13 shows the view from the visual control tower at night. It is clear from the picture that it was not possible for the tower controller to either see the ladder coming off WV4 or to spot it laying on the runway. The approximate area where the ladder was found is highlighted.

View from the visual control tower at night with the approximate area where the ladder was found highlighted
