ACCIDENT

Aircraft Type and Registration:	DJI Matrice 200 V1, (UAS, registration n/a)
No & Type of Engines:	4 electric motors
Year of Manufacture:	2018 (Serial no: 0FZDF7U0P30222)
Date & Time (UTC):	1) 21 September 2019 at 1318 hrs 2) 29 November 2019 at 1022 hrs
Location:	1) Near Raigmore Hospital, Inverness 2) Montrose, Angus
Type of Flight:	Commercial operation
Persons on Board:	Crew - N/A Passengers - N/A
Injuries:	Crew - N/A Passengers - N/A
Nature of Damage:	1) Landing gear, lower cowl, rear antennas and forward camera damaged 2) Landing gear and rear control link antenna damaged
Commander's Licence:	Other
Commander's Age:	39 years
Commander's Flying Experience:	1) 86 hours (of which 27 were on type) Last 90 days - 9 hours Last 28 days - 4 hours 2) 88 hours (of which 29 were on type) Last 90 days - 11 hours Last 28 days - 2 hours
Information Source:	AAIB Field Investigation

Synopsis

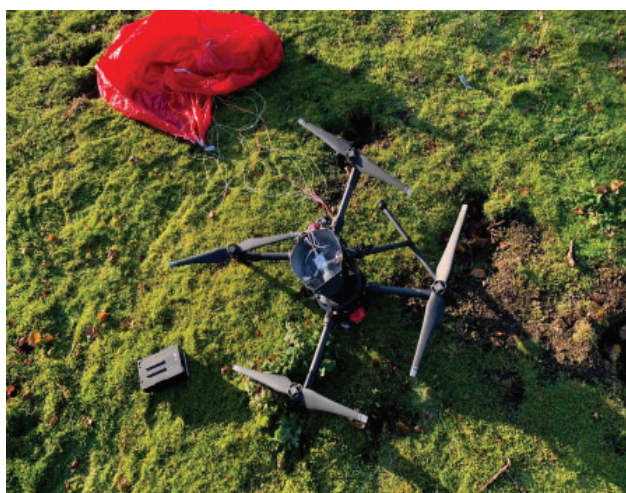
Figure 1

The aircraft descended under the parachute drifting to the east in light winds. It remained in sight during the descent and came to rest approximately 130 m from the launch point in grassy, open ground (Figure 1). One of the batteries dislodged as the aircraft struck the ground.

There were no injuries to people on the ground or damage to other property. The pilot inspected the aircraft and determined that the parachute mounting bracket, mounting legs and associated screws were secure. After recovery the aircraft could still be started and operated with the same battery set that had been installed during the accident flight.

Aircraft after parachute deployment on 29 November 2019

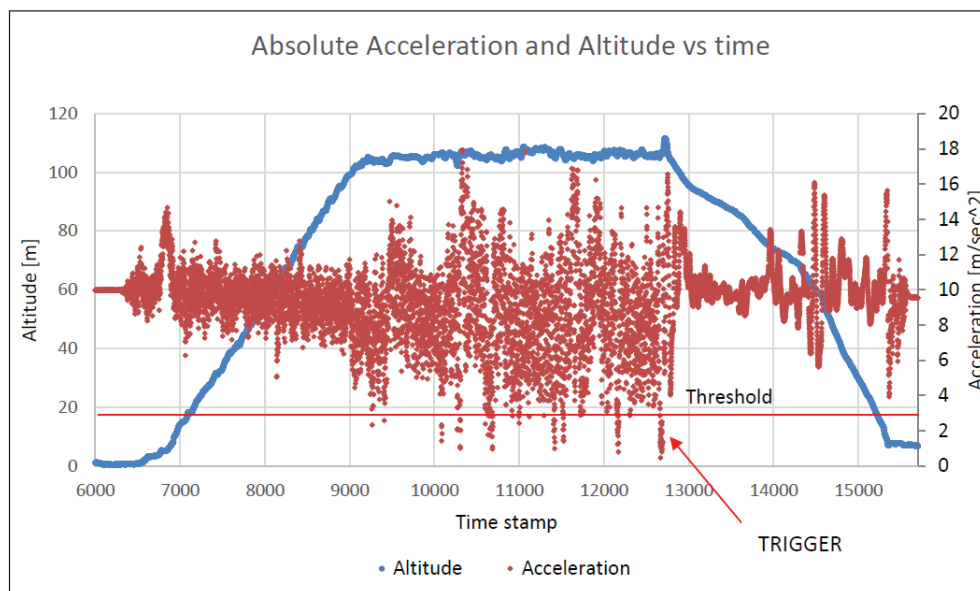
Figure 4

The parachute manufacturer analysed the log file from the parachute system. This showed an extensive vibration pattern after 9000 on the 'Time stamp' x-axis (Figure 4), which subsequently triggered the parachute deployment. The vibration pattern changed after deployment of the parachute as the power to the aircraft motors was cut by the TerminateAir system.

Plot showing salient recorded data from SafeAir for the accident flight

The parachute manufacturer concluded that it was highly probably that the cause of the parachute deployment on the 21 September 2019 accident flight was induced vibration due to loose attachment of the SafeAir unit to the aircraft.

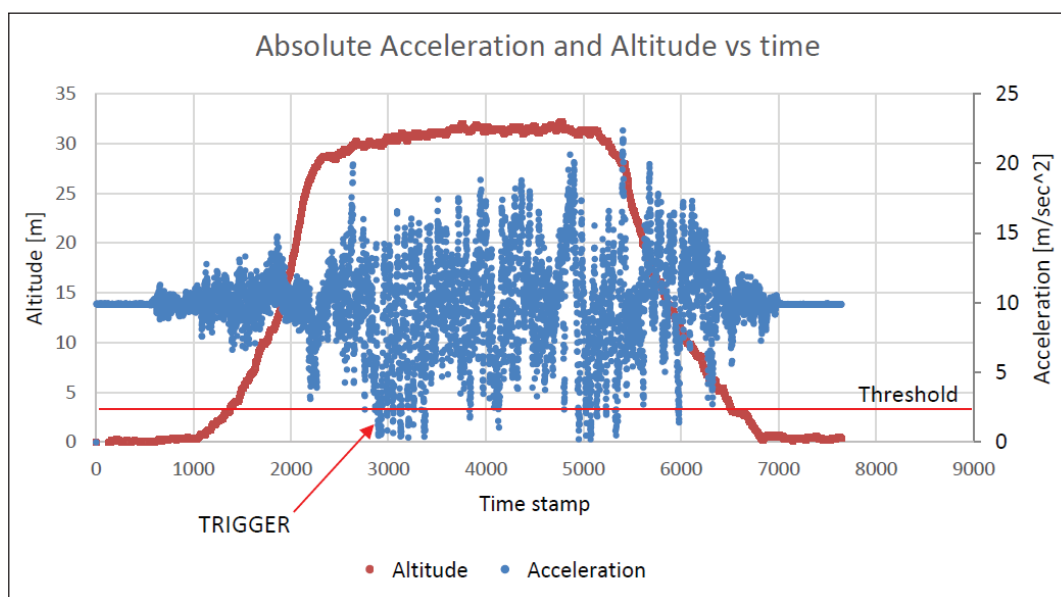
Figure 5

The parachute manufacturer advised that vibration can arise due to an attachment problem between the SafeAir system and the UAS. To try and replicate the unusual vibration pattern seen during the accident flight, a second test flight was performed. For this flight, the four thumb screws which connect the parachute to its mounting legs, were intentionally loosened. This produced an extensive vibration pattern which triggered a parachute deployment signal (Figure 5). Unlike the accident flight, the vibration pattern continued after the parachute trigger, as the dummy pyrotechnic device prevented the parachute from deploying.

Plot showing salient recorded data from SafeAir for the second test flight

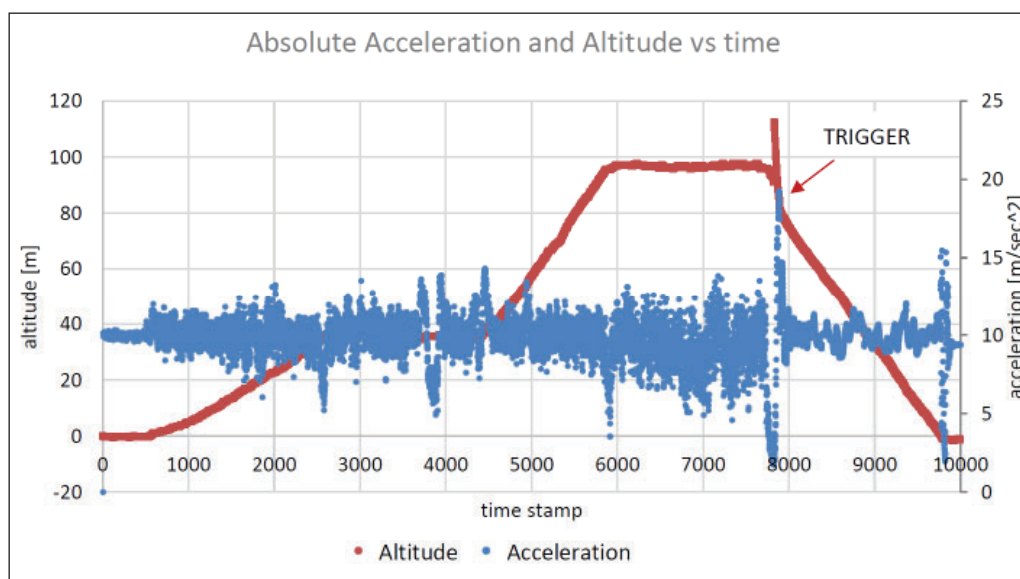
Figure 6

The parachute manufacturer analysed the log files from the parachute system and the aircraft and stated that both files were similar, with identical altitude and acceleration, until the point of parachute deployment. The aircraft's data log ended at cruise altitude, while the parachute system log (Figure 6) continued to record a fall in altitude, followed by the parachute deployment, which was characterised by erratic altitude and acceleration readings, before a constant rate descent to the ground.

The parachute manufacturer noted several warnings/errors in the aircraft's flight log and it considered that the sudden end of the aircraft's data log could be explained by a total aircraft power failure. It therefore did not examine the SafeAir system and no test flights were performed.

Plot showing salient recorded data from SafeAir for the second parachute deployment

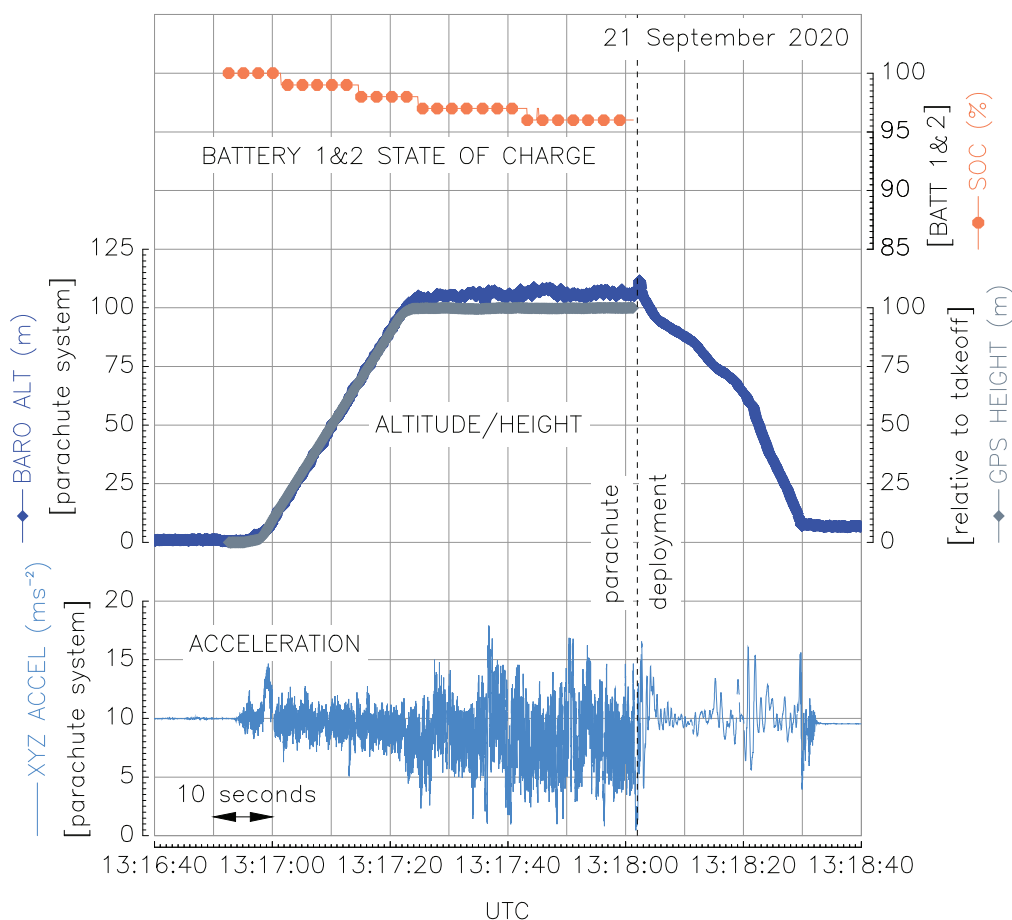
The recorded aircraft data confirmed that the recording ended abruptly after about 65 seconds of flight with the aircraft in the hover about 100 m above the ground, and at which point the energy level (state of charge (SOC)) of the aircraft's batteries was 96% (Figure 7). Not shown in Figure 7 is the aircraft's vertical velocity which changes from zero (whilst the aircraft is hovering) to 0.4 m/s in a downward direction over the last 0.2 s of recording. No warnings were recorded in the aircraft's controller log file.

The acceleration recorded by the parachute system is also plotted in Figure 7 and shows that the amplitude of the oscillations in acceleration appear in places to be biased below 9.81 m/sec² (1g) and dropping briefly below the 3 m/sec² trigger threshold about 20 times.

Flight data from the aircraft's controller and the parachute system for the 21 September 2019 accident flight

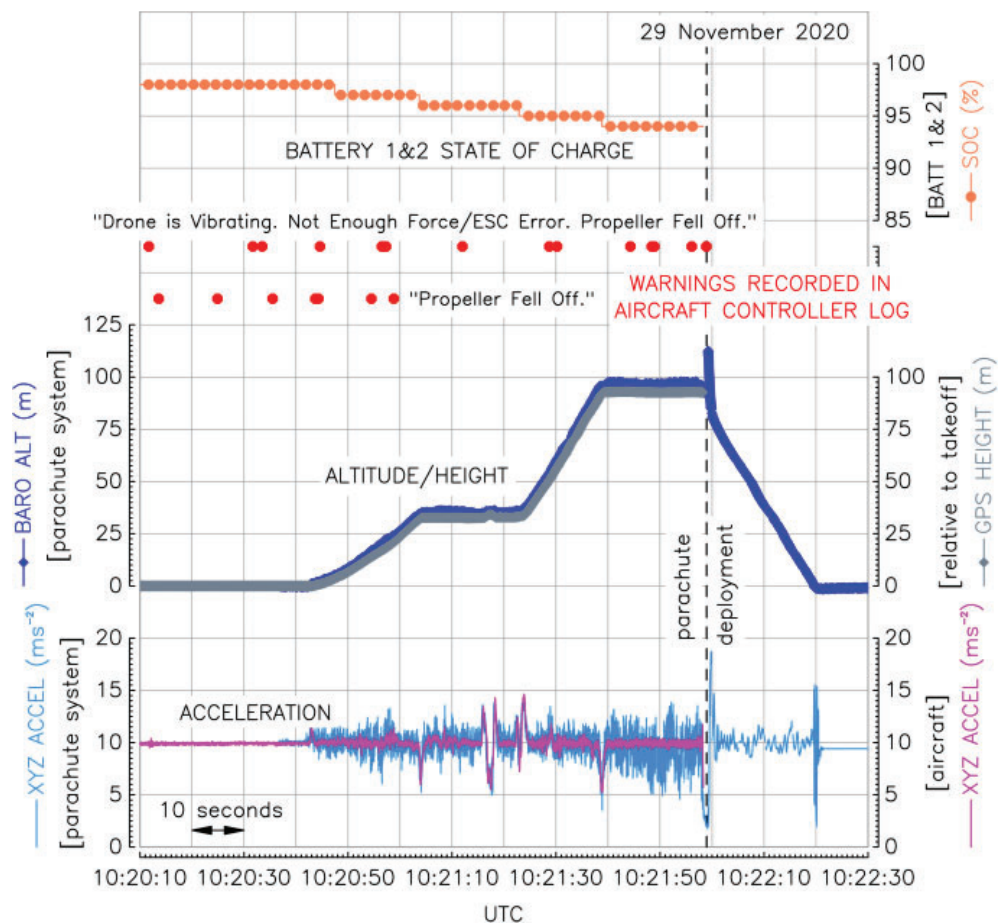
The recorded aircraft data confirmed that the recording ended abruptly after about 75 seconds of flight with the aircraft in the hover about 93 m above the ground, and at which point the energy level (state of charge(SOC)) of the aircraft's batteries was 94% (Figure 8).

Figure 8 also shows some of the warnings recorded in the aircraft controller log³. These included seven 'Propeller Fell Off' warnings, prior to takeoff, three of which also contained the message 'Drone is Vibrating. Not Enough Force/ESC Error.' After takeoff there were another 15 'Propeller Fell Off' warnings, 12 of which contained the message 'Drone is Vibrating. Not Enough Force/ESC Error'. Some of these also contained the message 'Barometer is Dead in Air. Motor is Blocked'.

Flight data from the aircraft and controller and the parachute system for the 29 November 2019 accident flight

Figure 8 also compares the aircraft's altitude and acceleration data with the equivalent data from the SafeAir log file. It shows that as the flight progressed, the acceleration recorded by the SafeAir system grew in amplitude compared to that recorded by the aircraft. The two data sets were aligned to within 10 ms at the start and throughout most of the recording, by matching the acceleration peaks and troughs associated with level changes in altitude. The accelerations throughout the flight were generally smaller in amplitude than those of the 21 September 2019 accident flight shown in Figure 7 and did not suggest the presence of excessive vibration

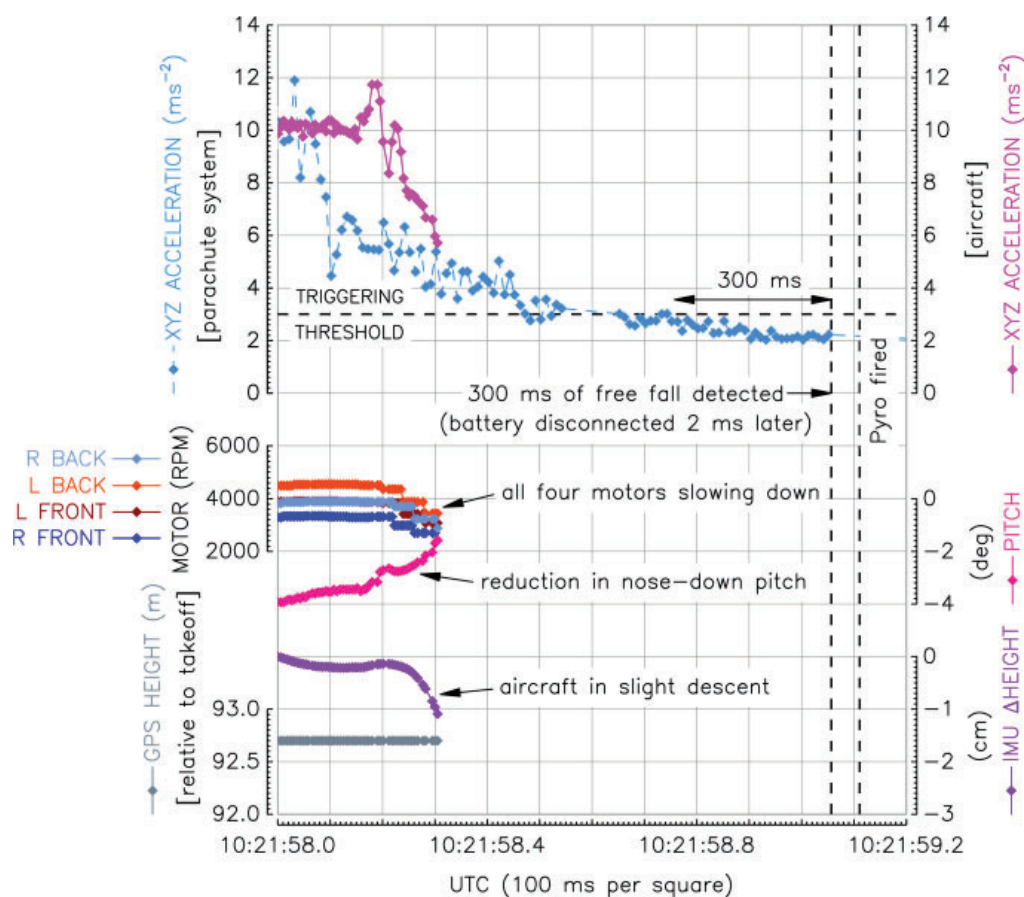
Figure 9 is a close up of the end of the aircraft data and when the parachute was deployed. The aircraft data shows that all four motors started to slow down over the last 0.1 s of recording with a corresponding decrease in the height and acceleration. The drop in the aircraft's acceleration is similar to that recorded by the parachute system; however, they are misaligned by about 150 ms. The parachute system's acceleration continued the fall below the parachute trigger threshold where it remained for 300 ms before triggering the TerminateAir and then deploying the parachute 50 ms later.

Comparison of acceleration prior to parachute deployment
