## ACCIDENT

<b>Aircraft Type and Registration:</b>	Cessna F150K, G-BJOV	
<b>No &amp; Type of Engines:</b>	1 Continental Motors Corp O-200-A piston engine	
<b>Year of Manufacture:</b>	1970 (Serial no: 558)	
<b>Date &amp; Time (UTC):</b>	1 October 2020 at 1615 hrs	
<b>Location:</b>	Near Tiffenden Airfield, Kent	
<b>Type of Flight:</b>	Private	
<b>Persons on Board:</b>	Crew - 2	Passengers - None
<b>Injuries:</b>	Crew - None	Passengers - N/A
<b>Nature of Damage:</b>	Severe damage to nose landing gear. Damage to wings, fuselage, engine and propeller	
<b>Commander's Licence:</b>	Private Pilot's Licence	
<b>Commander's Age:</b>	55 years	
<b>Commander's Flying Experience:</b>	1,146 hours (of which 851 were on type) Last 90 days - 28 hours Last 28 days - 6 hours	
<b>Information Source:</b>	Aircraft Accident Report Form submitted by the pilot

## Synopsis

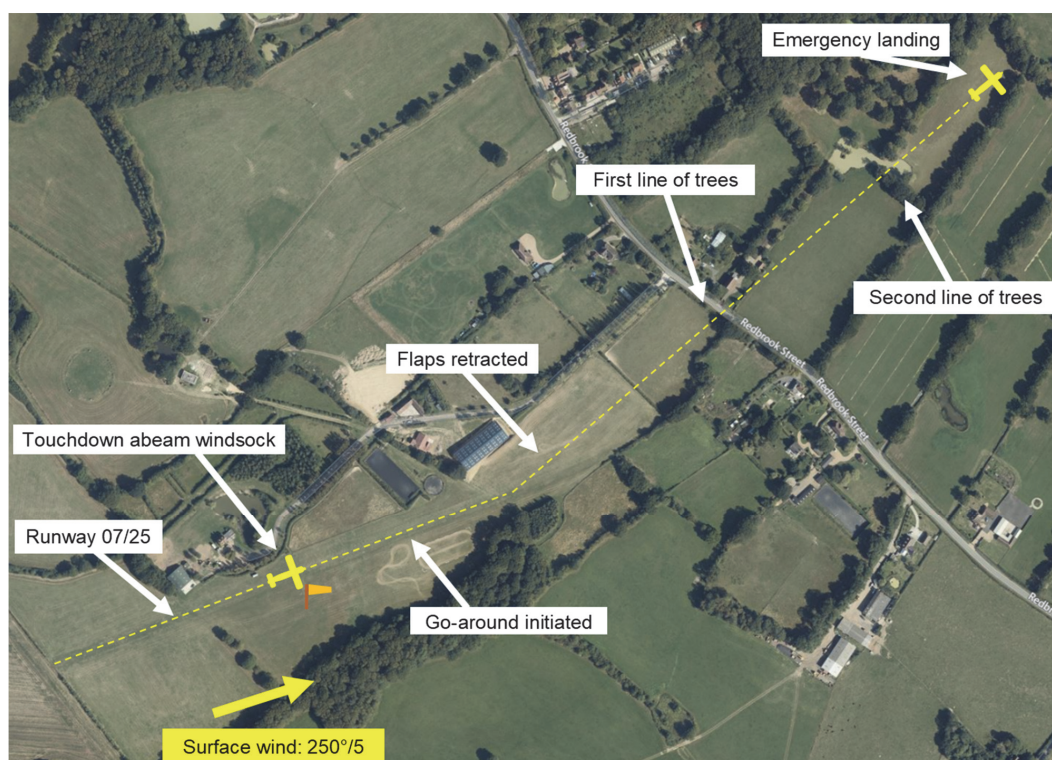
**Figure 1**

Likely because of the steep approach coupled with the tailwind, the aircraft landed heavily further along the runway than planned, approximately abeam the windsock (Figure 1). Due to the heavy landing G-BJOV bounced back into the air. With less than half the runway remaining ahead, the PIC took control and initiated a go-around.

Overview of accident ground track  
(image courtesy of Ordnance Survey ©2021 TomTom)

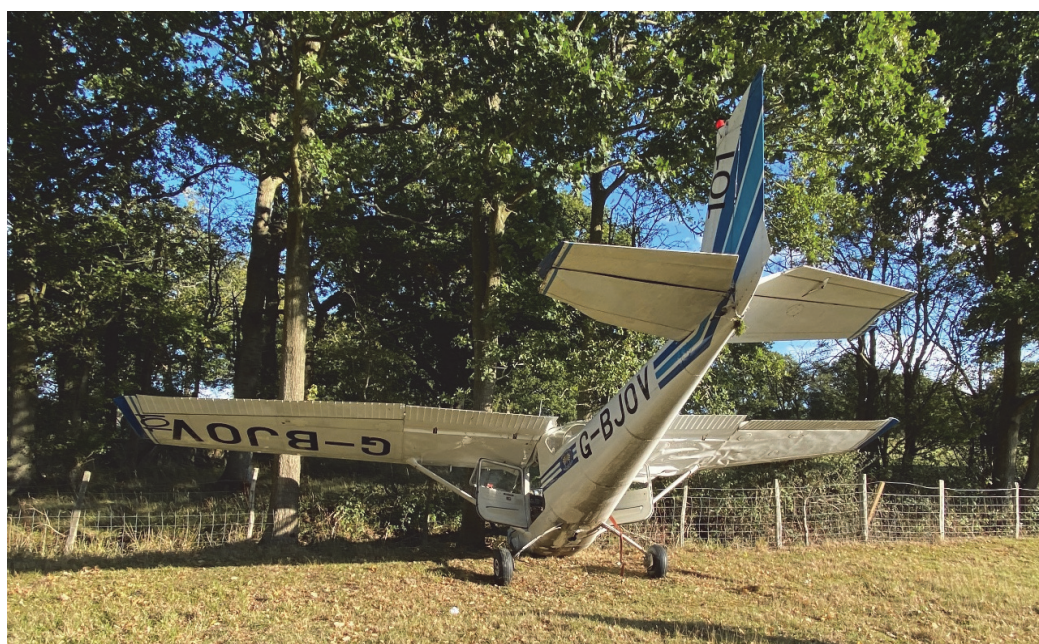
**Figure 2**

landing in the field. At touchdown, the nosewheel collapsed and the aircraft slid to a halt at the edge of the field (Figure 2).

G-BJOV in the treeline  
(image courtesy of PIC)
